Building America Case Study

Field Testing of Compartmentalization Methods for Multifamily Construction

Construction: New construction

Builder: K. Hovnanian Homes, khov.com
Building Science Corporation,
buildingscience.com

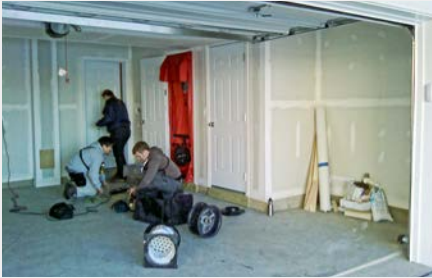
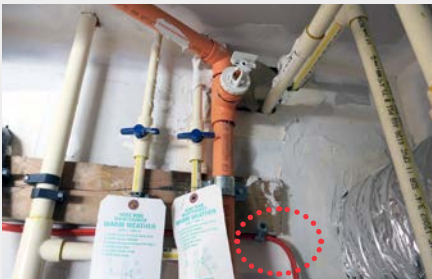
Garage Mechanical Room

Mechanical rooms are located in the rear-facing garage and house the furnace and water heater. This detail appeared to be the source of substantial air leakage. Blower door testing of these rooms' pressure revealed that they were consistently 40% to the exterior/60% interior. The team also ran a "guarded" test, simultaneously depressurizing the mechanical room and the unit. The results indicated that roughly 20% of the unit's total leakage originates at the mechanical room.

Each mechanical room is well connected to the interior (via a supply duct), and to the floor/ceiling cavity above (because of unsealed mechanical penetrations). The floor/ceiling cavity above connects across all framing bays of the garage ceiling, because of a dropped duct soffit. The mechanical penetrations are difficult to address, given the congestion and limited access for air sealing the ceiling and wall details.

Interior mechanical rooms or nonducted mechanical systems are possible options to address these air leakage issues.

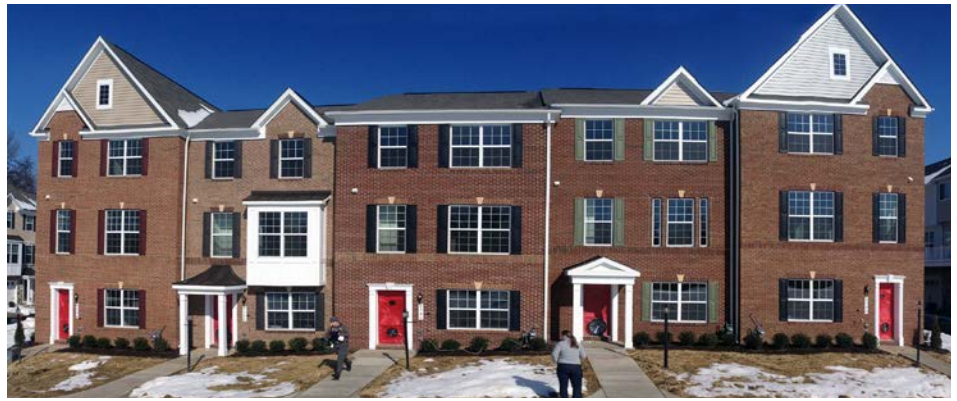
Front elevation, set up for multifan "guarded" testing.
