BACKFLIP: A Comparison of Emerging Non-Fluoropolymer-Based, Co-Extruded PV Backsheets to Industry-Benchmark Technologies

Comparison of market-benchmark BACKsheet technologies to novel non-FLuoro-based co-extruded materials and their correlation and ImPact on PV module degradation rates (BACKFLIP)

NREL/PR-5K00-80362

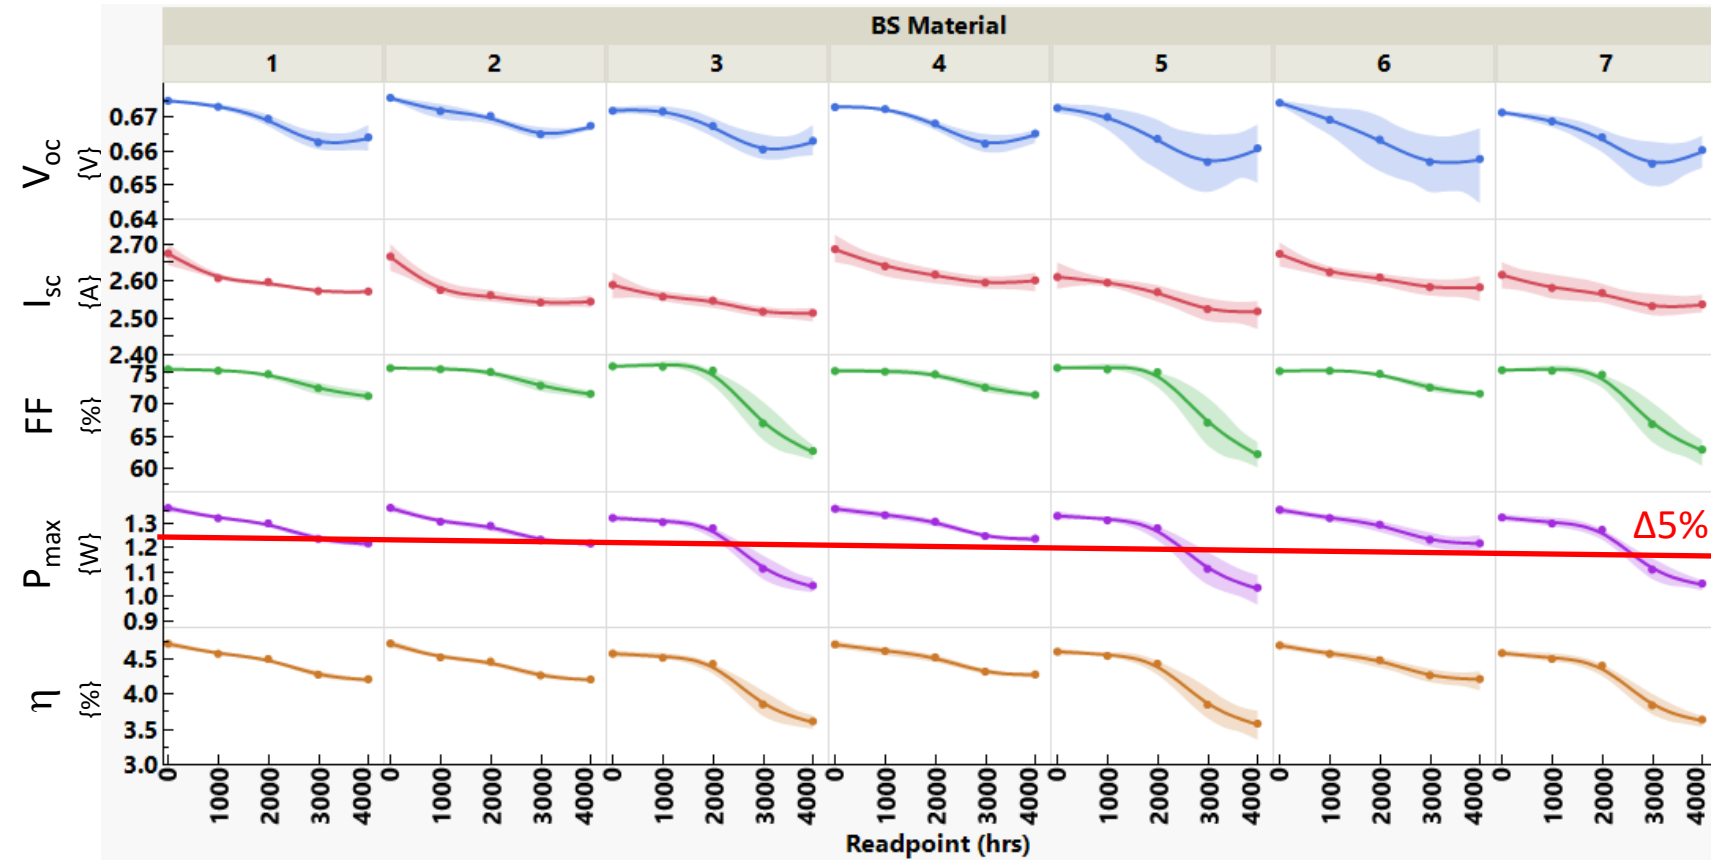
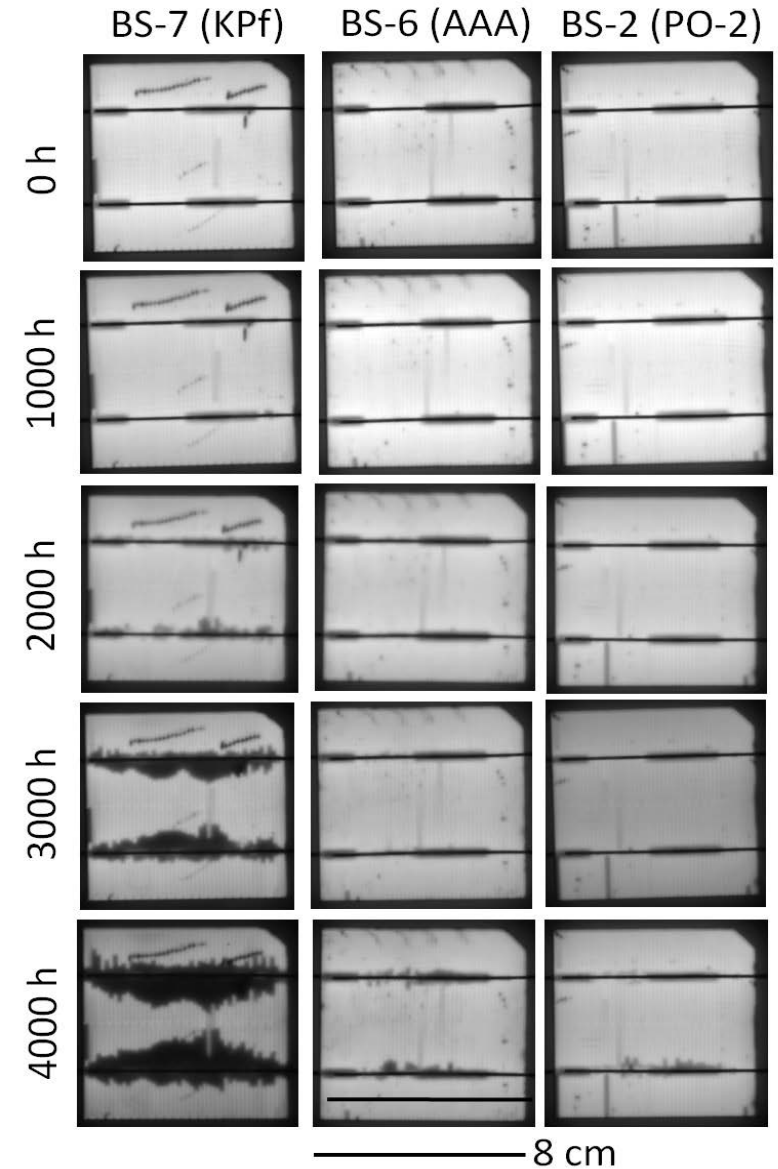
Corrosion of Interconnects Through Damp Heat (85°C/85%RH)

I-V through the 85 °C/85%RH test.

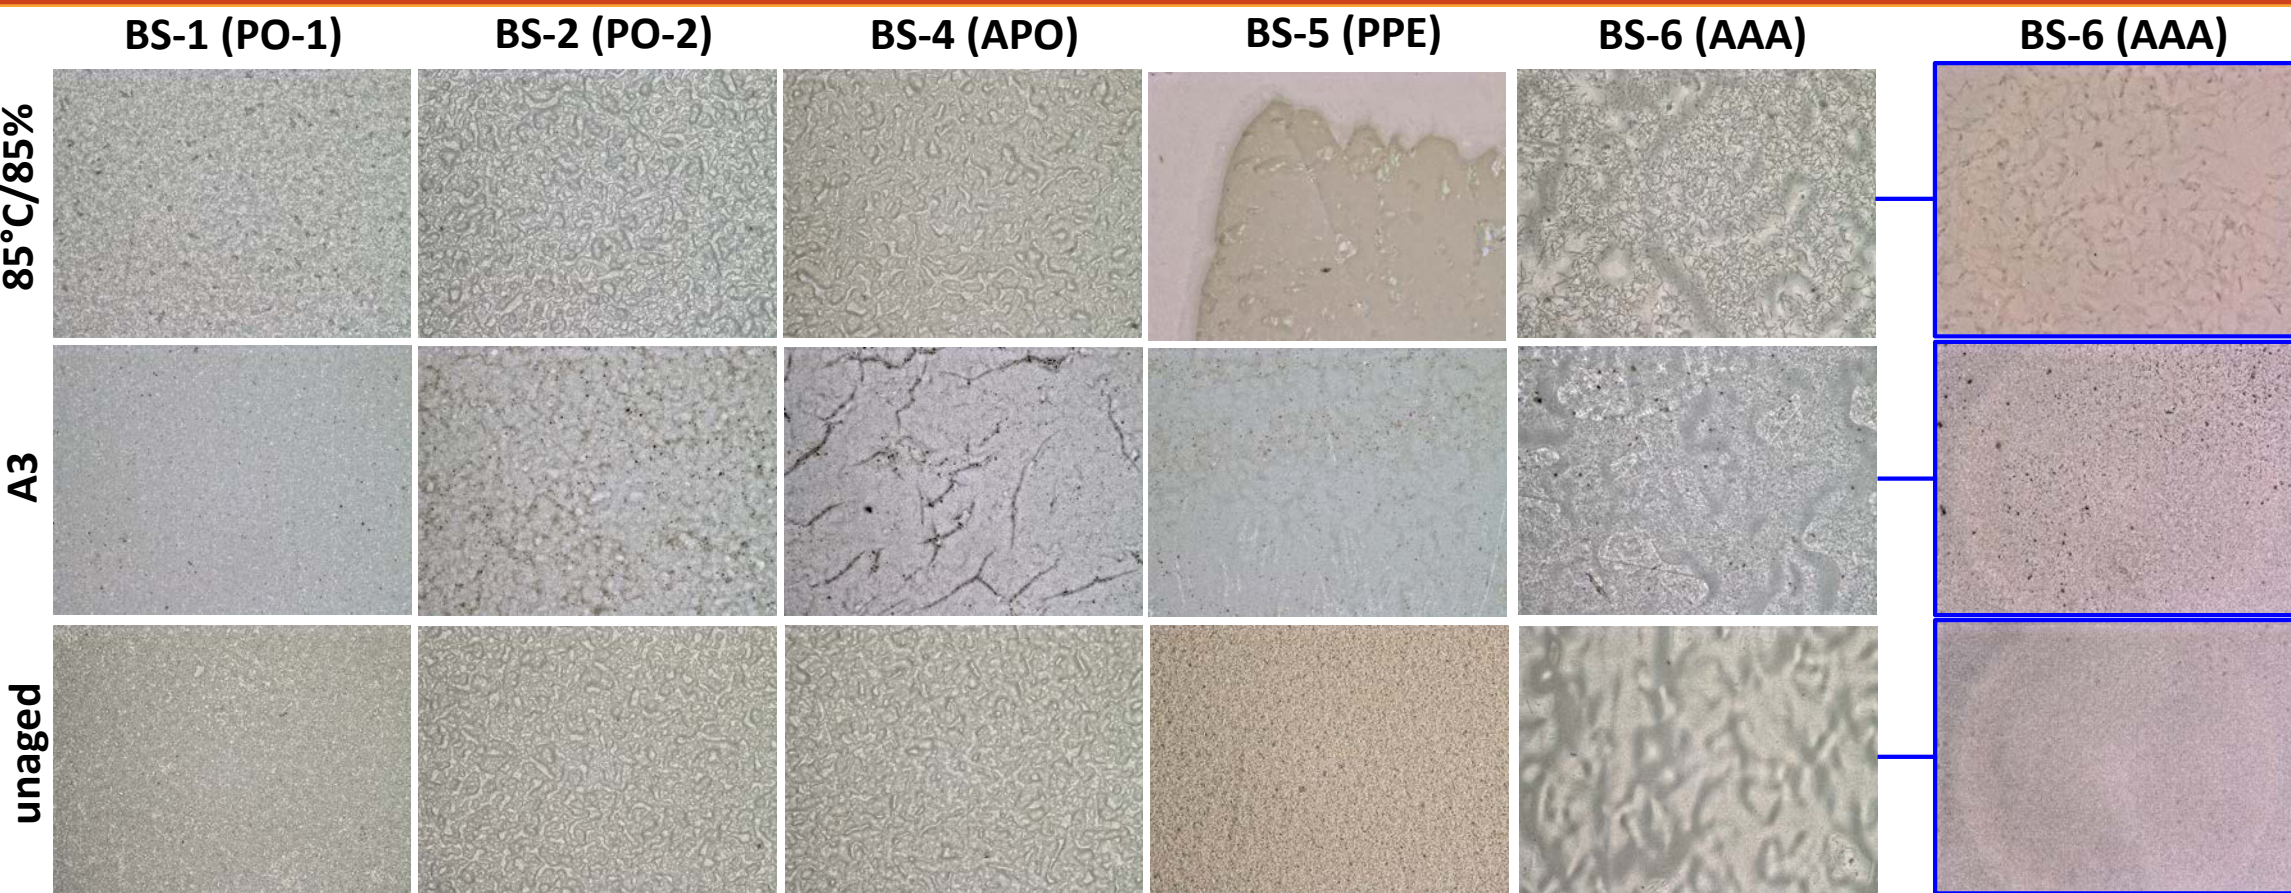
Surface Integrity of Coupon Air Side Surface From Optical Microscopy

Comparison of surface morphology at 4000 h (85°C/85% and A3) relative to unaged. — 500 μm — 100 μm

- Local delamination of surface layer, spalling and cracking of core layer for BS-5 in 85°C/85%. Core probably cracked from handling.
- Micro-cracking of surface layer for BS-4 in A3.
- Incipient micro-cracking of surface layer for BS-6 in 85°C/85%.
- Change in contrast from A3 texture ⇒ roughening of surface for BS-1, BS-2.
- BS-3 and BS-7: no surface damage. ???!!!

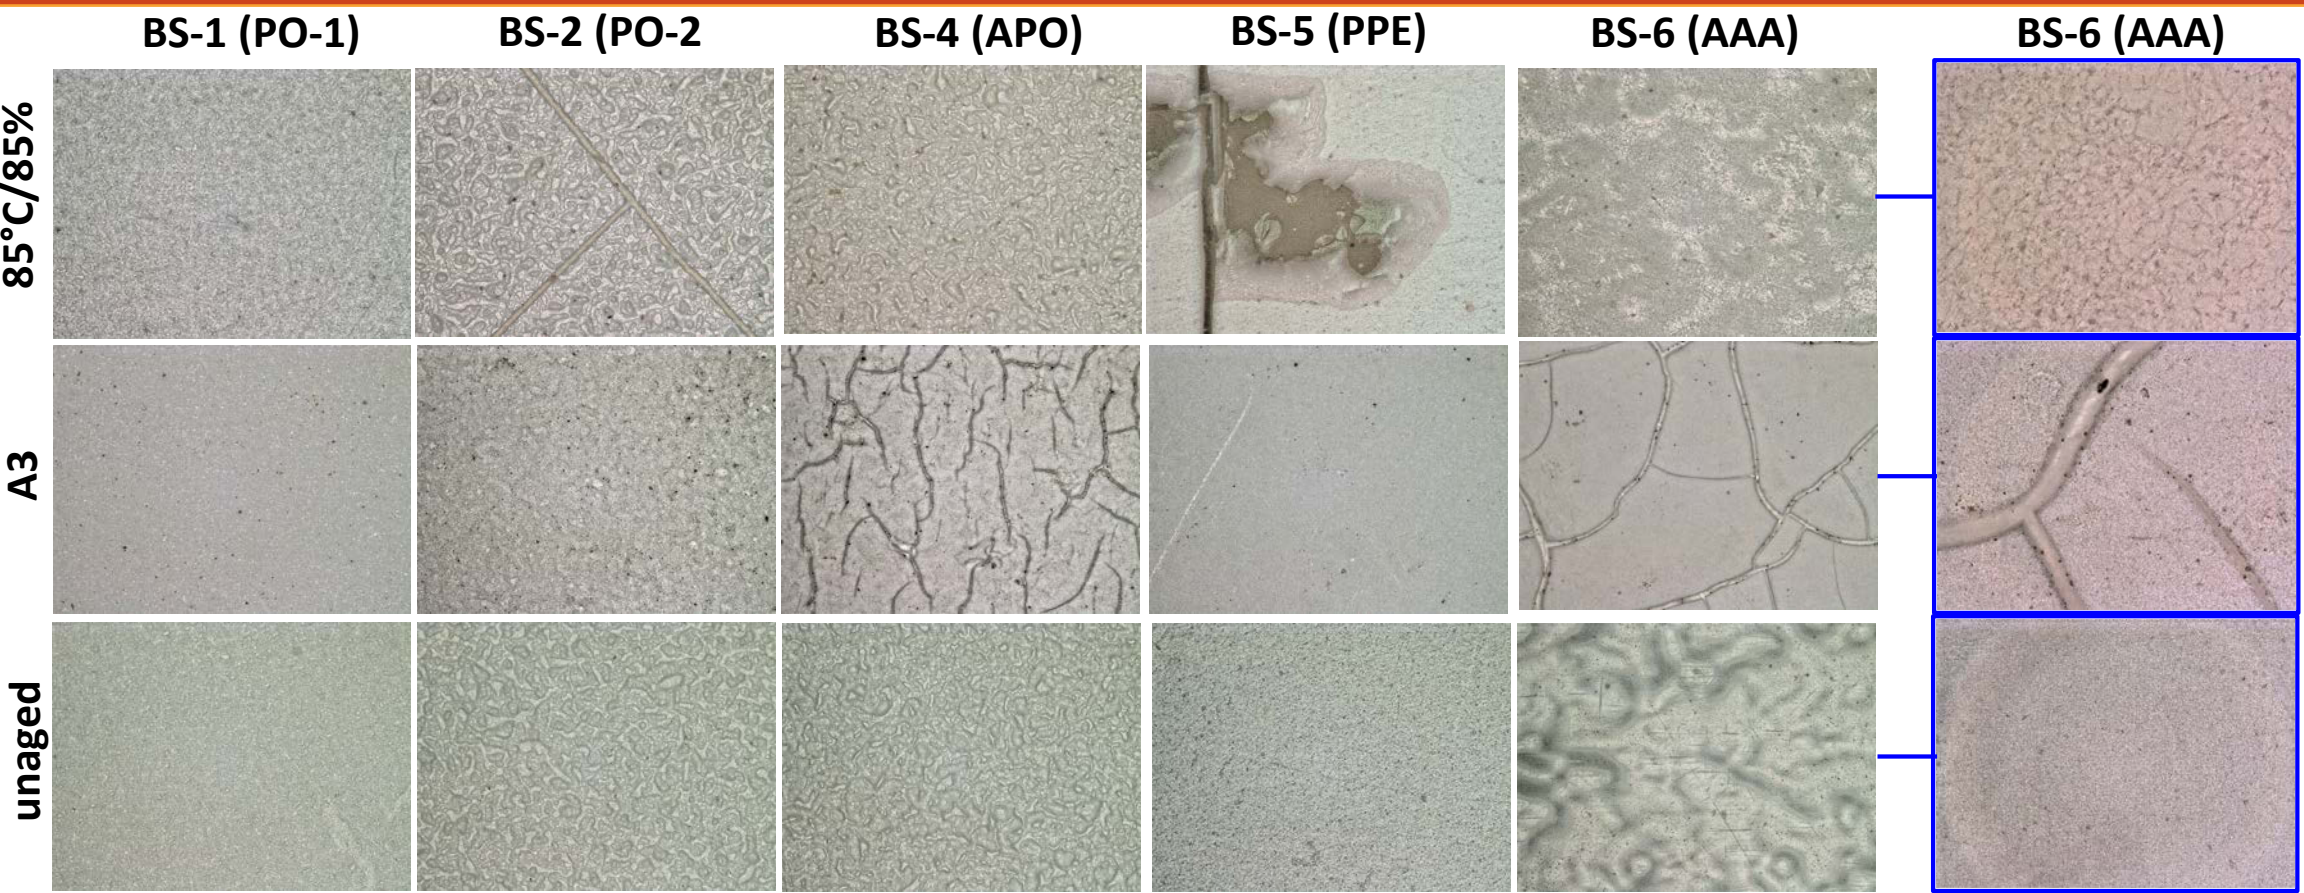
Surface Integrity of MiMo Air Side Surface From Optical Microscopy

Comparison of surface morphology at 4000 h (85°C/85% and A3) relative to unaged. — 500 µm — 100 µm

In addition to coupon observations:

- Surface scratch (observed all BS's) shown for BS-5.
- Micro-cracking BS-2 in 85°C/85%.
- Micro-cracking of surface layer for BS-6 from A3. No incipient micro-cracking in A3.
- BS-4, BS-6: biaxial mud crack geometry presumably results from added misfit strain in MiMos.

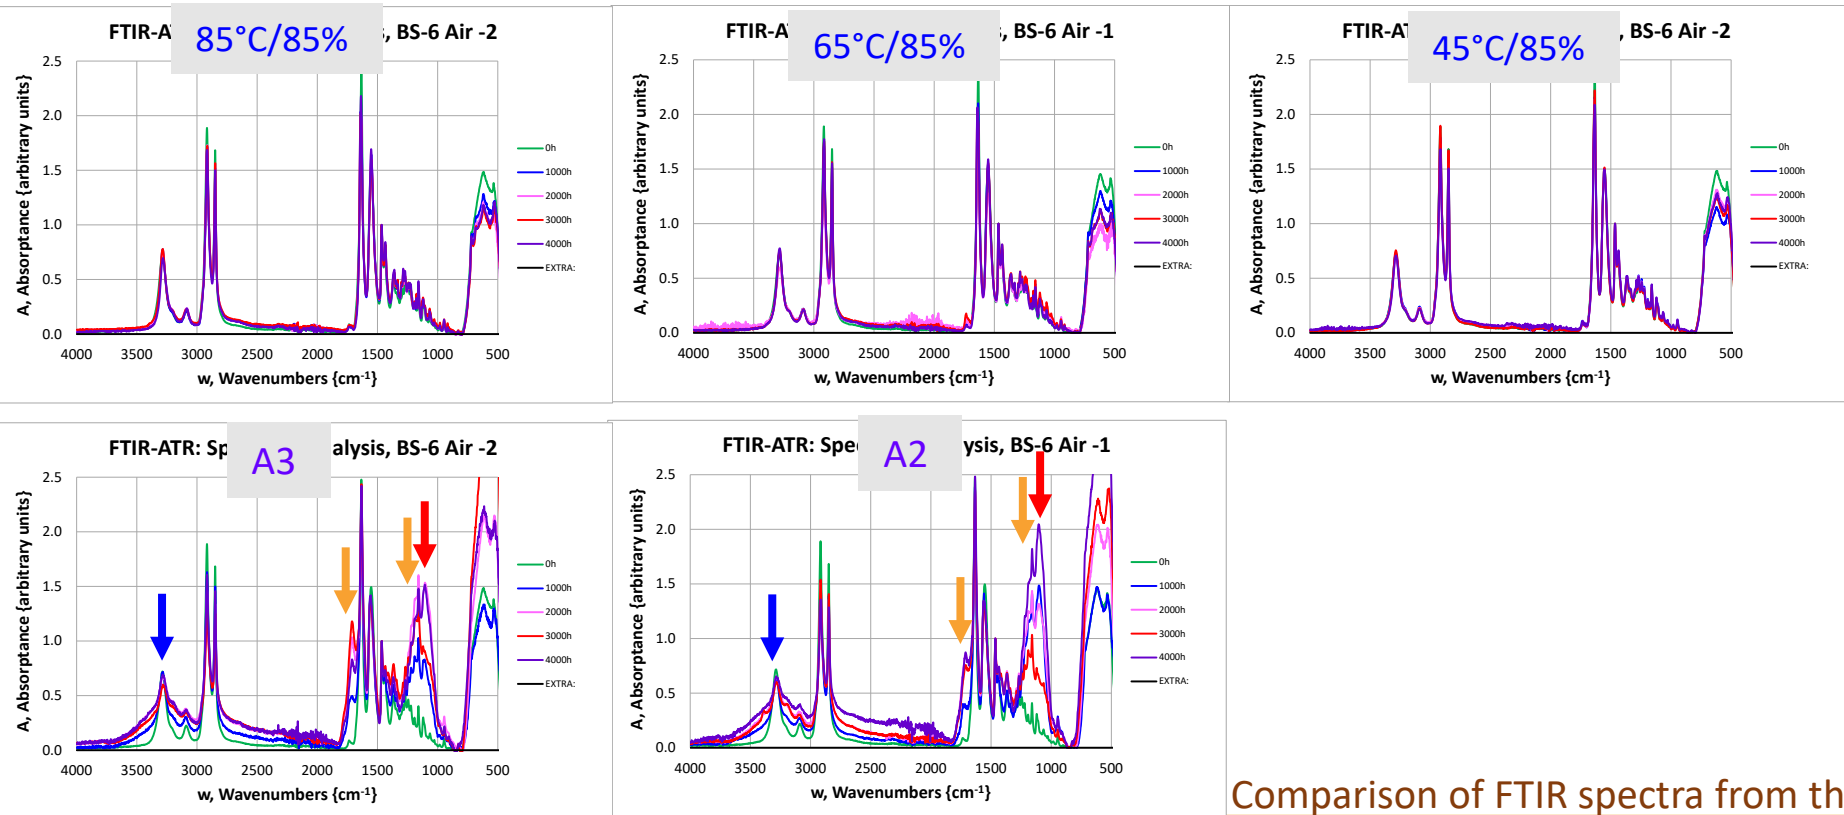
FTIR Confirms Surface Degradation for BS-6 (AAA, Air Side)

- Spectra changed for UV weathering only... photodegradation:
 - Peak broadening about 3282, 2912 cm^{-1} . Peak enhancement at 1710, 1159 cm^{-1} . New peak at 1102 cm^{-1} .
- No changes observed from hygrometric weathering (incipient micro-cracking observed in microscopy).
 - Second thermal degradation mechanism (by chain scission)?
 - Roughening of surface, facilitating cracking?

Comparison of FTIR spectra from the 5 completed experiments.

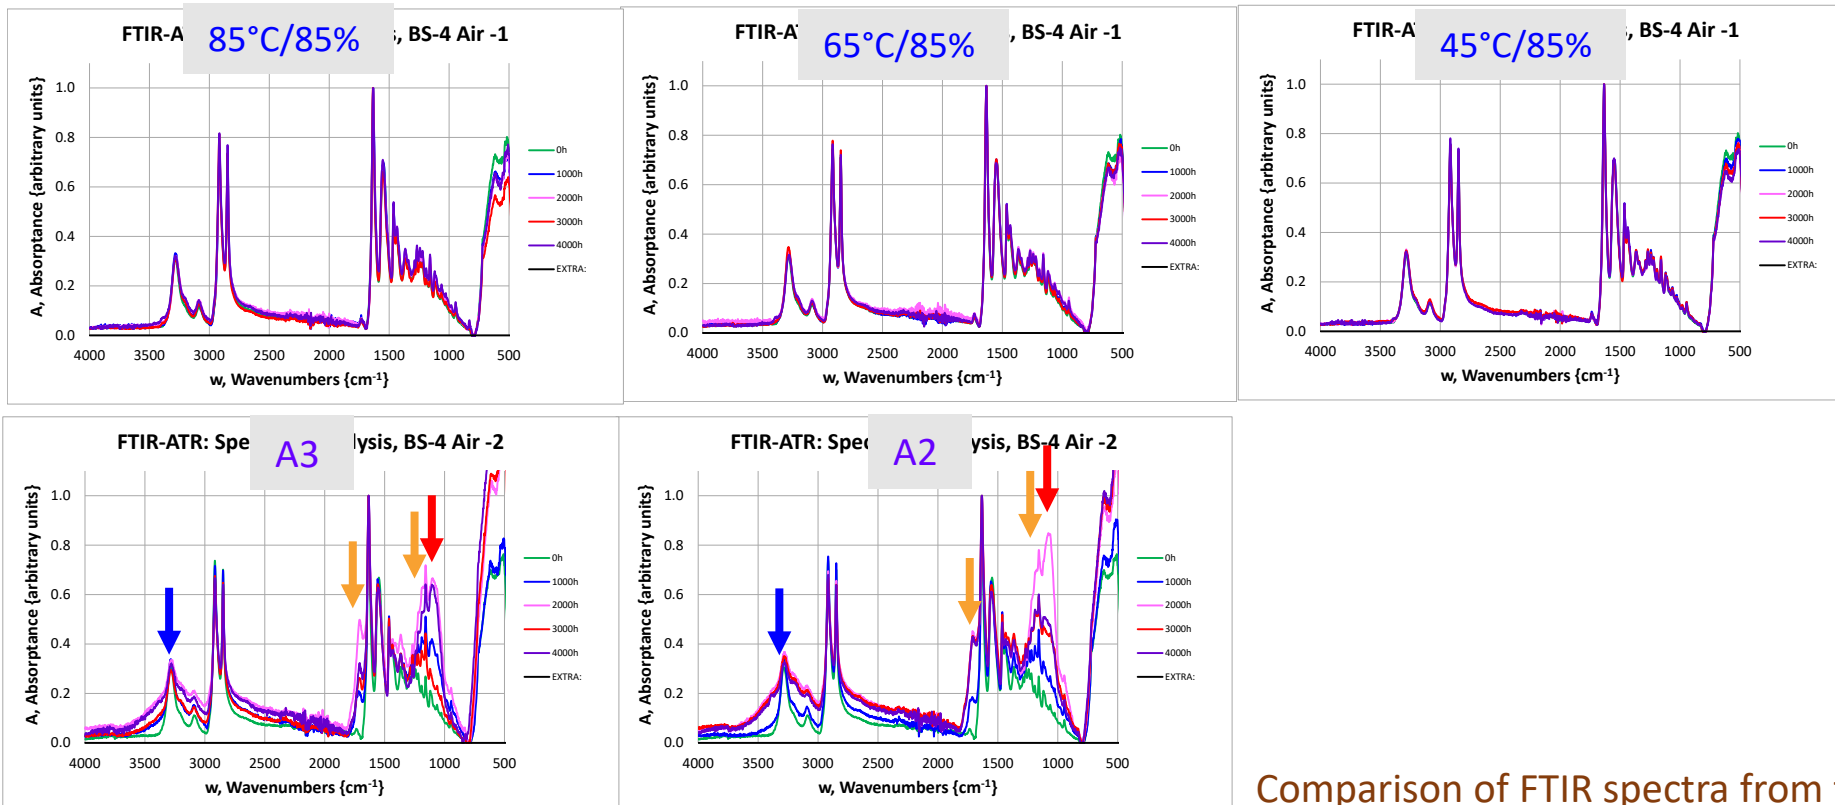
FTIR Confirms Surface Degradation for BS-4 (APO, Air Side)

- Spectra changed for UV weathering only... photodegradation:
 - Peak broadening about 3280, 2914 cm^{-1} . Peak enhancement at 1708, 1157 cm^{-1} . New peak at 1080 cm^{-1} .
 - UV damage occurs with micro-scale mud cracking observed in optical microscopy.
- BS-6 and BS-4 use PA layers.

Comparison of FTIR spectra from the 5 completed experiments.

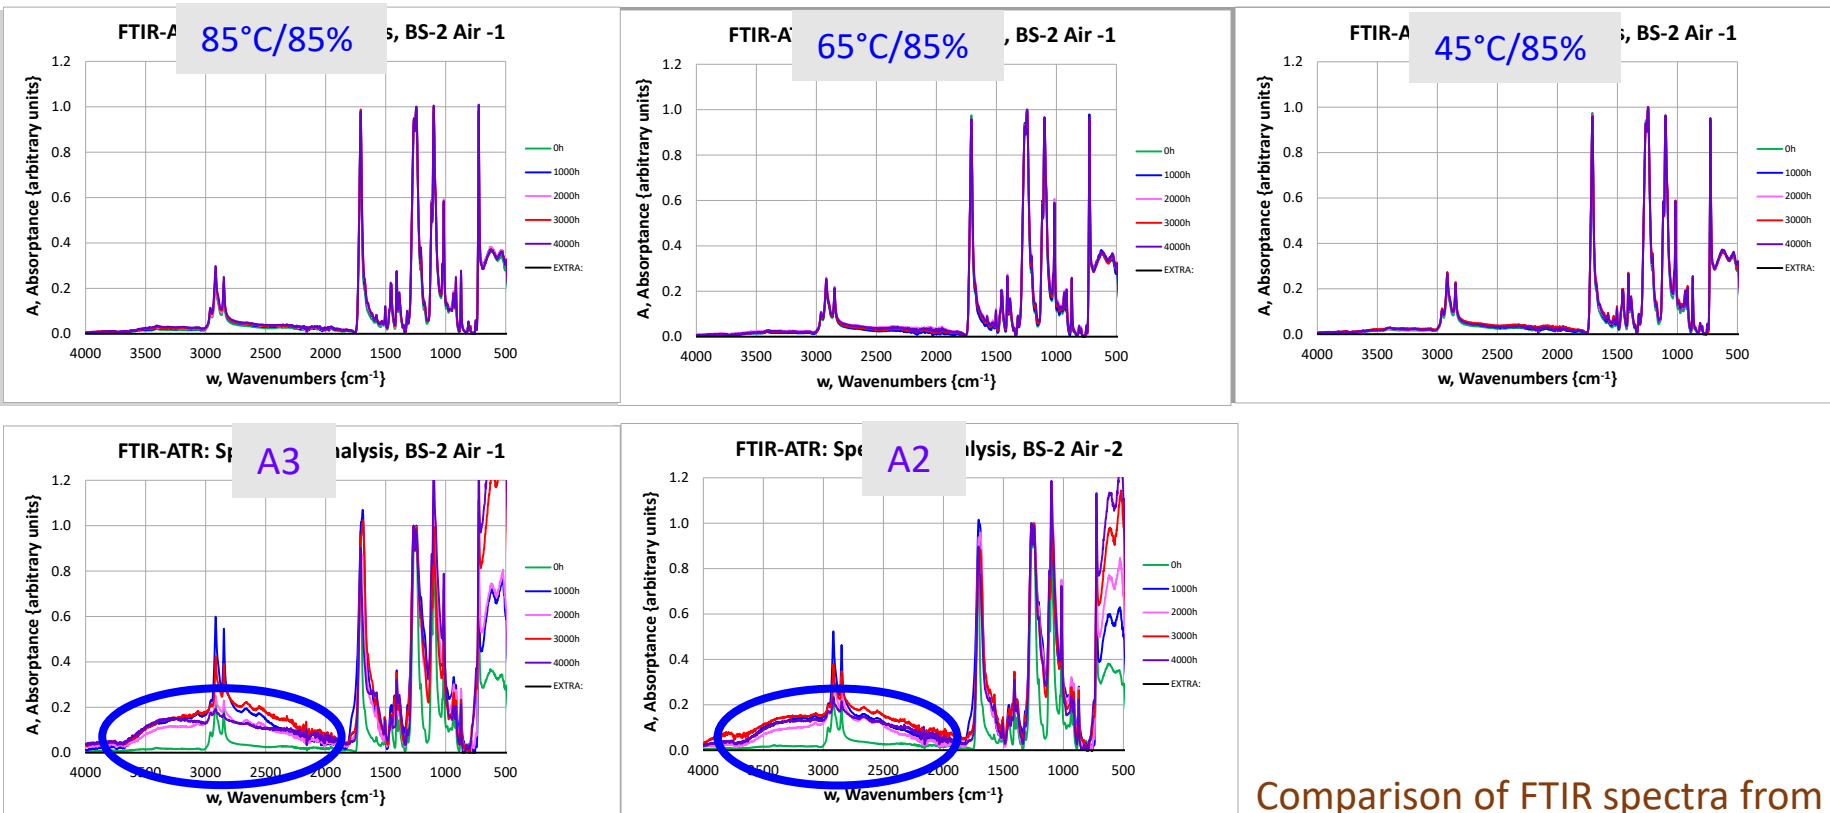
FTIR Confirms Surface Degradation for BS-2 (PO-2, Air Side)

- Spectra changed for UV weathering only... photodegradation:
 - Peak broadening about 2914, 2847 cm^{-1} .
 - UV damage occurs with micro-scale surface roughening in optical microscopy.
- No indication of hygrometric degradation, despite camera & microscope observation of surface cracking.

Comparison of FTIR spectra from the 5 completed experiments.

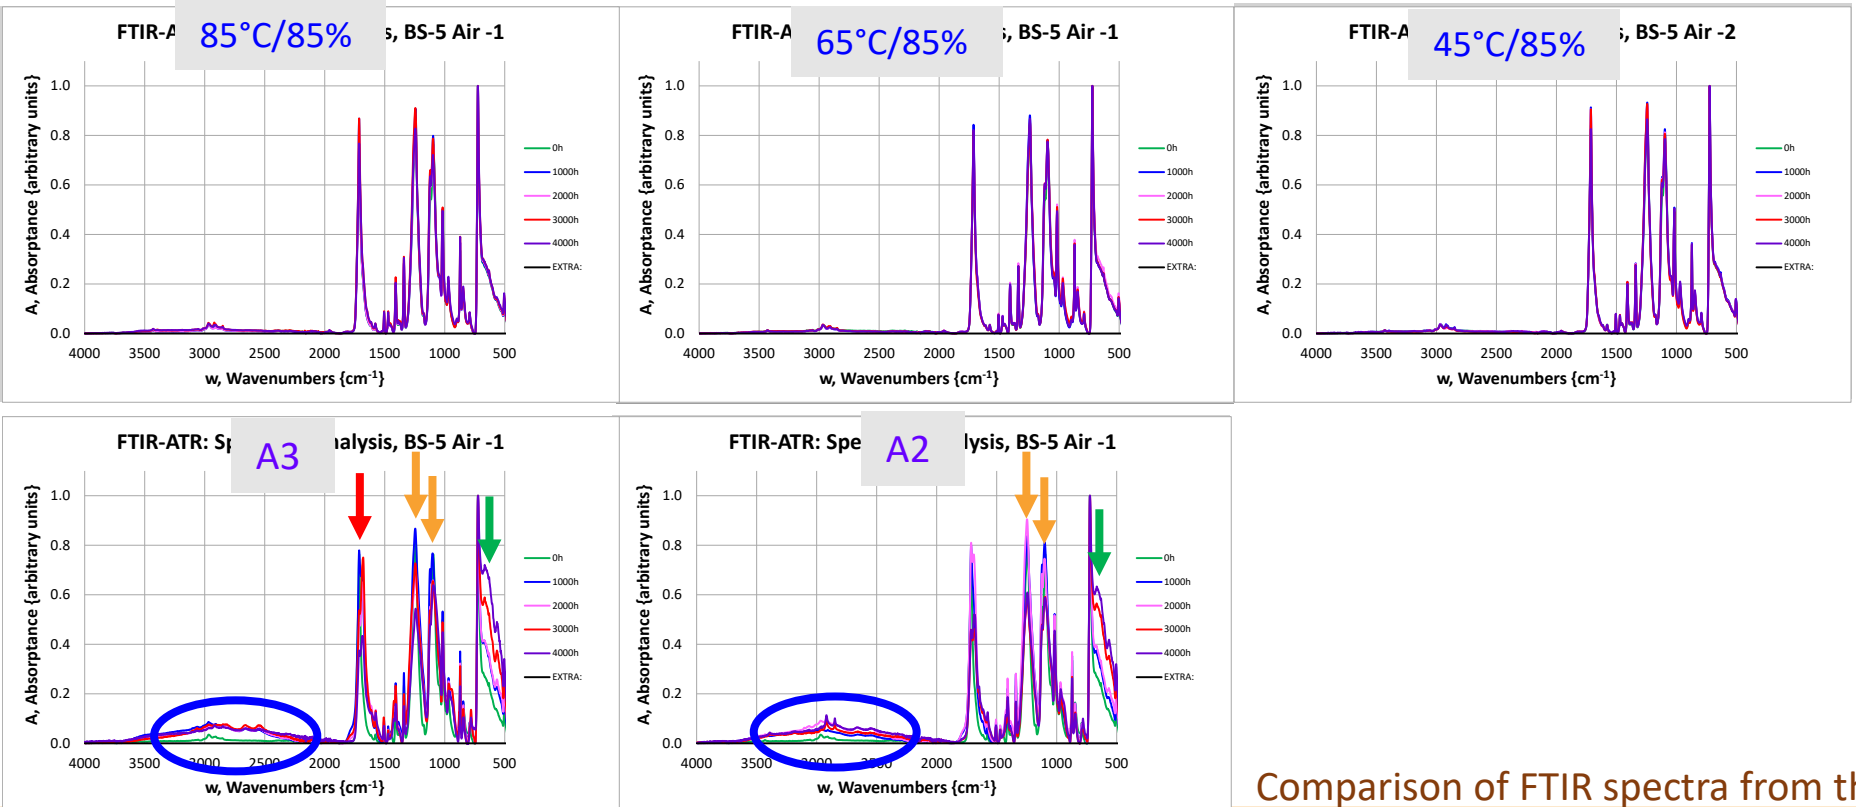
FTIR Confirms Surface Degradation for BS-5 (PPE, Air Side)

- Spectra changed for UV weathering only... photodegradation:
 - Broadening of 2914, 2845, 2653, 2539 cm^{-1} peak region.
 - Shift from 1711 to 1677 cm^{-1} .
 - Loss of intensity at 1237, 1092 cm^{-1} . Increased intensity at 667 cm^{-1} .
 - UV damage occurs with embrittlement, spalling, delamination of surface layer in optical microscopy.
- FTIR examines surface only, no information related to the core layer. Sample depth $\sim 2 \mu\text{m}$ for ATR crystal.

Comparison of FTIR spectra from the 5 completed experiments.

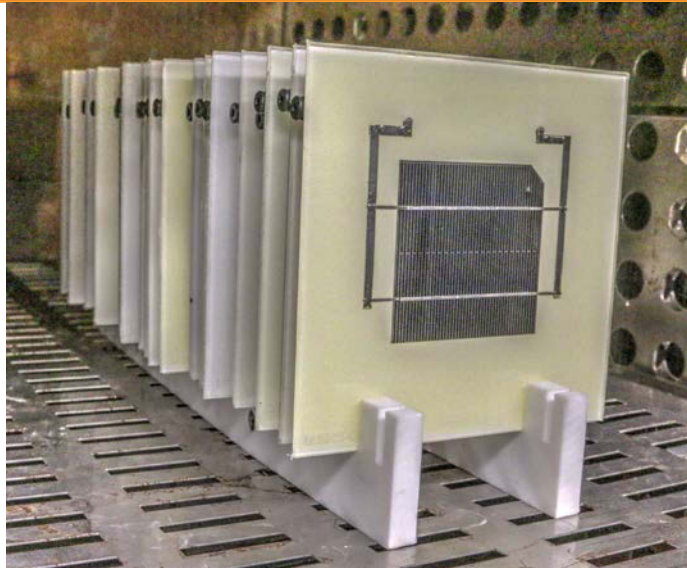
- Overt discoloration observed early ($\sim 300\text{h}$) in experiment 1: $85^\circ\text{C}/85\%$.
- Suspect interaction between EVA/backsheet or EVA/E-layer on backsheet.

MiMo appearance early in Damp Heat experiment.

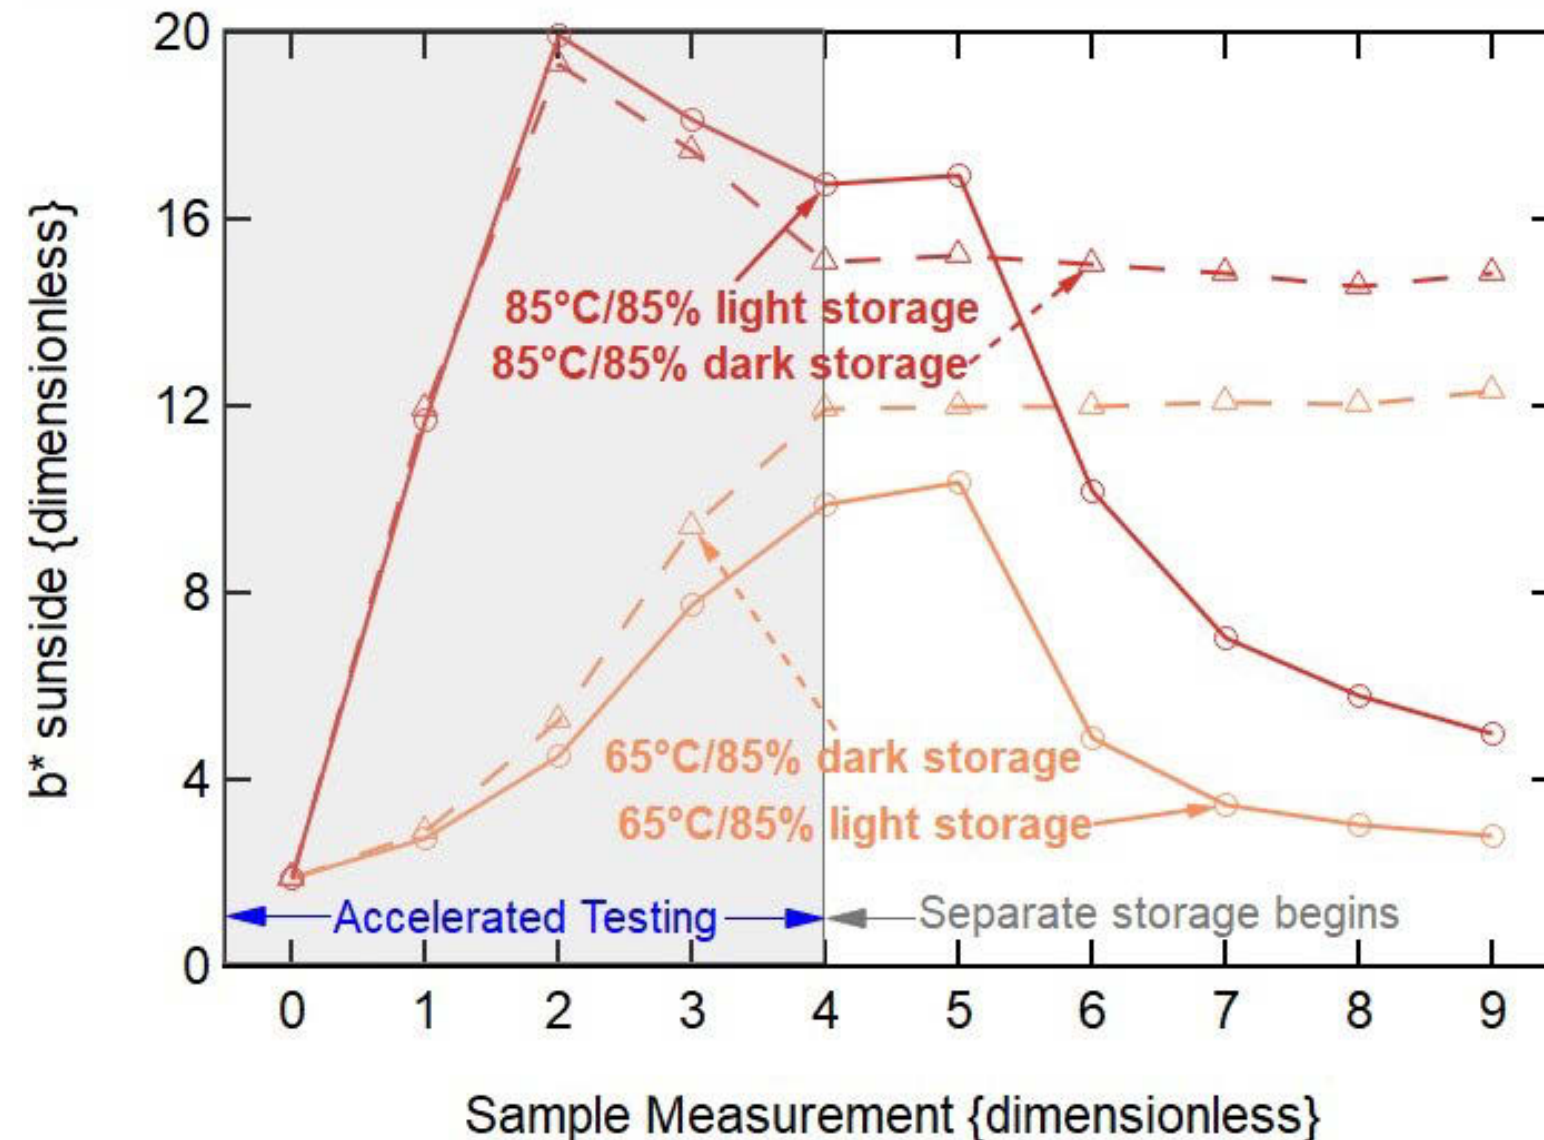
Evolution of b^* , BS-4 (APO) Sun Side Through Darkness and Light

- Substantial photobleaching observed after accelerated testing.
- Both 85 °C/85% and 65 °C/85% affected.
- How close will final b^* approach initial color?

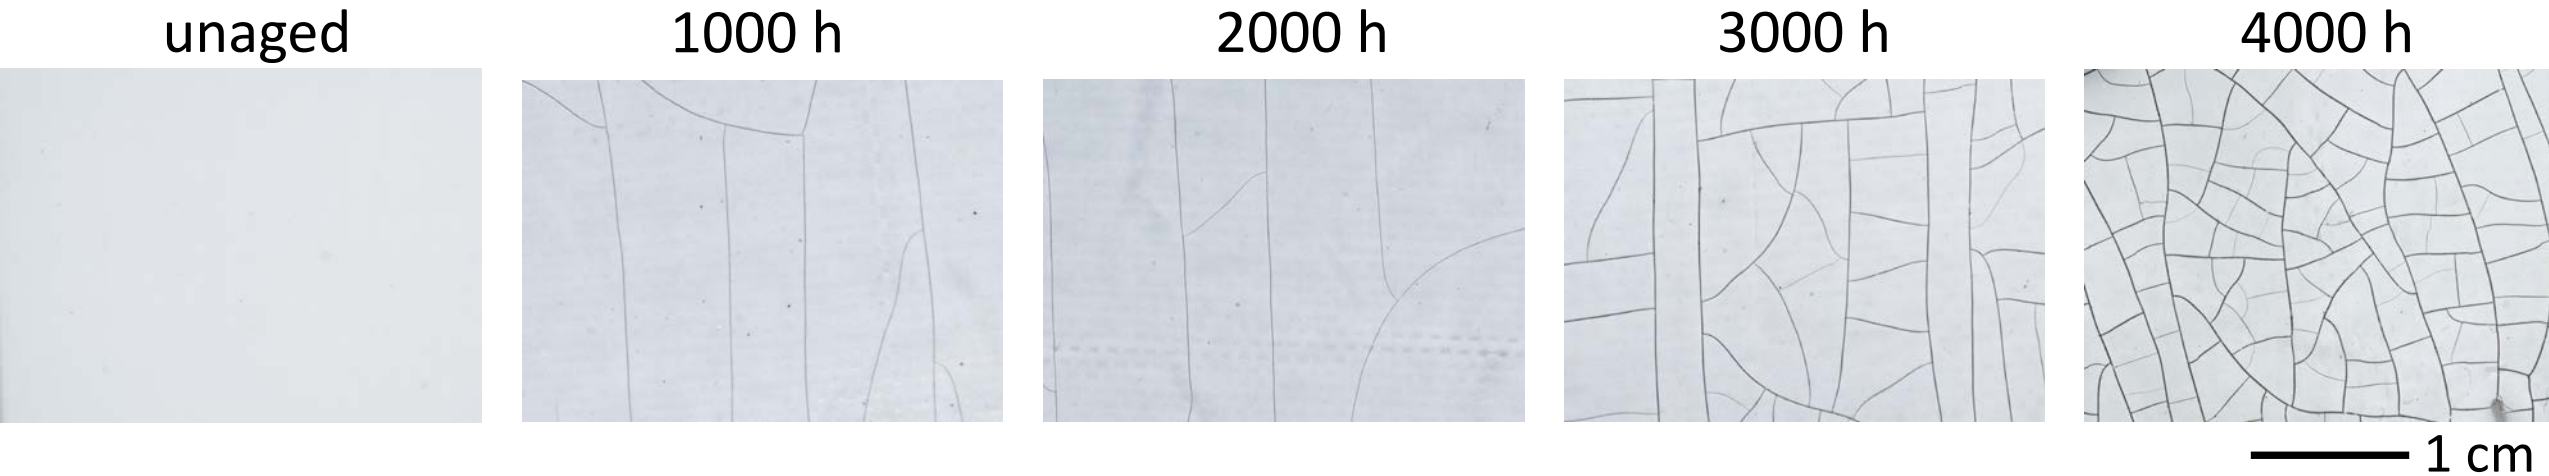
Cracking of the BS-5 (PPE, Coupons Only) Sun Side

- Camera photos: macro-cracking of BS-5 coupons on sun side.
- Observed through A3, A2 experiments.
- Also observed in auxiliary (“Type-5”) coupons (laminated backsheet and encapsulant) in A3.
- No cracking of BS-5 coupons in hygrometric weathering or in BS-5 MiMos.
- Added mechanical constraint of layers in MiMo likely prevents cracking.
- Unlikely that transfer of additives prevents cracking here (as observed in auxiliary coupons).
