# Photovoltaic Module Imaging for Hail Damage Assessment with Multi-Year Follow Up

Steve Johnston, Dana B. Sulas-Kern, and Dirk Jordan  
National Renewable Energy Laboratory, Golden, CO, 80401, U.S.A.

An array of 36 multicrystalline silicon modules installed in 2007 is oriented facing south at a tilt angle of 30 degrees above horizontal. It is located approximately 2 km southwest of NREL in Golden, CO.

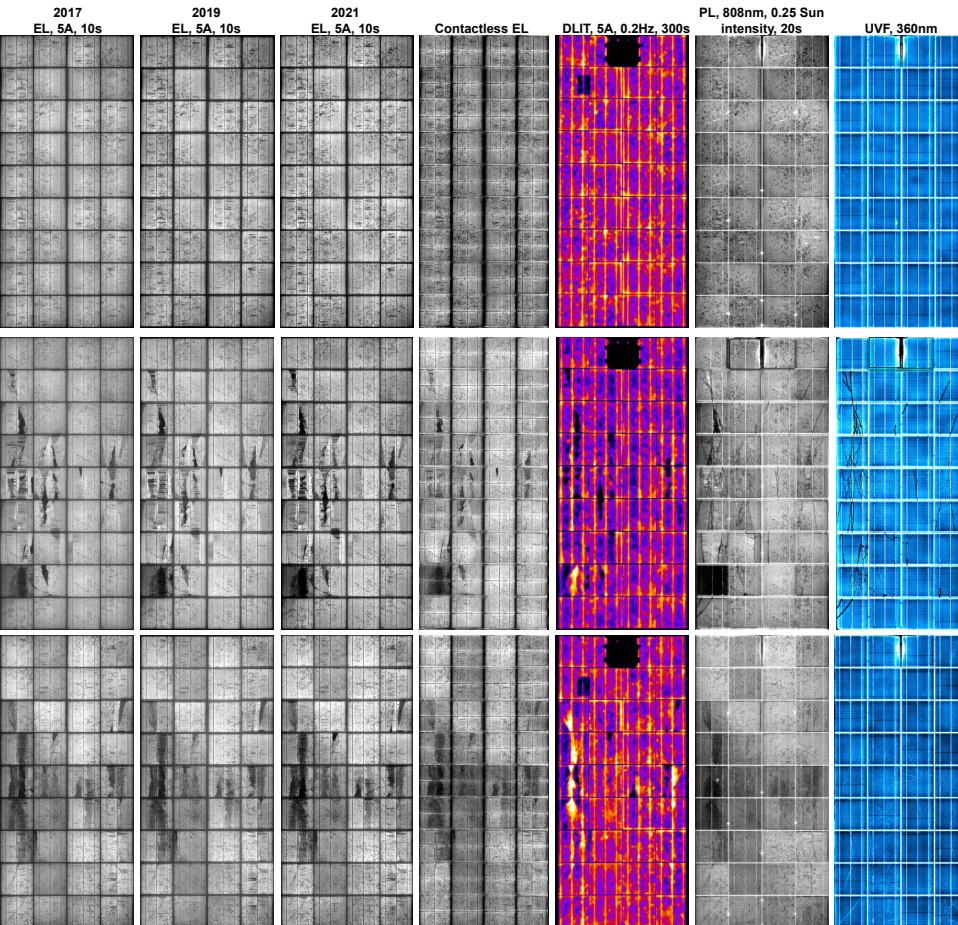
Comparisons of module power from flash tests

- For series S/N 17xx, hail-damaged modules exhibit <4% power loss due to cell cracking, even when up to half of the cells in a module have cracks.
- After four years, modules with hail-induced cell cracks do not yet appear to have a higher degradation rate than same-series modules with little to no hail-induced cracks (based on room temperature flash testing and imaging).
- Series S/N 25xx may have started with higher initial power since hail-damaged modules have higher power compared to similarly-damaged 17xx modules.
- Cell cracks appear dark in UVF for series S/N 25xx modules. However, cell cracks for 17xx modules are bright in UVF due to strong UVF of the backside polymer layers. The different series have a different bill of materials.
