# Photovoltaic Cable Connectors: A Comparative Assessment of the Present State of the Industry

National Renewable Energy Laboratory (NREL), Golden, CO

\*Updated from UL-NIST 2023, PVRW 2024 workshops

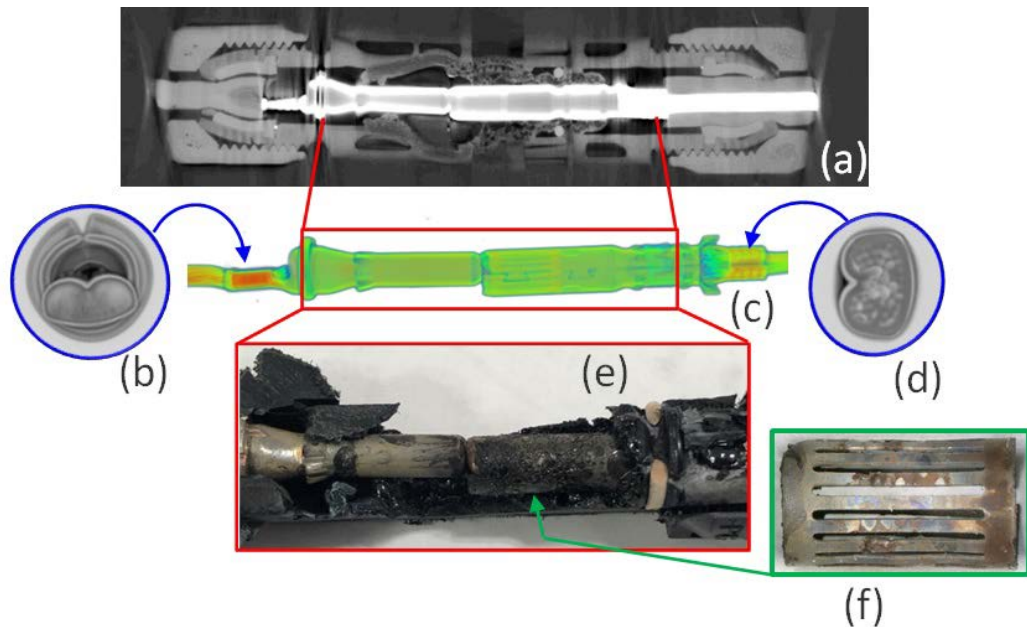
- Outward blister (mm's) on plastic socket.
- Externally: plug and socket fit together without physical separation.
- R of 90 m $\Omega$  in 2-wire measurement.
- Crimped metal folded over, no extruding wire strands, no extra space inside crimp.

*A field-degraded connector: (e) photograph of deconstructed pin and socket as well as XCT cross-sections of: (a) the entire connector; (c) the detail of the metal pin and socket; (b) and (d) crimp site on the metal pins; and (f) the convolute spring.*

- "Incomplete connection".
- Field assembly suspected – metal pin(s) not seated correctly/inactive alignment features.
- Primary damage occurred between metal pins rather than in the crimps.
- Early basis for R-I sweep (10's of A as in PV system, rather than 1 mA test current).

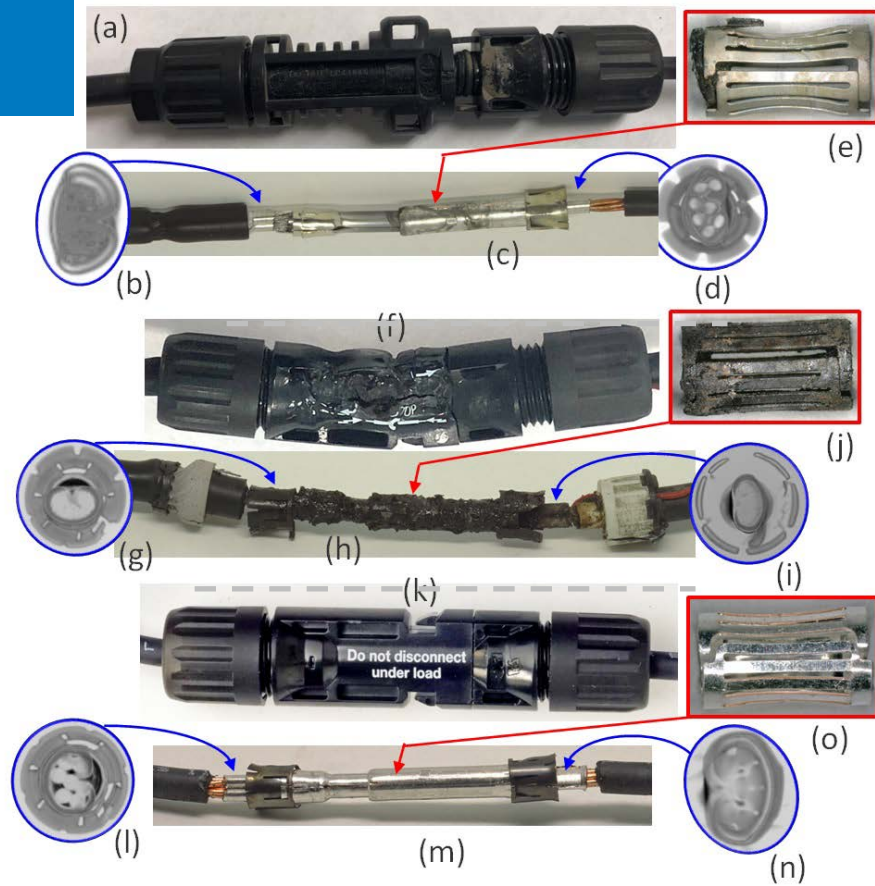
- (a)-(e): incompatible end, compromised electrical connection.
- (f)-(j): cracks and vias extend into plastic body. Failure identified visually; not identifiable from module I-V and power history!
- (a) and (f): loose end nut on the right.
- (k) and (n): unaged (reference).
- Other specimens: vaporized end (plug or socket), large blister(s), locking pins no longer fully seated, change in plastic surface gloss.

*Photos of connectors, including external appearance and springs after deconstruction.*

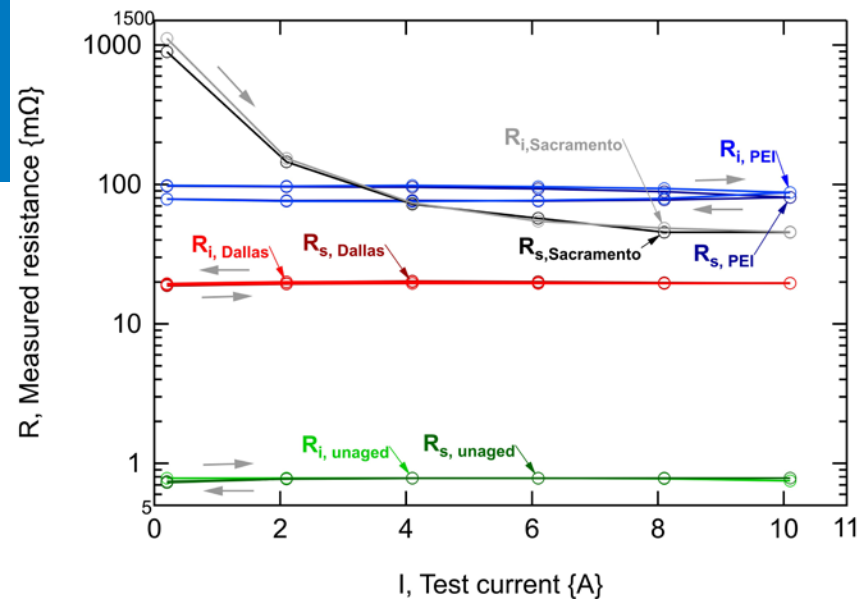
- $R_{\text{unaged}}$ : 0.73 m $\Omega$  at 0.2 A, 0.78 m $\Omega$  at 10 A.
- Elevated R (10's of m $\Omega$ ) observed for field degraded samples.
- PEI: hysteresis from high to low R.
- PEI, Dallas, other specimens: measurable difference between initial and stabilized (1 min) R.

*Resistance-current sweeps for field and unaged specimens of the same model. The results are shown for initial and stabilized readings at each measured current.*

- $2 \leq \Delta R \leq 4$  m $\Omega$  criteria for accelerated aging in standards.
- 6%  $\Delta R$  consistent with 4 $^{\circ}$ C temperature rise for bulk Cu.
- R anticipated to increase with current, e.g., from Joule heating.
- $\downarrow R$  for PEI ... from thermal depletion of surface oxide or improved of contact (CTE misfit)?
- Examples show usefulness of 4-wire R-I sweeps as damage quantification & diagnostic tool.

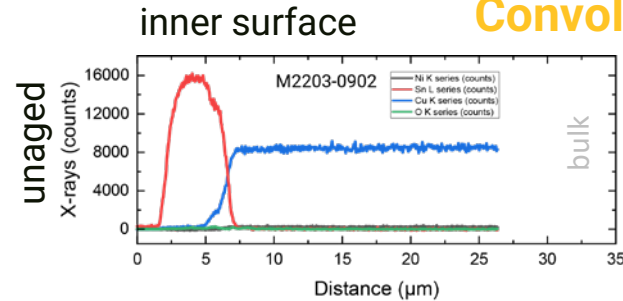
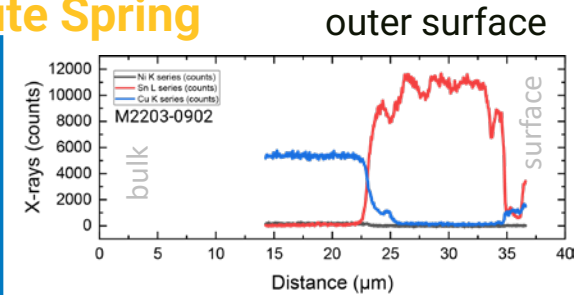
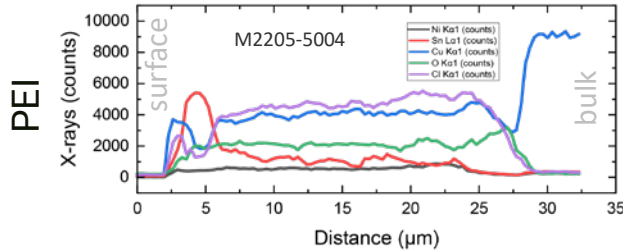
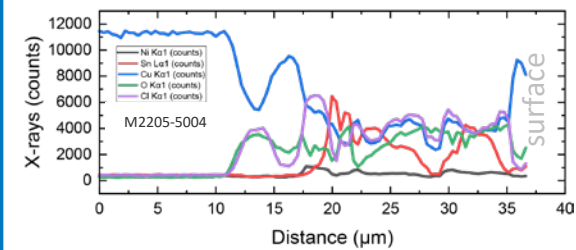
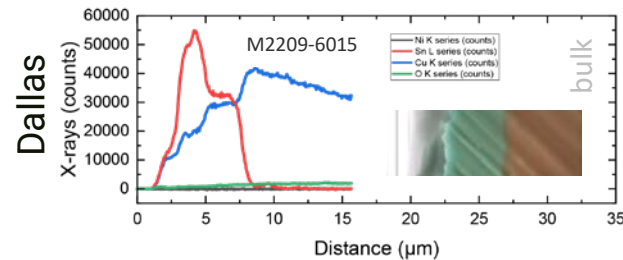
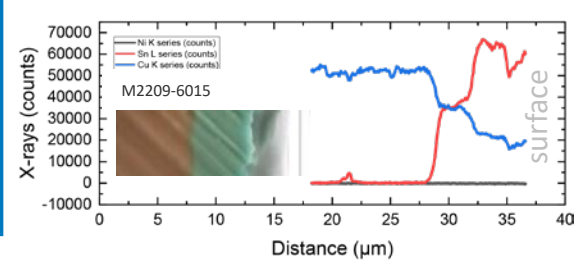
- 10 µm outer coating layer of Sn
- 5 µm inner coating layer of Sn
- little mixing between layers
- Z of Be too low for EDS detection

- thick (25 µm) scale layer, inside & out
- mixed Ni/Sn/Cu as well as heavy O and Cl traces
- Ni may be transferred at elevated T

- ca. 7 µm Sn on surface, concentration gradient
- equimolar Cu mixed-phase 3-4 µm at -Sn/Cu interface, inside & out
- -23.6±0.1 % at. Sn intermetallic ε phase gradient mixed-phase: Sn/Cu ratio decreases after 3-4 µm plateau toward surface

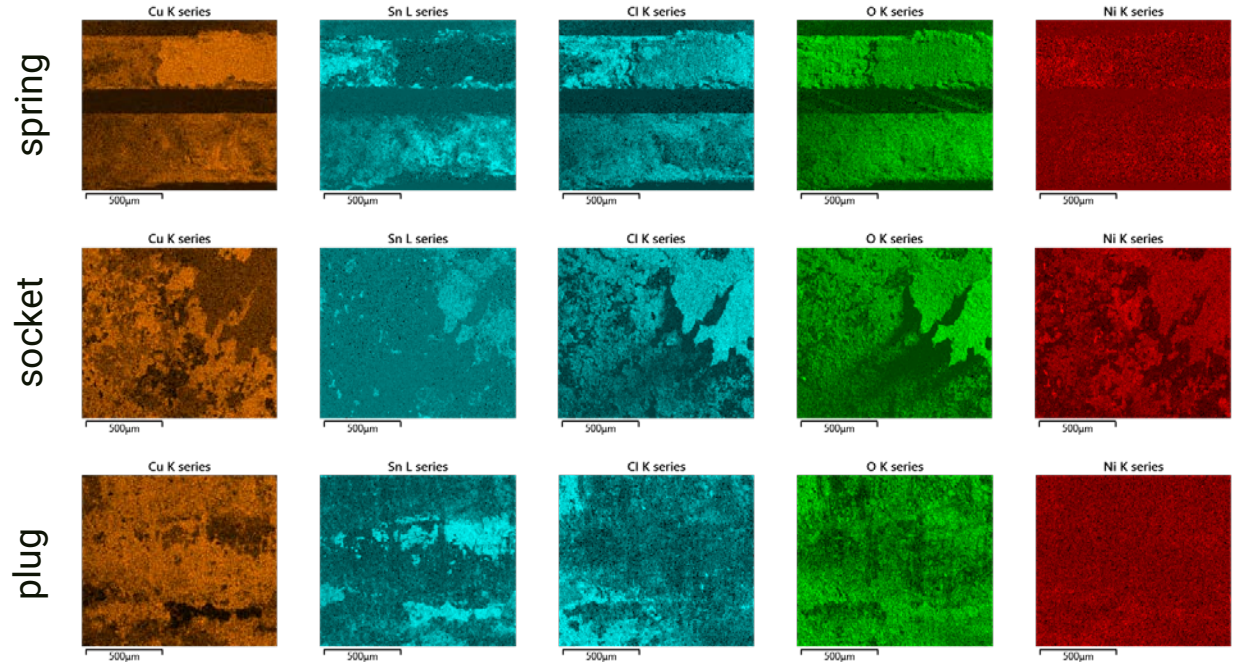
- PEI, oceanside, aged (M2205-5004)
  - Cl signal colocalized with both Cu and Sn regions
  - O signal everywhere Cl is present
  - Ni also detectable from surface

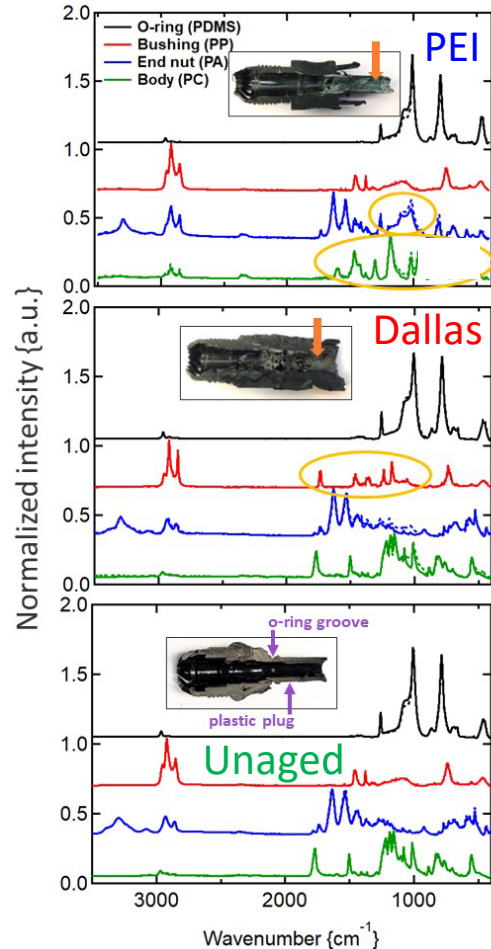
- **PEI:** PC body degraded, blue-green deposit from metal pin.
- **Dallas:** PP bushing degraded (lowest  $T_d$  polymer), gray discoloration, deformation of PC body from over-heating,  $T_d$  450 °C.
- Both: silicone O-ring not affected by field use.
- Damage to polymeric components is secondary, occurring from overheating after metal pins compromised near their connection.

*FTIR spectra for the polymeric components from the connectors: PEI, Dallas, and unaged. Notable differences in the spectra signature is identified with a circle. The cut connector body is shown in the insets.*

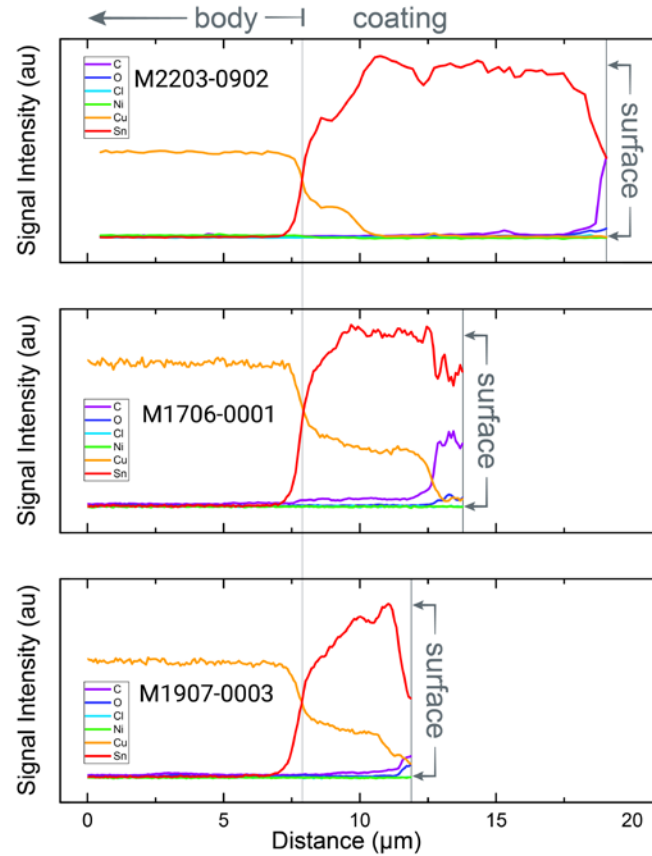
- Diffusion of Cu bulk into Sn surface layer.
- 12  $\mu\text{m}$   $\rightarrow$  8  $\mu\text{m}$  thick Sn surface layer.

- Diffusion of Cu bulk into Sn surface layer
- 12  $\mu\text{m}$   $\rightarrow$  6  $\mu\text{m}$  thick Sn surface layer.

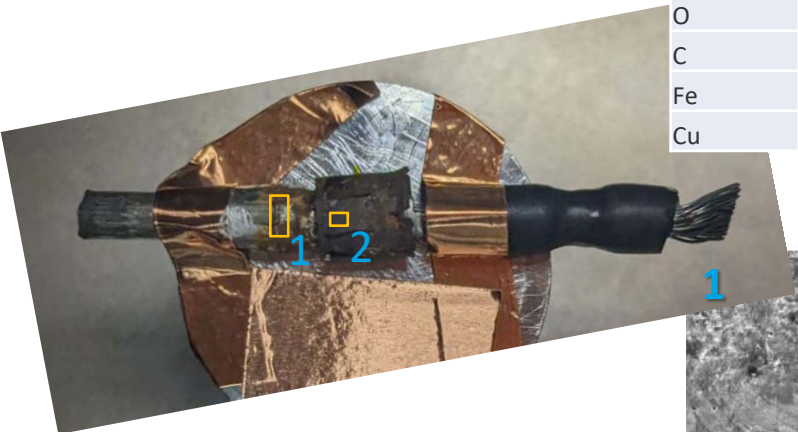
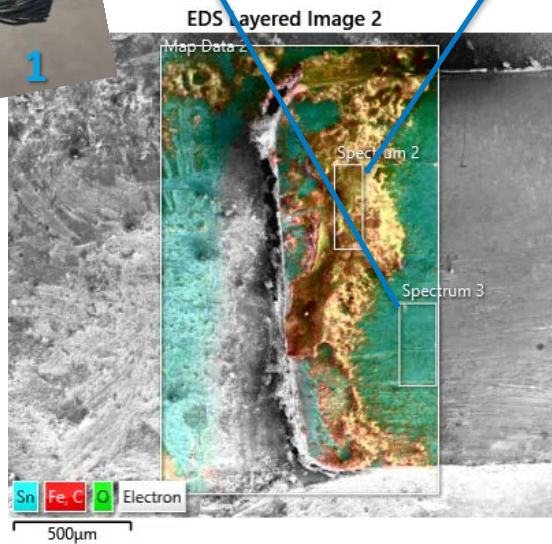
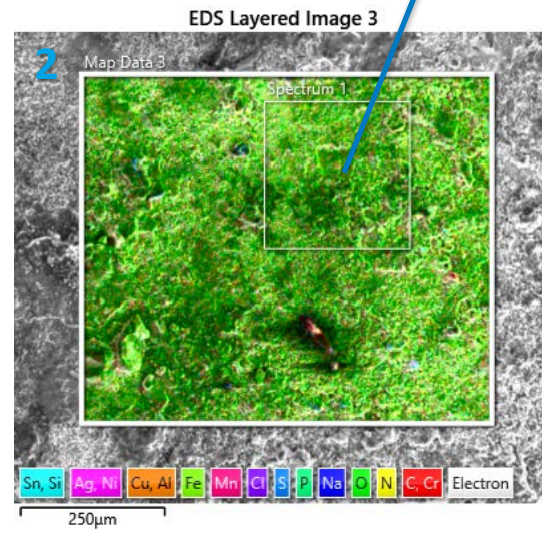
- C-AST 9x (M1907-0003):  
What Is Corroding?

- Fe is from retainer spring near connector end nut/cable.

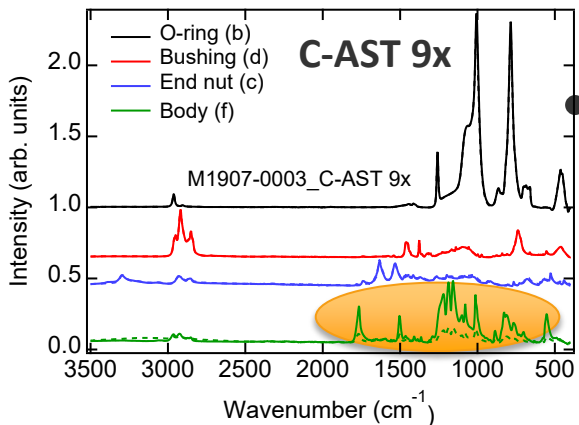
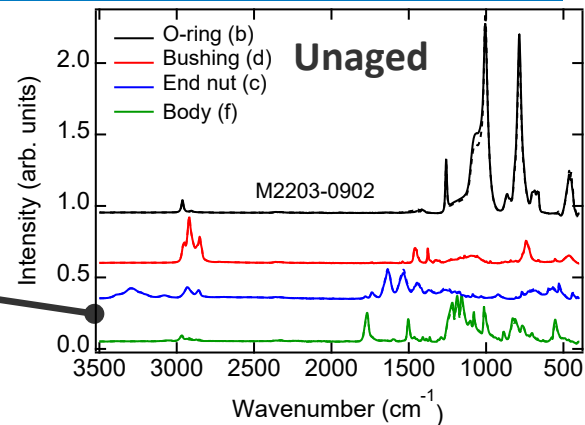
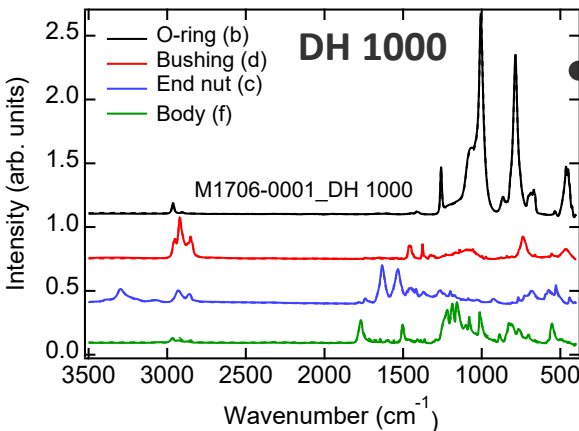
- Degradation of the connector PC body, suspect from heating following metal pin corrosion. Initial mechanical/hermeticity failure (not bulk degradation polymer) suspected.

- Silicone O-ring and PP bushing not chemically affected.

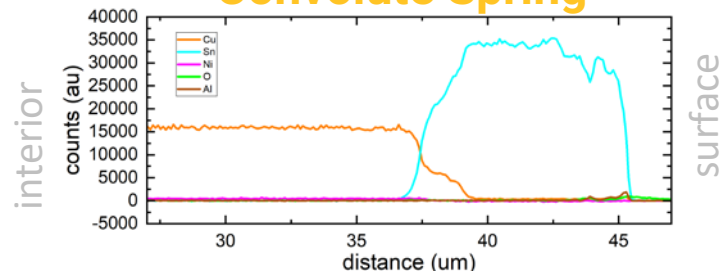
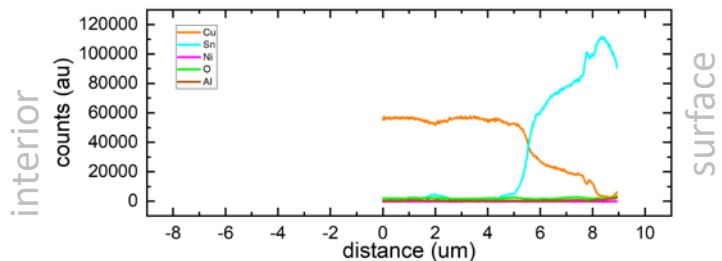
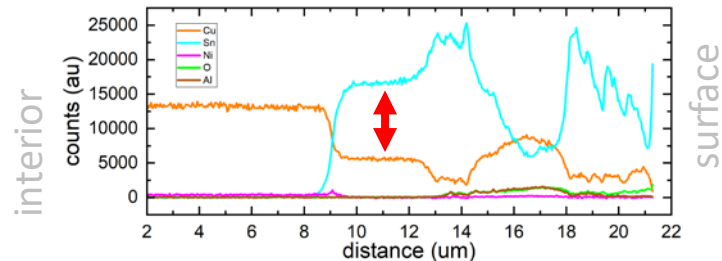
- 9  $\mu\text{m}$  Sn surface layer
- Negligible Intermetallic layer mixing (similar profile to unaged)

- 4  $\mu\text{m}$  Sn surface layer
- Intermetallic layer mixing
- Localized damage
- Surface oxidation. From HF10? (compare to -0001)

- 12  $\mu\text{m}$  mixed-metal surface layer
- Extensive metallic mixing past interface;  
61.5 Sn (%at) is not an intermetallic phase.
- Now more vulnerable to corrosion

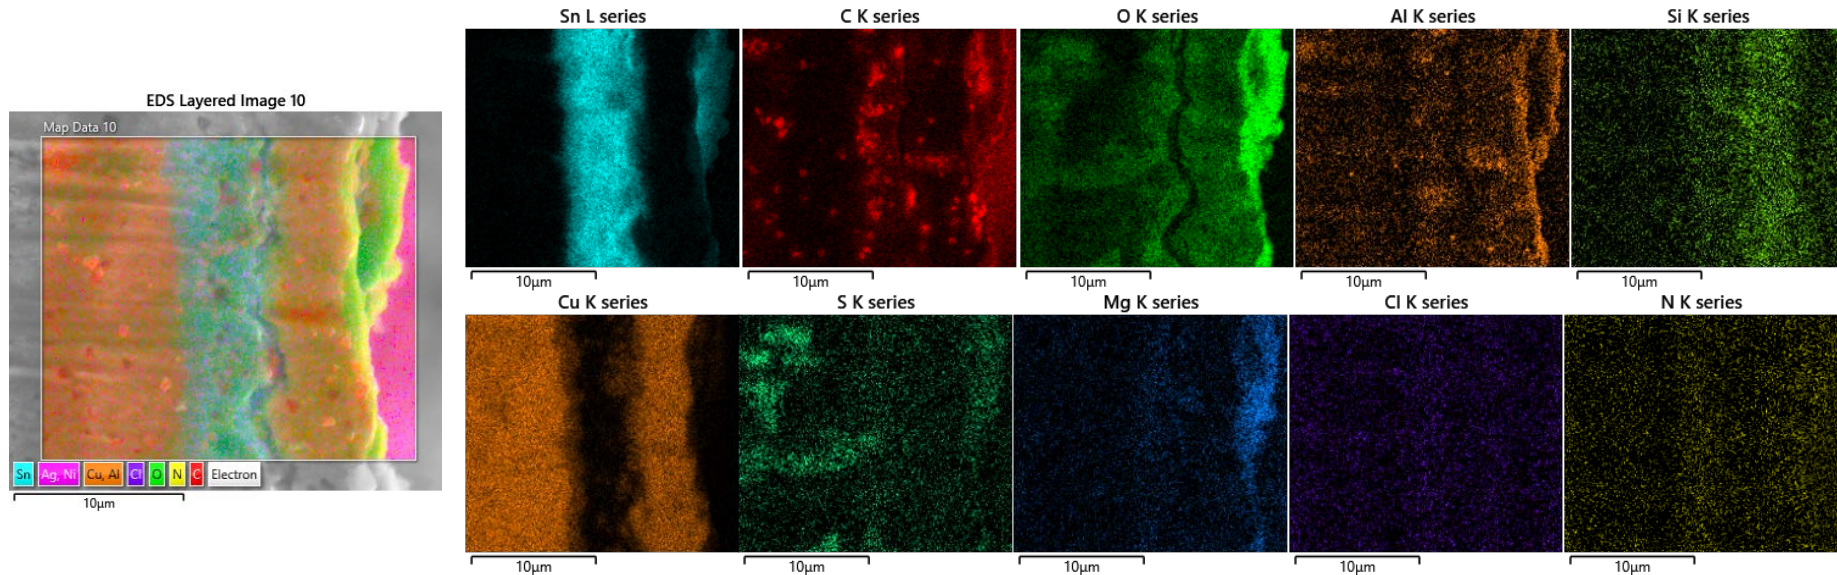
- Cross-section of the metal socket on M1706-0006 (TC 200)

- Sn surface layer is structurally compromised.
- Oxidized Cu (?@ pin/socket contact?), contaminated with Mg, present on top of Sn.
- Sulfur signal in body; C inclusions.

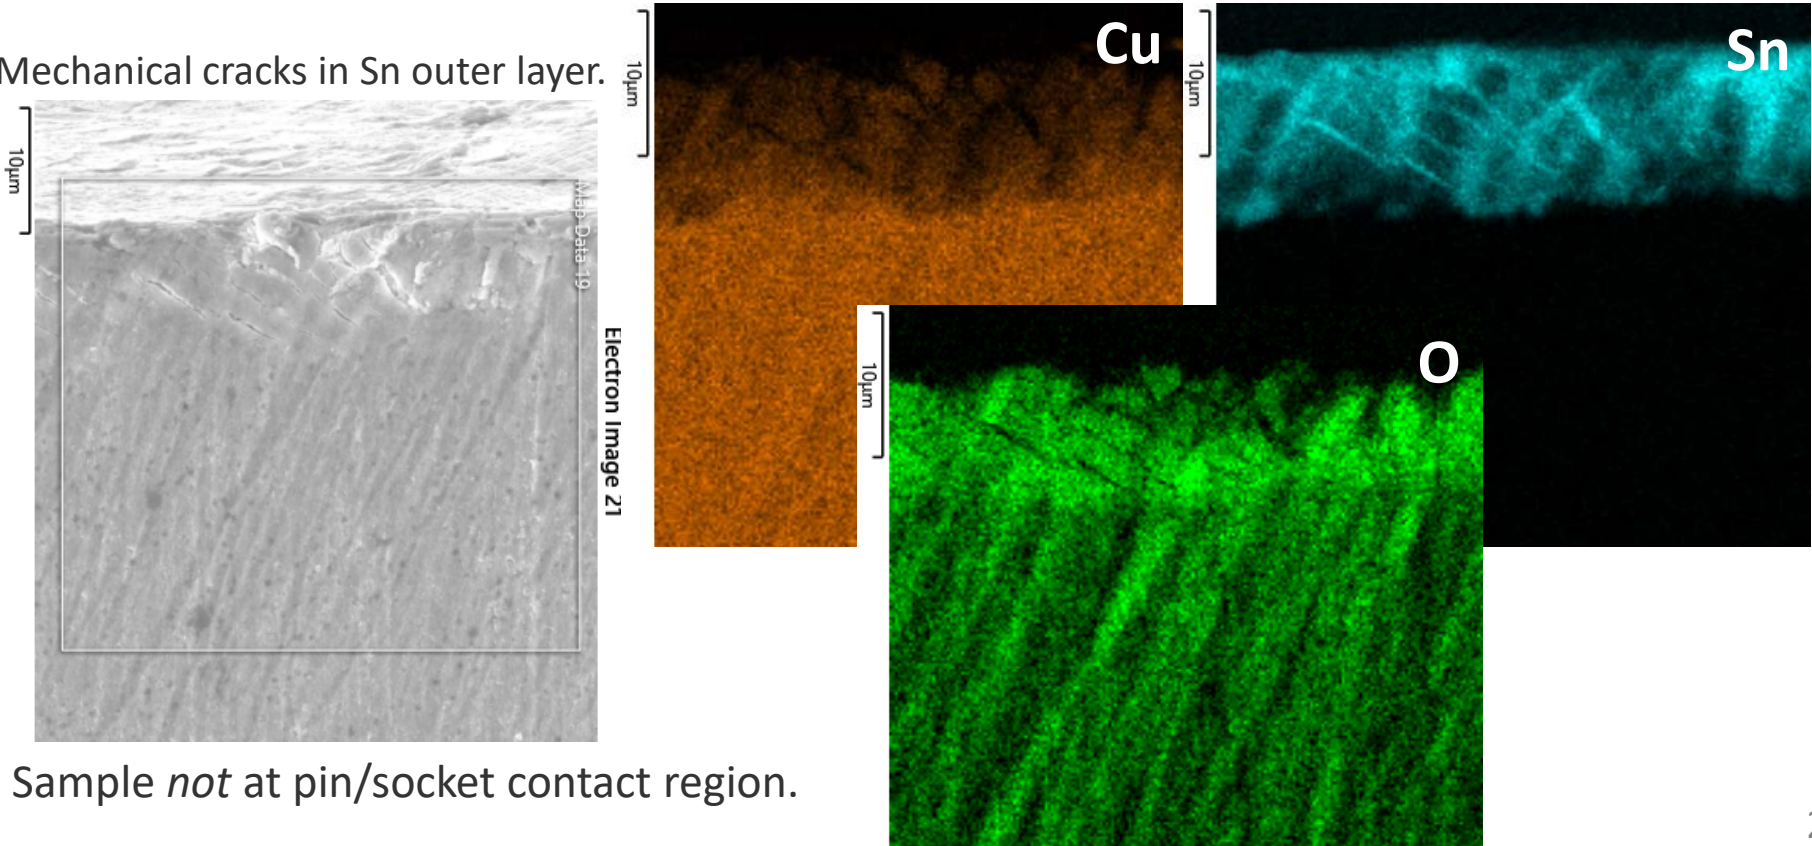
- Cross-section of the metal socket on M1706-0006 (TC 200)

- Mechanical cracks in Sn outer layer.

- Sample *not* at pin/socket contact region.

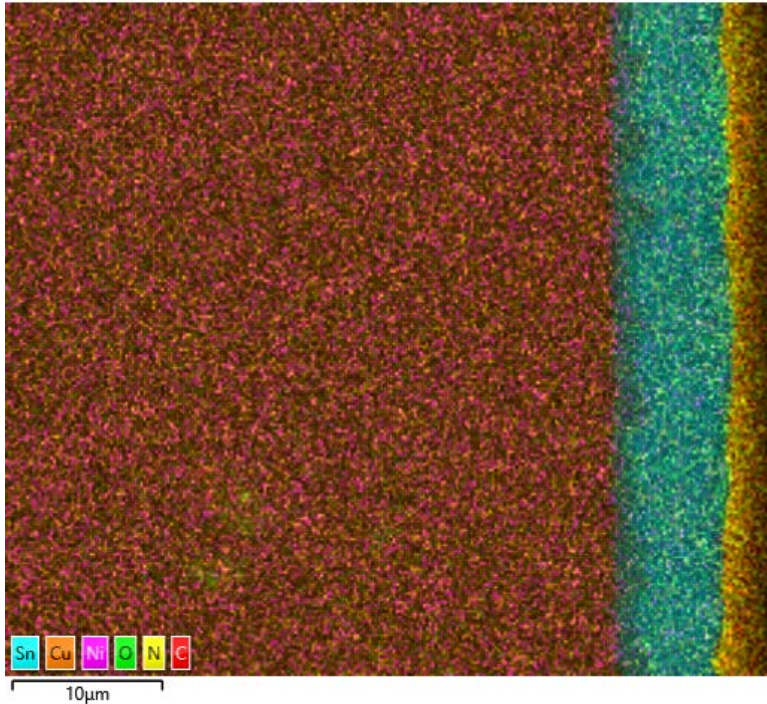
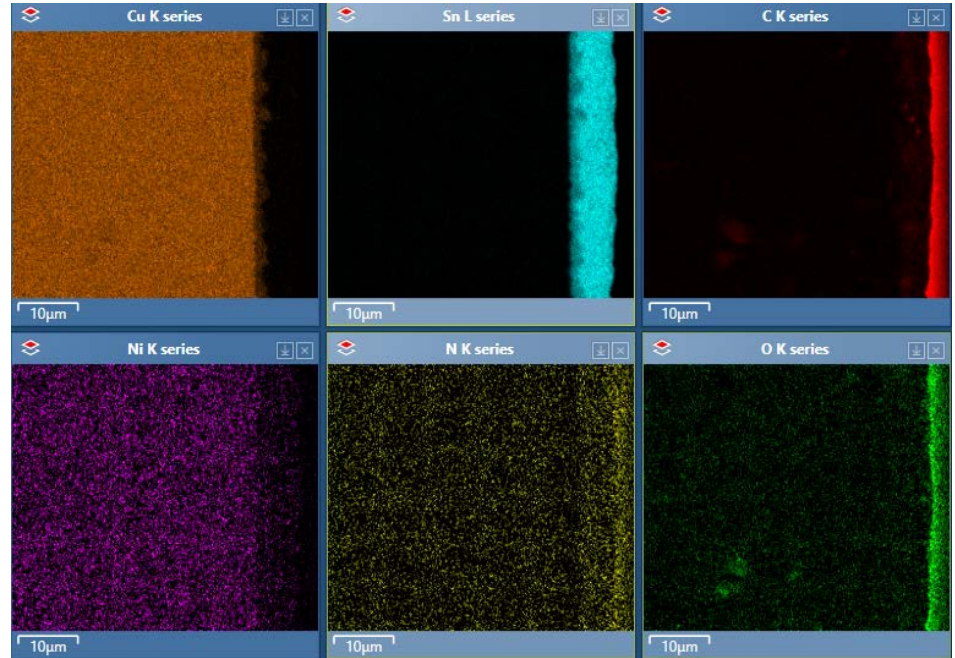
TC200 (M2212-0001)

*Nickel in bulk Cu, not Cu/Sn interface (some manufacturers)  
Ni:Cu is 2.6 for M2208-0001, M2212-0001, M2203-0902. < 10% at. as in strengthened Cupronickel alloy*

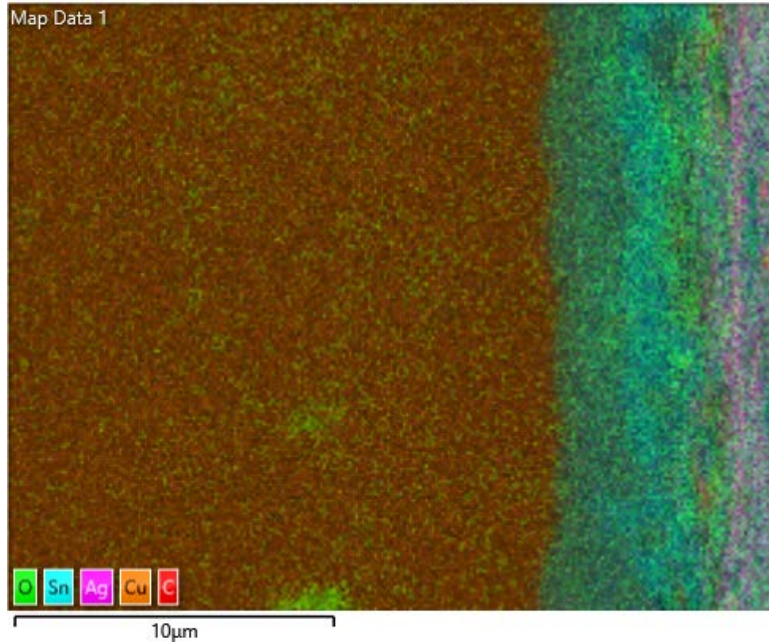
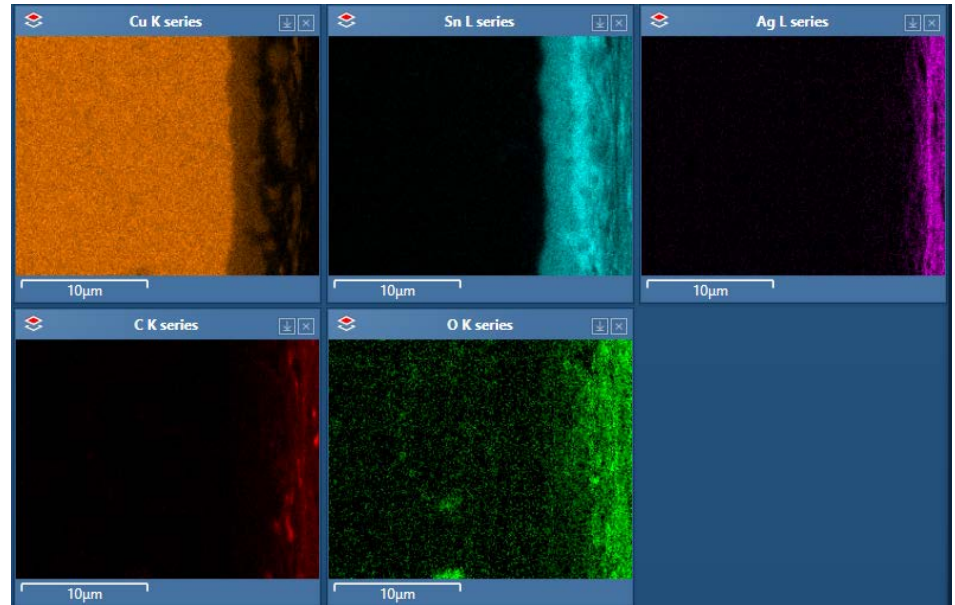
UV/TC50/HF10 (M1706-0004)

No nickel detected

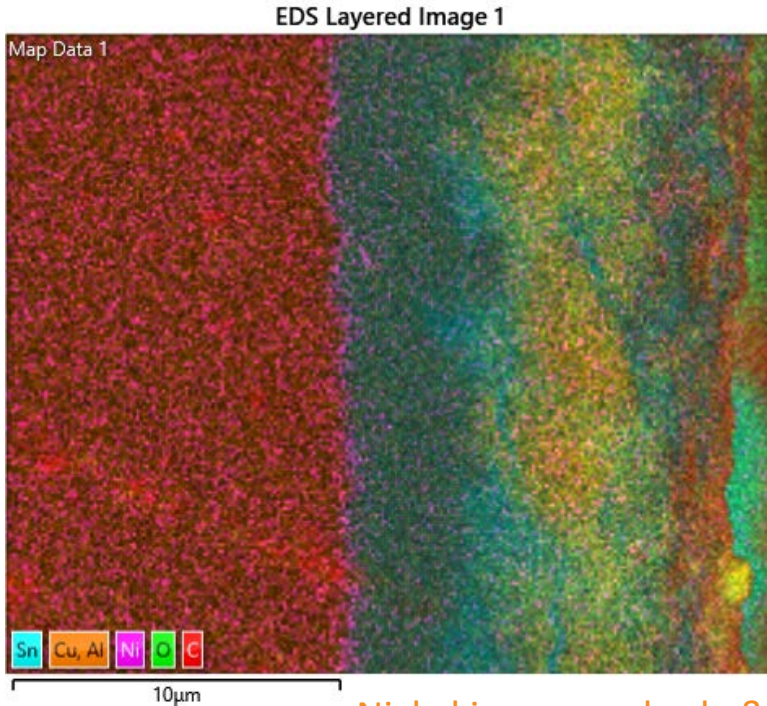
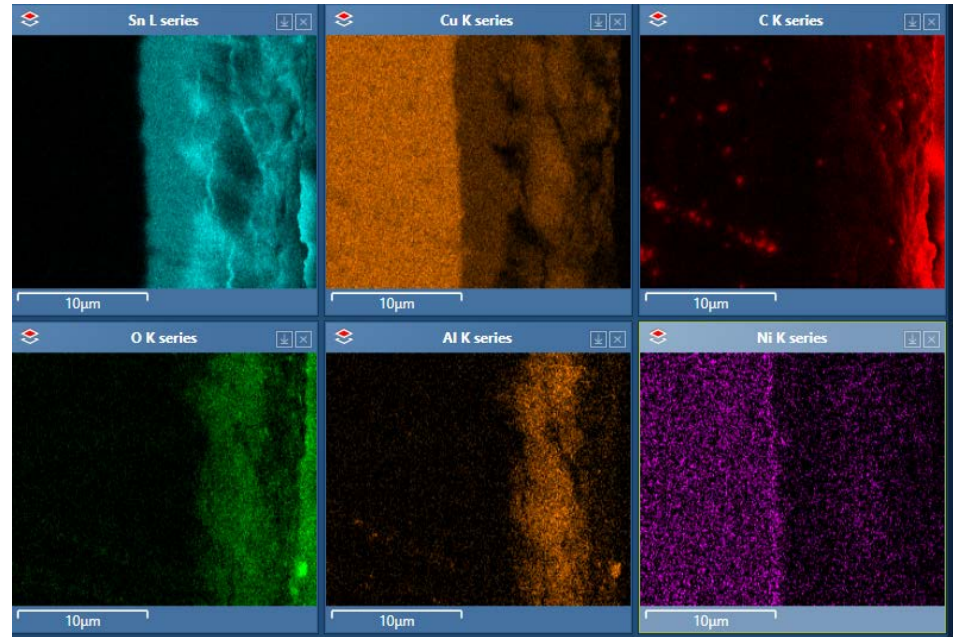
C-AST 2x (M2208-0001)

Nickel in copper body & spike at interface | Extensive scale present  
Al, C may be sample preparation artifact (polishing grit)

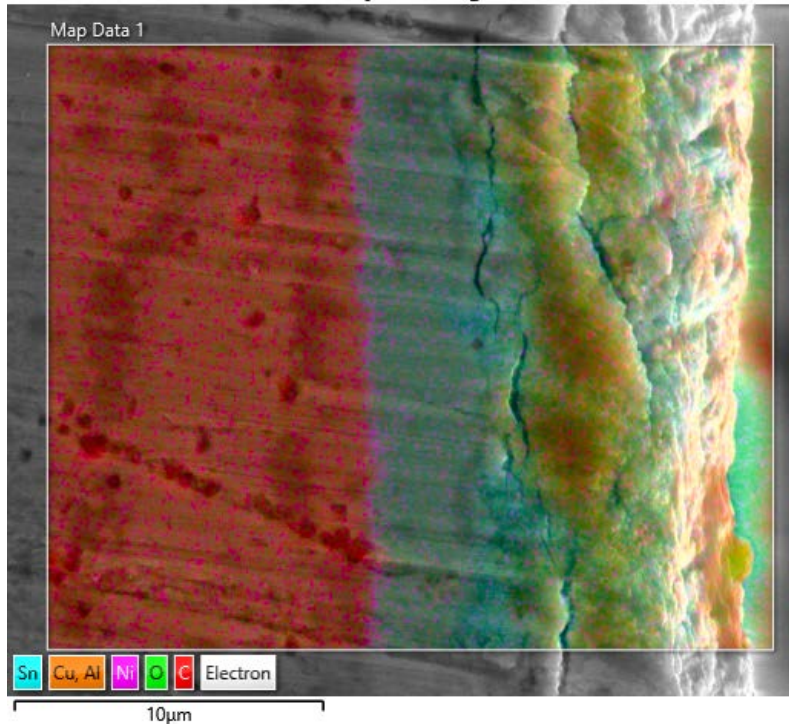
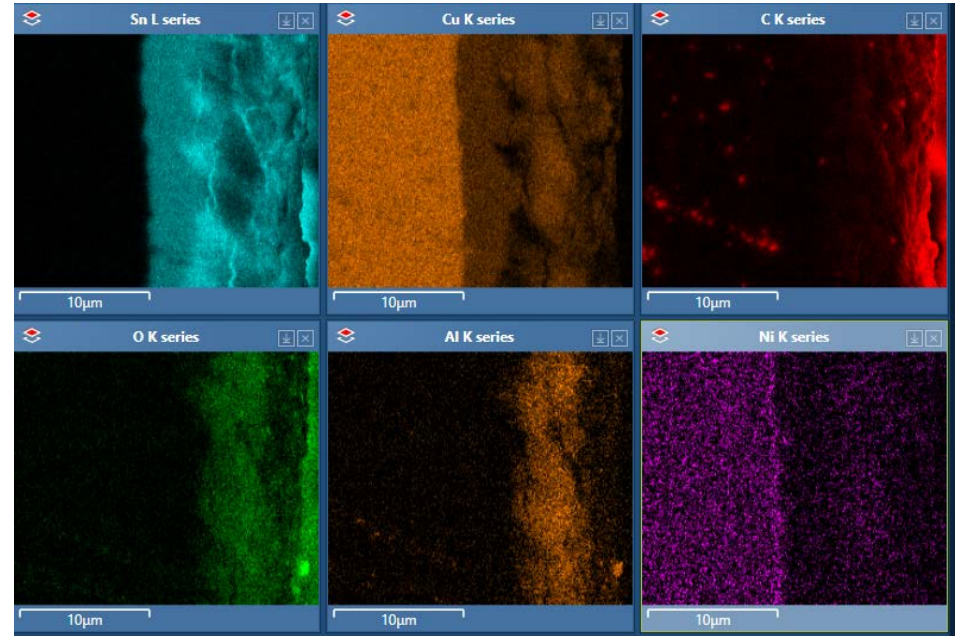
C-AST 2x (M2208-0001)

Nickel in copper body not consistent between samples.  
Multiple material vendors? (Specific Cu alloys observed in other models/components, e.g., aluminum bronze).

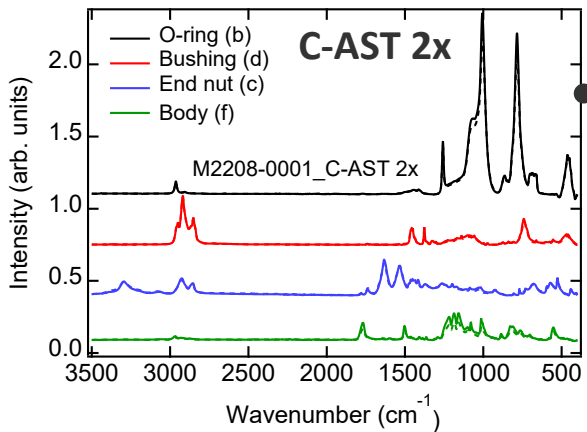
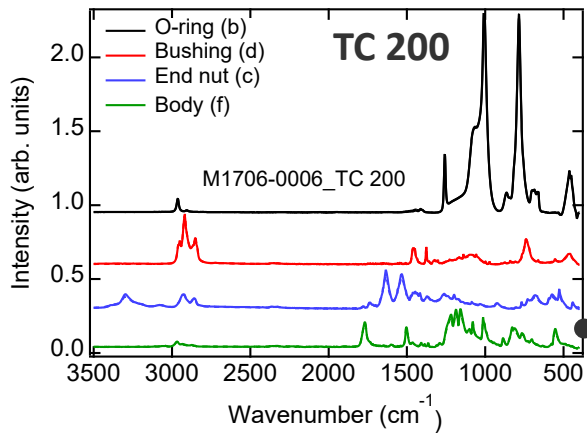
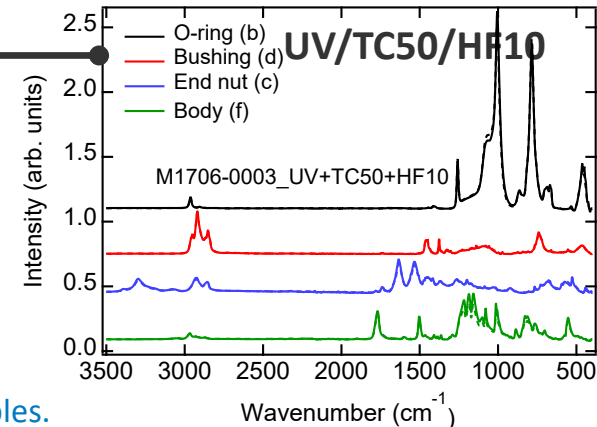
- No visual degradation of polymer, these samples.
- No chemical changes detected here in FTIR.

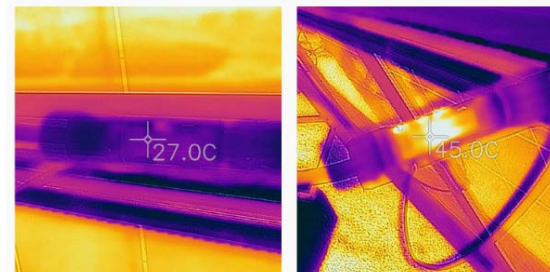
*Infrared inspection of intact (left) and degraded (right) cable*

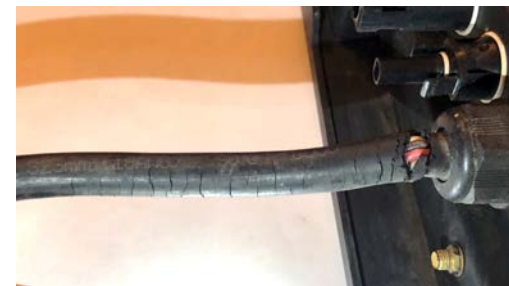
*Cracking of tracker cable at the controller box.*

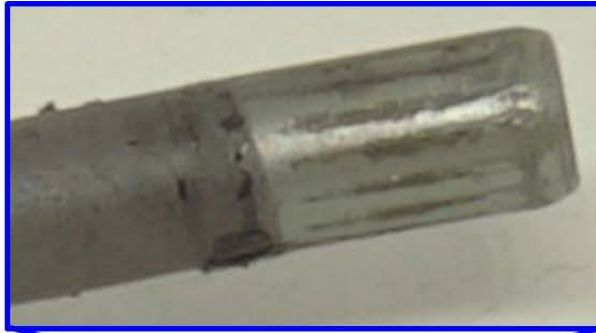
- Scorched pins observed on majority of field connectors, this project.
- Residual likeness of convolute spring often observed on metal pin.
- Causes: design, manufacture (plating), contamination, vibration, ?thermal misfit (localized abrasion & wear)?

*A field-degraded connector: residual from convolute spring (inset); plastic from the connector body (red); artifact of milling (green)*

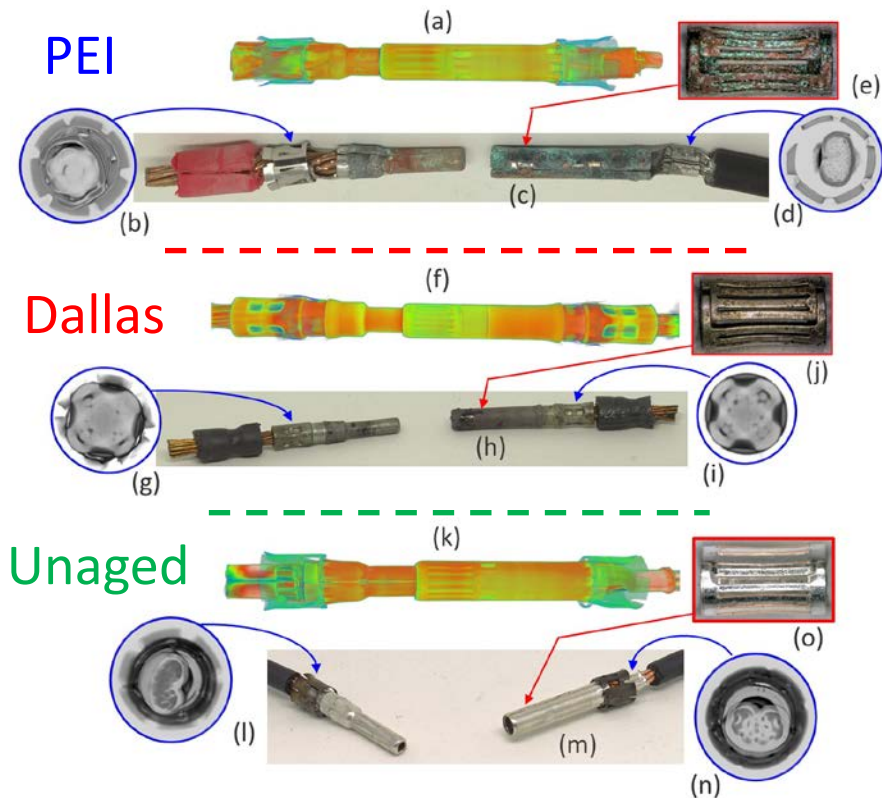
- Incompatible plug & socket compromise mechanical seal of PEI connector.
- Blue-green appearance  $\Leftrightarrow$  ocean side corrosion.
- Mixed gas test ( $H_2S$ ,  $NO_2$ ,  $Cl_2$ , and  $SO_2$ , IEC 62852); fixed gas method ( $H_2O$  and  $SO_2$ , ISO 22479); and stress corrosion test (humid ammonia-air mixture, UL6703) presently assess corrosion.
- Dallas specimen scorched at metal pins and spring, but not at crimps.
- Possibly: design, manufacture (plating), contamination, perturbation, thermal misfit (localized abrasion & wear), live disconnection.
- Barrel style pin (g & i, intended for 7 strand cable, USA); rolled pin (b) intended for higher strand count.

*XCT and external appearance of plug, socket, spring, and crimp after deconstruction.*

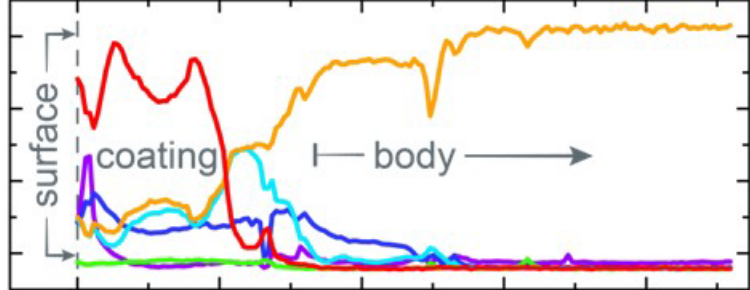
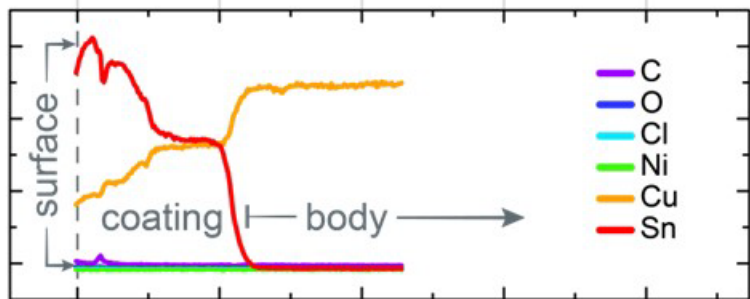
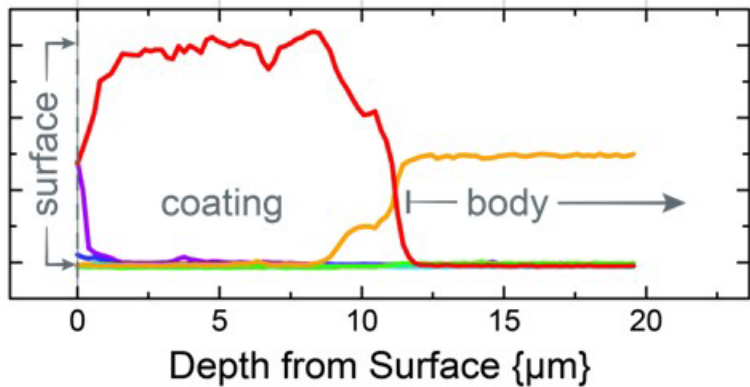
- Greatest concentration of Cl, O.
- 15-25 μm surface scale (corrosion).
- Ni may be artifact of incompatible plug & socket.

- Temperature → mass transport of Sn & Cu.
- Steady Sn/Cu alloy at  $3 < h < 5 \mu\text{m}$ .
  - $23.6 \pm 0.1 \%$  at. Sn.
  - Intermetallic  $\epsilon$  phase Sn:Cu (23-24 %at.)

- ~10 μm outer Sn surface layer.
- Rapid Sn → Cu transition at  $8 < h < 11 \mu\text{m}$ .
