Accelerated Lifetime Testing of Main Shaft Seals for Tidal Turbine Rotors

Technical Report
NREL/TP-5000-89380
May 2024

Executive Summary

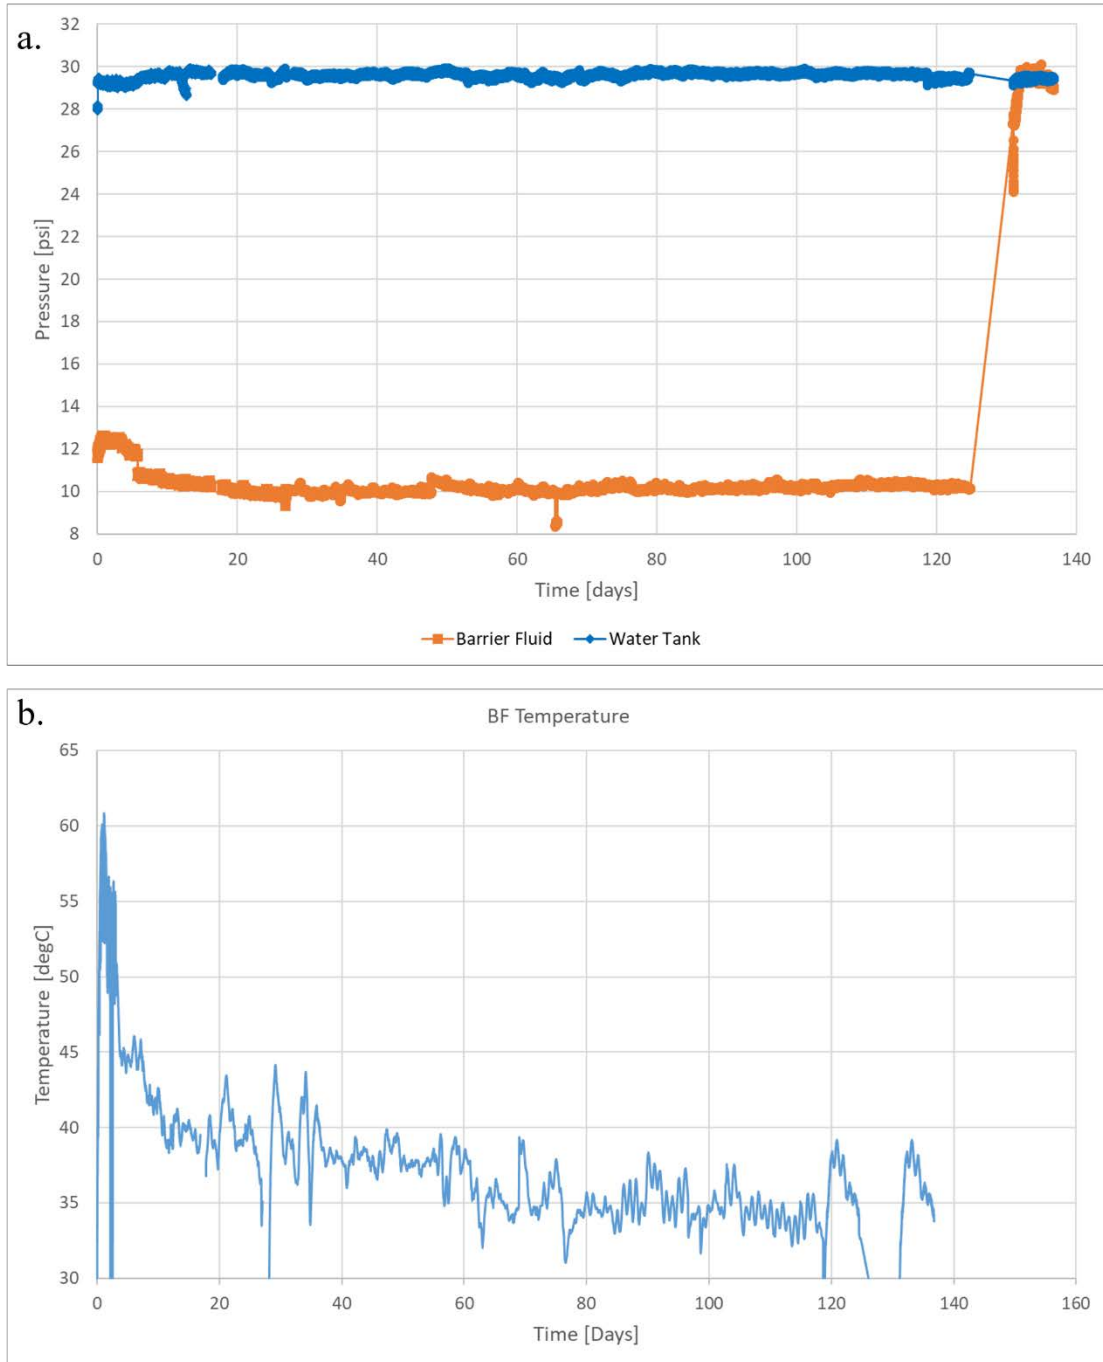
Figure 3. (a) Water tank and BF pressure during operation. (b) Temperature of the BF during operation. The BF temperature sensor was placed inside the housing to best measure the operating temperature of the seal.

Figure 3a shows the BF pressure increases marginally during the first few days of testing. During this time the BF temperature varied from a peak of 61°C (141.8°F) to a low of 30°C (95°F). The average temperature range for most of the testing was 35°C to 40°C (35°F - 104°F). The highest temperatures were recorded during the first 10 days. This period also corresponds to the largest motor current draw, shown in Figure 4, and when the most water leakage was recorded in the

At the end of testing at 137 days, an unexplainable step change in BF pressure was recorded. It was decided that any future results would not be meaningful, so testing was stopped for the final data collection. When draining the water and BF tanks, approximately 1.1 L (0.24 gal) of water was found in the BF, and an equal amount of BF was found in the water tank. Only minimal fluid leakage was recorded through the back of the seal into the atmosphere. The collected fluids are shown in Figure 5. Considering the seal maintains a pressure gradient between the water tank and the atmosphere, it was hypothesized a small pressure gradient would always exist across the seal. The observed fluid exchange from the end-of-test malfunction proved this was not the case.

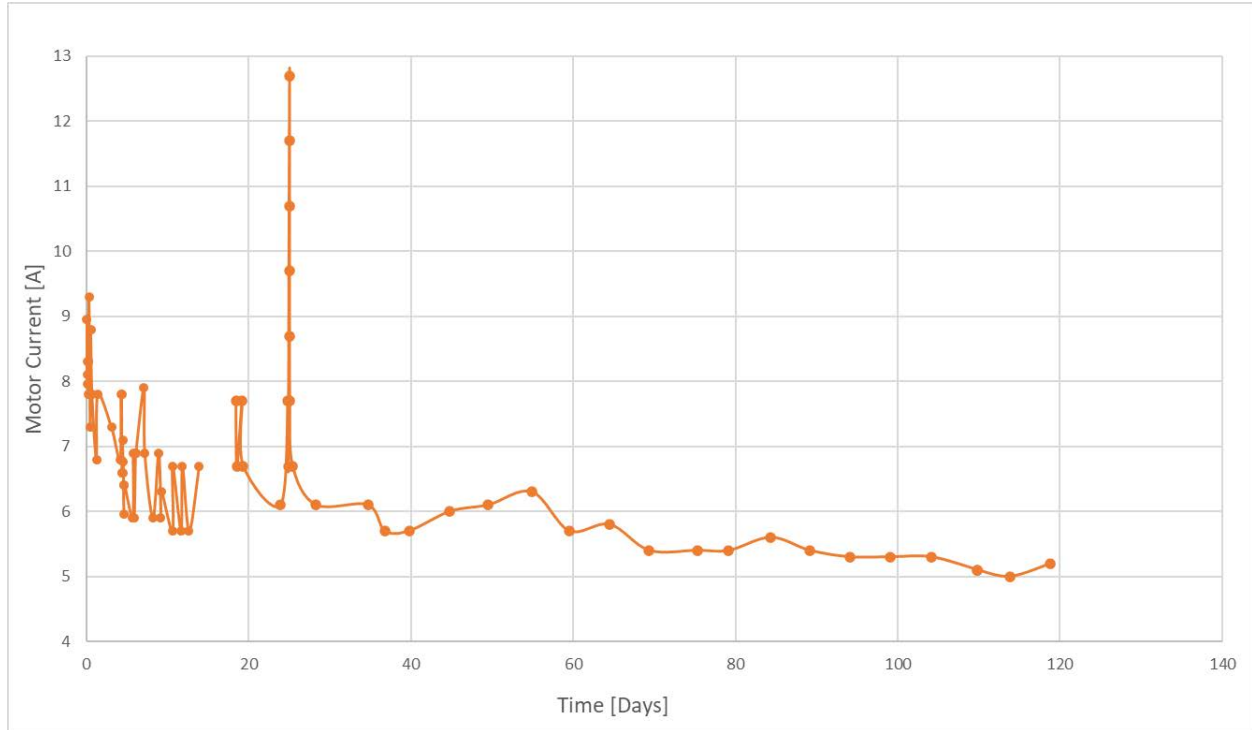
Figure 4. Motor current draw of test stand during operation. This measured the current required to maintain a constant 160 rpm.

The gap in the data at 18 days and the spike at 25 days were due to a circuit breaker failure and reactivation. The motor current draw was relatively large and chaotic initially during the theorized wear-in period before settling into a more stable, slowly decreasing trend for most of the testing. This is consistent with a brief wear-in period while the asperities are worn away between the mating surfaces. It also suggests that the BF and carbon particulate form an effective lubricating medium that produces more favorable interface conditions during operation.

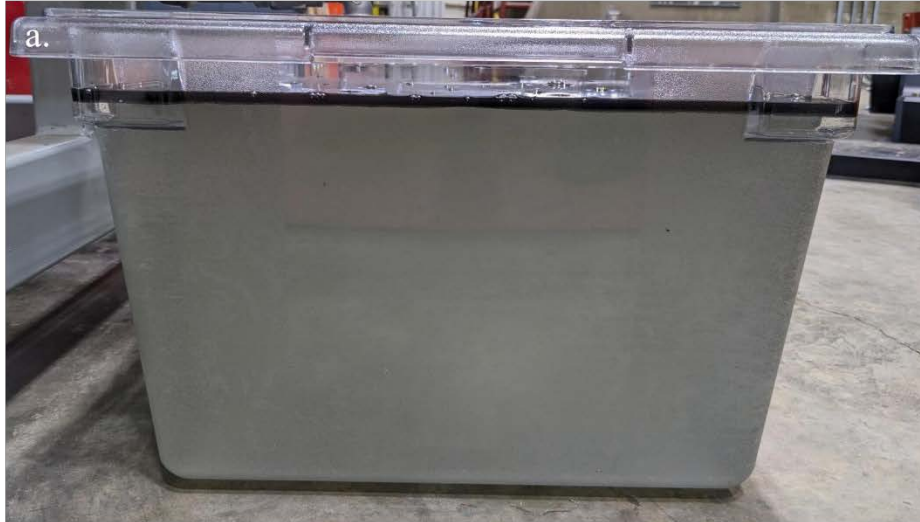
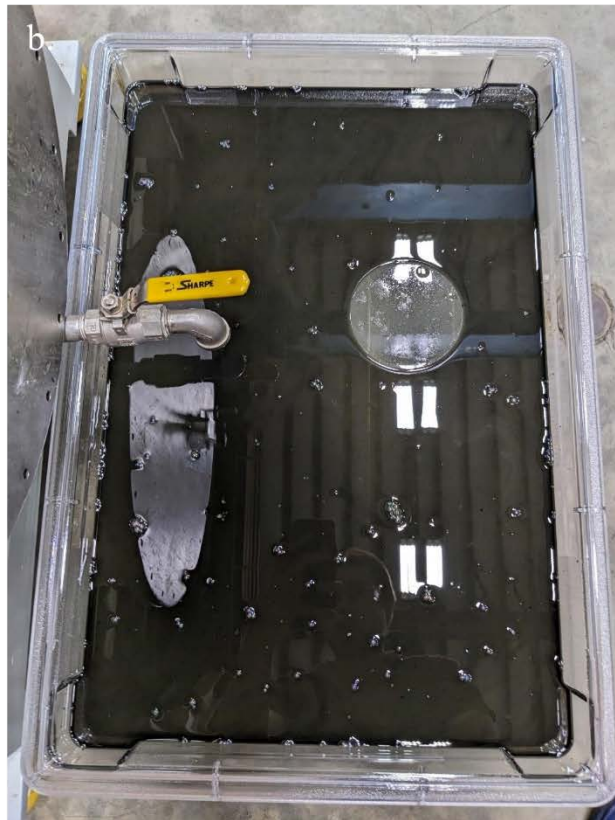
Figure 5. Images showing the fluid removed from the water tank: (a) side view; (b) top view. The BF floats on top of the water and is stained black from suspended graphite particles worn away from the antifriction rings.

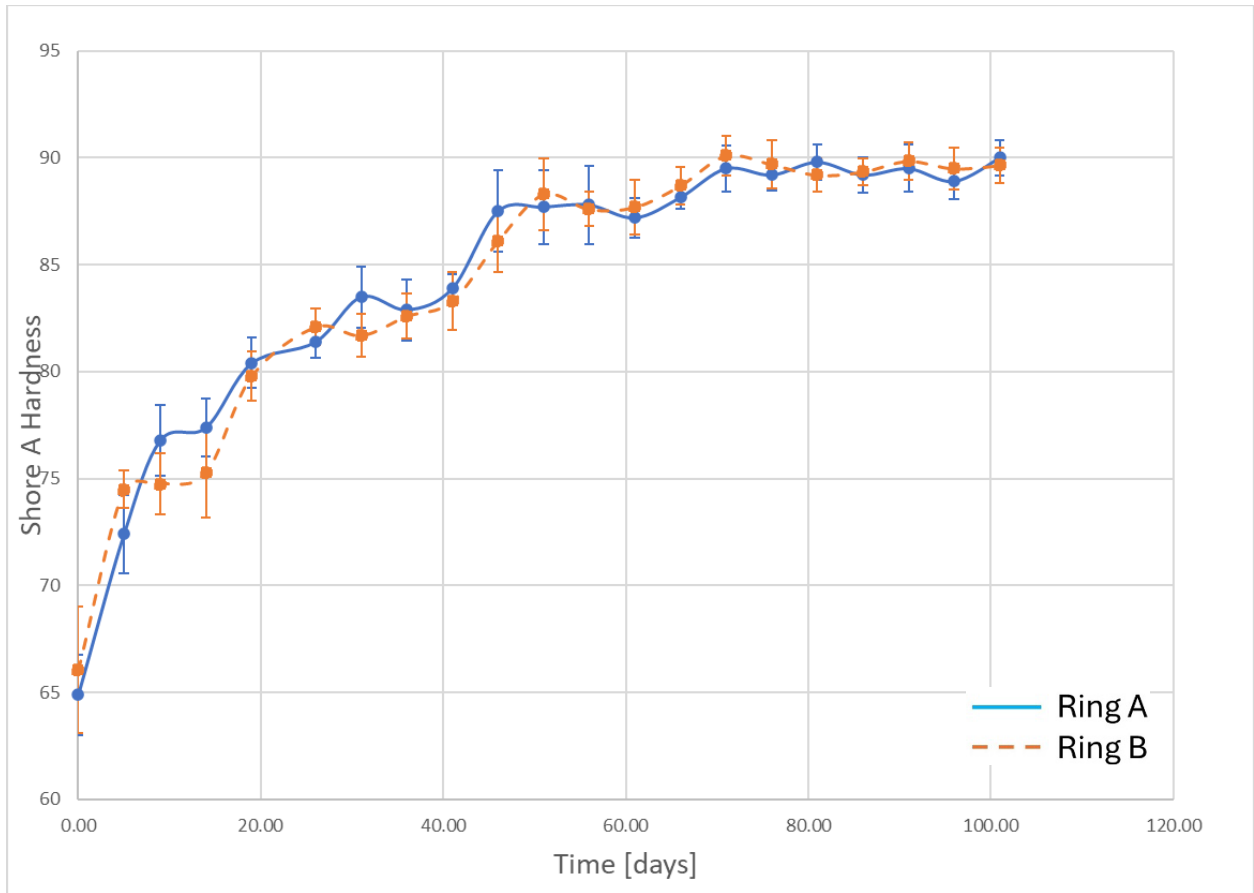
The data from the accelerated rubber aging tests is shown in Figure 6. The rubber drive rings began with a hardness of approximately 65 Shore A. The recorded hardness increased asymptotically up to 90 Shore A in 70 days. This is consistent with previously reported results (Jiang et al. 2019). Significant hardness variation was observed during testing and is largely attributed to variations in temperature. Hardness testing required handling, so samples were allowed to cool from 90°C to room temperature. However, the ambient temperature varied significantly from 16°C to 23°C (60°F-73.4°F).

After wear testing completed, the drive ring hardness for the in-situ rings was measured as 76.8 and 77.4 Shore A for the front and rear rings respectively. The wear testing was conducted for approximately 130 days at 35°C–40°C (95°F-104°F), depending on ambient temperature and heat generated from friction. This suggests the seal hardness is highly dependent on ambient temperature. Considering that wear testing simulated 40% of the expected SI, the drive rings are unlikely to reach full hardness before the SI completes.

Figure 6. Shore A hardness of the NBR drive rings during accelerated aging testing. The rings were allowed to cool to room temperature before measurements were taken. Note, the orange and blue lines identify the two NBR drive rings tested.

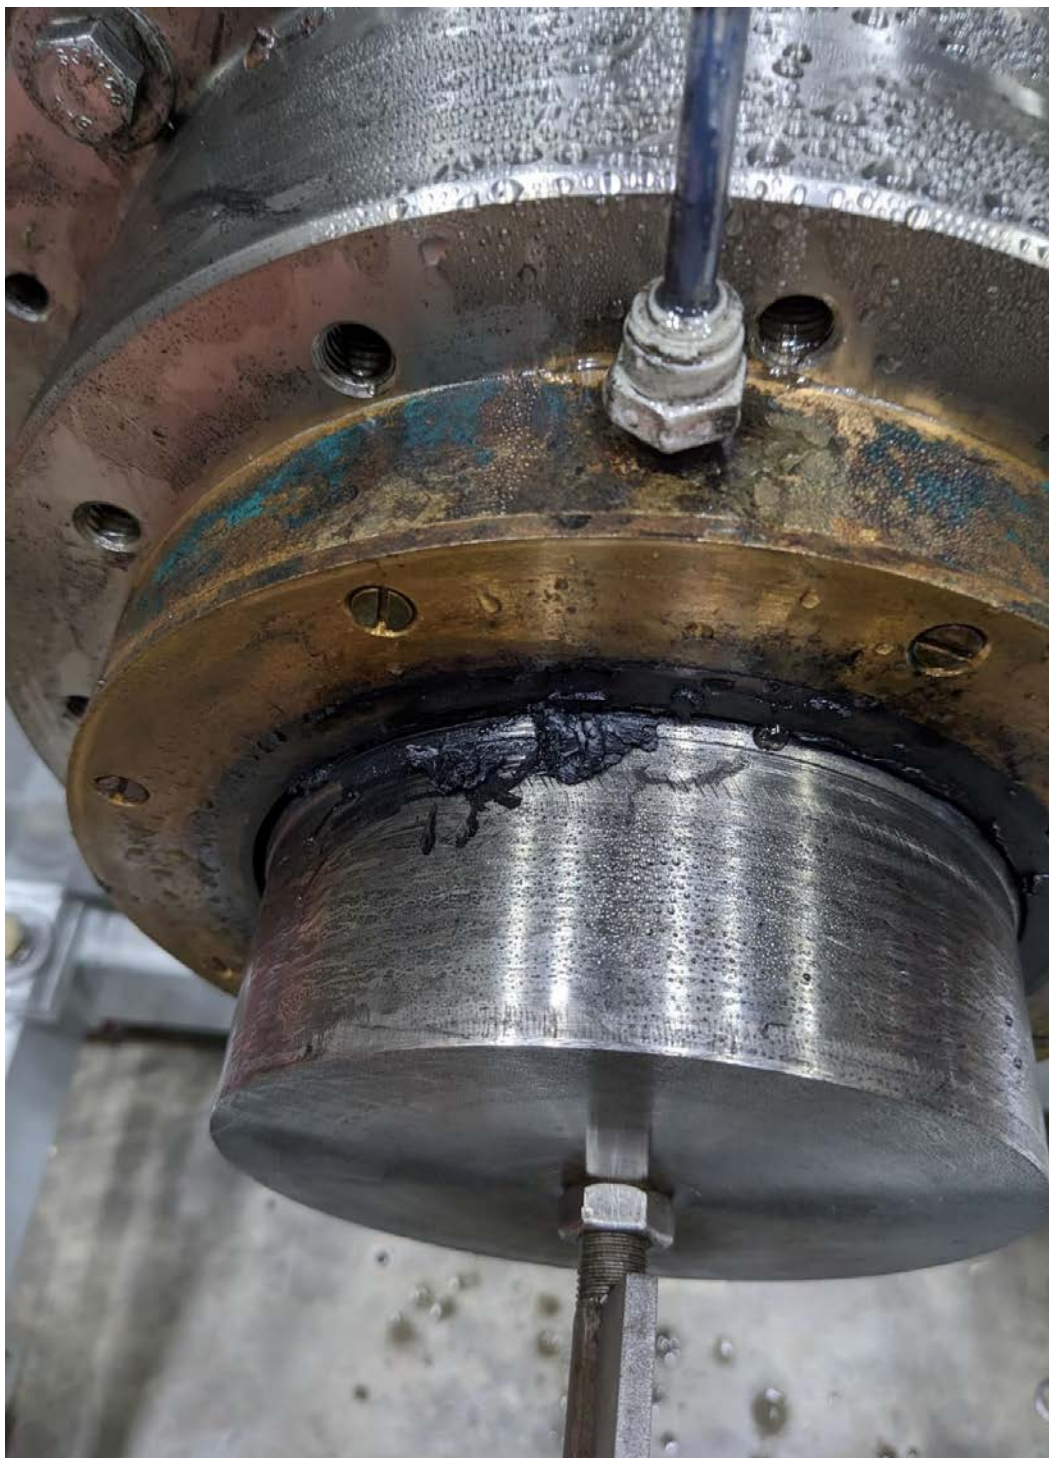
Figure A-2. Front of the MSS housing with water tank removed. A black paste can be seen extruding from the seal. The paste is a mixture of graphite and BF.

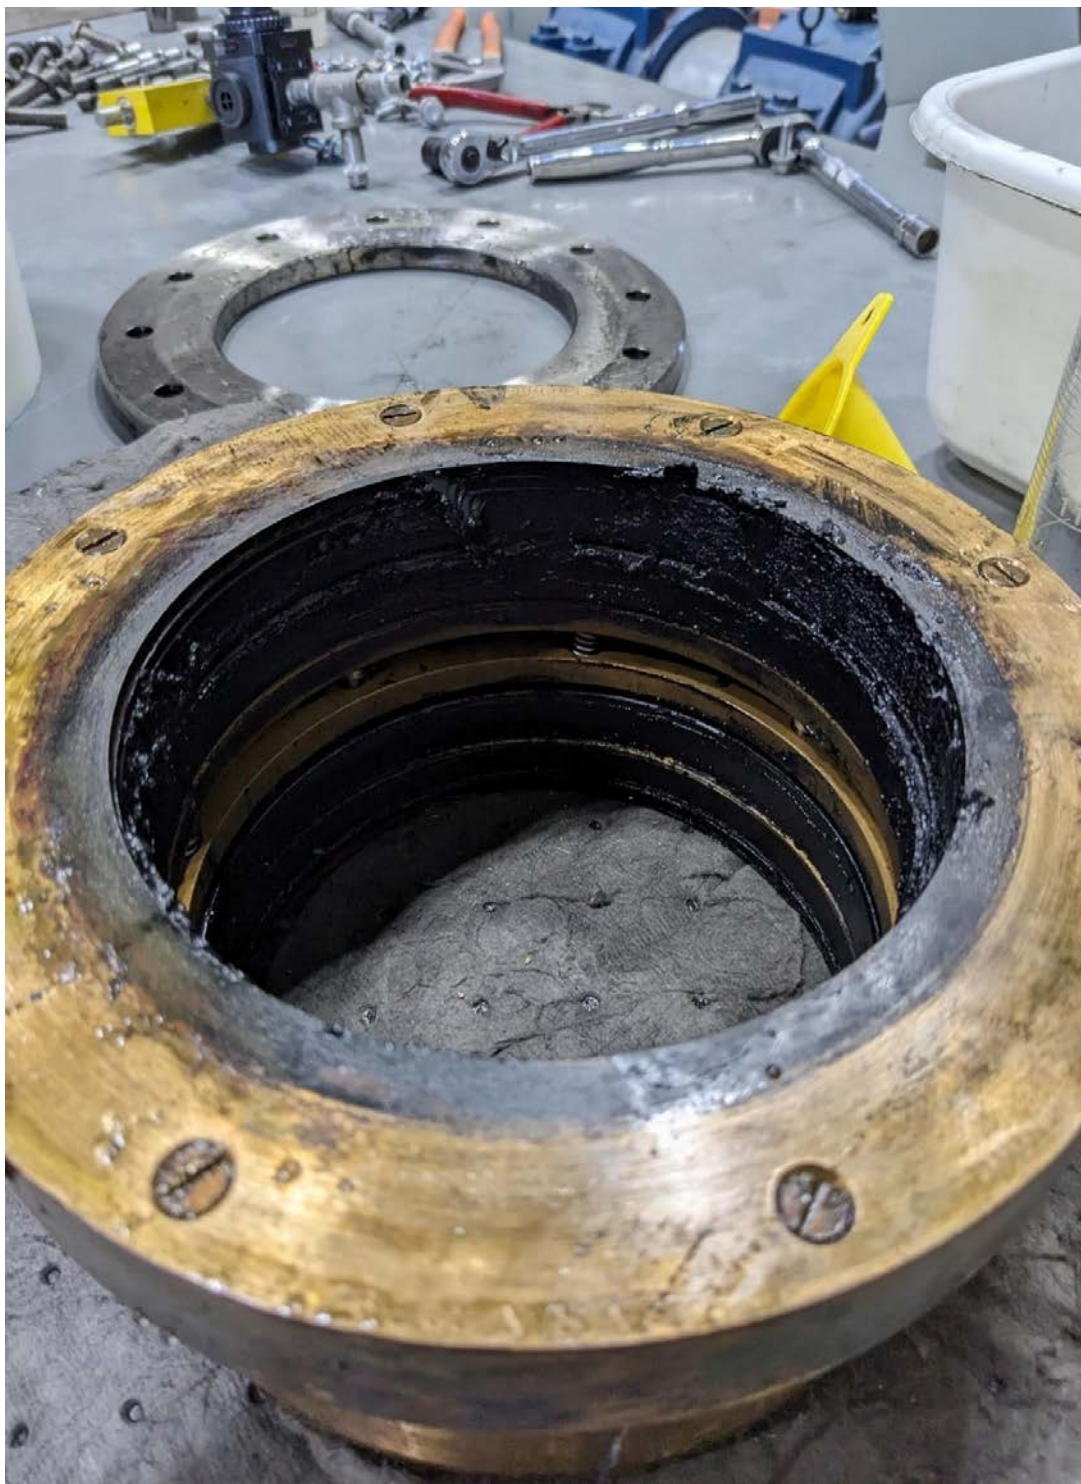
Figure A-4. MSS and housing removed from the shaft. The inside of the seal shows accumulation of graphite/BF paste. More accumulation can be seen at the front (top) of the seal than the back (bottom).

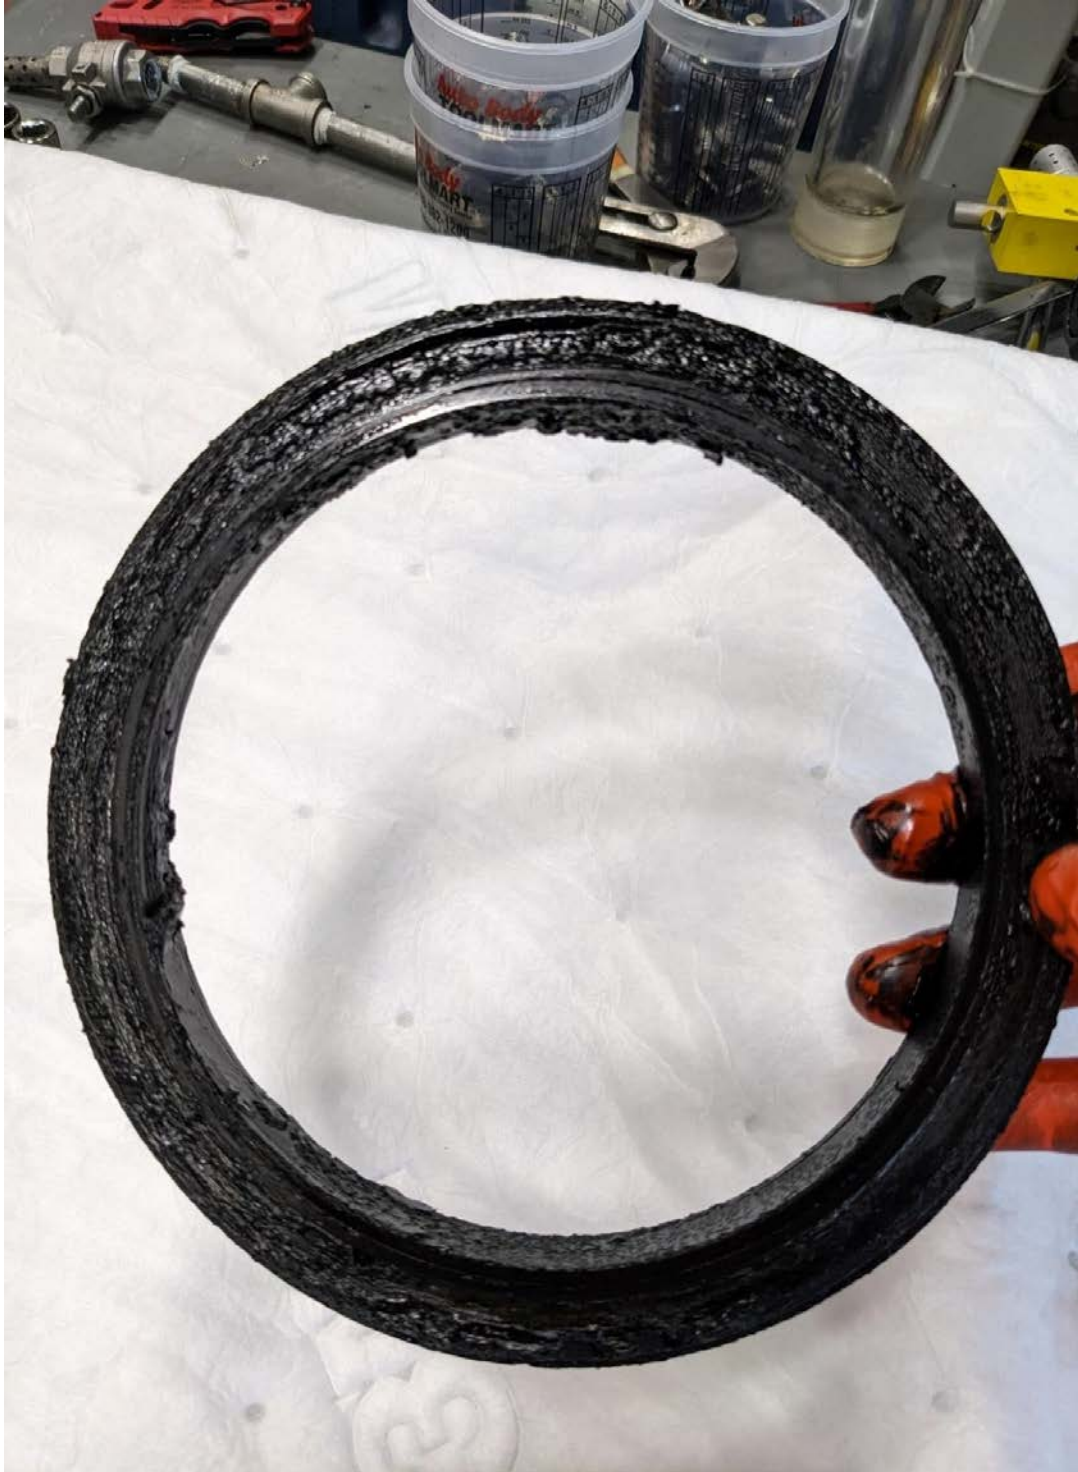
In addition to experiencing asymmetric wear between the front and back antifriction rings, the individual rings were also worn radially asymmetric. The carbon ring wore on a lip at the interface between the antifriction ring and the bronze seal-facing ring. The original and final height of this ring are given in Table 2. The front ring experienced more wear than the rear ring. The height difference between the highest and lowest point was 0.6 mm. This creates a plane angled 0.2 degrees relative to the back of the ring that does not experience any wear. The rear antifriction ring had significantly less wear with a maximum height difference of 0.21 mm. After testing, the wear surface of the front ring was almost completely worn away at the lowest point (see Appendix).

Component		Original Height [mm]	Minimum Height [mm]	Maximum Height [mm]
Graphite Antifriction Ring	Front	1.167	0.27	0.87
	Rear	1.167	0.88	1.11

The axial asymmetric wear observed on the graphite antifriction rings is a concern. It is not entirely clear why the front ring experienced wear more drastically than the rear ring. The compression ring should apply equal force on the front and rear ring, so compressive forces should be equalized front to rear.

Considering only the front graphite ring, the circumferentially asymmetric wear is more difficult to understand. The most likely explanation is an assembly error or disruption to the test stand setup machine during the power outage. The MSS was assembled according to instructions provided by the manufacturer and functioned continuously for 137 days, suggesting the seal was assembled correctly; however, the wear pattern suggests nonuniform loading from the compression rings. The compression rings use a series of springs and alignment pins to create constant outward pressure in the wear surfaces and increase sealing potential. Cocking of the springs or pins in the housing, combined with the more hazardous environment at the front of the seal housing, could create the necessary conditions for the observed wear pattern. Aside from the observed results, there is little evidence to support this theory, so further evaluation of the seal components is warranted.

The results suggest the MSS may not have completed the entire SI before failure. The front graphite ring was worn through 77% of the interfacial lip on one side, suggesting failure was likely to occur before completing the SI, but this is difficult to determine because the wear rate is uncertain. Based on the wear-in period shown in Figures 3 and 4, the wear rate is not constant, but its actual value cannot be determined without more information. The objective of BF sampling was to determine the graphite particle generation rate, but this was unsuccessful because BF pressure prevented sampling.

Figure A-5. Wear surface of the front graphite antifriction ring with accumulation of graphite/BF residue. The visible surface interfaces with the bronze seal face ring.

possible causes are an assembly issue or the suspected misalignment. Documentation should be created to detail the proper assembly of the seal and, if possible, ways to inspect the assembly during operation to ensure consistent performance.

- Garlock recommends the next steps for root cause determination should include examining the test rig itself to see how the shaft is moving relative to the surface the seal is mounted to and compare that to the worst case expected in the real world.

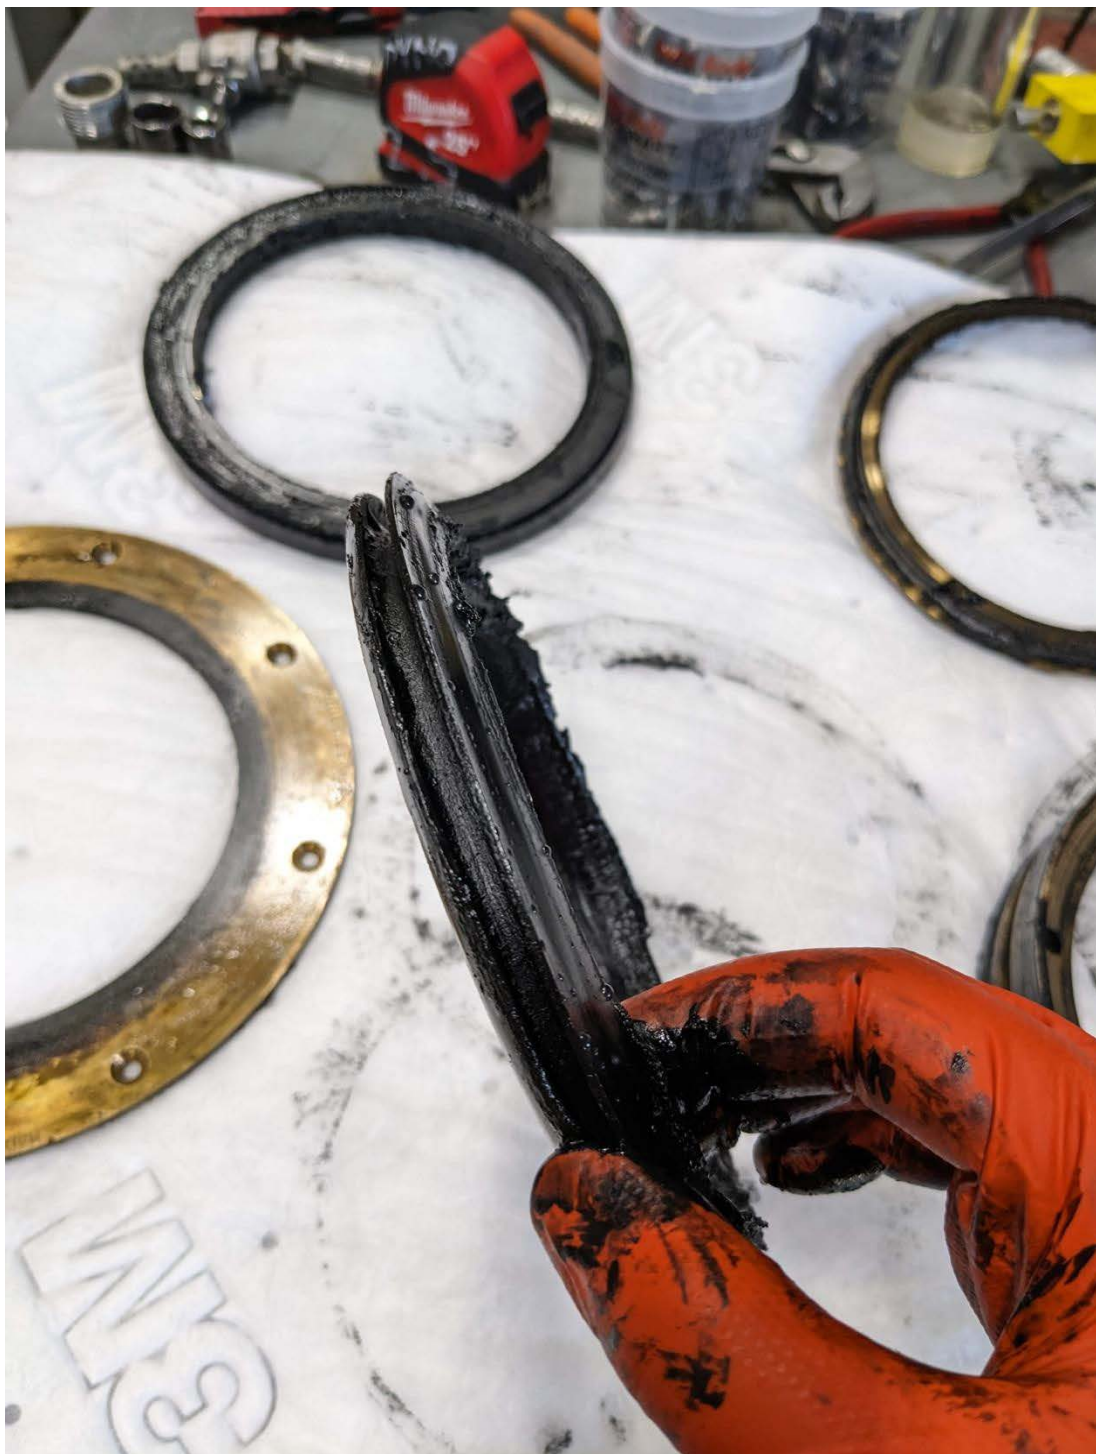
Figure A-6. Front drive ring showing permanent deformation caused by constant pressure from the seal face and compression rings.
