Solar Photovoltaic (PV) Damage Assessment After Typhoon Mawar: Findings and Recommendations for Resilient PV on Guam

Technical Report
NREL/TP-5R00-89629
November 2024

A team from the National Renewable Energy Laboratory (NREL) visited Guam in August 2023 to assess failure modes of solar photovoltaic (PV) systems as a result of Category 4 Typhoon Mawar and to provide recommendations to increase the resilience of PV systems on Guam. The team visited 30 systems, all commercial and utility scale, comprised of rooftop, ground-mounted, and canopy/carport systems. The team observed systems with no apparent damage, as well as systems that were completely lost. Systems fared very well overall. The average damage to rooftop systems was 18%, with a median of 2%, meaning that few systems suffered total loss. Only 8 of the 25 rooftop systems suffered more than 5% damage. All ground-mounted systems suffered less than 0.5% damage. One carport had 16% damage. PV systems at Andersen Air Force Base suffered 5% damage on average, with a median of 0.6%. In almost all cases, damage was the result of:

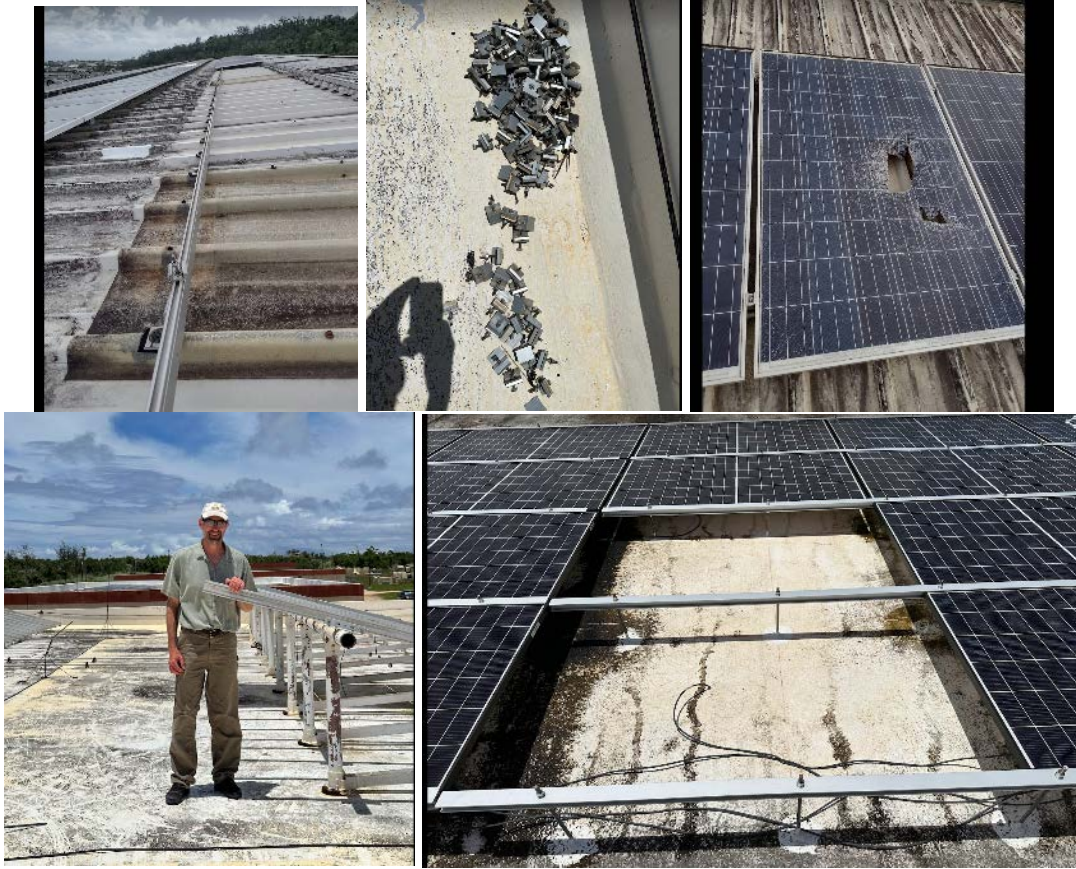
Figure ES-1. The most common failure modes, clockwise from top left: (a) Inadequate clamping of module frame to mount, leading to cascading failure. Module mounting clamps in this case rotated out of the support rail and can be seen on the roof in (b). (b) Undamaged module clamps remaining on roof surface after they rotated out of the racking and released modules. (c) Module damage from debris impact. (d) Modules that released from the mounting system. (e) System with excessive tilt angle.

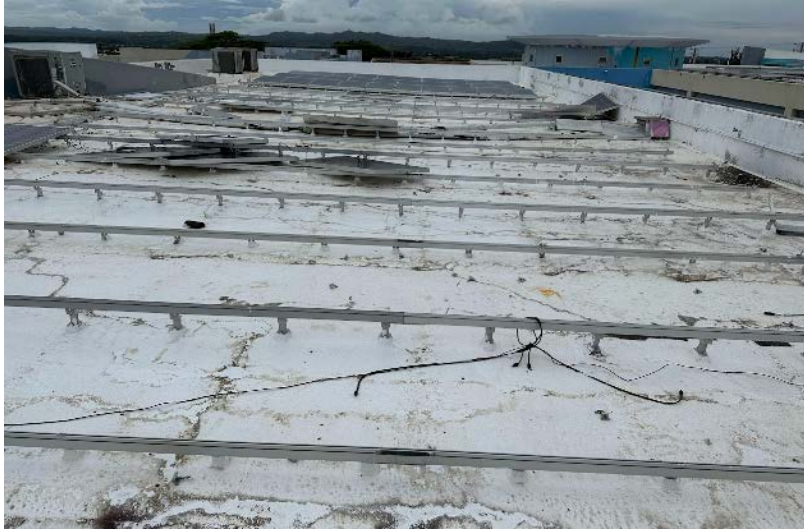
1. The most common was modules that had blown off the racking.
 - A. This is not necessarily a module failure. It is likely a failure of the attachment system meant to fasten the modules to the racking. Many modules seen scattered around arrays were relatively intact, indicating the attachments failed.

Figure 10. Catastrophic failure: modules blown of racking at Guam Community College. This is most likely not a module failure, but a failure of the module attachments.

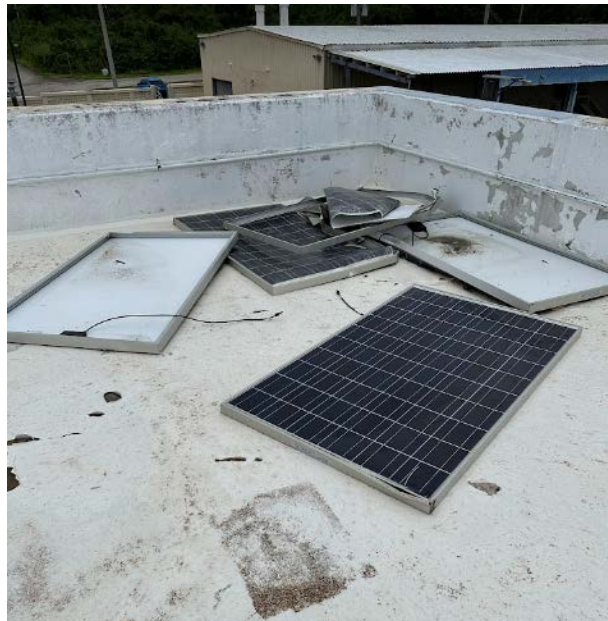
- B. Some modules could have first been damaged and were able to come free of the racking because of this. If the glass is broken by flying debris, for example, the module might lose structural integrity and be able to come free of the racking. Many modules scattered around the arrays were damaged with broken glass, broken frames, and with the cells separated from other components. There is no way to tell whether this damage occurred before or after the modules came free of the racking.

Figure 11. Damaged modules that came free of racking scattered around a rooftop. It often cannot be determined if modules were damaged before or after coming free.

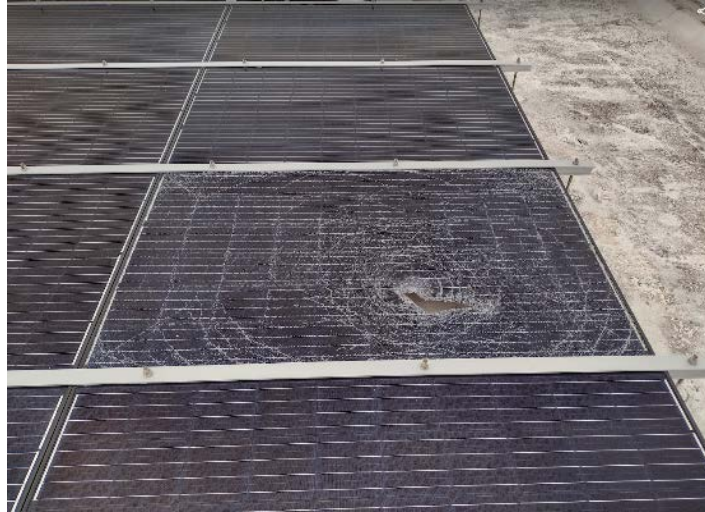
2. Some modules were still intact in the racking system but had broken glass.
 - A. In almost every case, this appeared to be the result of impact from flying debris, as there was a clear impact point on the glass from which the shatter emanated. This flying debris could well have been another PV module.

Figure 12. Module intact in racking damaged from flying debris

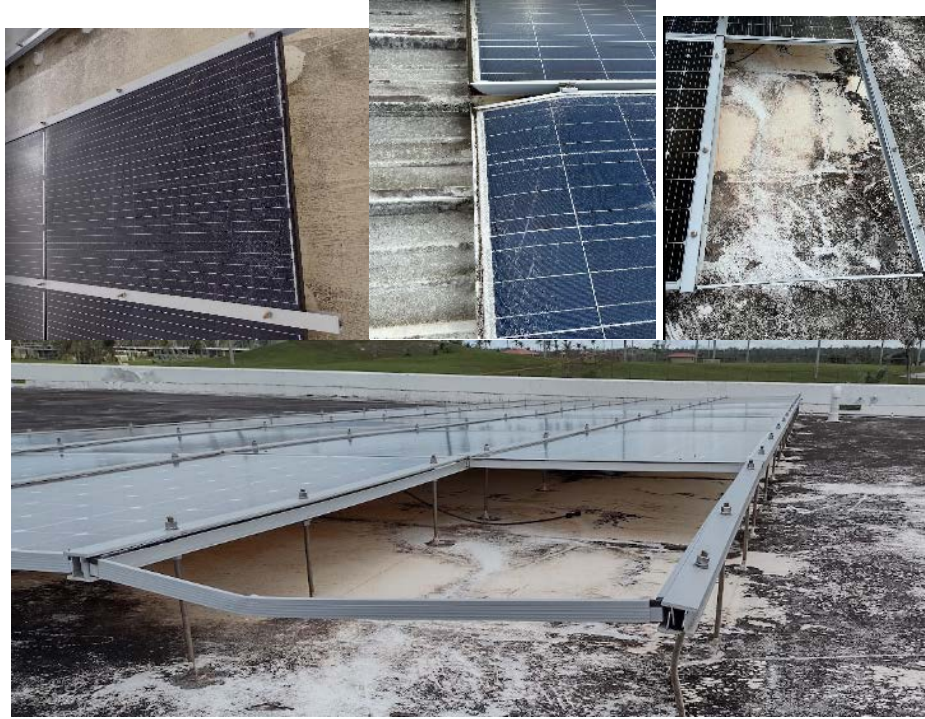
- B. Out of the thousands of broken modules and hundreds of thousands of total modules seen, only two were seen with shattered glass and no obvious impact point, two were still held in bent frames (this could have been frame yielding under wind load or the result of debris impact), and one module's frame was left in the racking (damaged) with the rest of the module (cells, glass, and backsheet) missing.

Figure 13. Module damage with undetermined cause, only seen on five of the hundreds of thousands of panels seen on the trip. Top left: Cracked glass with no clear impact point; top middle: module frame bent; top right and bottom: module frame remaining in racking with the rest of the module missing.

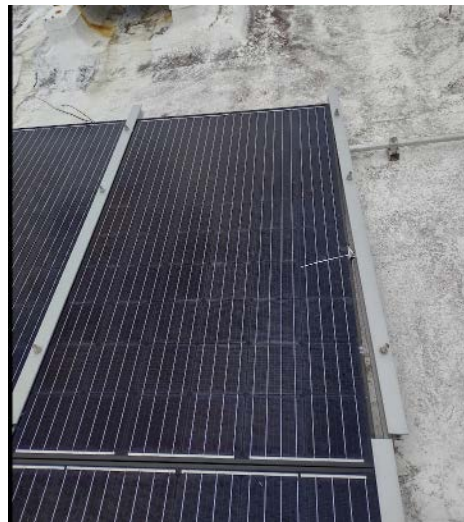
Figure 14. Scratch and flying debris impact damage

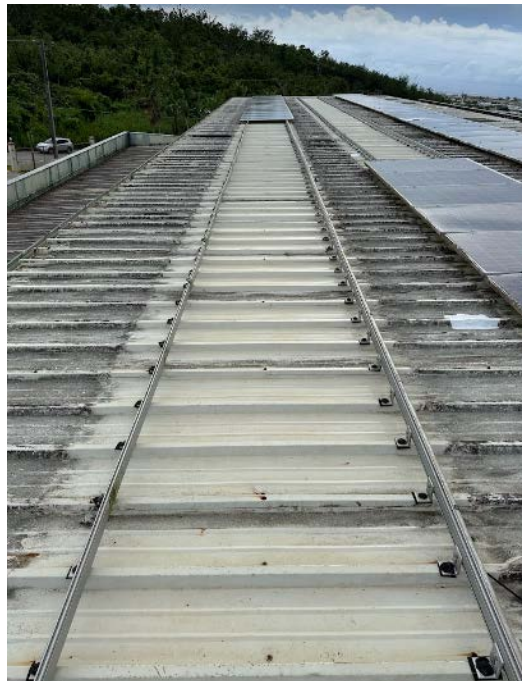
Figure 20. Cascading/progressive failure of two rows of modules that were held with top clamps. One (or a small number) of failures can lead to the loss of many neighboring modules. This is because the top clamps used require the presence of two adjacent modules to maintain adequate clamping force. If one module comes loose, the whole row is vulnerable to failure.

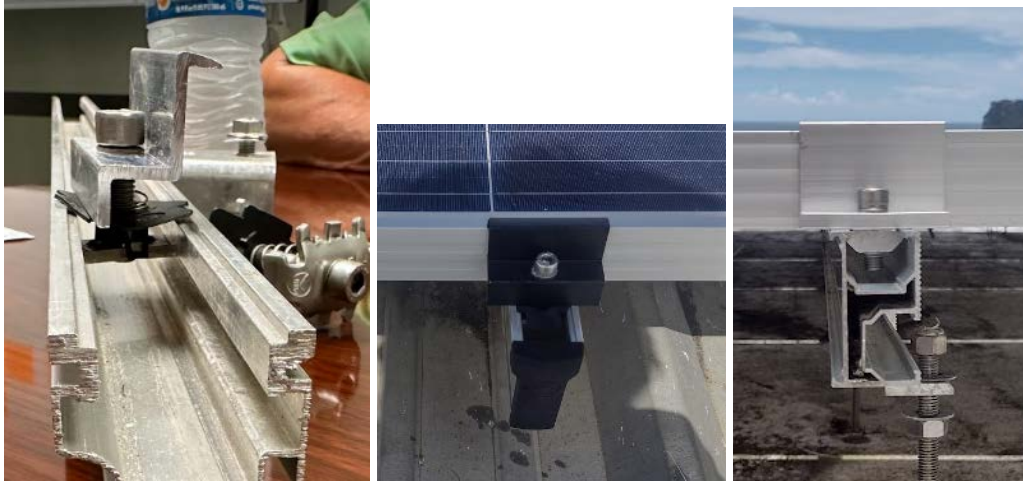
Figure 24. Top clamps typically have nuts or bolt heads that slot into racking rails. If the bolts come loose, they can rotate in the rail and easily pull out of the slot.

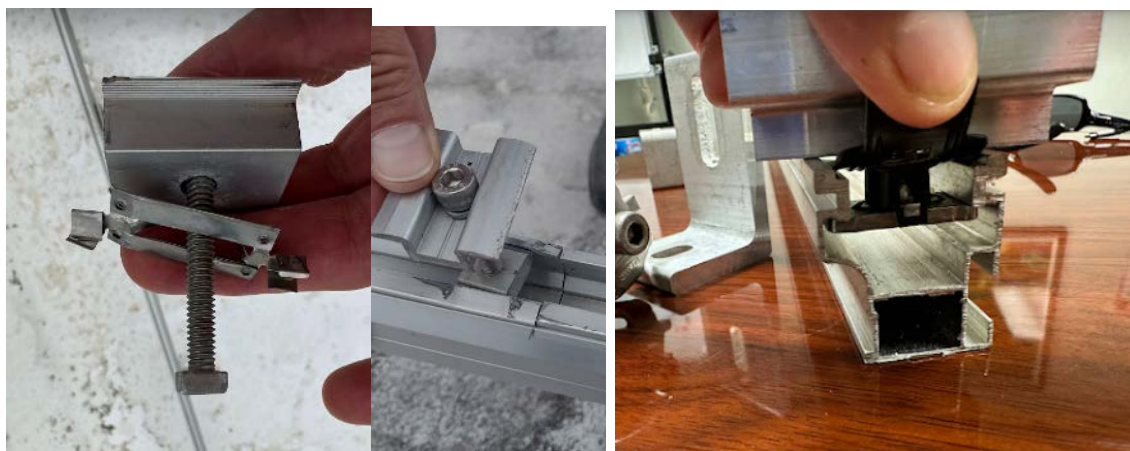
Figure 27. Some clamps have small bolt head (left) or nut (middle) contact area with the rail. These are prone to tearing out of the rail slot. Some products have significantly more contact area (right).

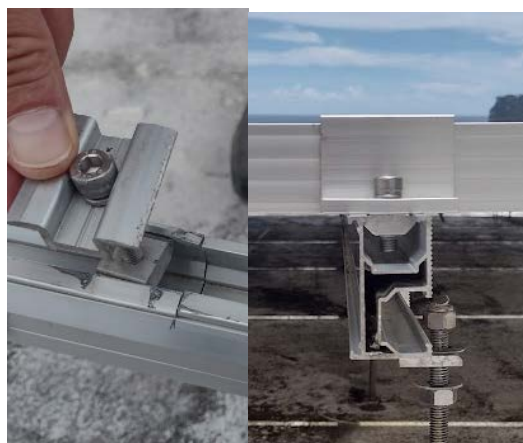
Figure 29. Weak racking material and a small amount of contact area/overlap between the rail and the clamp nut led to many clamps tearing out of the racking at JFK High School

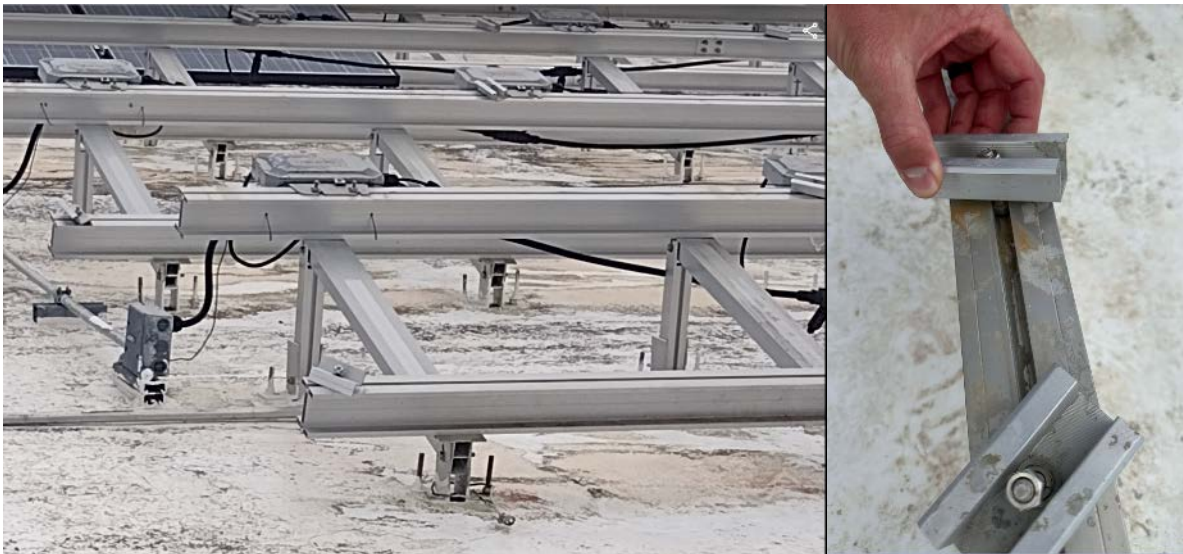
Figure 30. At the FIFA soccer stadium, the clamps did not come free from the rail because of the narrow rail slot. Still, they loosened and released modules.

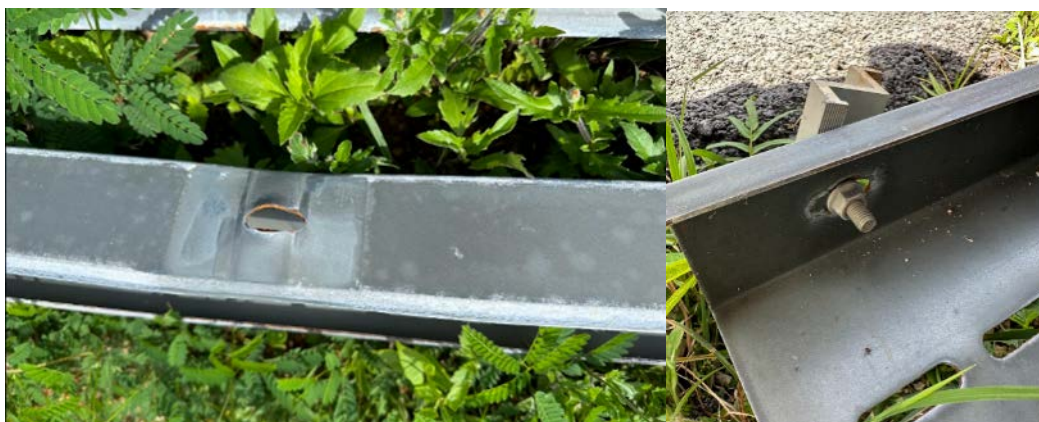
Figure 32. Evidence of direct bolt tear-out of racking rails (left) and steel deformation from a top-clamp bolt that was close to tearing out (right)

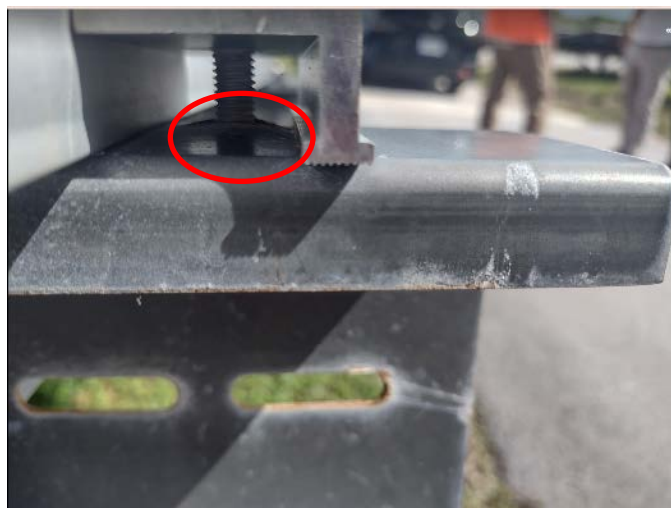
Figure 33. Steel deformation where a bolted joint was likely overtightened during installation

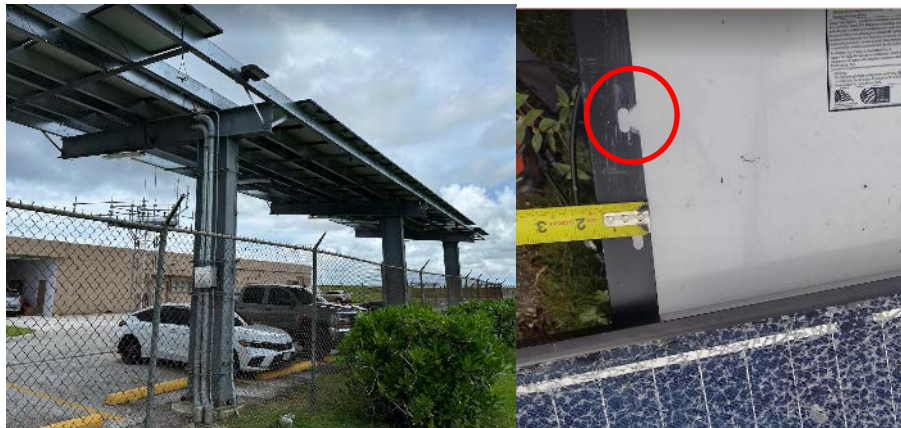
Figure 34. One carport system on Guam lost modules due to bolts tearing out of the module frames and due to flying debris. This tall structure mounted the modules about 22 feet above the ground. The modules had two potential bolt slots; only one was used. These slots were also close to the edge of the module frame where the bolts tore through (right).

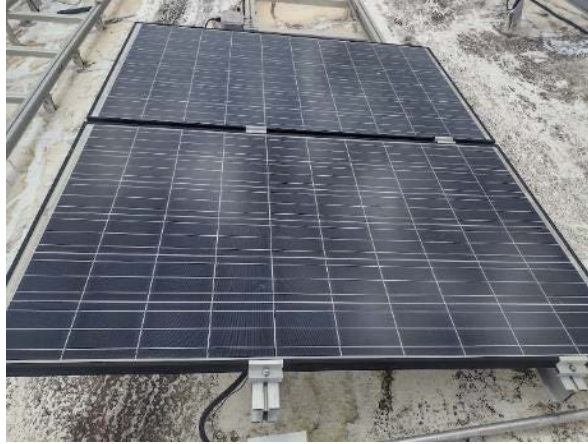
Figure 36. Clamps should be installed on modules as required in installation manuals, not off-center as shown here

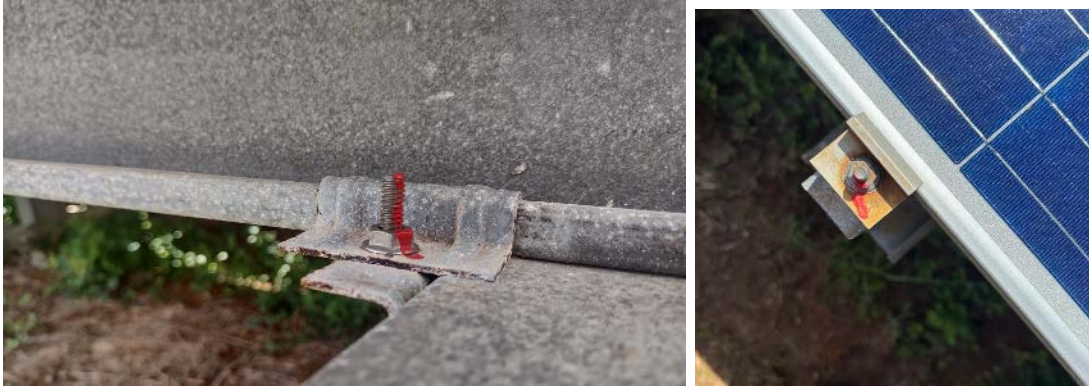
Figure 39. Torque stripes on torqued bolts can give a visual indication if bolts have loosened over time. The bolt on the left is in line. The bolt on the right appears to have rotated loose slightly.

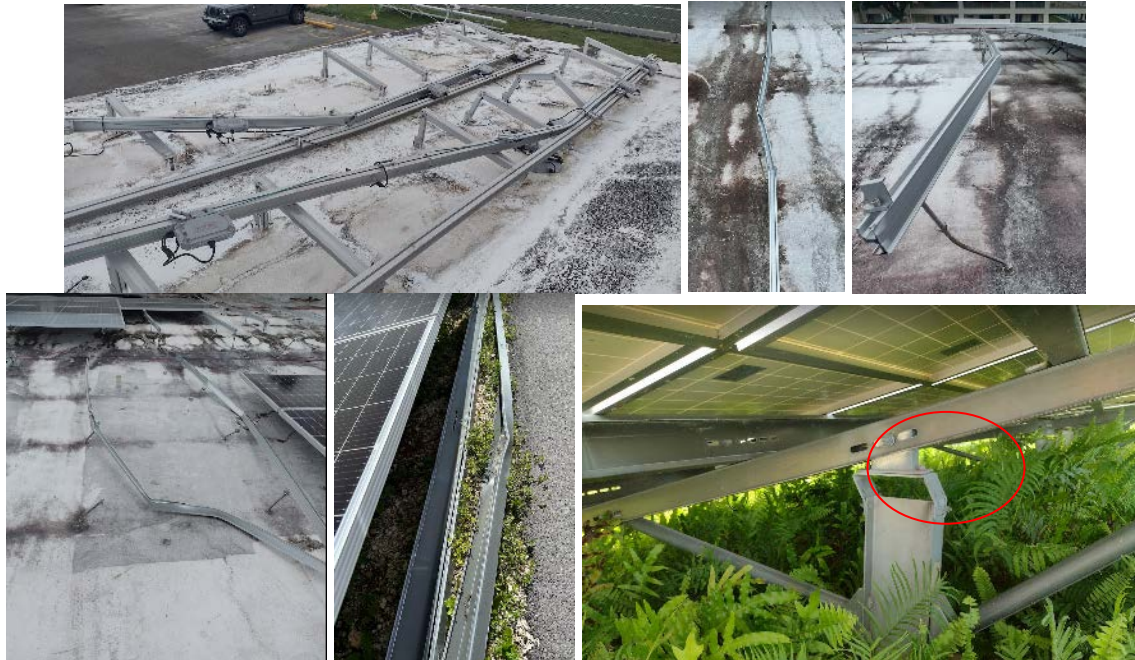
Figure 40. Deformation of various racking components. Top left experienced higher loads due to its location near the roof corner. Top middle, top right, and bottom left used too thin gauges and low-quality components. Bottom middle and bottom right were likely the result of extreme loads and bolts that slipped in their slotted connections.

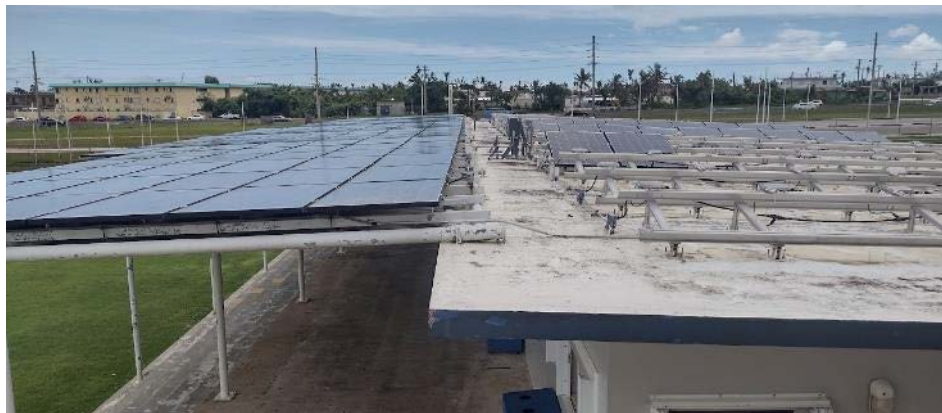
Figure 42. The right section of this array had a high tilt angle (14°) and suffered extensive damage. The left portion of the array was mounted flush to the roof at a low tilt angle (4°) and suffered no damage.

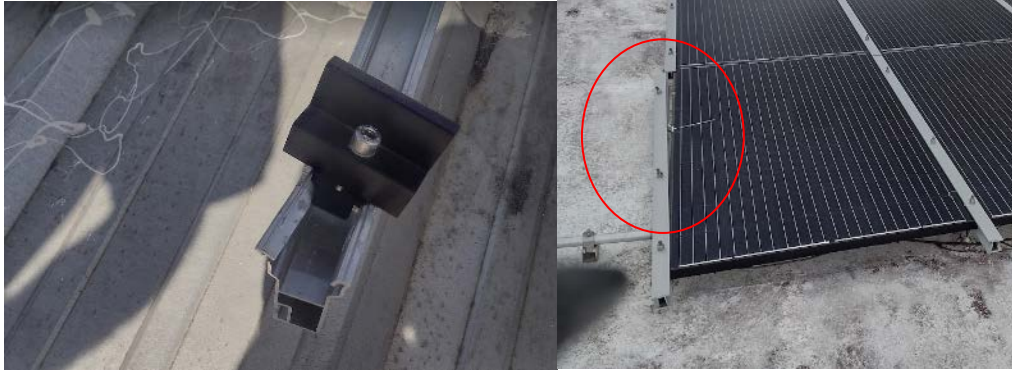
Figure 43. Debris impact can damage racking, which may free modules

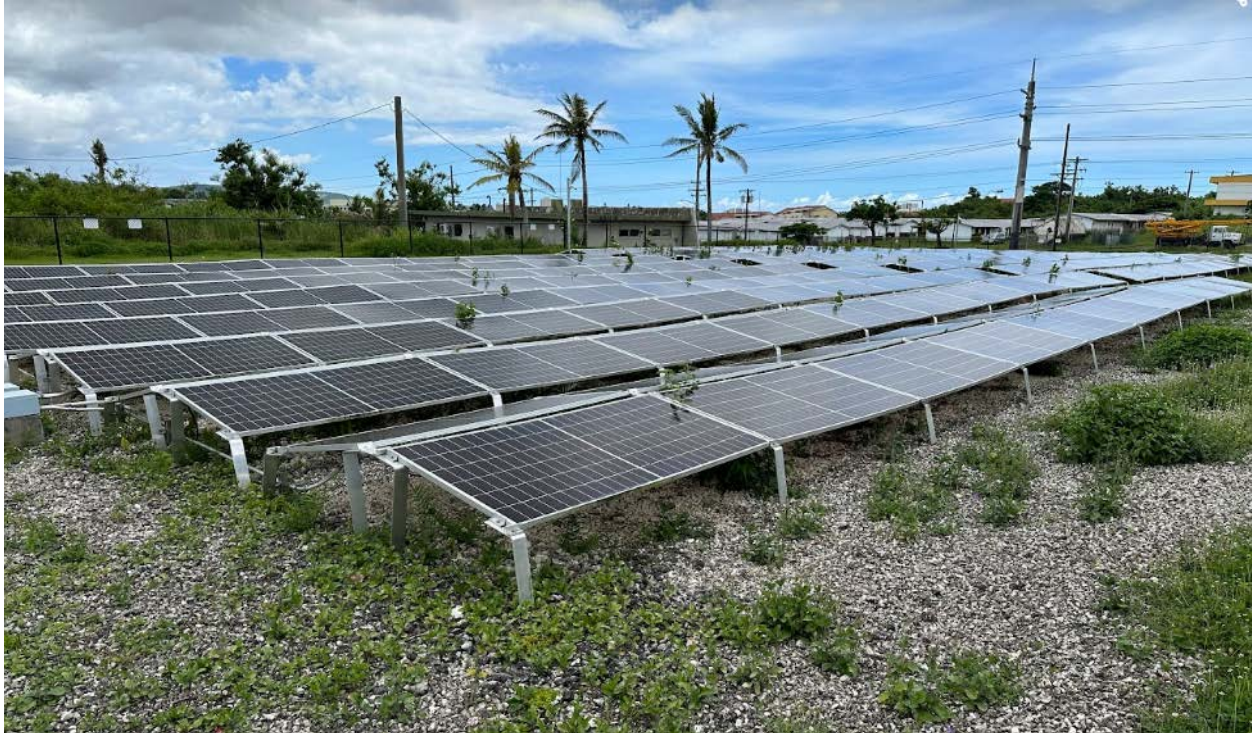
Figure 44. The lack of a substantial racking system on this “east-west” ground-mounted system puts extra loading onto the modules themselves. Modules in this array are deformed, sagging in the middle. They are vulnerable to damage in a future event and could have suffered internal damage that might diminish power production or shorten useful life.

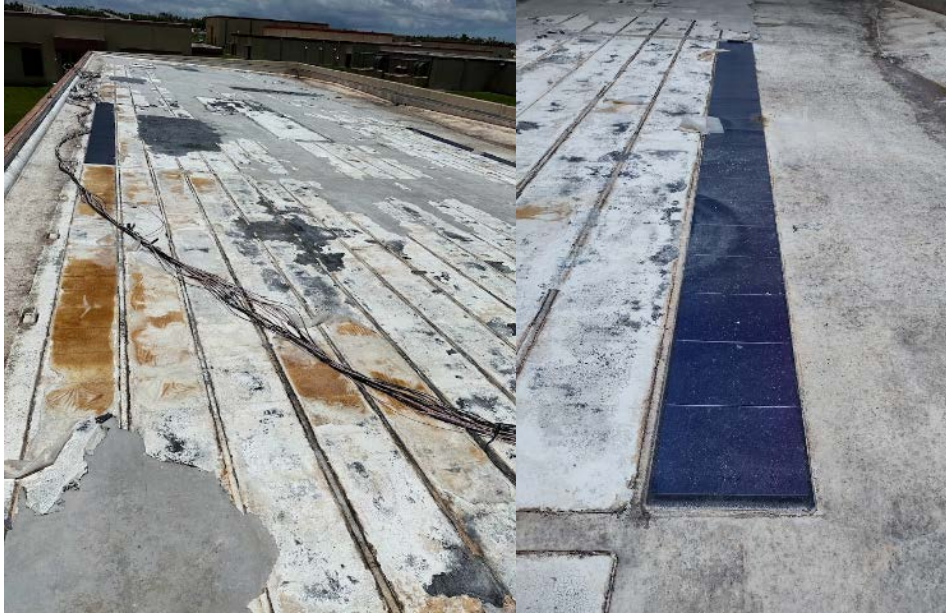
Figure 45. One system that used an adhesive to attach solar directly to the roof surface was nearly totally blown away. Although this product is no longer on the market, avoid systems like this that use adhesives or attach solar directly to the roof.

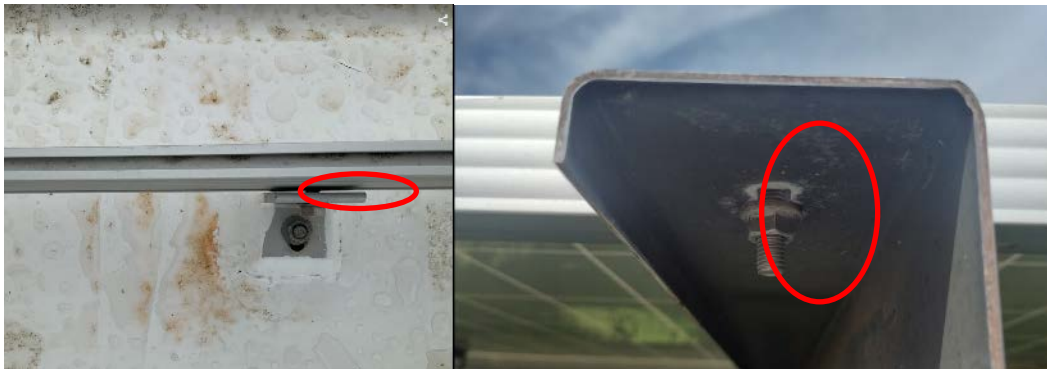
Figure 46. Left: Loose bolted connection between roof anchor and racking rail. Bolts were loose down the entire length of this rail, and it could move easily. Right: A loose nut on a bolted connection.

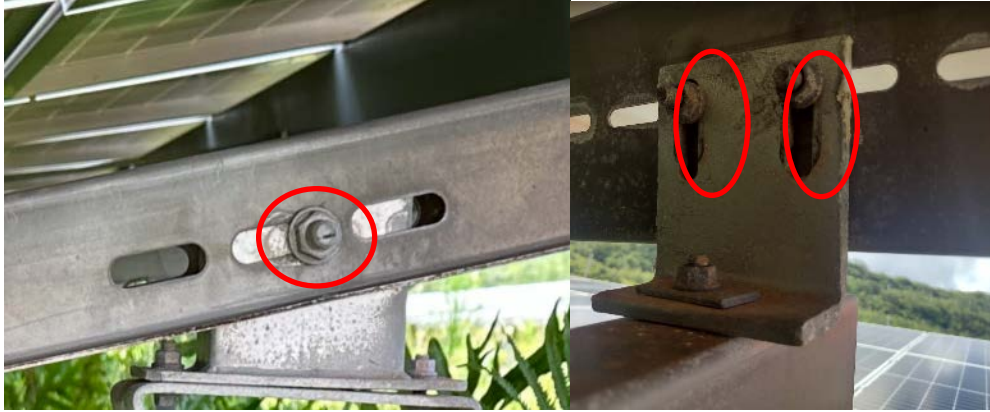
Figure 47. Racking bolts that slipped in slotted connections, clearly shown by impressions left from the original position of the bolt. Bolts may have loosened due to wind-induced vibrations and then slipped.

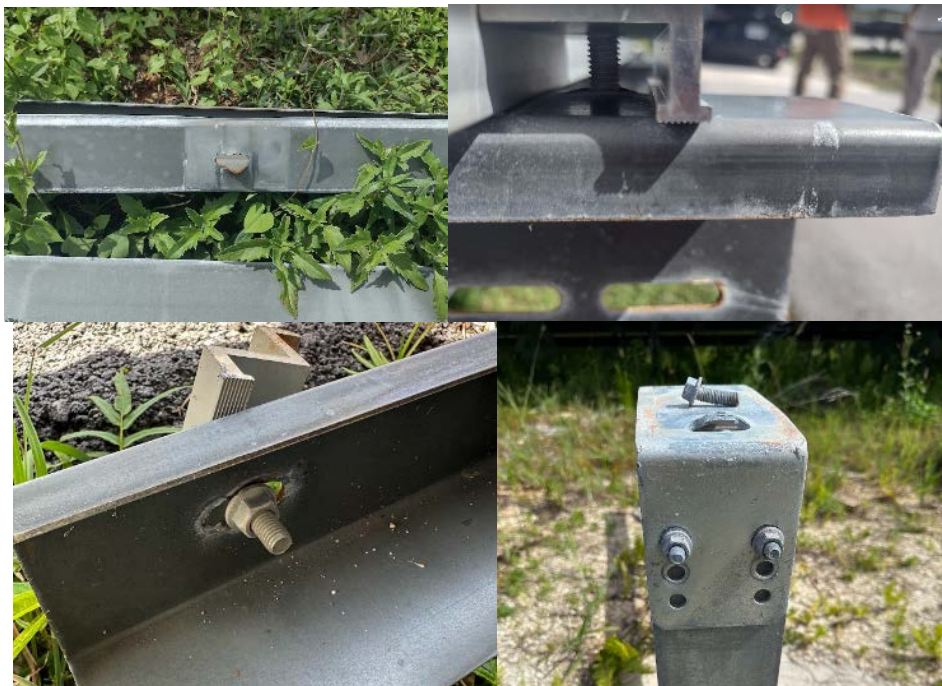
Figure 48. Various instances of bolt tear-out or near tear-out at various places within the racking system

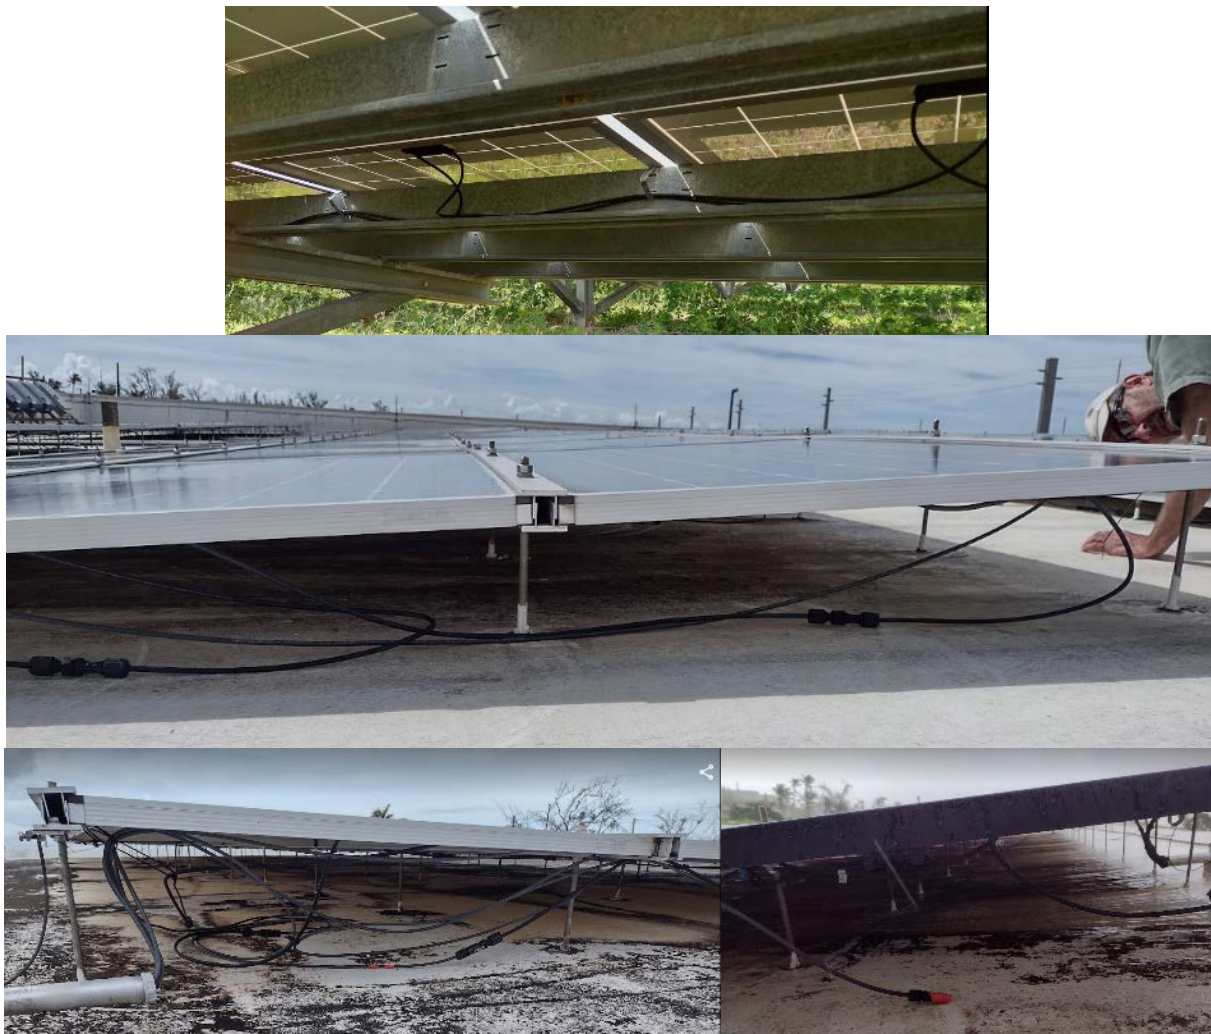
Figure 53. Various wire management approaches—some good, some bad—and failures. Top: Metal PV-specific wire management system that has held wires in place for more than 10 years. Middle: Wires and PV connectors down on the roof are a safety and fire risk due to potential water damage and insulation damage as wind drags them across the roof surface. These were likely tied under the panels with plastic or nylon wire ties that failed. Bottom left: More wires and connectors down on roof surface, likely because of failed wire ties. Notice the one plastic wire tie under the left side of the module. Bottom right: A PV connector that has come unattached, breaking the circuit and stopping power delivery from a whole string of PV modules.

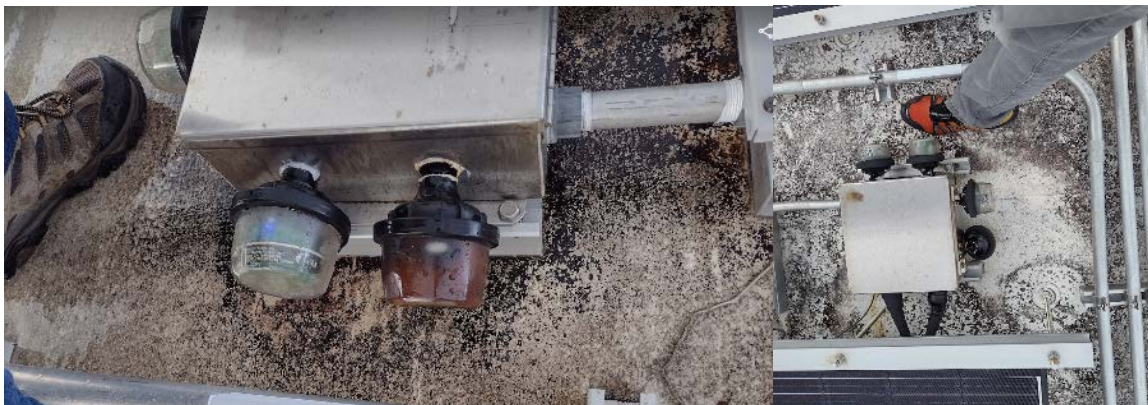
Figure 55. Failed DC surge protection devices with signs of water ingress and burnt components

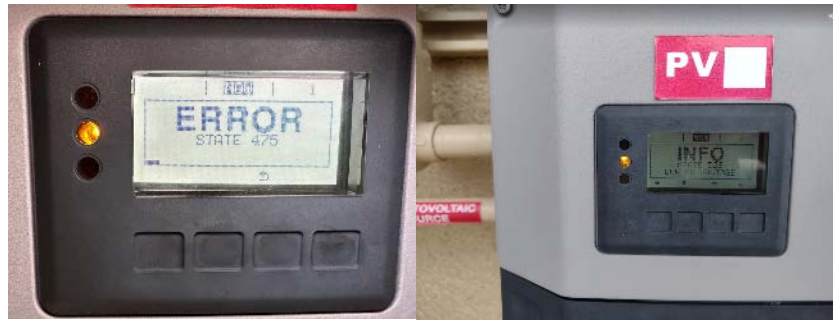
Figure 57. Inverter error codes. Many inverters displayed error codes and were not providing power, even before the storm.

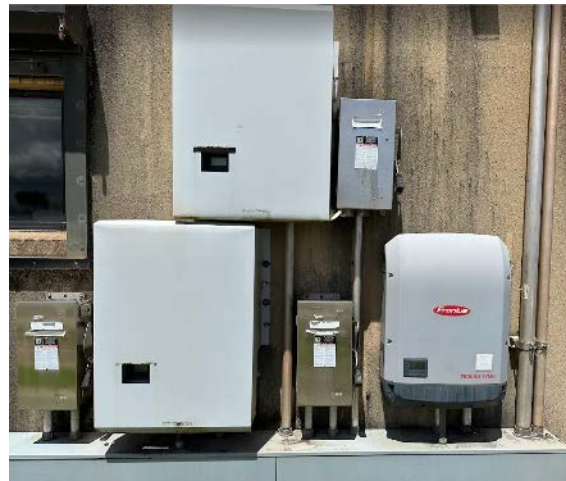
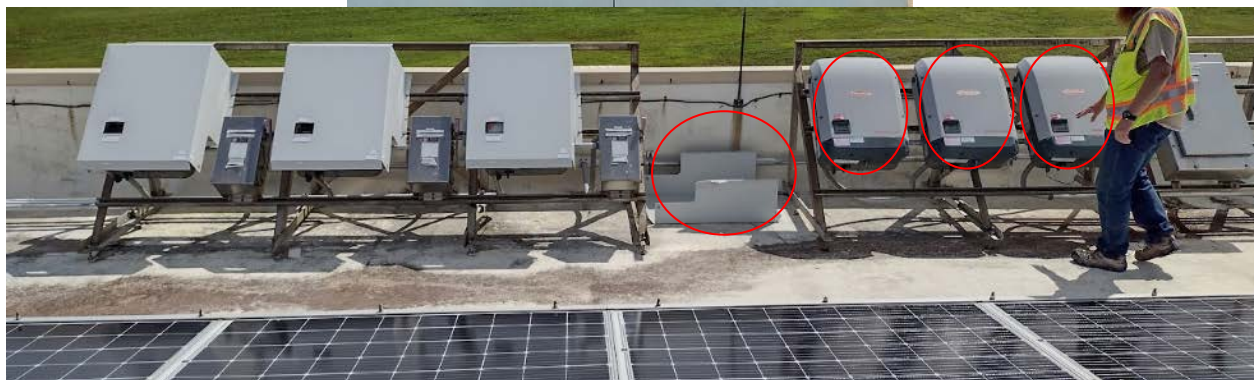
Figure 58. Shade covers blown off inverters; low-impact and low-priority failure. Notice the faded labels on the disconnect boxes, too.

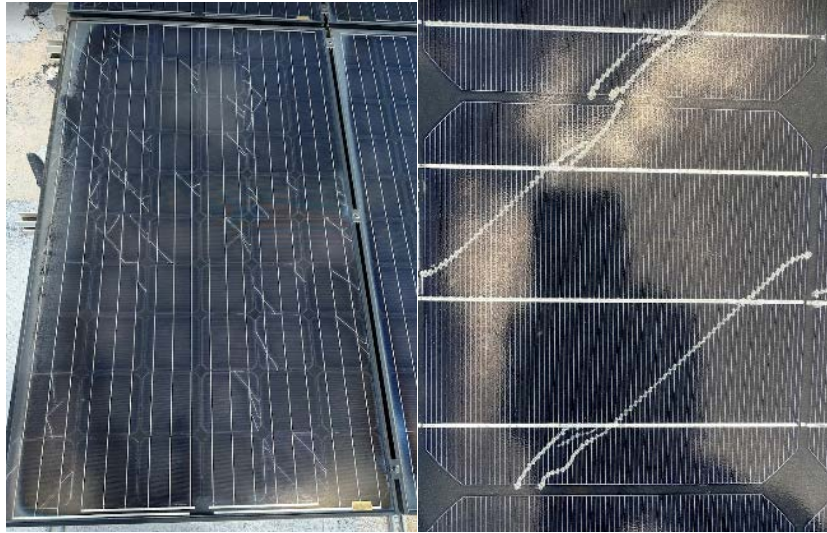
Figure 59. Snail trails most likely predated the storm, though they can be caused by water ingress. These will lead to loss of production over time and may be grounds for a warranty claim.

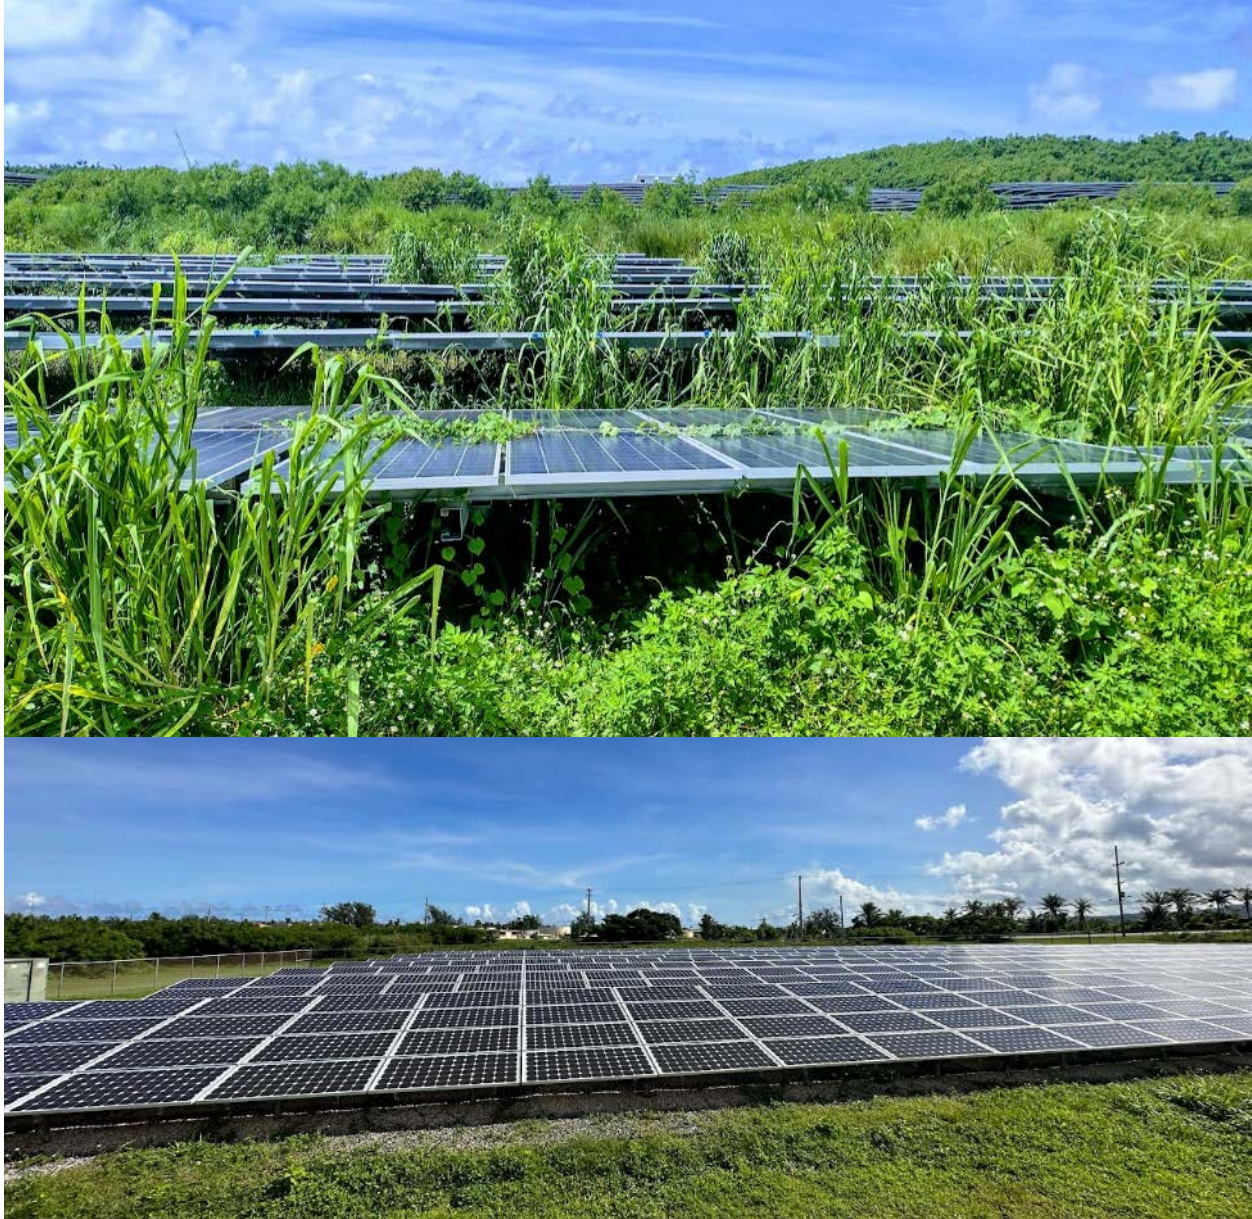
Figure 61. Vegetation management is a big concern on Guam. Top: An overgrown section of a utility-scale PV array. Bottom: An excellently maintained PV array at Naval Base Guam. There is a third-party service contract for this array, and it is in excellent condition, even 15 years after installation.

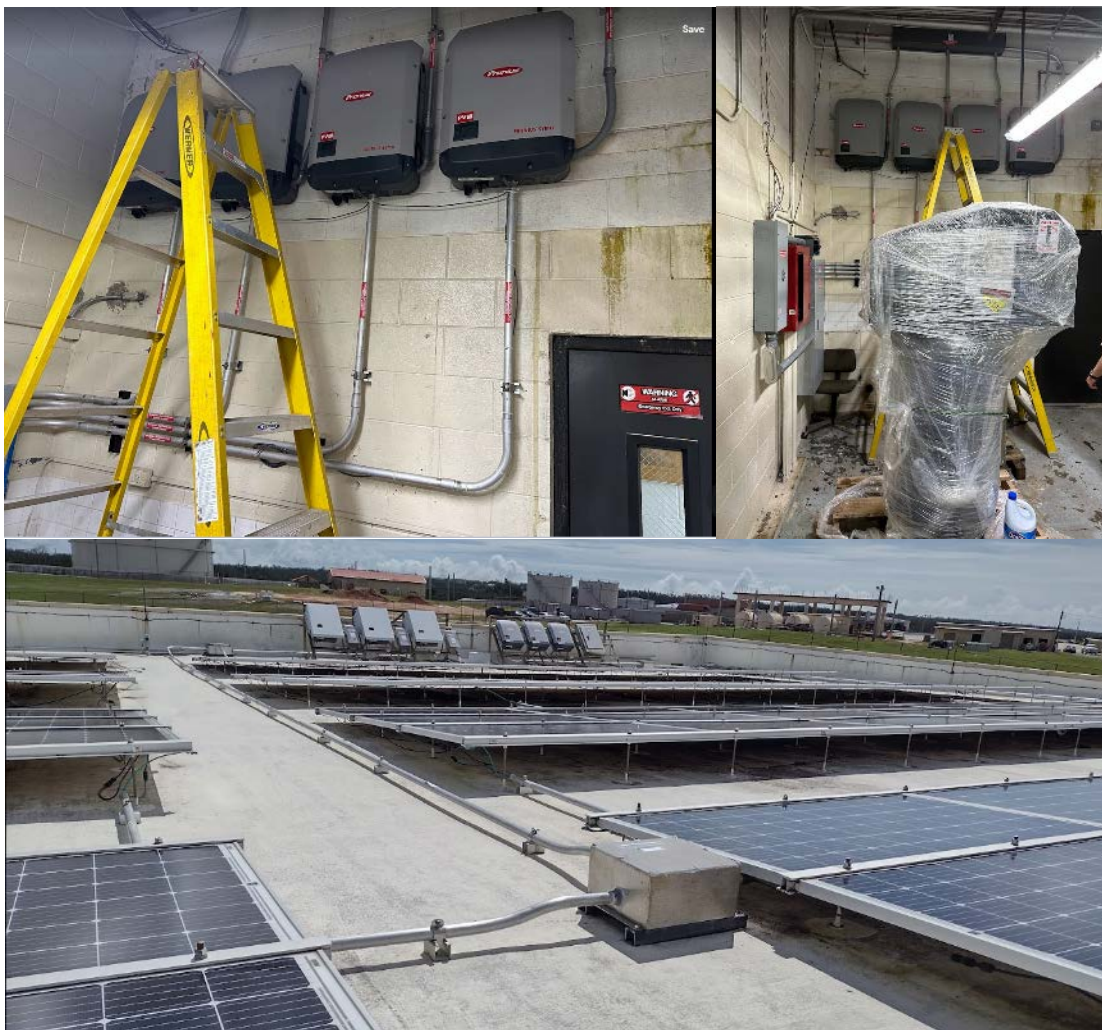
Figure 64. Inverters mounted high on walls or on roofs are difficult to access and read, which hinders maintenance and makes it more likely faults will go undetected

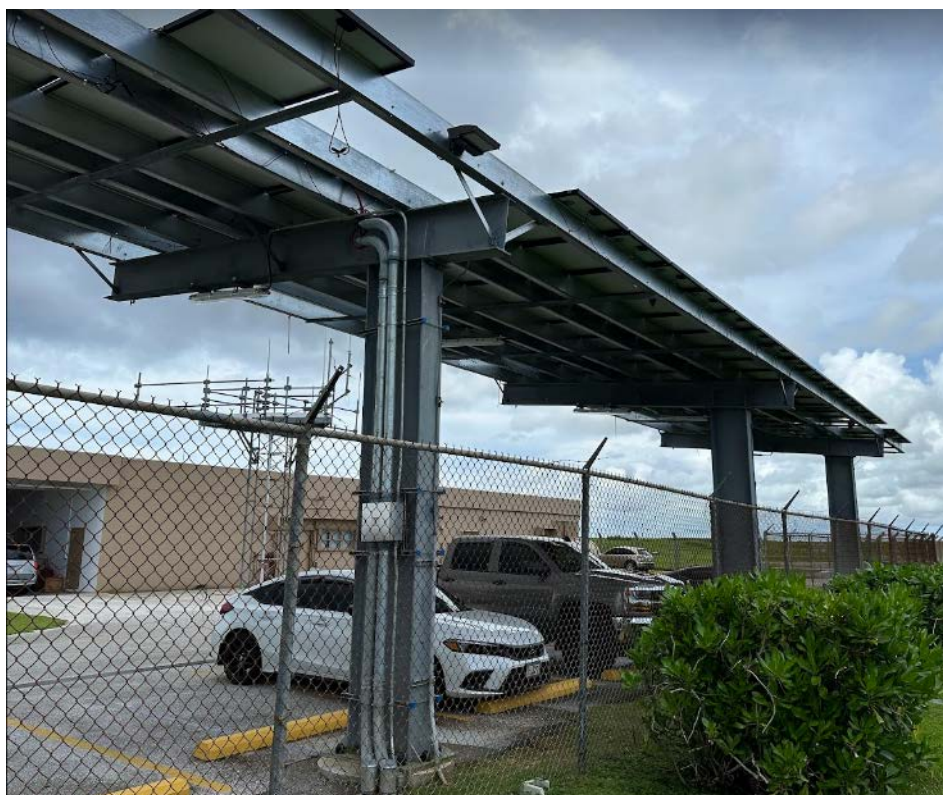
Figure 65. PV carport structure with isolated missing modules where modules tore off the bolts holding them down. The structure is also very tall (approximately 20 feet high) and thus susceptible to higher wind loads.

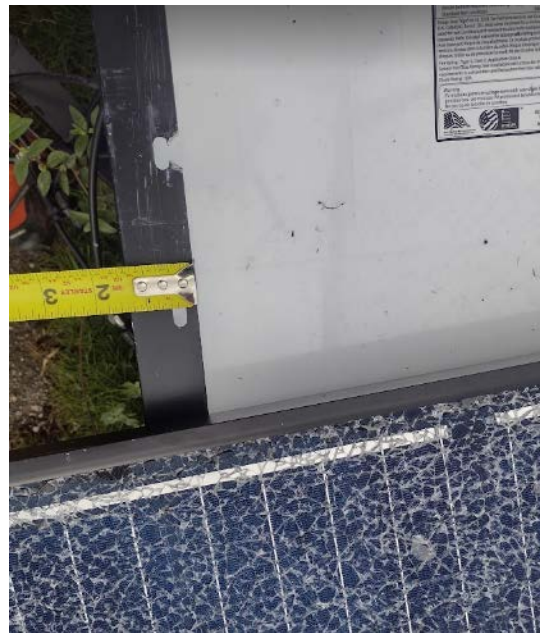
Figure 66. The predrilled bolt slots on this module were very close to the edge of the module frame lip, allowing the bolts to tear out of the frame more easily. Larger-diameter washers could help.

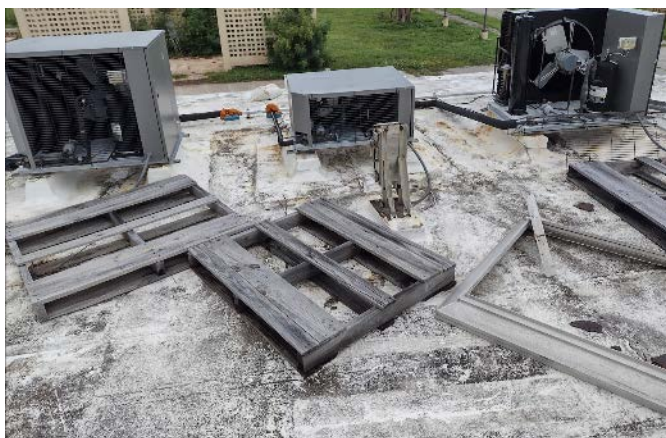
Figure 67. Debris left on rooftop after the typhoon

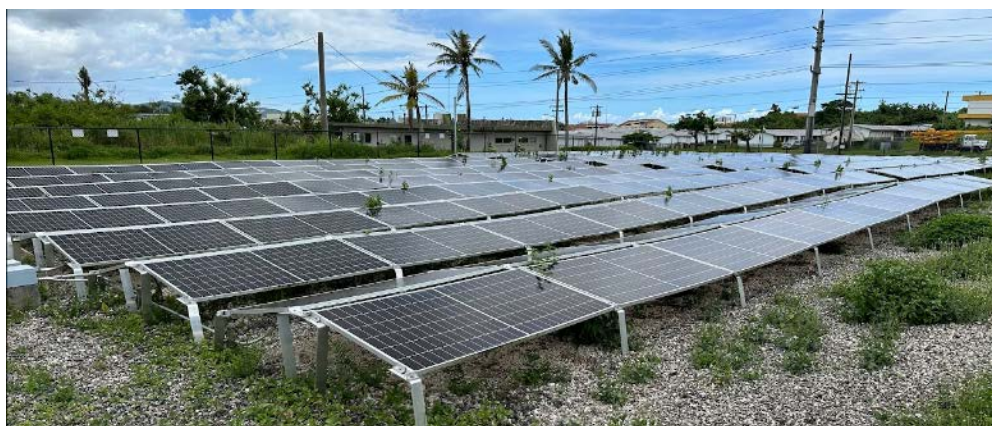
Figure 69. Upon close inspection, modules in this array are deformed and sagging. While it did not suffer any obvious damage from the typhoon, this will likely impact production and leaves the array more vulnerable to damage from future events.

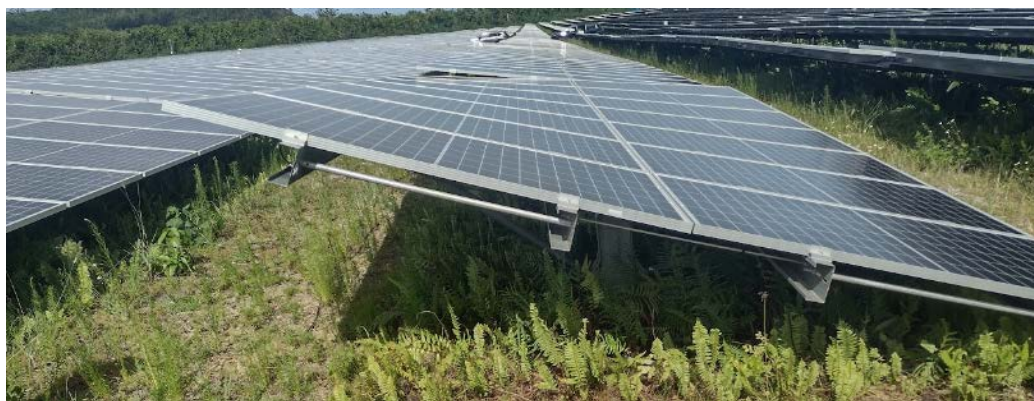
Figure 70. Racking deformation or shifting has led to some modules raised higher than others. These sections of the array are likely more exposed and racking components are more fatigued, leaving it more vulnerable to damage from future wind events.
