Solar Photovoltaic (PV) Damage Assessment After Typhoon Mawar: Findings and Recommendations for Resilient PV on Guam

Technical Report
NREL/TP-5R00-89629
November 2024

A team from the National Renewable Energy Laboratory (NREL) visited Guam in August 2023 to assess failure modes of solar photovoltaic (PV) systems as a result of Category 4 Typhoon Mawar and to provide recommendations to increase the resilience of PV systems on Guam. The team visited 30 systems, all commercial and utility scale, comprised of rooftop, ground-mounted, and canopy/carport systems. The team observed systems with no apparent damage, as well as systems that were completely lost. Systems fared very well overall. The average damage to rooftop systems was 18%, with a median of 2%, meaning that few systems suffered total loss. Only 8 of the 25 rooftop systems suffered more than 5% damage. All ground-mounted systems suffered less than 0.5% damage. One carport had 16% damage. PV systems at Andersen Air Force Base suffered 5% damage on average, with a median of 0.6%. In almost all cases, damage was the result of:

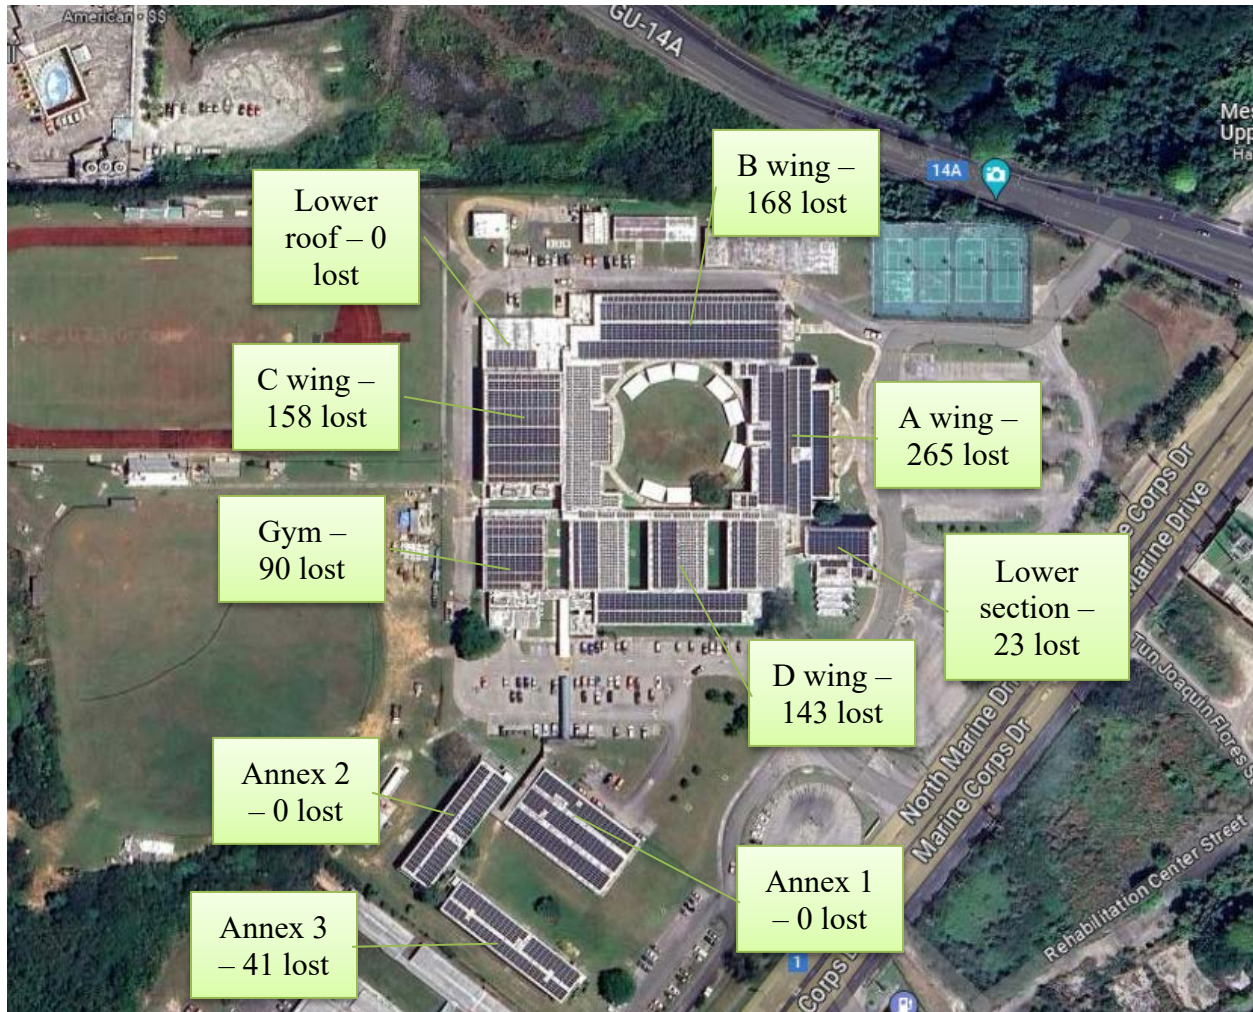
Figure A-4. Aerial view of John F. Kennedy High School, Guam. Array installed December 2022, less than half a year before Typhoon Mawar. Callout boxes show the number of modules lost from various sections of the array.

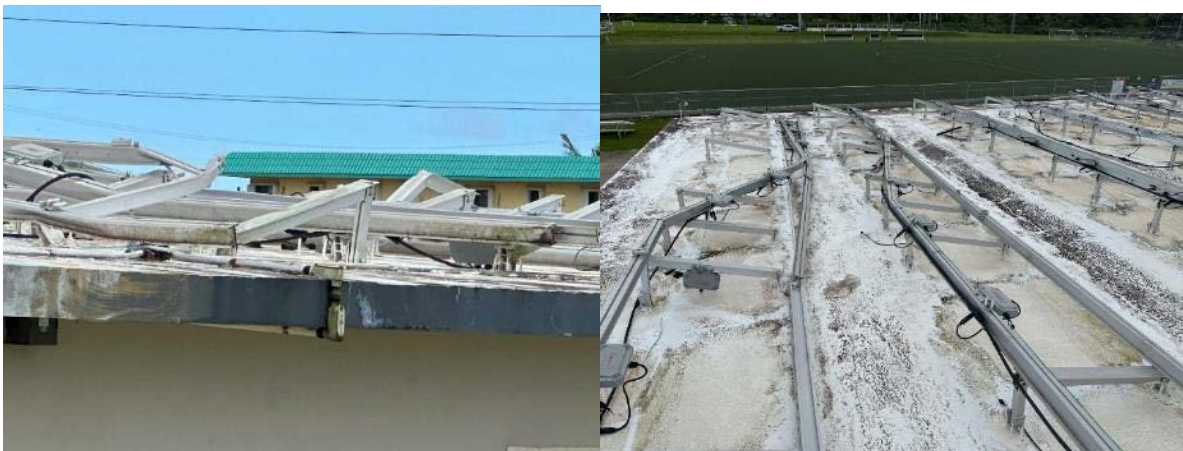
Figure A-5. Racking destroyed near roof corner that likely experienced the highest wind loads

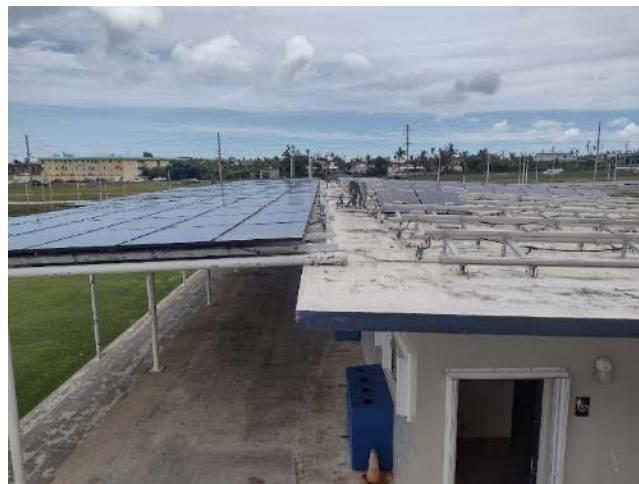
Figure A-6. Array on northeast roof (right) suffered much more damage. Racking was higher off the roof.

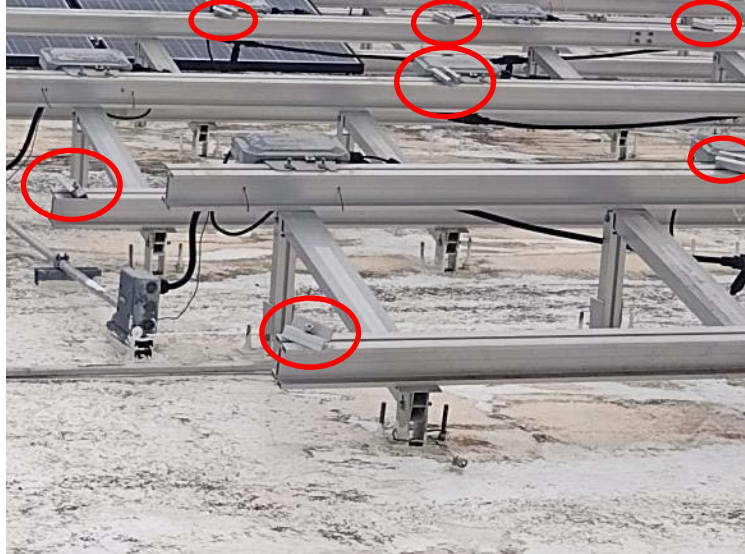
Figure A-7. Clamps largely still present in racking even after modules dislodged

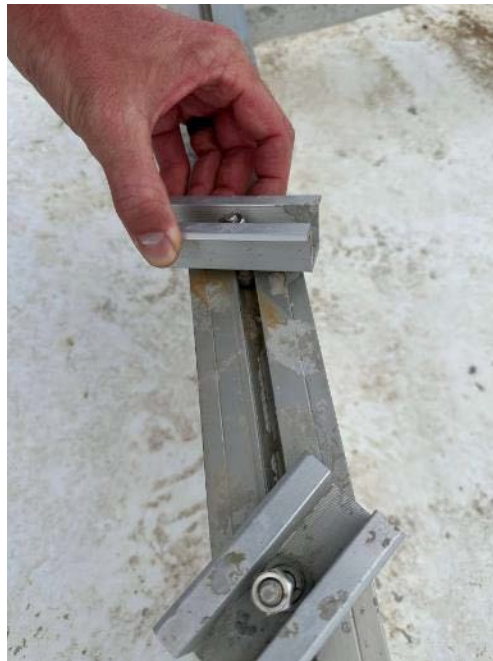
Figure A-8. Module clamps appeared to have loosened. Split washers do not provide locking capability.

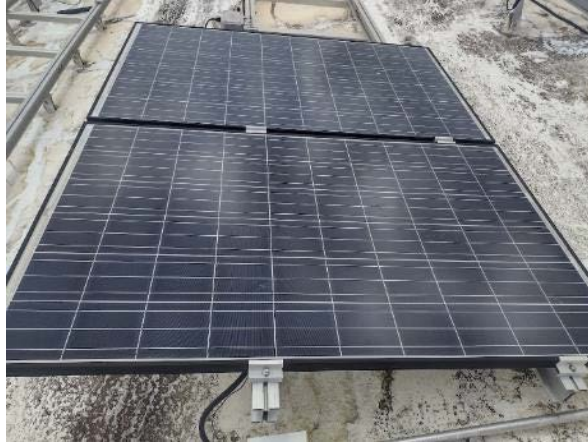
Figure A-9. Four module attachment clamps were offset toward the lower side of the modules. Modules not as supported against wind uplift forces from the rear/underside of the top of the modules.
