Advanced Diagnosis and Accelerated Testing of Balance of System Components for Utility Scale PV Installations

David Miller

National Renewable Energy Laboratory

Technical Report
NREL/TP-5K00-91818
January 2025

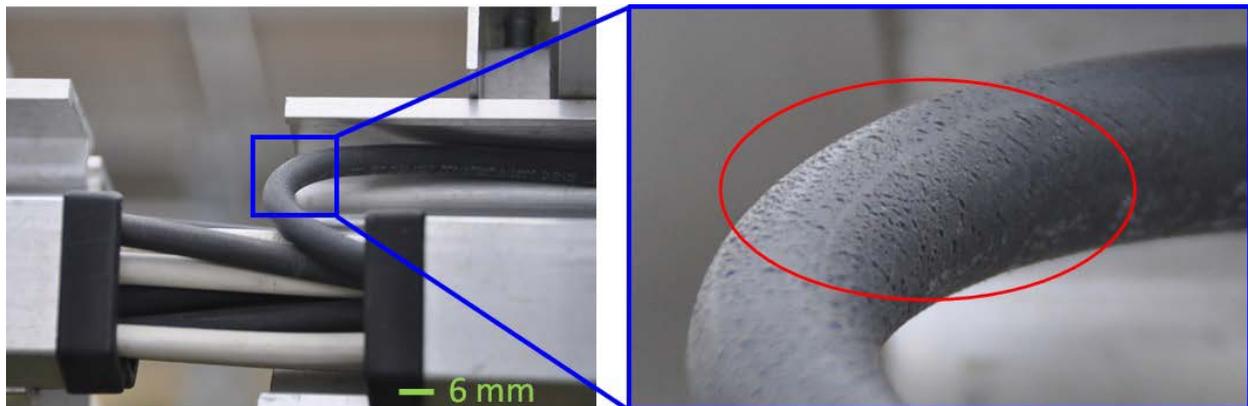
Figure 1: Cracking of cable jacket (red circle) – an industry example from a utility PV system in upstate New York.

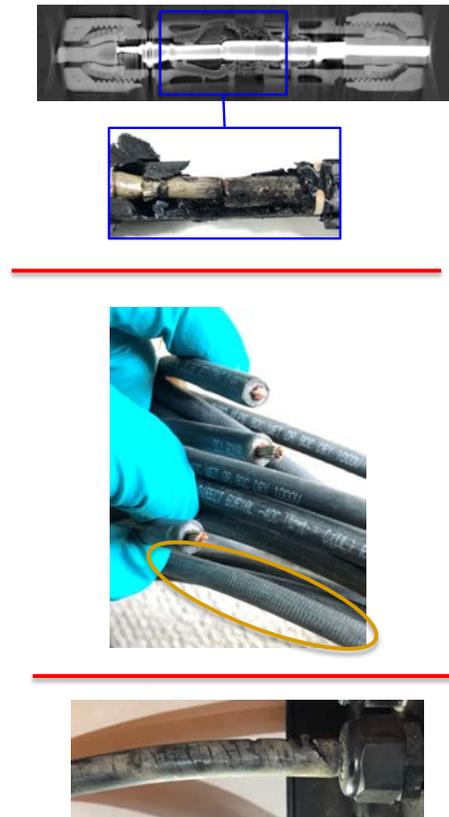
As represented in Figure 4, NREL initially obtained more than 3 separate instances (including multiple replicates) of field degraded BOS components, including cable connectors (Sacramento, CA), cable jackets (Albany, NY), and tracker cable jackets (Bengaluru, IN) as well as internal samples (references for comparison) including accelerated aging cable jackets and cable connectors (IEC 61215 qualification and C-AST MiMo). Regarding the cable connectors, a wide variety of sample integrities has been observed (including deformed plastic, blistered plastic, cracked plastic, or up to one component end being mostly vaporized and no longer existing after failure). In other cases, we presume system owners identified and removed connectors based on their temperature, but the cause of degradation is not readily diagnosed prompting the creation of a test stand to characterize resistance (where current is incrementally stepped to application levels). Regarding the cable jackets, a roughened morphology (including micro-scale cracking) was observed on field degraded specimens that was not observed for specimens after the IEC 61215 qualification tests. Regarding the tracker cable jackets – no examples were anticipated at the start of this study. A greater scope was realized (including system components such as the tracker) and the meaning of early advice (multi-conductor SJOOW cables are indeed purchased for PV systems – including from the Home Depot) is clear. Progress on the Task has proceeded ahead of deadlines as we have gotten samples and offers towards samples through the IIG as well as industry partners.

Figure 4: Examples of degraded cable connectors (top, in XCT and after removing the external plastic), cable jackets (middle, selected for study based on their appearance - circled), and tracker cable jackets (bottom, where cracking was observed at both of the connectorized ends).

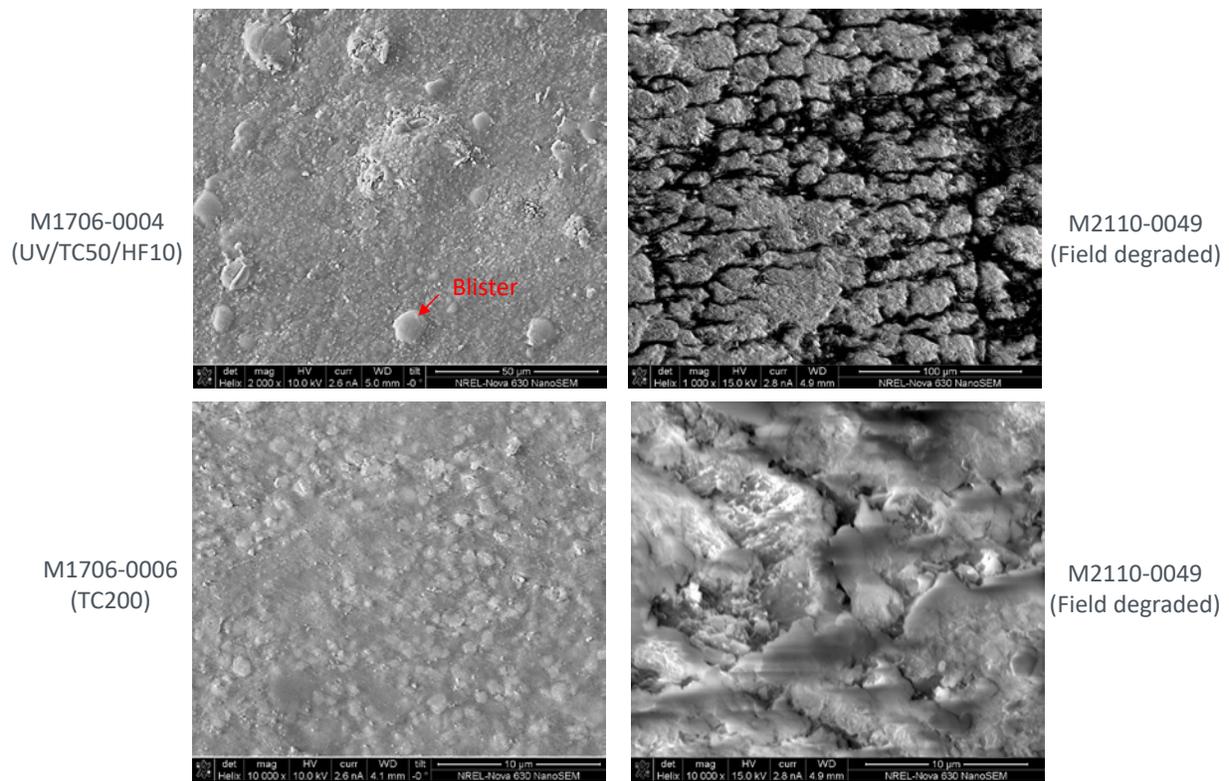
Figure 5 compares the morphology of cable jackets, including: field degraded (right) and references run through separate accelerated tests (left). The field degraded specimen (from Albany, NY) shows a coarse roughness (top right) in addition to micro-scale cracking (bottom right). The specimens subjected to accelerated testing do not show the same extent of surface roughness (also quantified using AFM), rather they instead have their own unique morphology. For example, the cable jacket after UV weathering/50 thermal cycles/10 humidity freeze cycles shows bumps (“blister”, top left) also observed during damp heat testing (not shown); whereas the cable jacket after 200 thermal cycles with no hygrometric accelerated testing (bottom left) shows a smoother surface without roughening or cracking. We continued to obtain and analyze field-degraded specimens, including cable and cable connector specimens through the second year of this project. These specimens may be compared to additional specimens presently undergoing accelerated testing, including steady state IEC TS 62788-7-2 method A3 UV weathering and C-AST (using two successive kinematic fixture designs). Degraded specimens will also be compared to the formal C-AST cable experiment (“D1” and “K3” fixtures).

Figure 5: Comparison of cable jackets after IEC 61215 testing (left, including the test sequence of UV weathering followed by thermal cycling followed by humidity freeze as well as aging using thermal cycling only) and field degraded specimens (showing the damage to the same specimen at different magnifications).

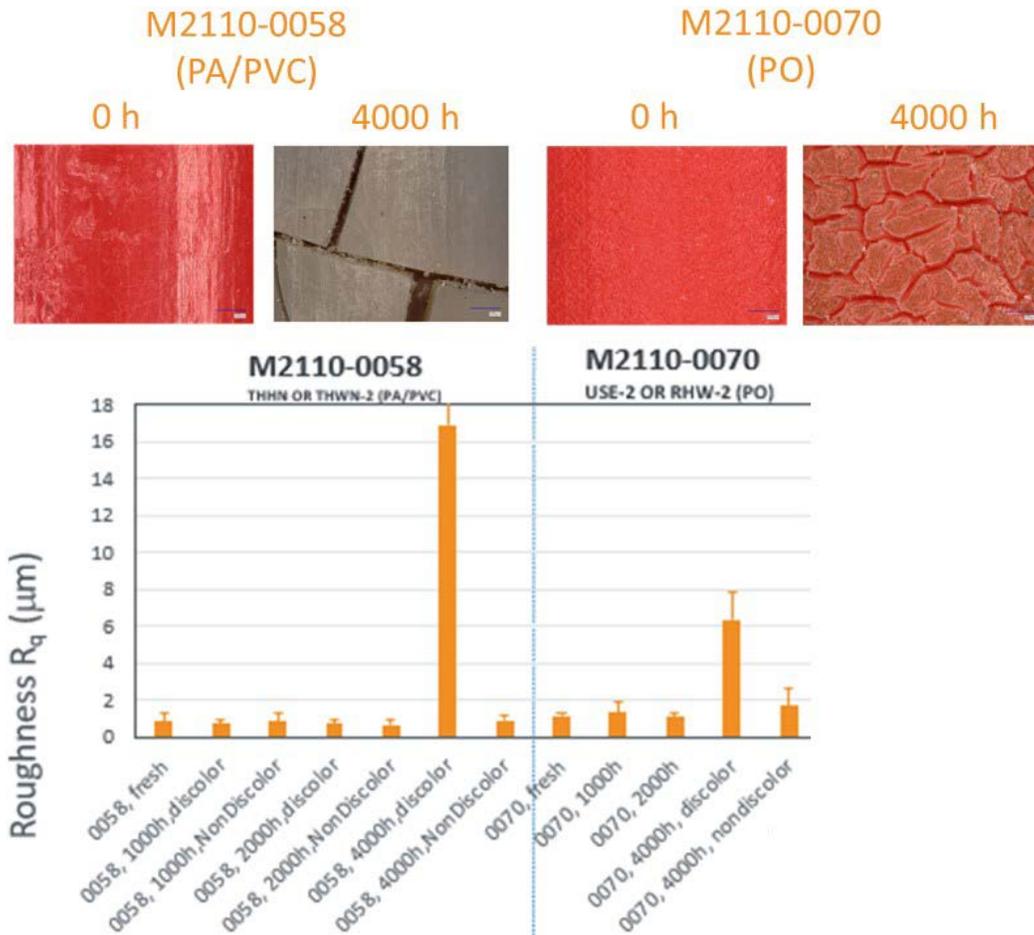
As shown in Figure 7, NREL performed advanced characterization on indoor aged degraded BoS samples. One interesting finding for cable jackets is that their surface roughness was greatly increased after 4000 h UV weathering using IEC 62788-7-2 method A3, Figure 7 (bottom). In contrast, prominent cracking was observed at the 4000 h read point, which may indicate a critical embrittlement for PA/PVC cables whereas the cracking was more incremental for PO cables (including damage observed at 2000 h). To date rounds of examination have also been applied to cable connectors, where interior parts may be extracted after the exterior features have been examined. Polymer analysis has not been well suited to cable connectors as most examples to date seem to feature issues related to the conductive metallic pin and socket components, where secondary degradation is only featured in the heating and deformation of the exterior plastic.

Figure 7: Comparison of the morphology (from optical microscope, top) and corresponding surface roughness (from Dektak profilometer, bottom).

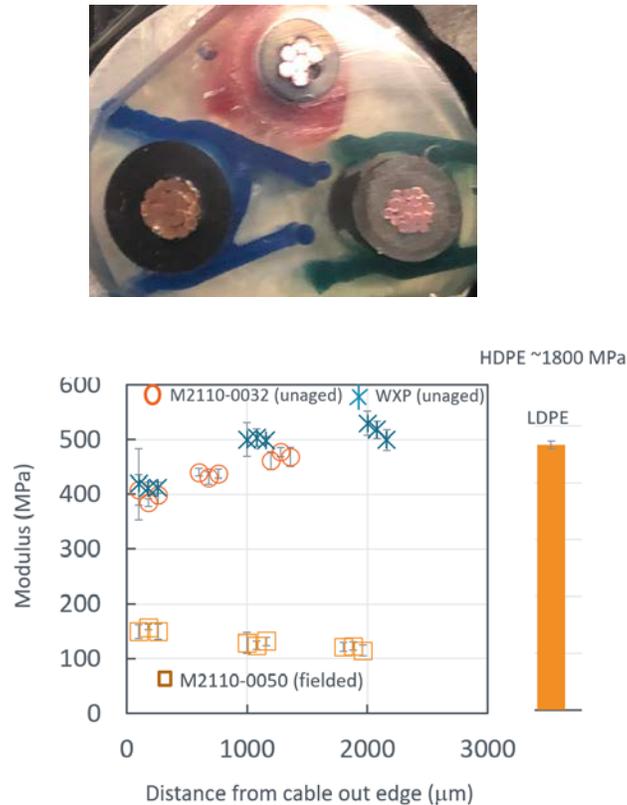
As shown in Figure 8, NREL performed advanced characterization on field degraded BoS samples. Here, a microindenter was unexpectedly found at NREL that could be used towards the project. The polymer characterization has been slow to date, limited by the start of dedicated post-doc at NREL, but has allowed other characterizations to be completed for the same specimens. Samples extraction and characterization benefits from a previous DuraMAT project, specifically focused on PV branch connectors and discrete fuses, where many of the same methods were applied to specimens of different size and geometry.

Figure 8: Degraded and reference cable jacket samples prepared in cross-section for indentation (top) and corresponding modulus results (bottom).

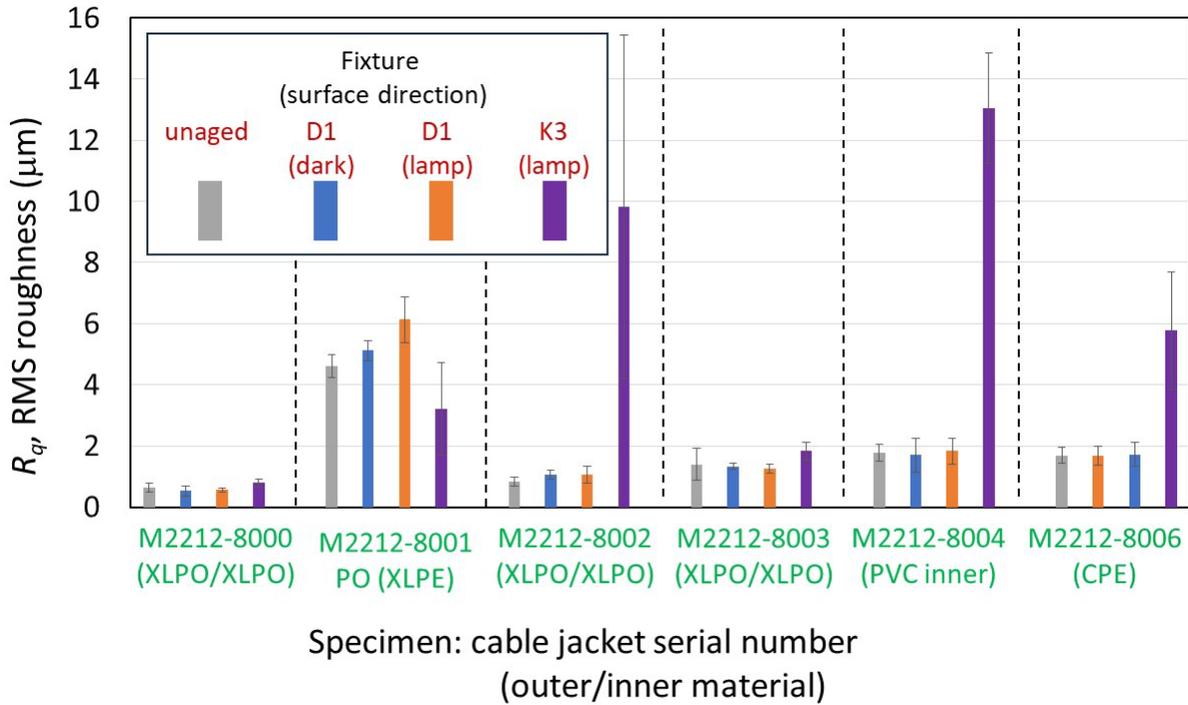
Figure 11: Summary of the root mean square roughness, R_q , for the C-AST cable specimens. Unaged jackets are compared to the D1 fixture (dark side with abrasion on the metal mandrel or lamp side) and the K3 fixture (at least twice the UV dose).

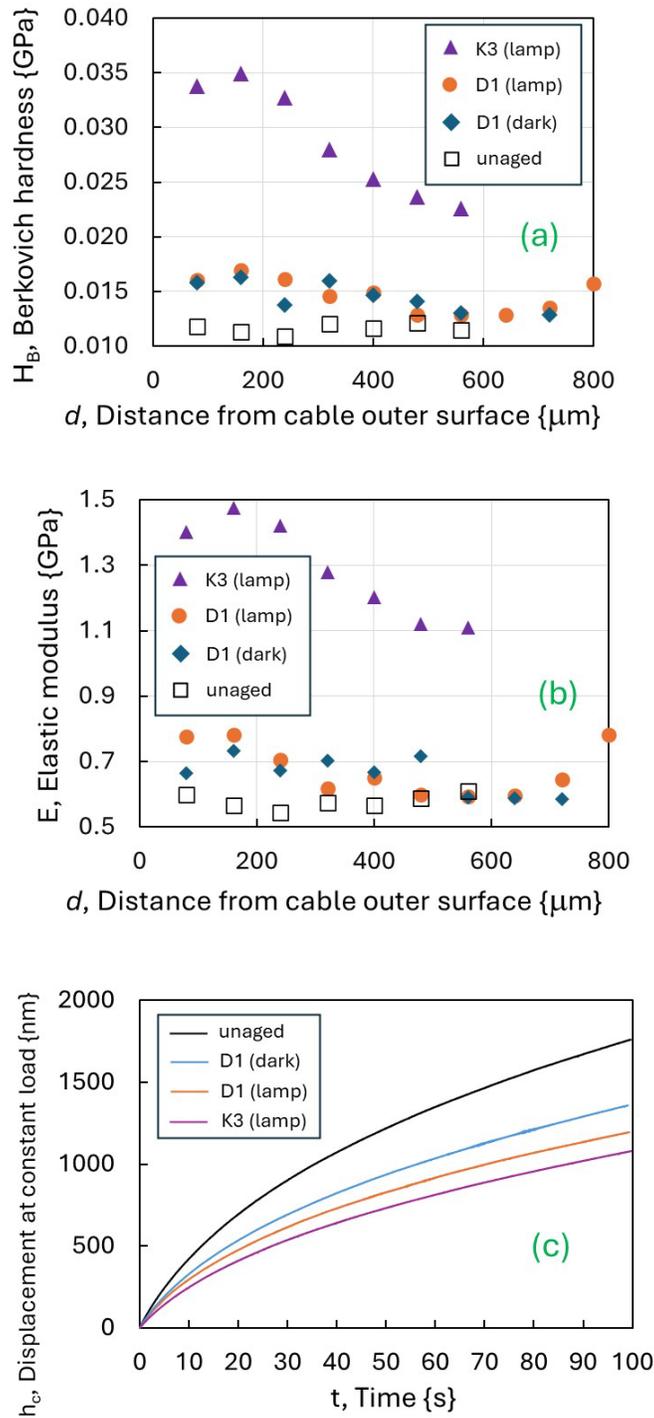
Figure 12: Comparison of the mechanical indentation of cable serial number M2212-8004 (PVC inner), including: (a) the hardness (during indentation, for $4 \mu\text{m} < h < 5 \mu\text{m}$), (b) the modulus (averaged through the same depth range), and (c) the displacement-time data profile (for the creep hold, at $d = 240 \mu\text{m}$). The results are shown for specimens: unaged, after C-AST using the D1 fixture, and after C-AST using the K3 fixture.

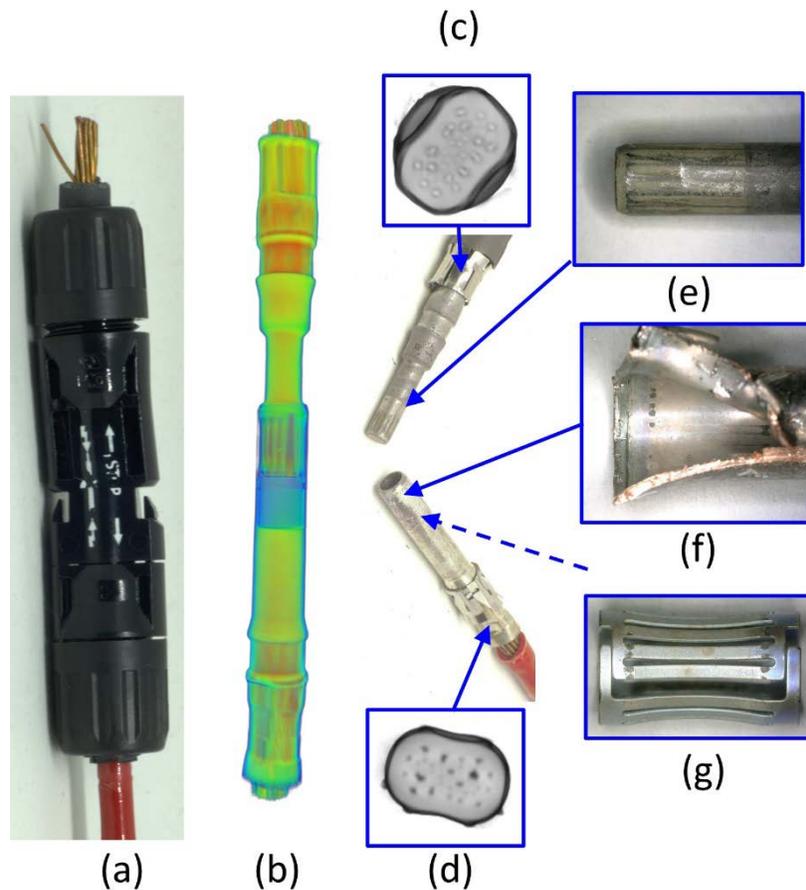
Figure 13: Forensics of specimen serial number M2212-8004d, from the fixture to cable in the C-AST D1 fixture, including: (a) camera photograph of after it was taken out of the experiment, (b) XCT scan prior to deconstruction, (c) detail of the crimp from XCT, (d) detail of the crimp from XCT, (e) detail of the pin after deconstructing and separating the connector, (f) detail of the inside of the socket after deconstructing and separating the connector, and (g) detail of the contact spring after it was extracted from the socket. S/N M2212-8004d was a connector used at the end of the corresponding D1 cable specimen.

Highlights from the forensics of the branch connectors include: Local spots where the Sn outer coating was thin and may have been scraped through, as evidenced by the intermediate Ni layer showing through. The coating materials (Ni, Sn) were not deposited or depleted at edges of louver springs on the contact spring. Carbon was deposited at inner radius between the louvers on the ends of the contact spring, presumably from elevated electric field. Highlights from the forensics of the uncapped connectors include: The pin, socket, and contact spring were discolored (from corrosion of Sn outer layer) in humid locations (PEI and Gaithersburg). Mineral contamination was observed in the desert location (Barstow). Artifacts of insect/small organisms (including spider webs and eggs) were observed inside socket and contact spring in all locations.
