Fatigue of Composite Material Beam Elements Representative of Wind Turbine Blade Substructure

John F. Mandell, Daniel D. Samborsky,
David W. Combs, M. Ethan Scott,
Douglas S. Cairns
*Department of Chemical Engineering
Montana State University
Bozeman, Montana*

NREL Technical Monitors:
Richard Osgood and Walt Musial

November 1998

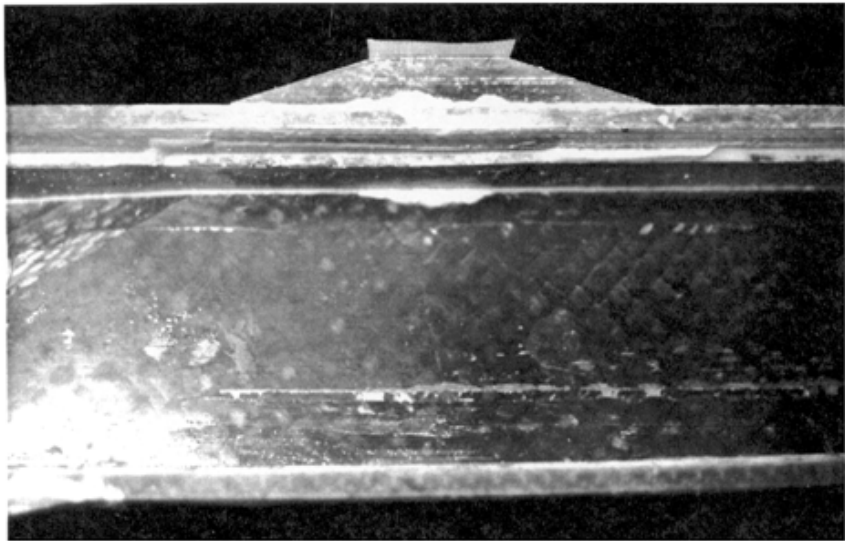
Beam 1 failed with massive damage in the shear web, separation of the outer flange from the flanges of the C-channels, and growth of the compression damage zone under the load pad. We hypothesized that the initial compression damage was a nucleation site for crack growth in the adhesive joint between the outer flange and the flanges of the C-channel. Under cycling, cracks extended, releasing the tension flange from the C-channel flanges and the next stroke of the piston crushed the shear web.

Beam 2 was manufactured and tested to judge the validity of this hypothesis. We terminated the testing of beam 2 before failure because of the growth of damage zones on the tension side flange at the center of both support pads. After dissecting beam 2 we determined that the aforementioned damage was failure of the tension flange-to-web adhesive joint. Visual inspection revealed a smooth fracture surface, which is indicative of an adhesive-line failure as opposed to a rough fracture surface. The latter would have indicated matrix damage (see Figure 12(b)). Therefore, the original hypothesis was incorrect: beam 1 failed because of adhesive failure at the interface of the flanges.

**Figure 12. (a) Load pad damage and compression damage zone, tension side of Beam 1.
(b) Adhesive failure of Beam 2.**

The adhesive failure of beams 1 and 2 called for a redesign of the beam. The deflection equation for four-point bending (Equation 7) revealed that reducing the value I_{ZZ} of the beam by a factor of n allows for a reduction of the load by the same factor to achieve the same deflection. Also recall that $\epsilon = f(k, y)$, i.e., for a given curvature/deflection, the strain is a linear function of y . I_{ZZ} was reduced by narrowing the flange width from 76 mm to 51 mm (now equal to the flange width of the

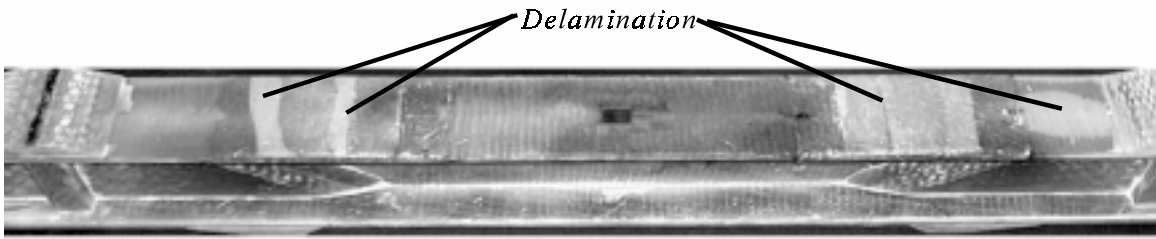
Figure 27. Accumulated damage on inner surface of tension flange, $\pm 45^\circ$ plies, 2.26 million cycles, beam 4.

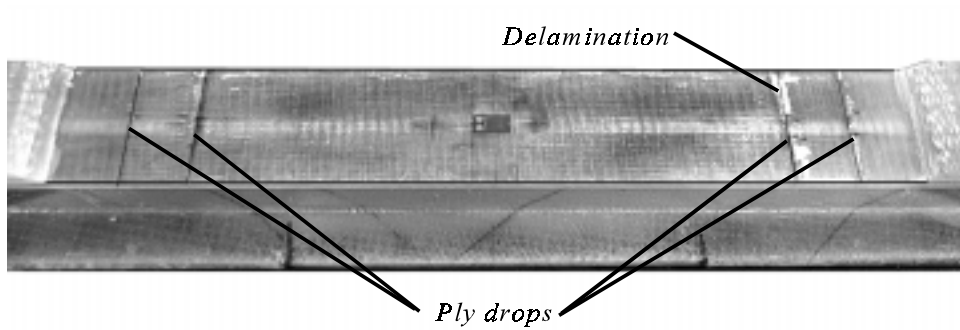
Figure 28. Outer surface of compression flange, 2.26 million cycles, beam 4.

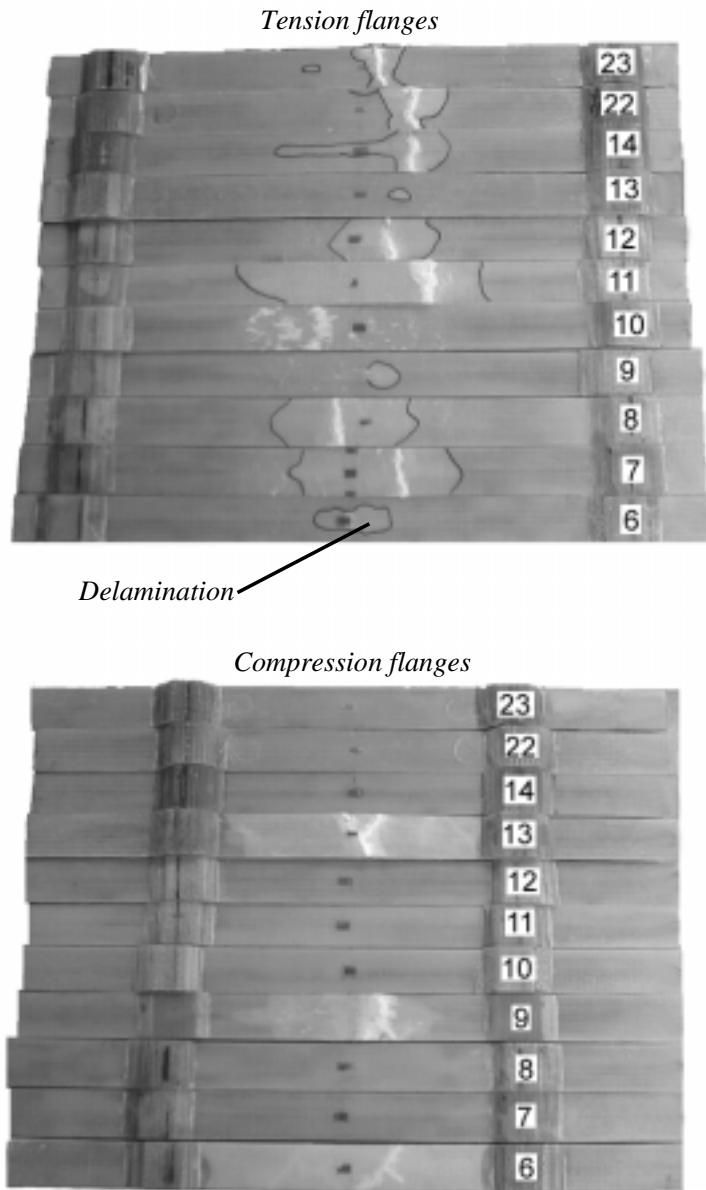
Figure 32. Tensile and compressive flanges of failed beams with material AA flanges and material CH10 webs.

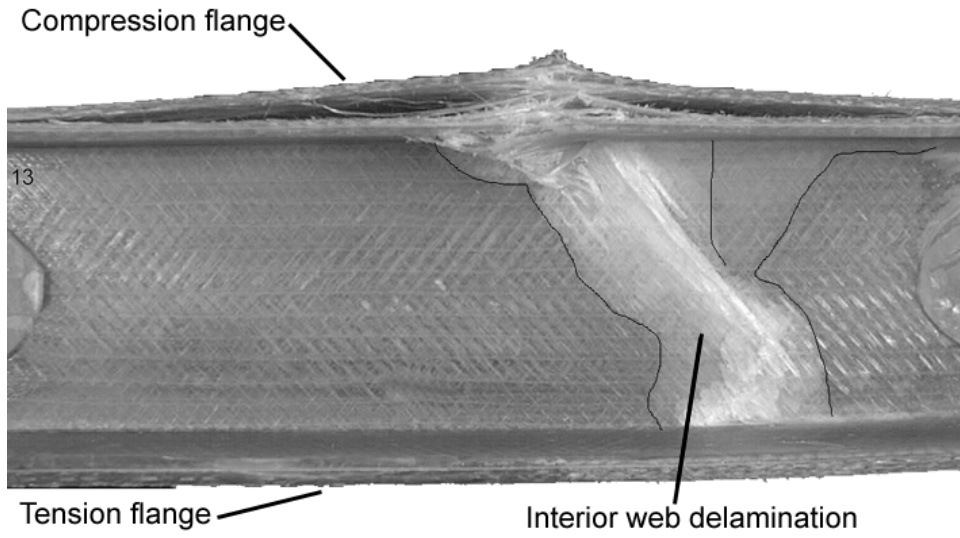
Figure 33(a). Beam 13 static compression flange failure.

Beam 13 involved a static test. The beam was loaded under actuator displacement control at a rate of 0.51 mm/s until failure, which involved a total ramp time of 21 seconds. An initial beam stiffness of 3,516 kN/m was measured. The ultimate load was 60.72 kN and corresponded to a maximum tension flange strain of 2.10%, a minimum compression strain of -1.85% and a maximum mid-span deflection of 17 mm. The load versus maximum strain graph is shown in Figure 80. The beam failed in the compression flange at $x = 330 \pm 25$ mm with delaminations between the 0° (ply 10, Table 22) and +45 plies (ply 11, 22) over the distance of $x = 165$ mm to $x = 457$ mm. The failed beam is shown in Figures 81 and 82. The failure at $x = 330$ mm caused the web to delaminate towards the tension flange under this failure point, causing an additional delamination spot under the tension flange. No shear stiffener, torsional stiffener or other tension flange damage or delaminations were visible.

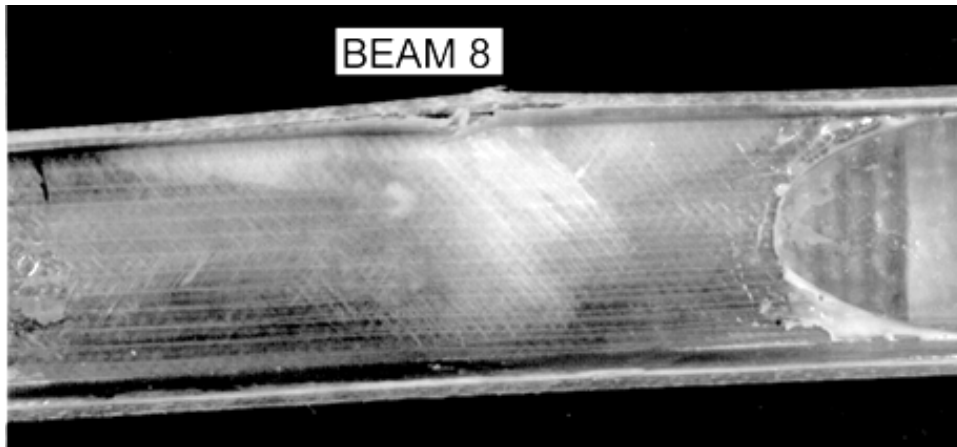
Figure 33(b). Beam 8 tension flange failure.

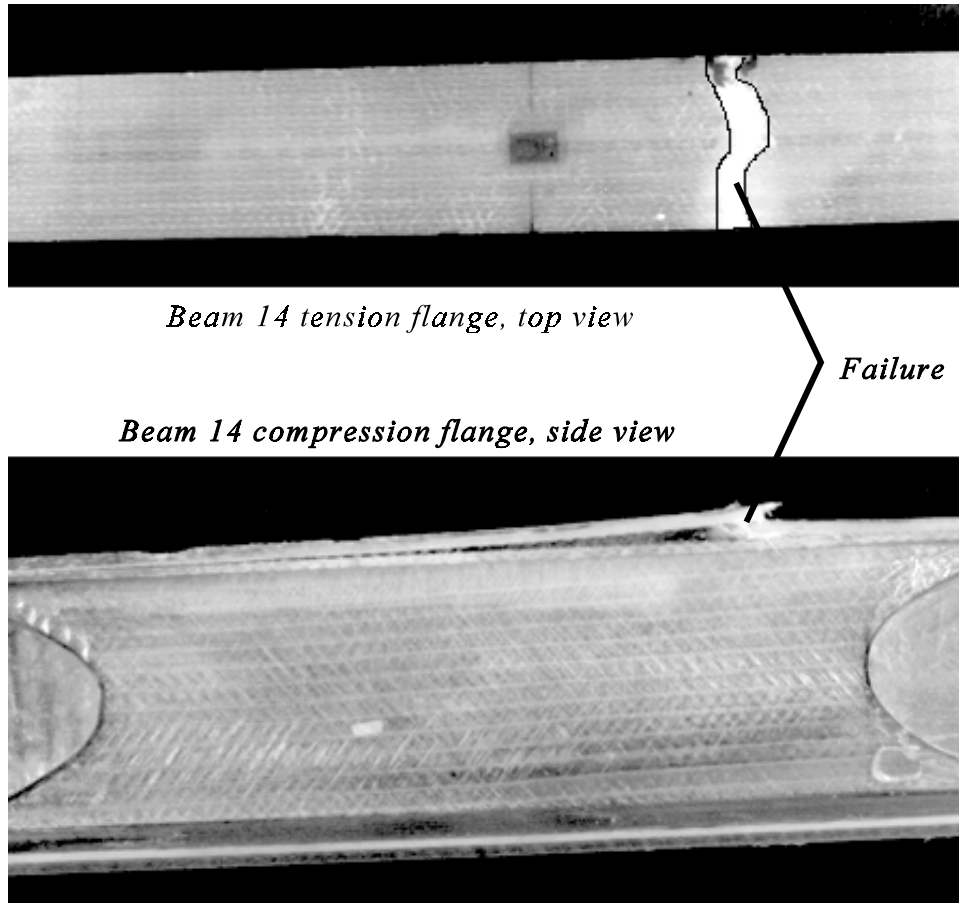
Figure 33(c). Beam 14 tension flange fatigue failure.

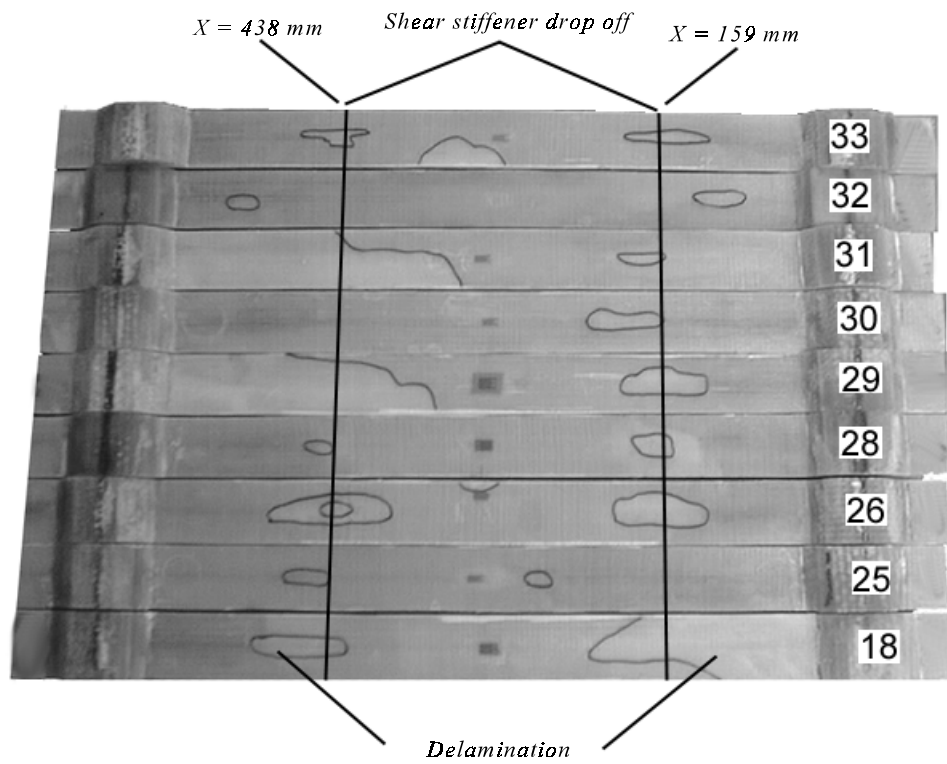
Figure 36. Tension flanges of failed beams with material DD5P flanges and material CH3 webs.

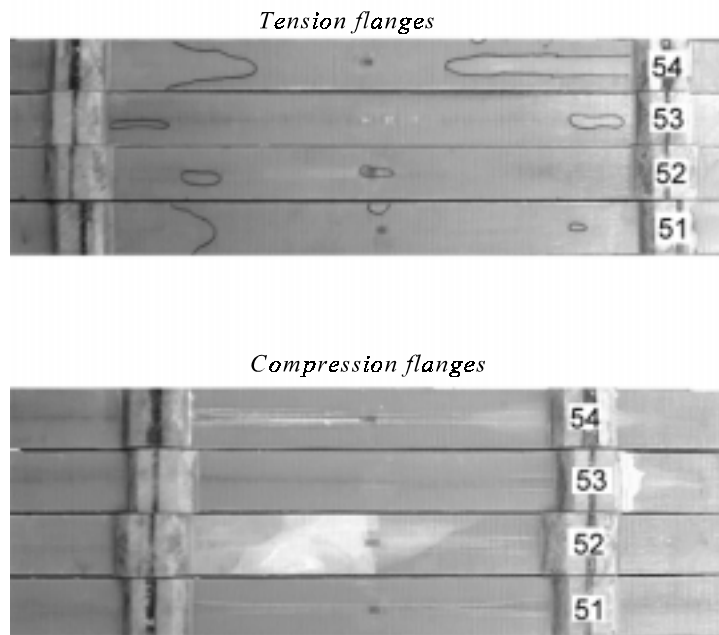
Figure 41(b). Tension and compression flanges of failed beams with material DD5P flanges and webs.

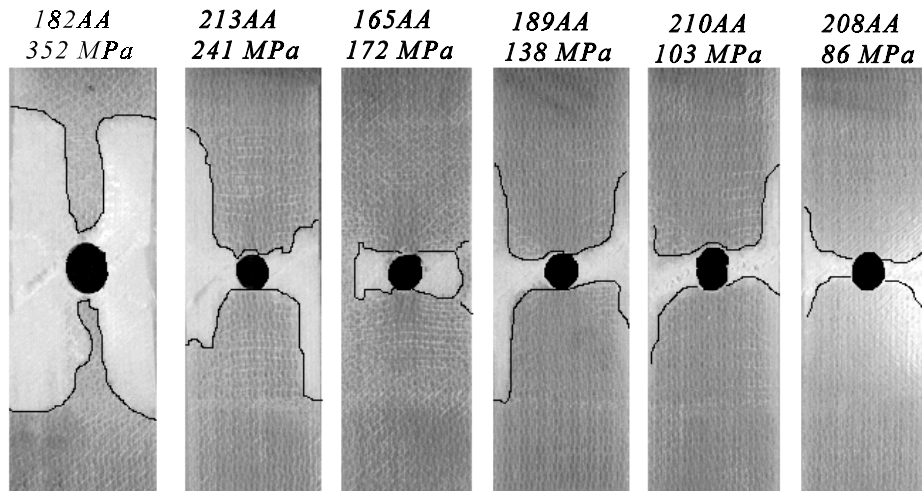
Figure 45. Photograph of damage around the 13 mm diameter hole at different stress levels, R = 0.1.

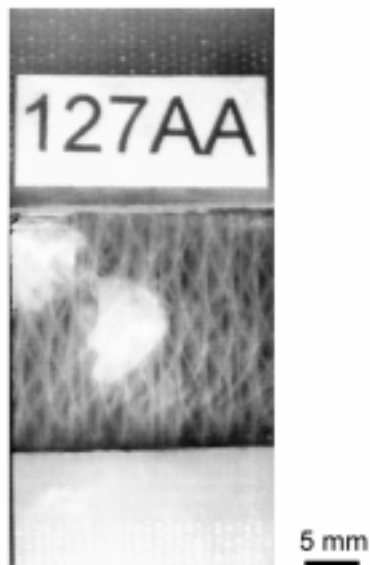
Figure 46. Delamination on a compression fatigue coupon.

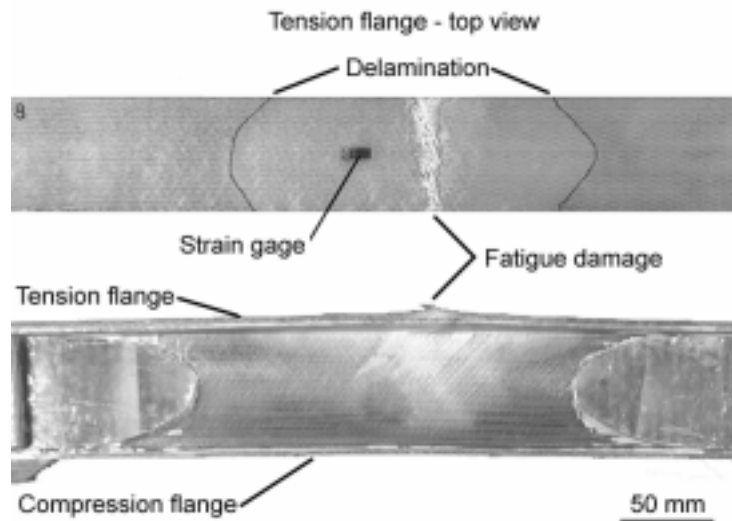
Figure 68. Beam 8.

At 29,051 cycles, the tensile flange failed and separated at $x = 324 \pm 9$ mm, which caused the flange to delaminate from the preform between $x = 255$ to $x = 368$ mm and is shown in Figures 68 and 69. The delamination involved extensive fiber bridging between the inside flange $+45^\circ$ (ply 12, Table 22) and the adhesive on the preform. This beam was fatigued at a higher strain than Beam 7 and thus had more internal strain energy stored in it prior to failure, which is apparent by the amount of damage generated in the web as compared to Beam 7. The web delamination extended 45 mm from the tension flange and was located at $x = 324 \pm 44$ mm. No shear stiffener, torsional stiffener or compression flange damage or delaminations were visible.

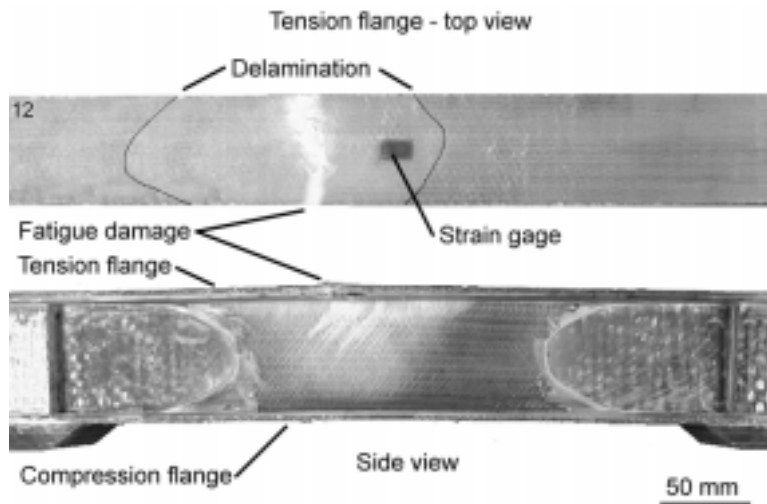
Figure 79. Beam 12.

The final failure site started at one edge of the flange and grew to the other edge. After 30,290 cycles, the beam failed on the tension flange at $x = 336$ mm and is shown in Figure 79. The flange delaminated between the adhesive and the $+45^\circ$ ply (ply 12, Table 22) from $x = 279$ to $x = 394$ mm and contained multiple fiber bridging sites. The tension flange delamination traveled 45 mm into the web directly under the failure site. Some other minor cracks were evident on the flanges of the preform as the $\pm 45^\circ$ fabrics did not completely fill the C-channel mold, and thus created a matrix rich region on the flange edge, which cracked and segmented. These cracks were on the order of 10 mm in length, 5 mm wide and were located over the shear stiffener area of the beam. The load pads showed the same minor delamination problem as in Beam 11. Both these manufacturing flaws did not seem to cause any problems with the performance of the beam during the test. Otherwise, no shear stiffener, torsional stiffener or compression flange damage or delaminations were visible.

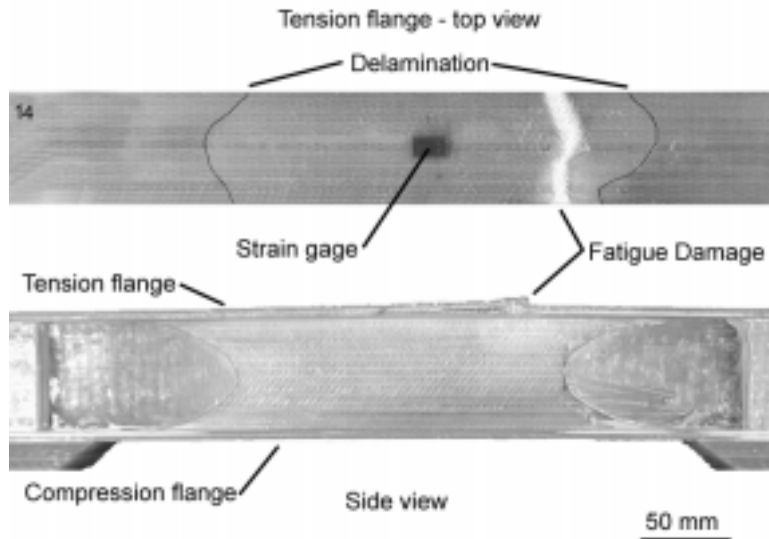
Figure 83. Beam 14.

Beam number 14 was fatigued at a rate of 5 to 10 Hz with a maximum load of 24.5 kN and a minimum load of 2.5 kN. The maximum load produced an initial maximum tension flange strain of 0.59% and a minimum compression flange strain of -0.58%. The initial beam stiffness was measured as 3,407 kN/m. The fatigue test was stopped after 160,000 cycles to check the stiffness, which had reduced to 3,271 kN/m or 96% of the initial stiffness. After 389,175 cycles the tension flange failed at $x = 248 \pm 6$ mm. The damage started at the edge of the flange and grew across the flange until final failure. The failure caused a delamination from $x = 229$ mm to $x = 394$ mm and was between the $+45^\circ$ ply (ply 16, 22) and the -45° ply (ply 17, Table 22) in the web flange. Figure 83 shows the failed beam. This delamination extended 10 mm down into the web. No shear stiffener, torsional stiffener or compressive flange damage or delaminations were visible.

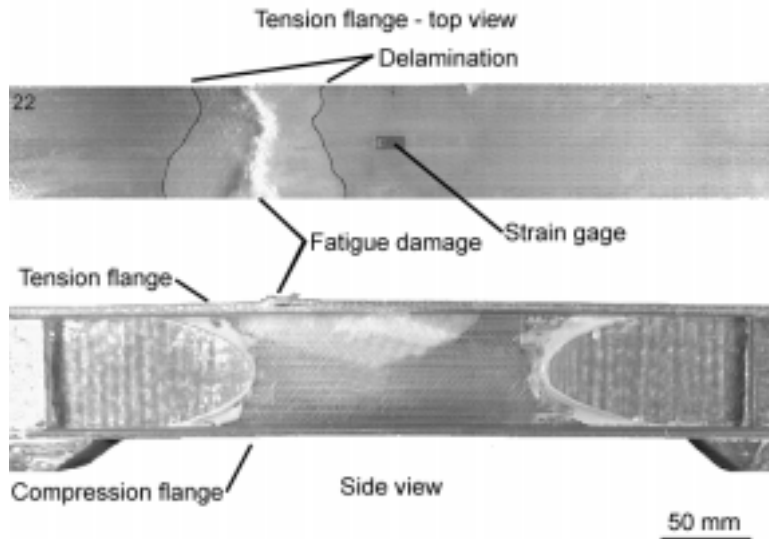
Figure 84. Beam 22.

Beam number 22 was fatigued at a rate of 5 Hz with a maximum load of 31.1 kN and a minimum load of 3.1 kN. The maximum load produced an initial maximum tension flange strain of 0.84% and a minimum compression flange strain of -0.76%. The initial beam stiffness was measured as 3,637 kN/m. This beam had two acoustic emission sensors on the tension flange centered at $x = 70$ and 543 mm and two on the compression flange centered at $x = 178$ and 432 mm. The acoustic emission testing was performed with Dr. Al Beattie from Sandia National Laboratory. This beam showed less white damage sites on the tension flange than the previous beams during the fatigue test. Final failure occurred on the tension flange at $x = 368 \pm 10$ mm with a delamination between the $+45^\circ$ ply (ply 11, Table 22) and the -45° ply (ply 12, Table 22). The delamination was between $x = 330$ and 406 mm and grew 25 mm into the web. The failed beam is shown in Figure 84. No shear stiffener, torsional stiffener or compression flange damage or delaminations were visible.

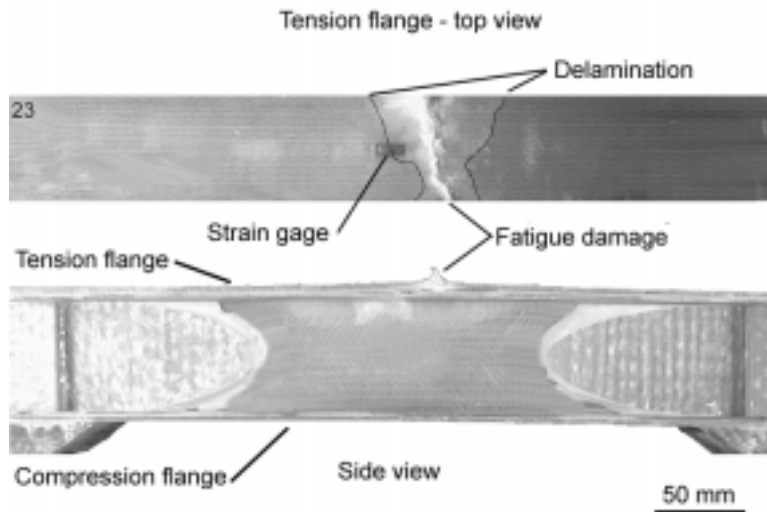
Figure 85. Beam 23.

Beam number 23 was fatigued at a rate of 5 Hz with a maximum load of 28.9 kN and a minimum load of 2.9 kN. The maximum load produced an initial maximum tension flange strain of 0.71% and a minimum compression flange strain of -0.64%. The initial beam stiffness was measured as 3,542 kN/m. This beam also had two acoustic emission sensors on the tension flange centered at $x = 64$ and 543 mm and two on the compression flange centered at $x = 178$ and 438 mm. The beam failed in the tensile flange after 119,995 cycles. The failure site was at $x = 318 \pm 10$ mm and created a delamination between the adhesive and the $+45^\circ$ ply (ply 13, 22) of the preform from $x = 292$ to $x = 356$ mm. This delamination extended 18 mm down into the web. The web flange had a matrix rich region on the edge of the flange between $x = 279$ and $x = 470$ mm and had a maximum depth towards the web of 8 mm. The failed beam is shown in Figure 85. The failure site of the tensile flange was within this matrix rich region and it is believed that the initial delamination was nucleated at this edge and between the adhesive and the preform. Although this beam went 89,705 cycles longer than Beam 12, it is assumed that this had some minor effect on the performance of the test, but not a large enough effect to be considered a structurally flawed beam. No shear stiffener, torsional stiffener or compression flange damage or delaminations were visible.

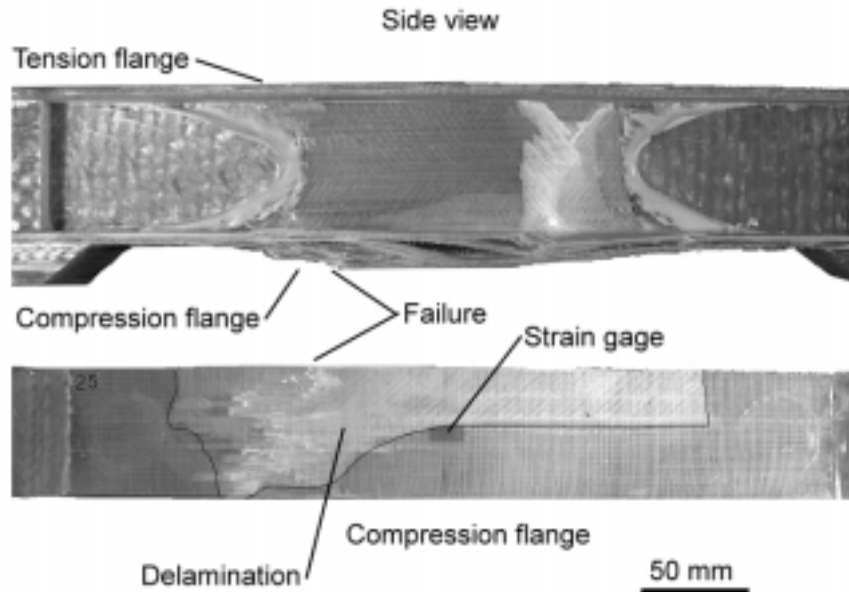
Figure 93. Beam 25.

Beam number 25 was fatigued at a rate of 2 Hz under sinusoidal load control with a maximum load of 62.3 kN and a minimum load of 6.2 kN. The maximum load produced an initial maximum tension flange strain of 1.43% and a minimum compression flange strain of -1.13%. The initial beam stiffness was measured as 4,305 kN/m. The beam had four acoustic emission sensors on the flanges: two on the tension flange centered at $x = 63$ and 533 mm, and two on the compression flange centered at $x = 170$ and 430 mm. After 7,636 cycles, the compression flange failed at $x = 229 \pm 13$ mm. A loud pop was heard one cycle prior to failure and it is suspected that a partial delamination grew to a point where it compromised the stability of the compression flange, lowering the strength of the beam to below the maximum fatigue stress. The final failure of the beam indicates a twisting of the compression flange at failure. The flange delamination extended from $x = 170$ to 432 mm and involved all the 0° to 45° interfaces and the adhesive layer. The delamination traveled into the web towards the tension flange and created two spot delaminations. Transverse tension cracks were also present on the tension flange over the web. It is not known if these transverse cracks were present prior to flange failure. No shear stiffener, torsional stiffener or other tension flange damage or delaminations were visible. The failed beam is shown in Figure 93.

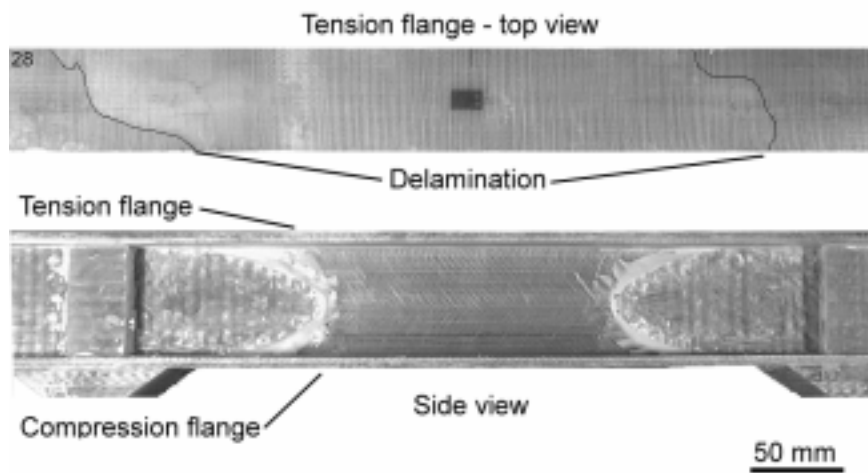
Figure 96. Beam 28.

Beam number 28 was fatigued at a rate of 5 to 12 Hz under sinusoidal load control with a maximum load of 44.5 kN and a minimum load of 4.4 kN. The maximum load produced an initial maximum tension flange strain of 0.86% and a minimum compression flange strain of -0.85%. The initial beam stiffness was measured as 4,142 kN/m. Tension flange delamination spots started to develop over the tapered shear stiffener area, $x = 178$ and 445 mm, after approximately 600,000 cycles. After 2,000,000 cycles, the beam was stopped and the only damage present was the delamination between the tension flange and the adhesive layer. This is shown in Figure 96. The compression flange has two transverse tension cracks, $x = 406$ to 445 mm extending under the load pad. No shear stiffener, torsional stiffener or other flange damage or delaminations were visible.

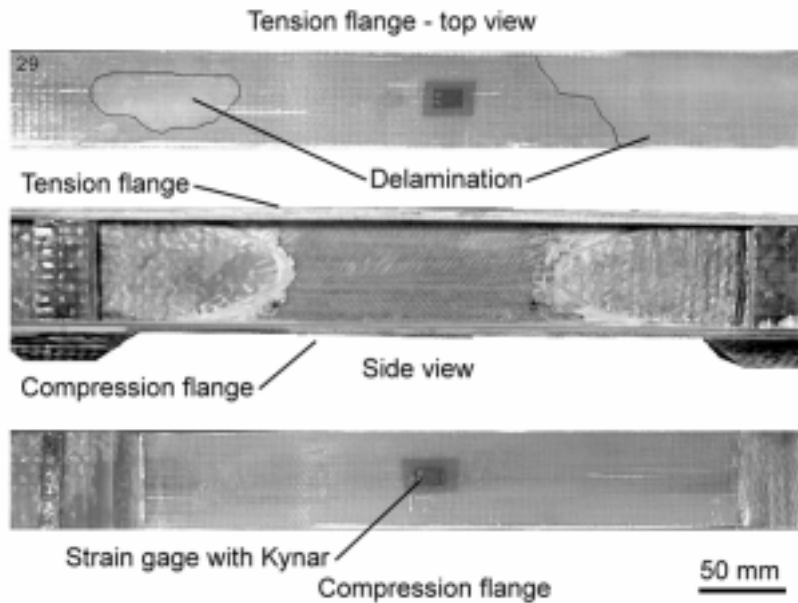
Figure 97. Beam 29.

Beam number 29 was fatigued at a rate of 4 Hz under sinusoidal load control with a maximum load of 48.9 kN and a minimum load of 4.9 kN. The maximum load produced an initial maximum tension flange strain of 0.92% and a minimum compression flange strain of -0.96%. The initial beam stiffness was measured as 4,100 kN/m. Kapton film was placed between the strain gages and the flanges in hopes of preventing the matrix cracks from traveling into the strain gages. The traveling was not stopped and the gages failed after 4,000 cycles. No significant improvement in strain gage lifetime, with the Kapton film, was observed. The beam was stopped after 815,684 cycles prior to beam failure. At this point the tension flange delamination extended between the 0° ply (ply 5, Table 24) and the -45° ply (ply 6, Table 4), $x = 0$ to 115 mm, and between the adhesive and the 0° ply (ply 8, Table 24), $x = 115$ to 260 mm. The compression flange showed three small transverse tensile cracks but otherwise no other damage. The beam is shown in Figure 97.

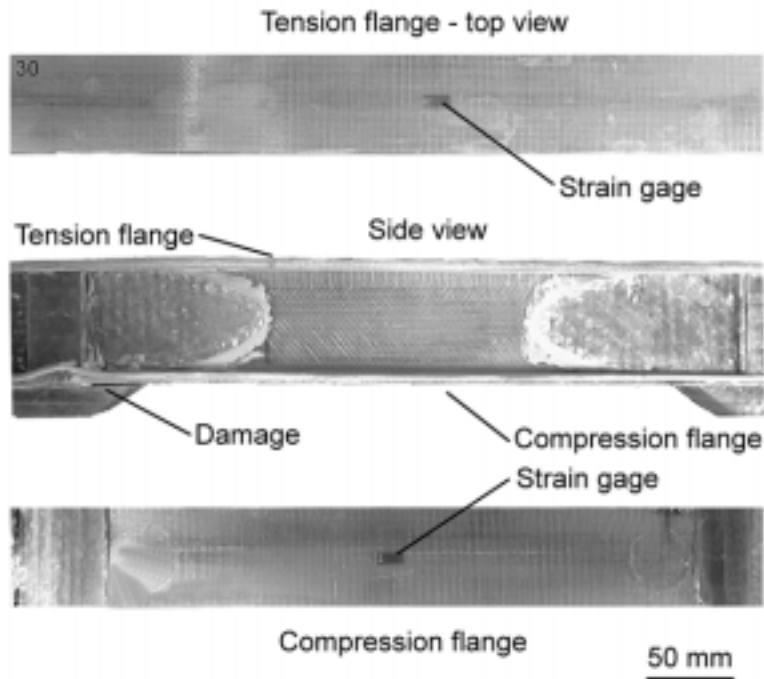
Figure 98. Beam 30.

Beam number 30 was fatigued at a rate of 2 Hz under sinusoidal load control with a maximum load of 62.3 kN and a minimum load of 6.2 kN. The maximum load produced an initial maximum tension flange strain of 1.20% and a minimum compression flange strain of -1.05%. The initial beam stiffness was measured as 4,345 kN/m. The beam had four acoustic emission sensors on the flanges: two on the tension flange centered at $x = 64$ and 533 mm, and two on the compression flange centered at $x = 178$ and 432 mm. After 5,741 cycles, the test was stopped as the failure mode was identical to Beam number 26. The shear stiffeners had delaminated and the compression flange had a shear failure through its thickness at $x = 120$ mm, under a compression flange load pad. The shear stiffener had a crack at $x = 120$ mm, which was the start of the stiffener taper, 30 mm up towards the tension flange. The compression flange had a few transverse tension cracks. The tension flange had started to delaminate over the shear stiffeners. No torsional stiffener or other tension flange damage or delaminations were visible. The failed beam is shown in Figures 98 and 99.

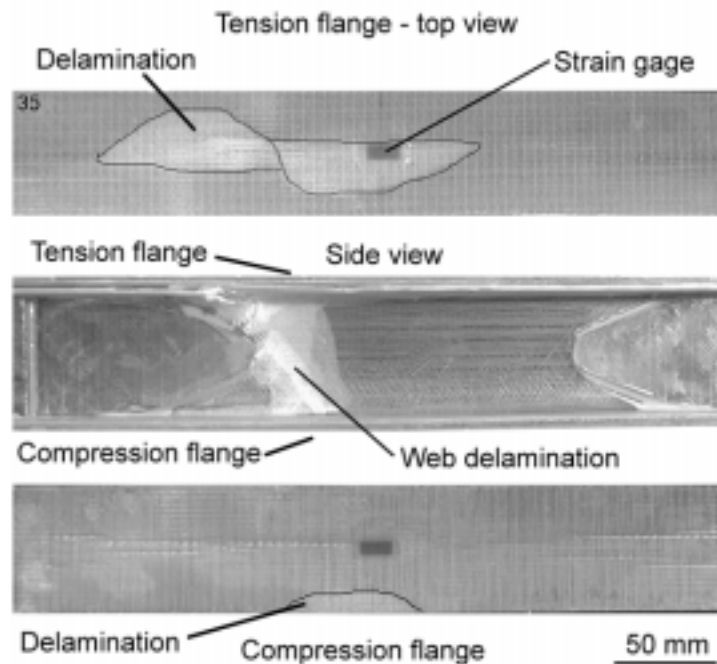
Figure 107. Beam 35.

Beam number 35 was fatigued at a rate of 2 Hz under sinusoidal load control with a maximum load of 62.3 kN and a minimum load of 6.3 kN. The maximum load produced an initial maximum tension flange strain of 1.04% and a minimum compression flange strain of -1.02%. The initial beam stiffness was measured as 4,347 kN/m. The compression flange delaminated from $x = -75$ to 458 mm, after 9,771 cycles. The delamination of the flange caused the web to fail at $x = 190$ mm with delamination in the web from $x = 178$ to 267 mm. There were two spot delaminations on the tension flange, caused by the failure, at $x = 190$ to 356 mm. The failed beam is shown in Figures 107 and 108.

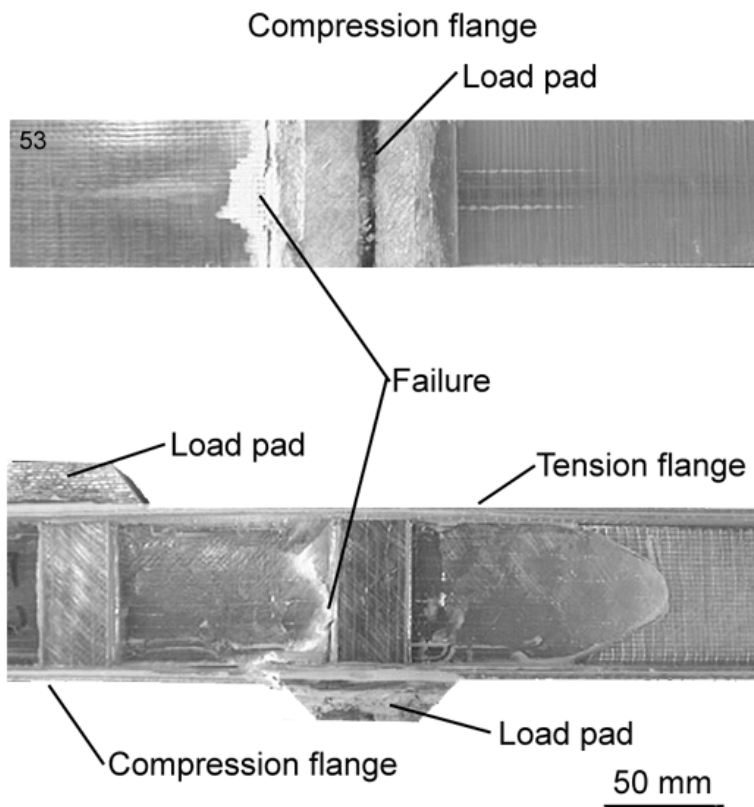
Figure 112. Beam 53.

Beam number 53 was fatigued at a rate of 3 Hz under sinusoidal load control with a maximum load of 62.3 kN and a minimum load of 6.2 kN. The maximum load produced an initial maximum tension flange strain of 0.94% and a minimum compression flange strain of -0.89%. The initial beam stiffness was measured as 4,901 kN/m. The beam was stopped after 8,700 cycles due to a shear stiffener and web failure inside the shear loading area of the load pads. This damage is shown in Figure 112. Due to this failure, additional stiffener material was added to the other beams (51, 52 and 54) tested at this or higher loads.

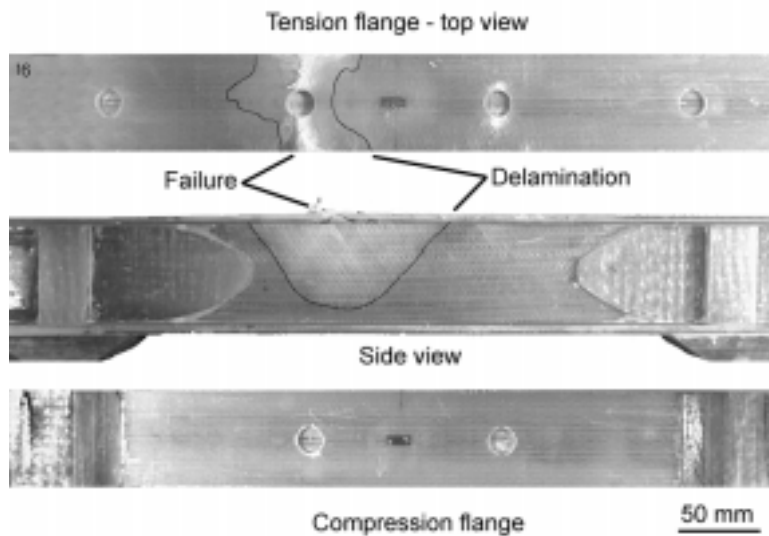
Figure 116. Beam 16.

Beam number 16 was fatigued at a rate of 5 Hz under sinusoidal load control with a maximum load of 24.5 kN and a minimum load of 2.5 kN. The maximum load produced an initial maximum tension flange strain of 0.58% and a minimum compression flange strain of -0.53%. The initial beam stiffness was measured as 3,340 kN/m. During the fatigue test, damage started at the outside edges of the holes and continued to grow until failure after 40,448 cycles. The beam failed on the tension flange at $x = 356 \pm 13$ mm with the underlying delamination between $x = 325$ to $x = 394$ mm. This delamination also traveled 25 mm down into the web. Prior to failure, the web had a large number of 1.0 to 1.5 mm long tensile cracks, all located at stitching cross over points. Although these small cracks probably did not have any influence on the failure, it is still disconcerting that every stitch cross-over point on the tension side of the neutral axis had a crack. Some minor delamination damage was present on the tension flange around the holes. No shear stiffener, torsional stiffener damage or delaminations were visible. The failed beam is shown in Figures 116 and 117.
