# Inspection of Compressed Natural Gas Cylinders on School Buses

Acurex Environmental Corporation  
*Mountain View, CA*

July 1995

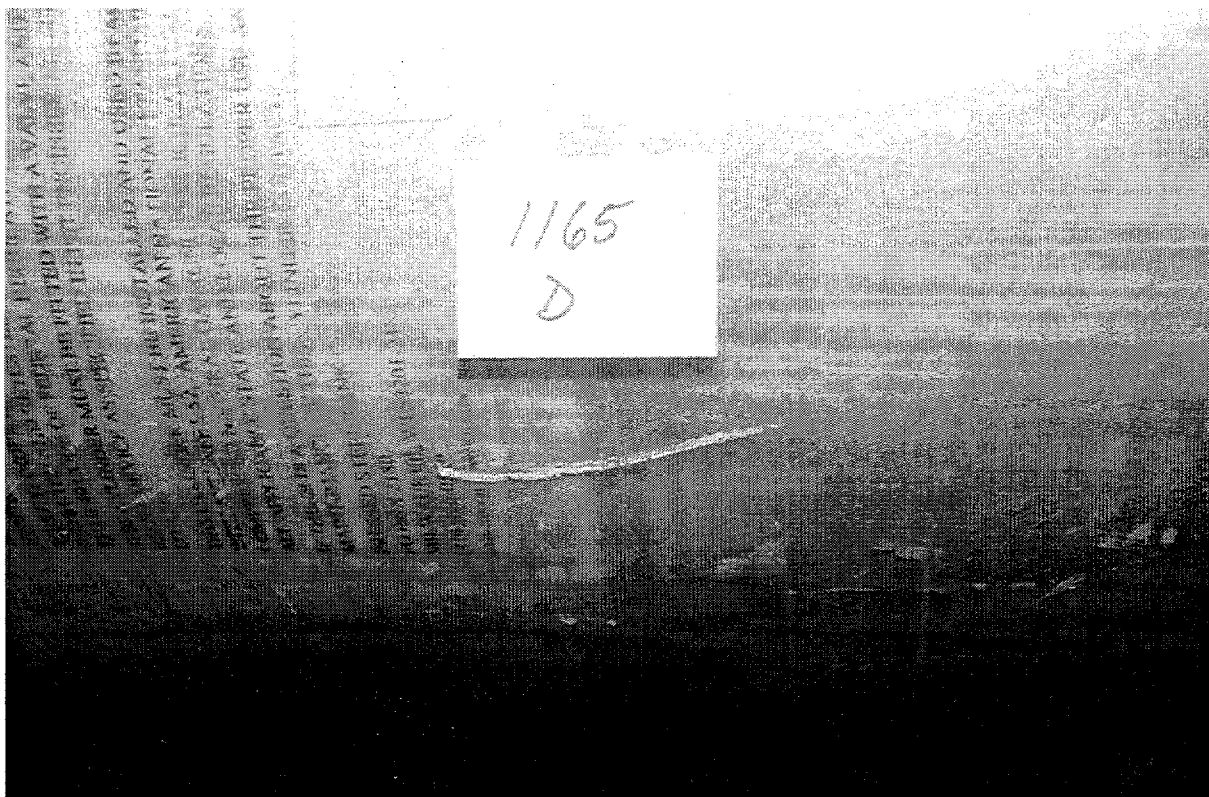
Cylinder D of the bus operating in service was tagged and isolated from the vehicle's remaining three cylinders. The inspection revealed a deep scratch in the composite wrap (approximately 0.05 in. in depth) along the bottom surface of the cylinder. Figure 2 is a photograph of the damage. A pitted hole, of approximately the same depth as the scratch, and numerous minor abrasions near the front cylinder mount were also found on the cylinder surface.

**Figure 2. Scratch along cylinder surface of the Site 2 bus operating in service**

The scratch and pitted hole on cylinder D of the operating bus most likely resulted from road debris kicked up onto the cylinder. The operational service area for these buses, as well as the storage/maintenance yard at the site facility, contains a number of rough/unpaved roads with many stones. There are no gravel guards for the outboard cylinders on the buses, only mud flaps. Because the operating bus sustained damage after an in-service period of only 2 weeks, the likelihood of future damage similar to that found during the inspection is high. For these reasons, the inspector advised the site contact to discuss with the manufacturer the possibility of more substantial shielding and gravel guards for the buses.

The damaged cylinder was tagged, and the site contact and shop supervisor were alerted to the condition. The site contact confirmed that the cylinder shut-off valve would be closed and the cylinder vented to reduce the pressure and the possibility of rupture. The bus was permitted to remain in service, but the damaged cylinder was to be isolated from the vehicle's fuel system until it was certified or replaced.

In a later phone conversation with the site contact, it was learned that site personnel had decided to replace cylinder D on the operating bus instead of testing and recertifying the cylinder.

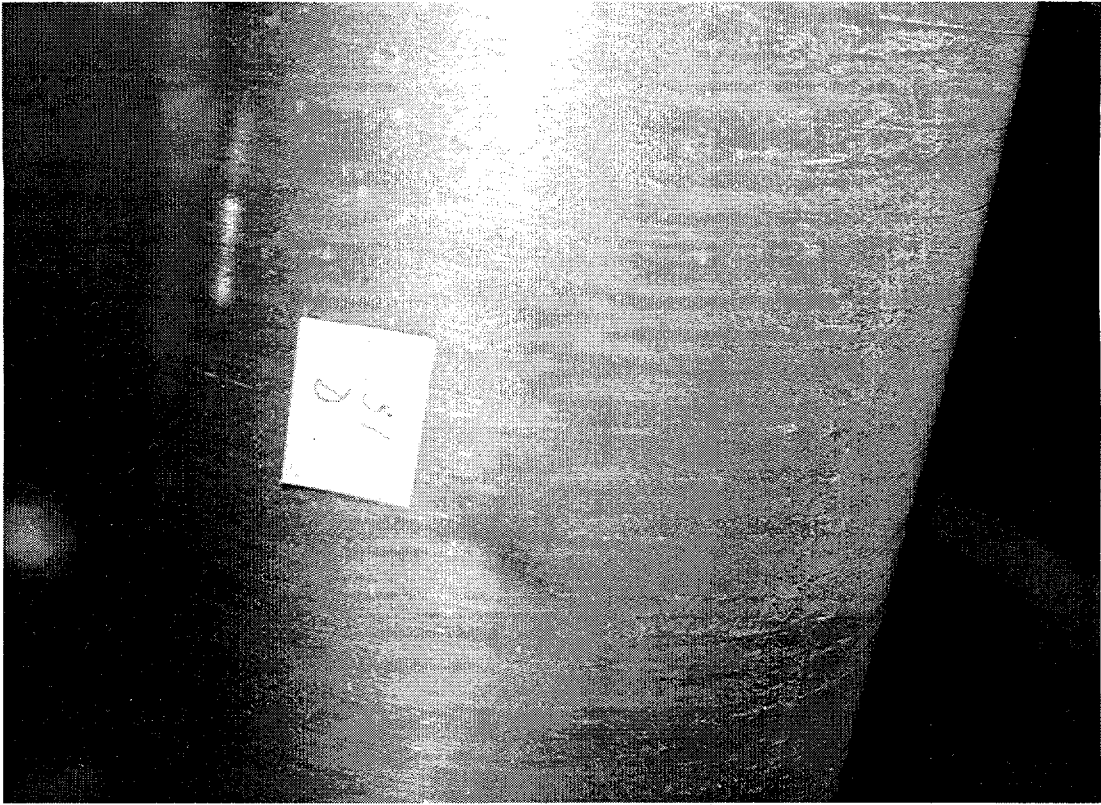
Cylinder D of one bus was tagged and isolated from the vehicle's remaining three cylinders. Inspection of the cylinder surface yielded three areas of discoloration. The source of the gray/black marks was unknown, but a tactile inspection of the area revealed a bubbled texture and possible burn marks. In the interests of safety, the cylinder was tagged for further testing. Figure 3 is a photograph of the marks on the cylinder surface.

**Figure 3. Possible burn marks on cylinder surface of first Site 7 bus**

The site contact and shop supervisor were alerted to the damage to the cylinders. The cylinder shut-off valves were closed, and the cylinders were vented to reduce the pressure. The vehicles were allowed to remain in service, with the damaged cylinders isolated from the rest of the fuel system.

The damage and the hazardous conditions mentioned here were discussed with the site contact, who informed the inspector that the vehicles would be taken to the local distributor so that the damaged cylinders could be tested and repaired/recertified. Additionally, the potential hazards identified would be discussed with the local distributor so that they could be corrected. The cylinders on the two buses were hydrotested and recertified or replaced by a local laboratory.

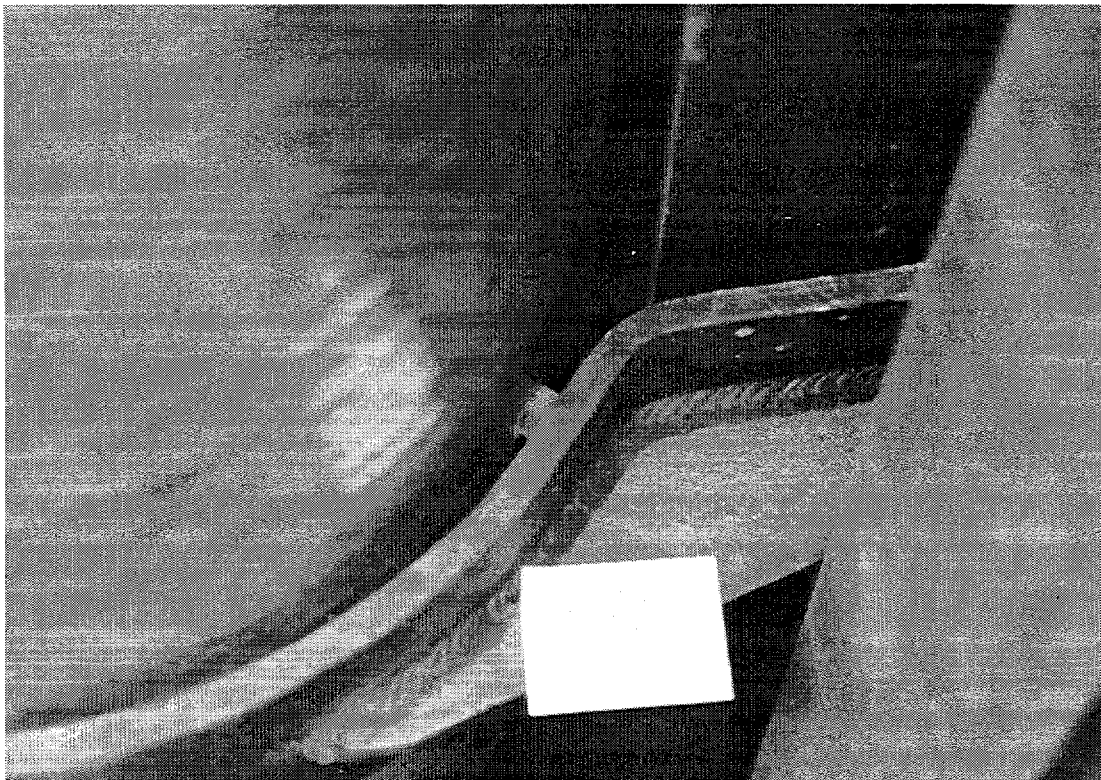
Cylinder B of a second bus was tagged and isolated from the vehicle's remaining three cylinders. Upon inspection, a metal nut was found wedged between the steel support band and the side of the cylinder. The nut was partially embedded into the composite wrap of the cylinder. Figure 4 is a photograph of the embedded nut. The nut appeared to be of the type used for bracket and cylinder installation.

**Figure 4. Nut embedded in cylinder surface of second Site 7 bus**

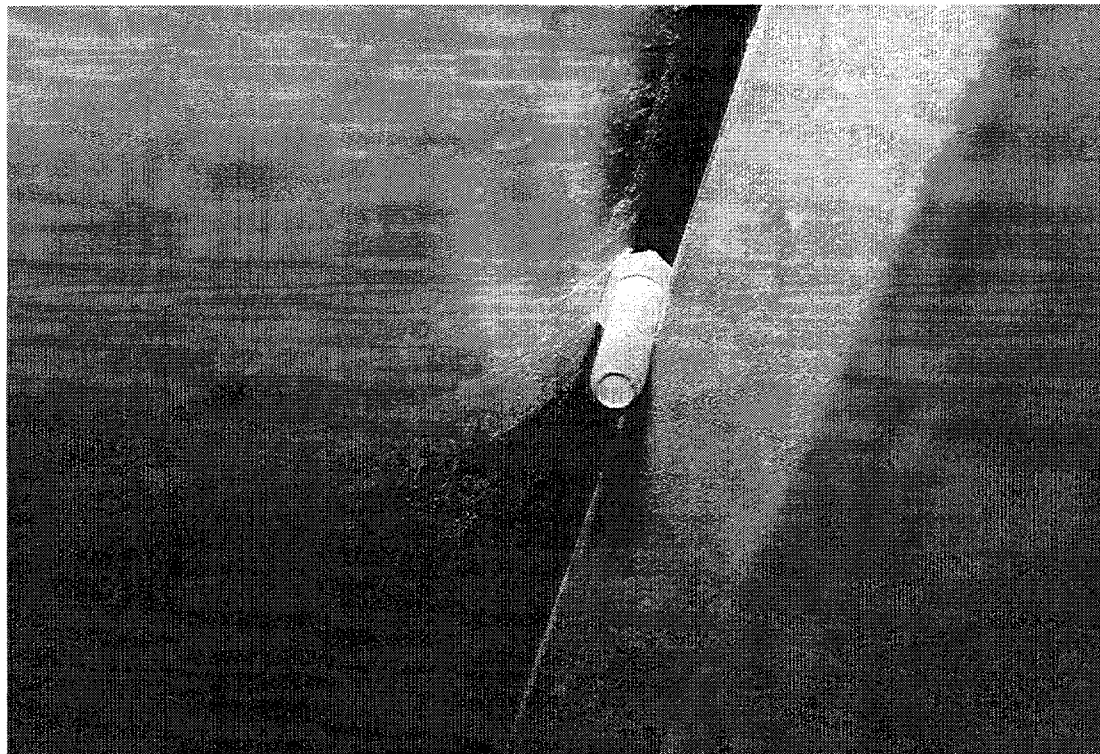
During the inspection of one bus, a bolt was found wedged between the chassis frame rail and the side of cylinder B. The head of the bolt was partially embedded (approximately 0.2 in.) into the composite wrap of the cylinder. Figure 5 is a photograph of the embedded bolt.

The embedded bolt appeared to be of the type used for the bracket and cylinder installation. On the same vehicle, an extraneous piece of CNG fuel line was wedged between the chassis frame rail and the adjacent cylinder (cylinder C). This line had not caused any damage to the cylinder's composite wrap and was easily removed by hand.

**Figure 5. Cylinder damage caused by an embedded bolt in a Site 9 bus**

When this damage was discovered, the cylinder shut-off valve was closed and tagged to indicate that the cylinder was damaged and that the valve should not be opened. This isolated the cylinder from the vehicle's remaining three cylinders. The site contact and shop supervisor were informed about the cylinder's status. The vehicle was permitted to remain in service without using the damaged cylinder. The vehicle had just finished refueling, so the cylinder was at full pressure. At the end of the daily route, the shop supervisor said he would open the valve before refueling, reduce the pressure in the cylinder, and re-close the valve on the tagged cylinder.

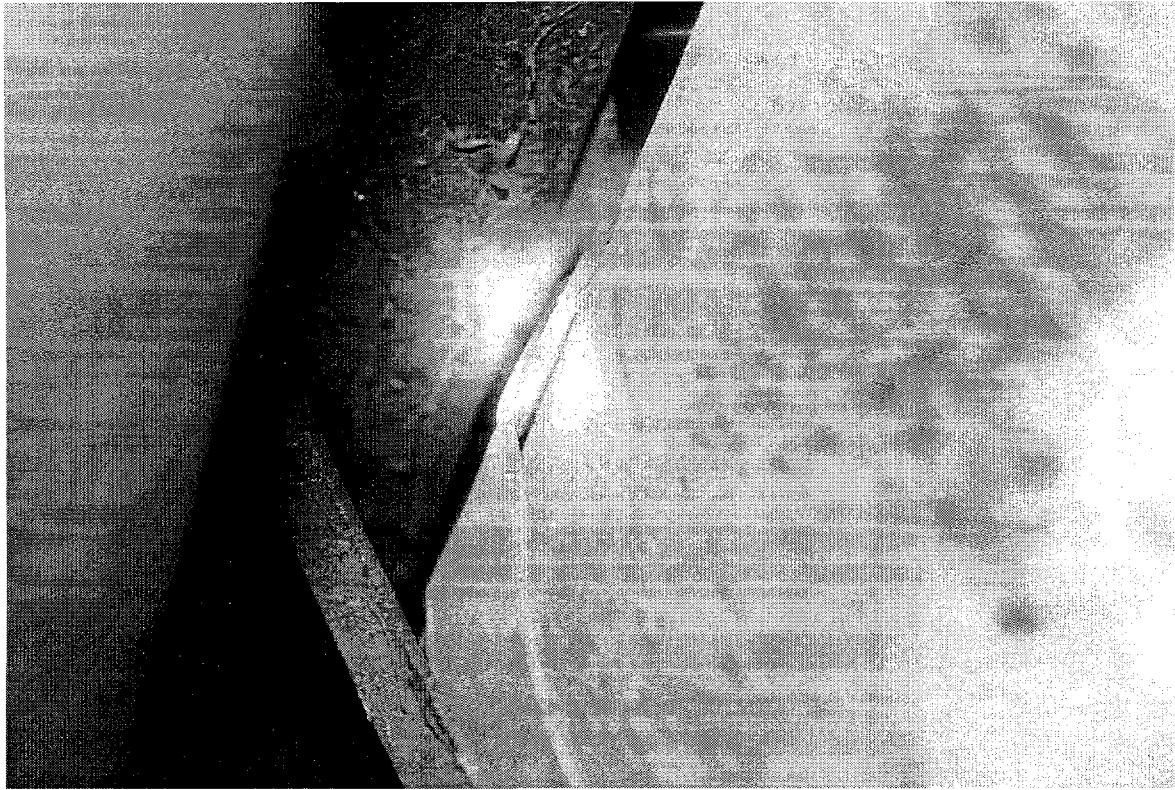
In certain applications, cylinders are not readily accessible. Many cylinder mounting systems are installed while the vehicle body is not attached to the chassis and the installation brackets are fully accessible. When recertification is due, or cylinder service is necessary, these brackets are no longer readily accessible and it is very difficult to remove the cylinders. Some designs left insufficient room for access to the support band mounting bolts, as a service technician has reported while trying to remove a damaged cylinder found at one site.

**Figure 6. Cylinder mounting design problem**
