Retrofit of a Multifamily Mass Masonry Building in New England

K. Ueno, P. Kerrigan, Jr., H. Wytrykowska,
and R. Van Straaten
Building Science Corporation

August 2013

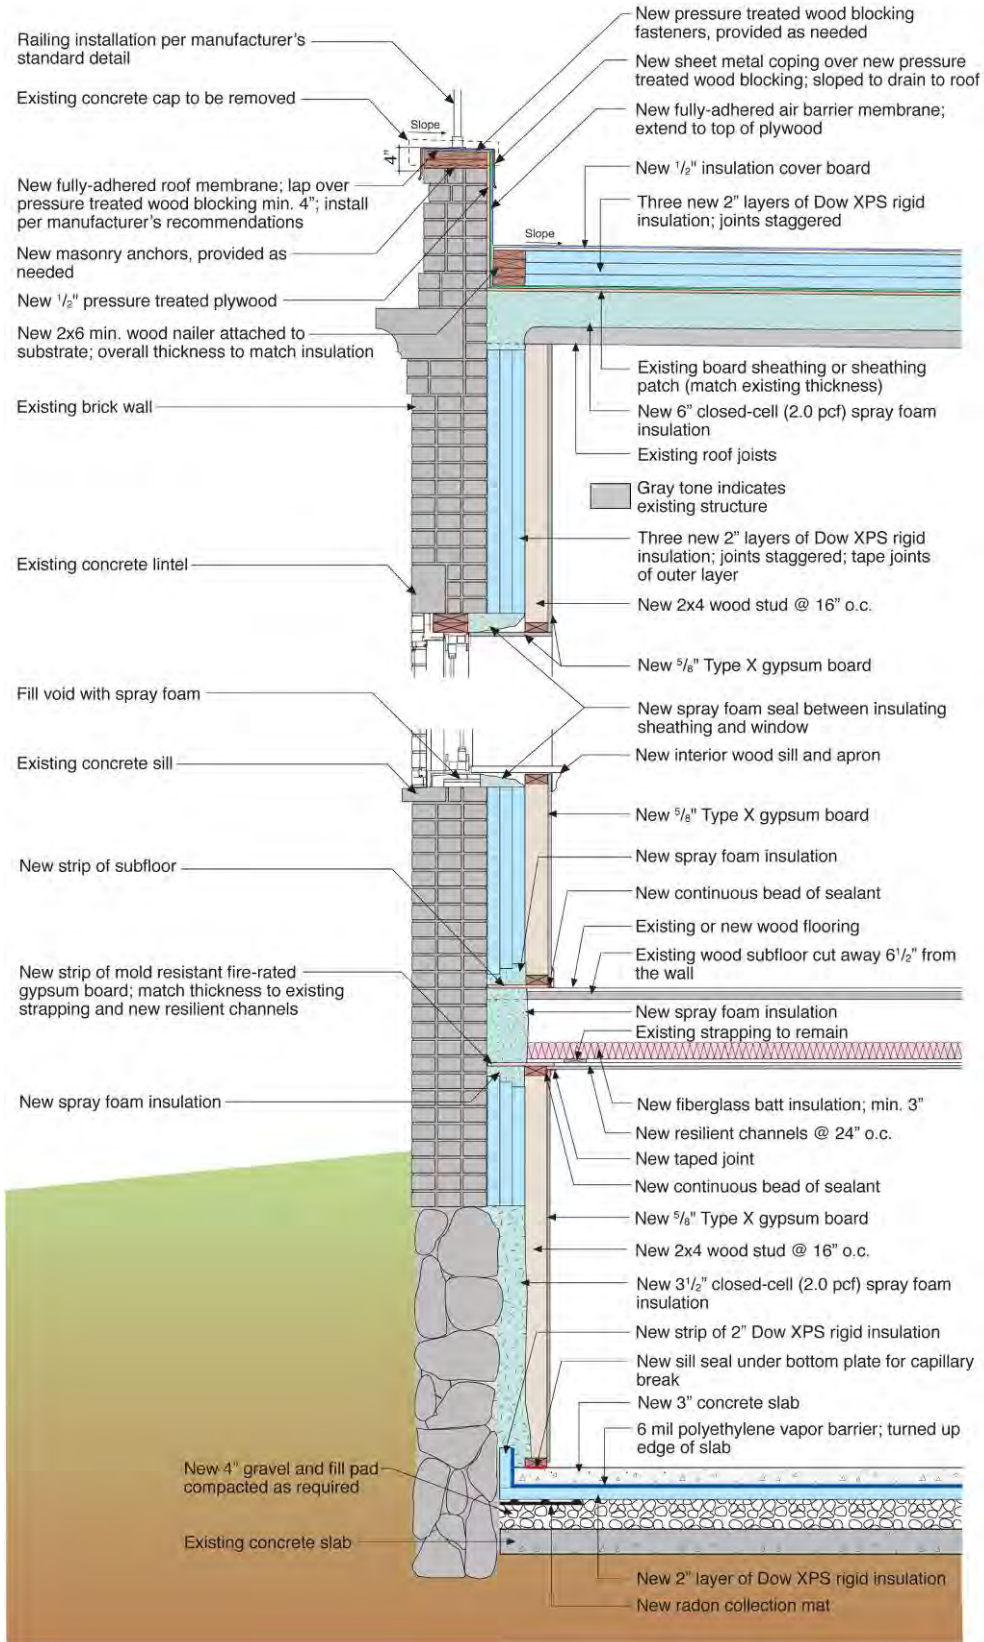
Figure 3. MVHfH building section

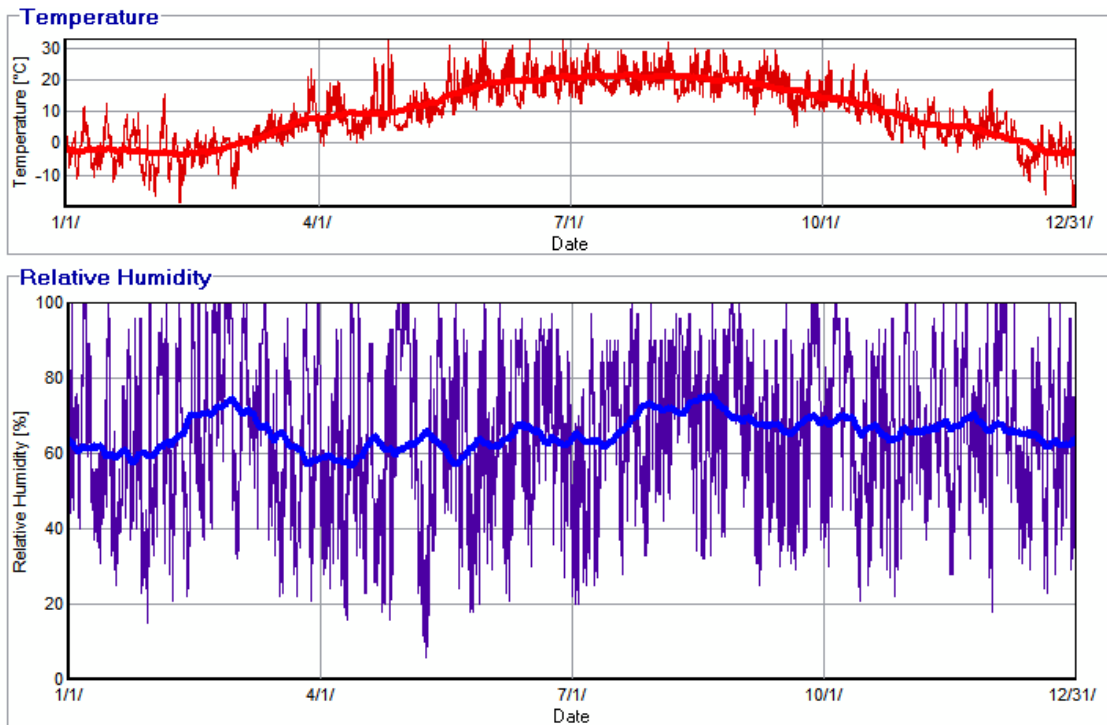
Figure 4. WUFI 5.1 Pro temperature and humidity for a “typical” cold year in Boston

WUFI includes climate data files for dozens of cities around the world. These climate files are typically generated from airport or other major weather station data. For the purposes of the Merrimack Valley Habitat for Humanity simulations we have used the Boston “cold” year weather file that is included in WUFI, summarized in Figure 4 and Figure 5. The existing interior conditions were simulated assuming heating only, as shown in Figure 6.

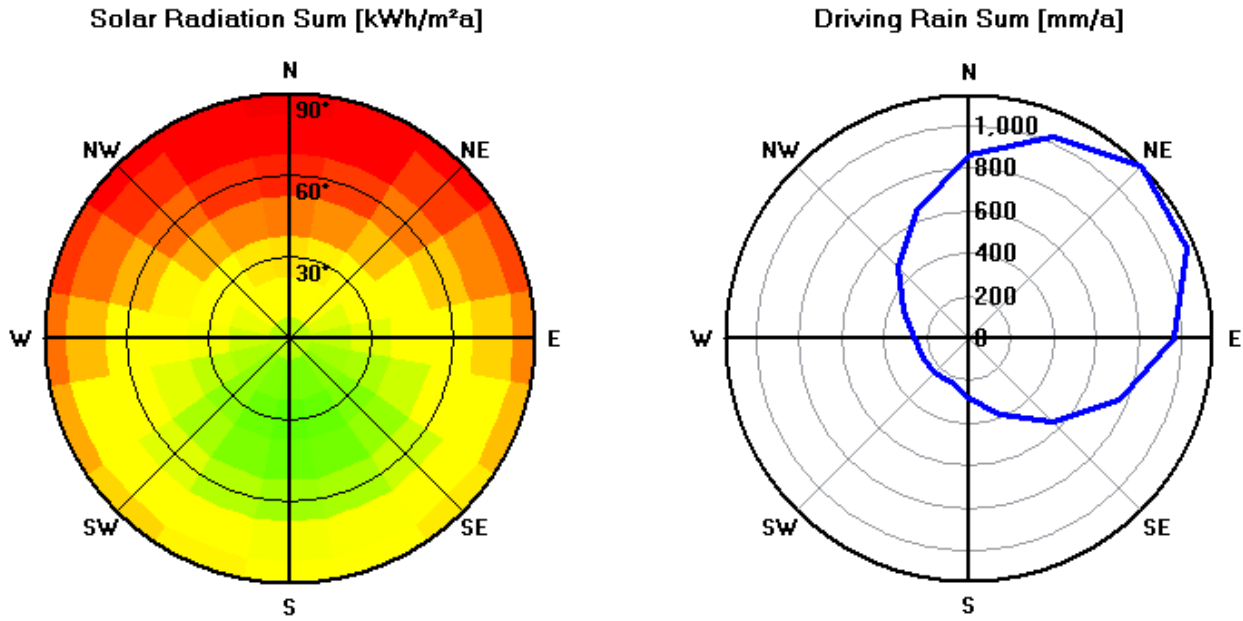
Figure 5. WUFI 5.1 pro climate summary for a “typical” cold year in Boston

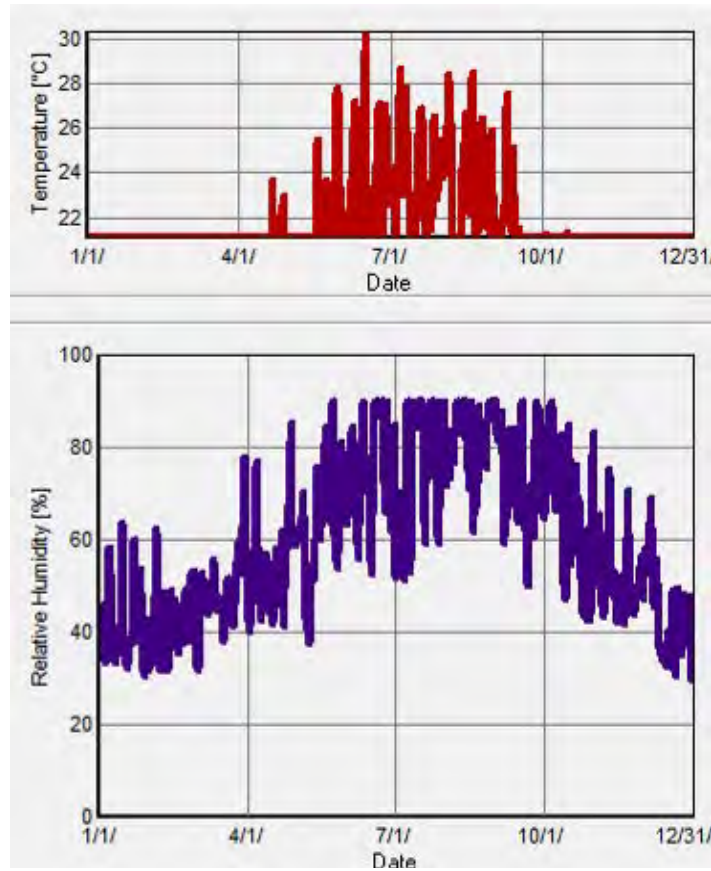
Figure 6. Indoor conditions used in WUFI simulation (temperature and relative humidity)

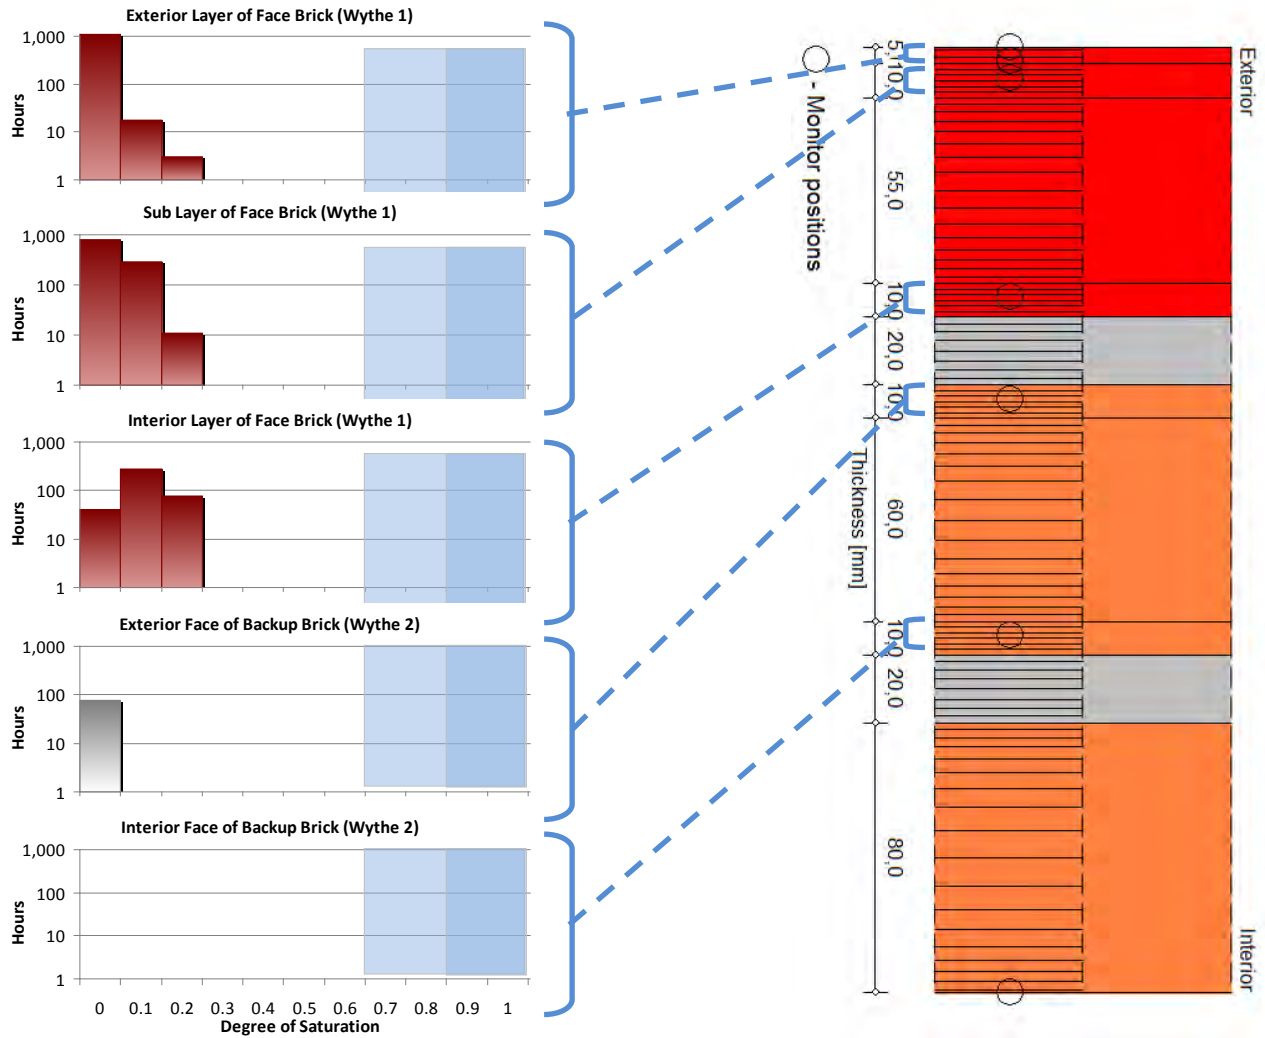
Figure 11. Example moisture content plot, correlated with assembly layers

The simulation results for the existing original building and the addition wall assemblies are plotted in Figure 12 and Figure 13. These simulations were repeated for the same wall assemblies and exposures after insulation, as plotted in Figure 14 and Figure 15. The multiple column graphs correlate with key vulnerable layers within the masonry assembly, as shown in Figure 11.

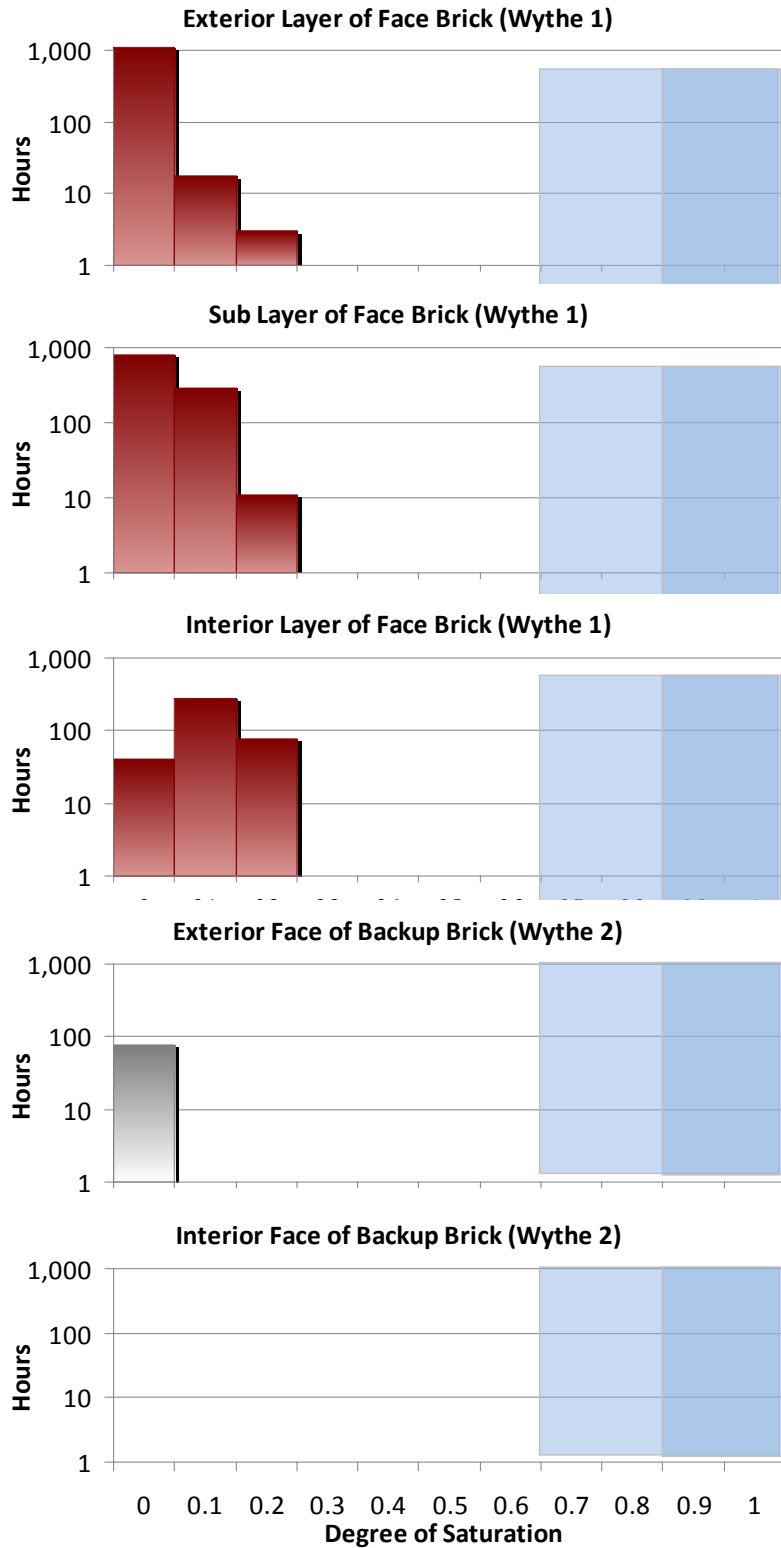
Wall assembly	Original (solid brick)
Wall condition	Uninsulated
Orientation	East
Rain exposure	Normal
Int. conditions	Heated

Figure 12. Predicted moisture distribution during freezing temperatures: existing original building wall assembly, normal exposure, east facing, heating only

- In both simulated wall assemblies, at normal rain exposures, brick FT risk is predicted to be minimal with or without the thermal insulation retrofit.
- The existing brickwork damage is likely due to the combination of rainwater concentrations due to poor maintenance and details (e.g., gutter/downspout failures).
- The rainwater management issues associated with the existing areas of damage must be addressed, as the thermal insulation retrofit will exacerbate such problems.

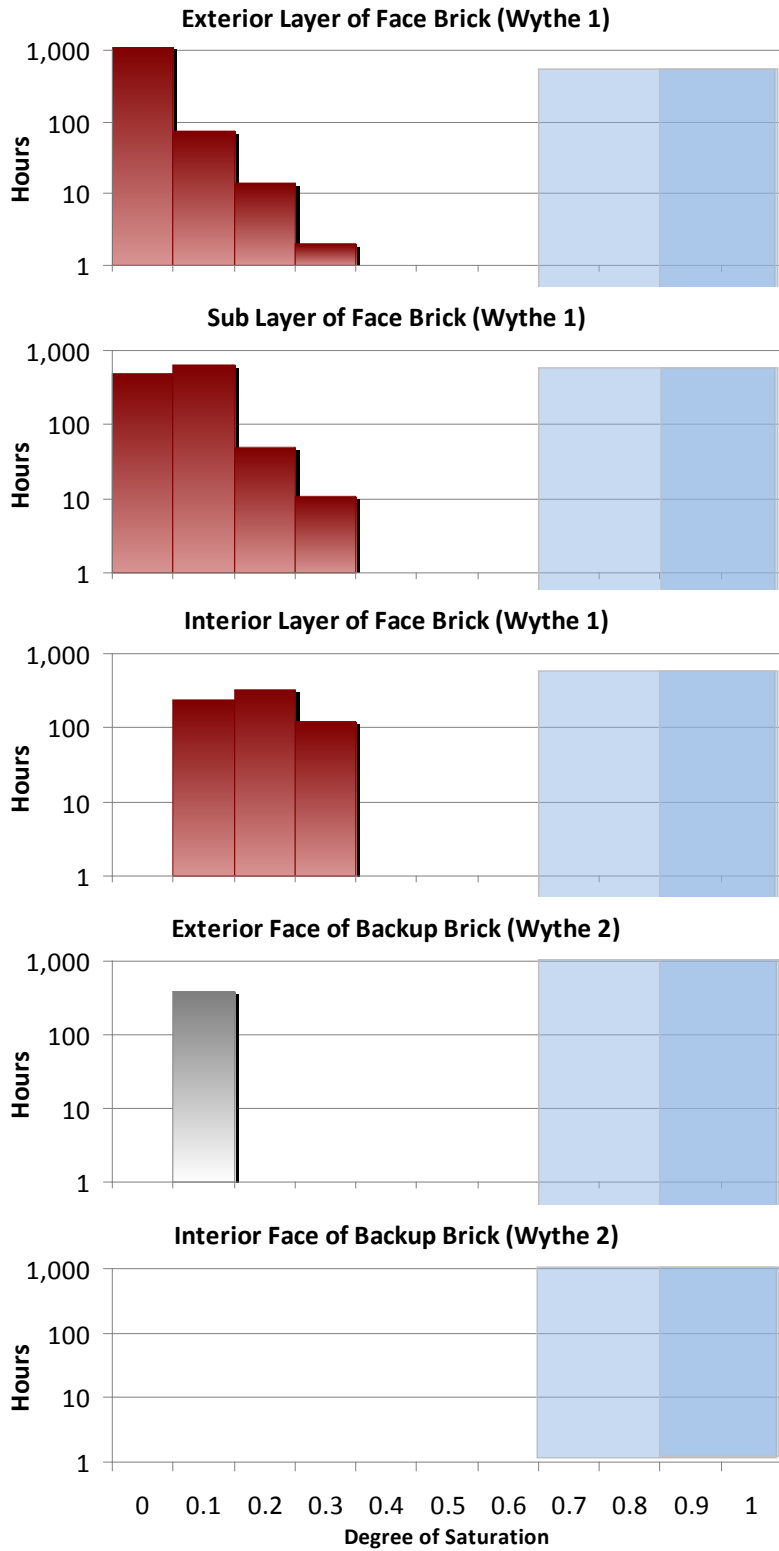
Wall assembly	Addition (clay block)
Wall condition	Uninsulated
Orientation	East
Rain exposure	Normal
Int. conditions	Heated

Figure 13. Predicted moisture distribution during freezing temperatures: existing addition wall assembly, normal exposure, east facing, heating only

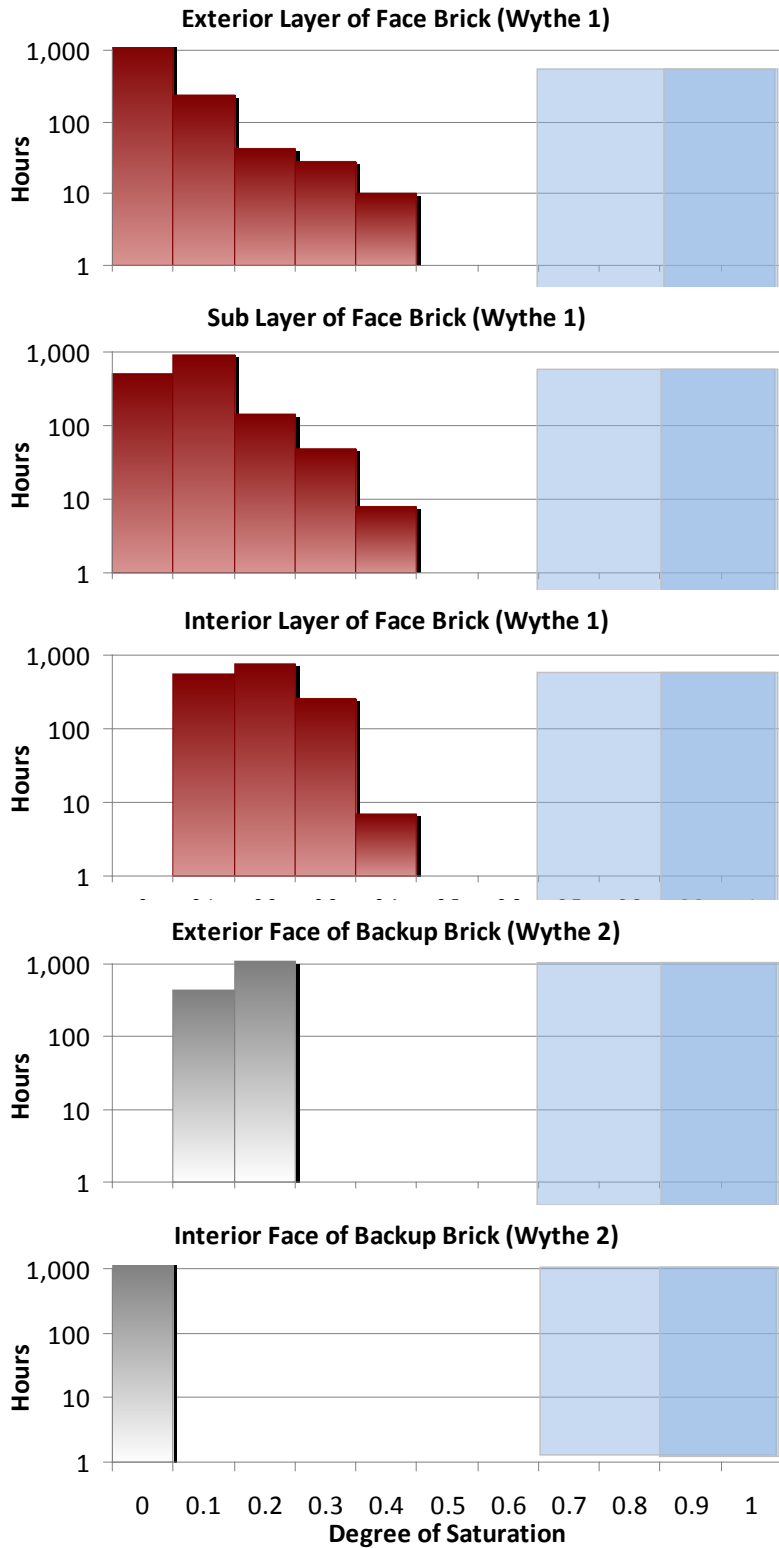
Wall assembly	Addition (clay block)
Wall condition	Insulated 6 in. XPS
Orientation	East
Rain exposure	Normal
Int. conditions	Heated

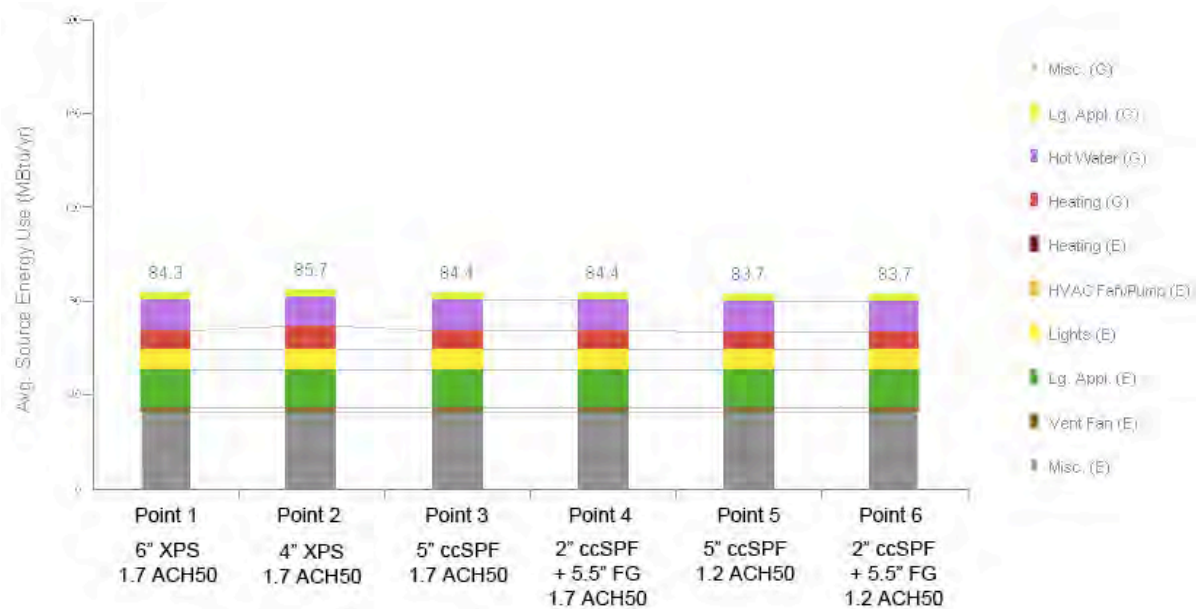
Figure 17. Unit 8 BEopt parametric results—average source energy use

Figure 17 shows the average source energy use (MBtu/yr) for the selected four wall systems generated by BEopt. The results indicate that options 1 (6 in. XPS rigid insulation), 3 (5 in. ccSPF), and 4 (2 in. ccSPF with batt insulation) use essentially the same amount of energy. Option 2 (4 in. XPS rigid insulation) uses 1.4 MBtu/yr (~2%) more than the proposed 6 in. XPS rigid insulation. These results were expected, as the R-values of options 1, 3, and 4 are comparable. The reduced air leakage for Points 5 and 6 improved the energy usage minimally.

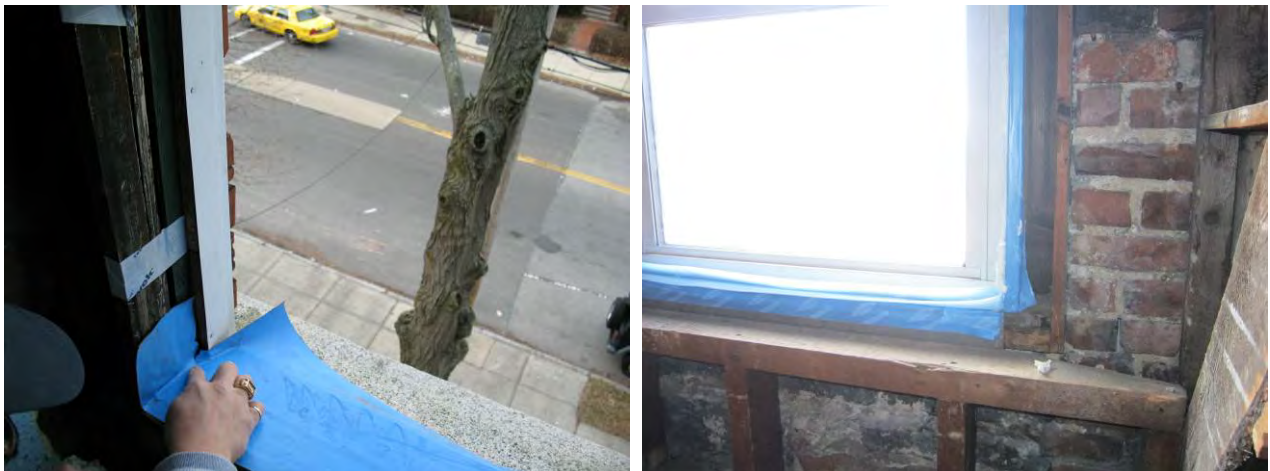
Figure 21. Test retrofit installation of flashing at the wood framed window openings

installation of flashing at the wood-framed window openings, and reinstallation of the existing units. See Appendix B for the retrofit construction details, and Figure 21 for a test installation of these retrofit details.

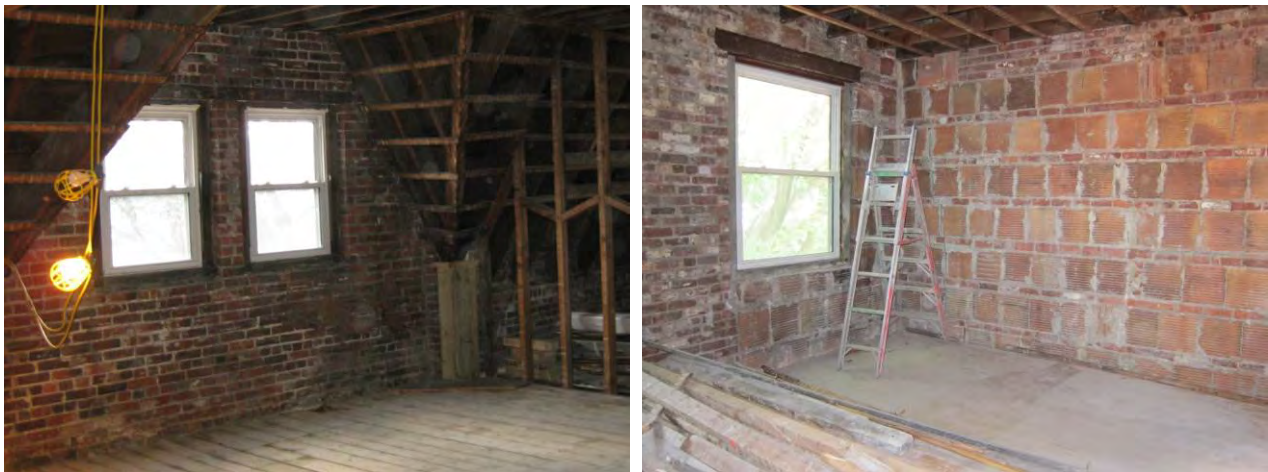
Figure 22. (L) Exterior wall conditions at solid brick; (R) hollow clay block infill conditions

The construction of the masonry walls at this project include both multiwythe solid brick walls, and exterior brick with a hollow clay block infill/backup wall, as shown in Figure 22. These photos show conditions after demolition of the interior furring, lath, and plaster.

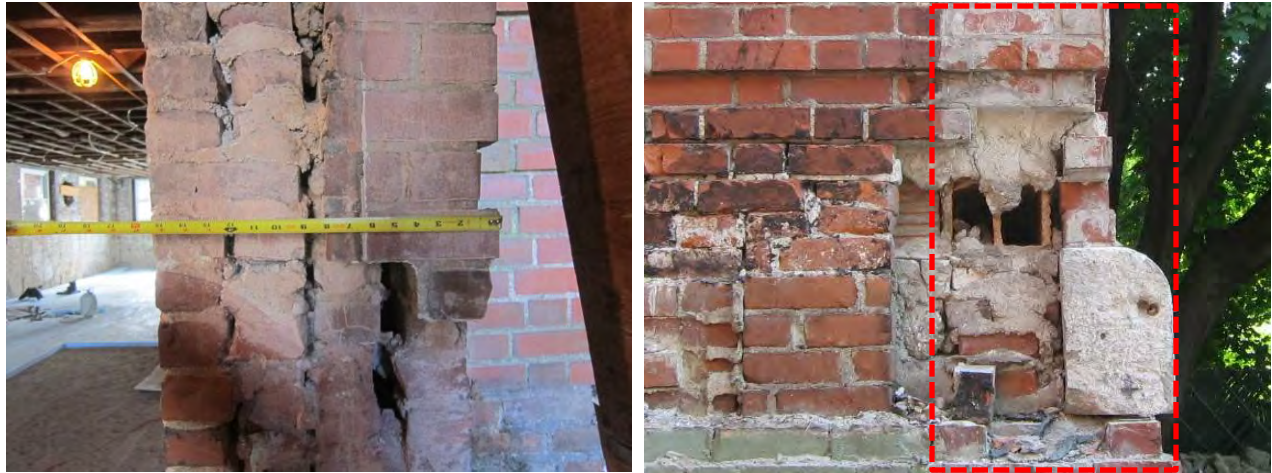
Figure 23. (L) Wall section at solid brick; (R) at hollow clay block infill conditions

Although these assemblies appear to be monolithic from the interior and exterior, there are a variety of interconnected air spaces, such as the incompletely filled collar joints between brick wythes (Figure 23, left). In addition, the hollow clay blocks provide a major interconnected airflow network laterally across the wall (Figure 23, right).

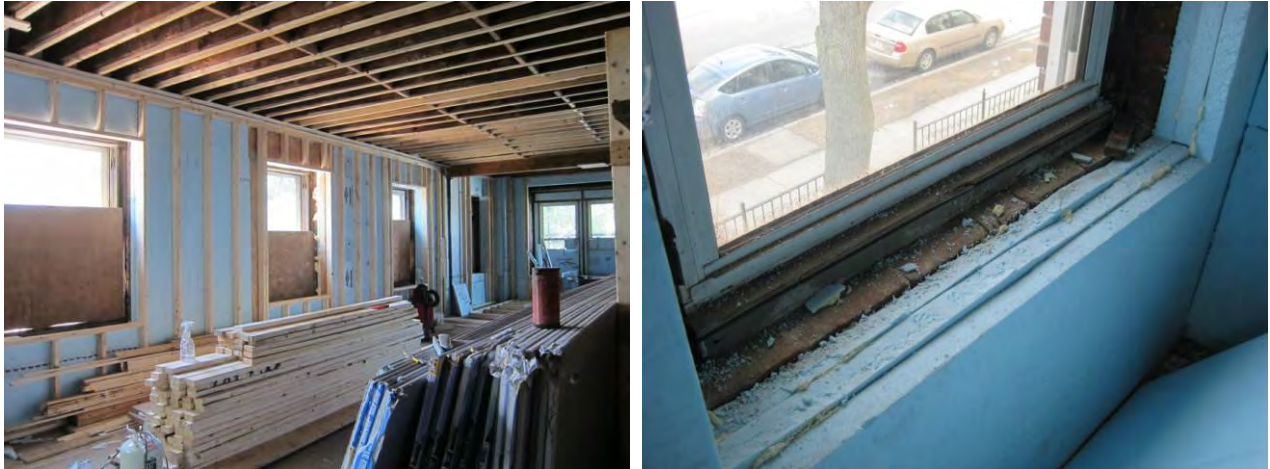
Figure 26. (L) Framing installed inboard of insulation; (R) conditions at window opening

Although the layers of taped rigid foam provide an effective air barrier in the field of the wall, the penetrations through this layer are a potential failure point for air barrier continuity. For instance, at the windows (Figure 26, right), air barrier continuity needs to be achieved from the foam to the window unit. The air spaces between the layers of foam have the potential to form a three-dimensional network of airflow paths.

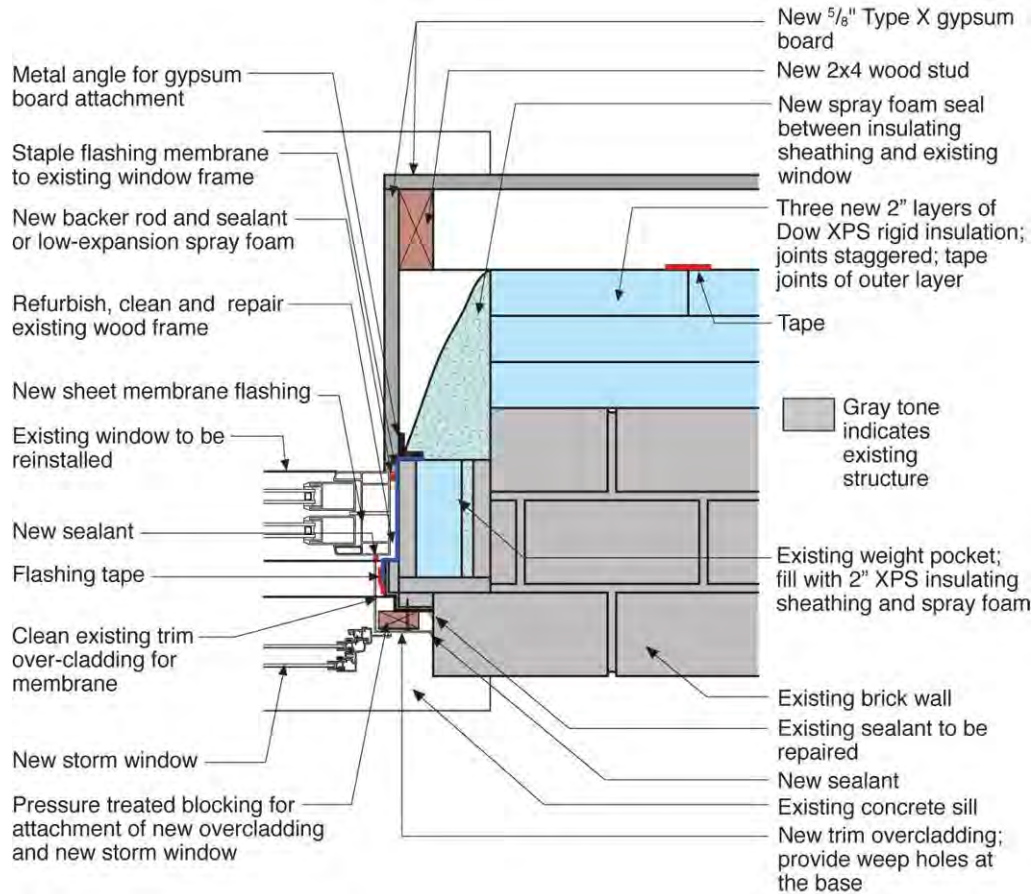
Figure 27. Window jamb retrofit detail, showing spray foam “fillet” for air barrier continuity

The solution detail uses two-component spray foam kits to “cap” the exposed foam edges, and connect them to the window rough opening, as shown in Figure 27. The window opening flashing materials (membrane or liquid-applied) are in turn connected to the window unit using low-expansion foam.

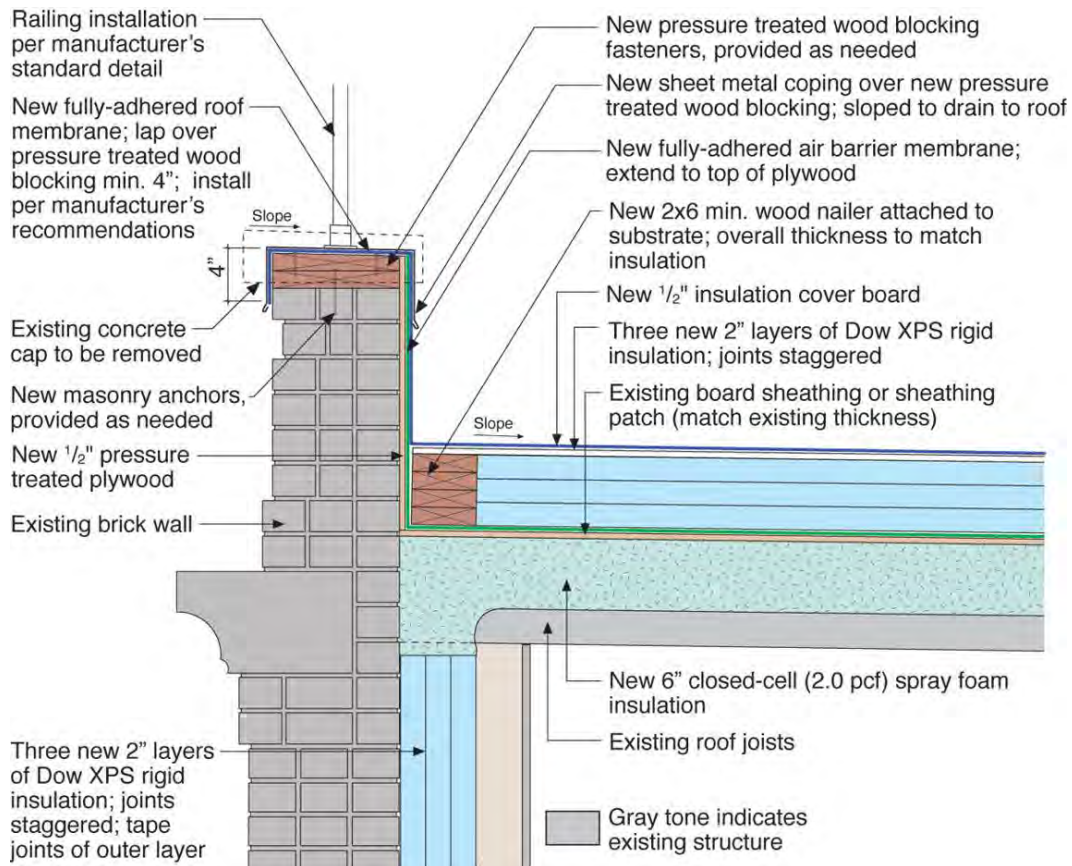
Figure 29. Lower roof retrofit detail at parapet

On the top side, a layer of self-adhered membrane is installed under the layers of rigid insulation and wrapped up the parapet, to provide an air barrier at the underside of the “roof sandwich” discussed above. This air barrier is actually somewhat redundant, given the spray foam installed from the underside; however, it was selected due to some of the specifics of this project.

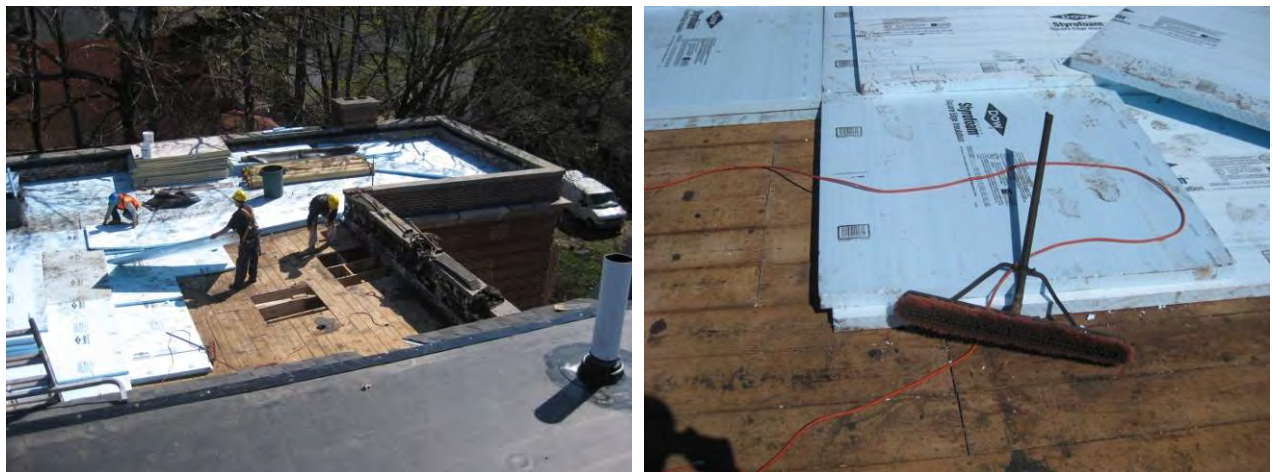
Figure 30. Insulation of lower roof, showing lack of air barrier at board sheathing

During the installation of the lower roof, it was found that the air barrier layer was not being installed; instead, the rigid insulation was being installed directly on the roof board sheathing (Figure 30). The site supervisor was notified of this deficiency, and it was corrected over the weekend before completion of the roof membrane installation.

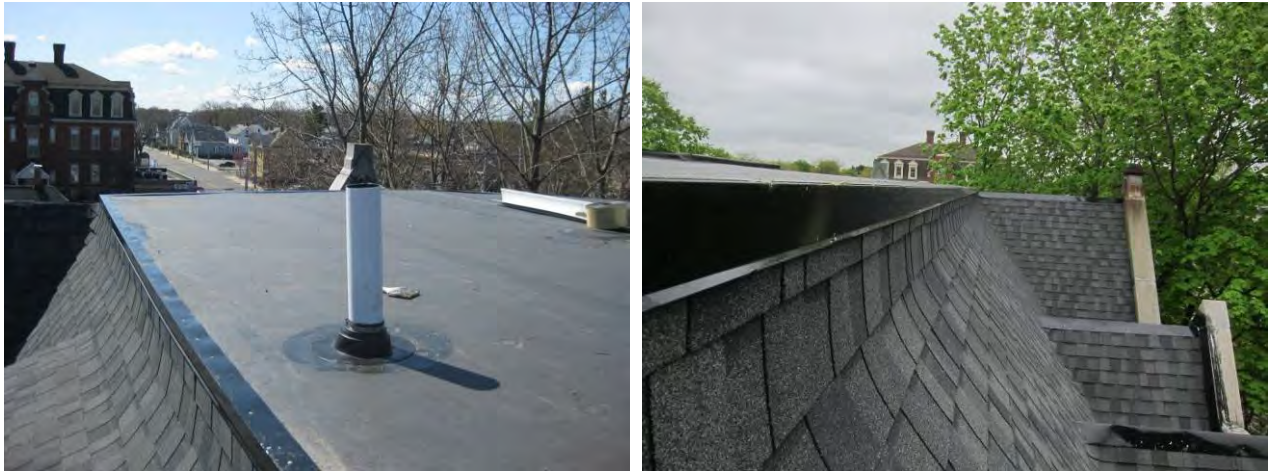
Figure 33. (L) Upper roof typical conditions; (R) upper roof edge detail

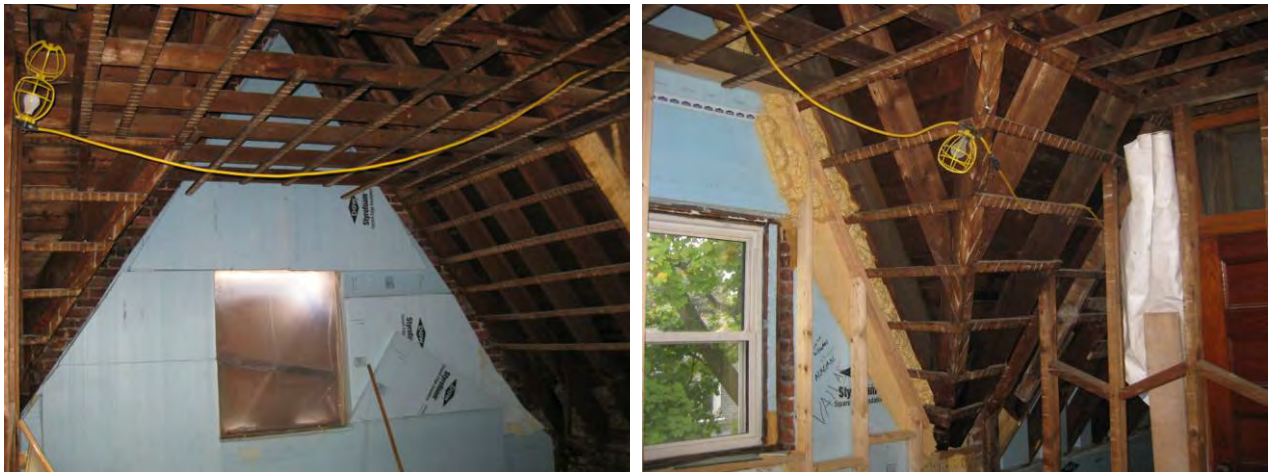
Figure 34. (L) Rigid wall insulation left clear of roof; (R) infill with spray foam kit

One example of the air barrier connection between the above-grade wall and the sloping roof is shown in Figure 34: the wall rigid foam board was left clear of the roof, and the connection from the wall air barrier to the roof spray foam air barrier was made with ccSPF. The example shown in Figure 34 was done by the volunteer crew using a spray foam insulation kit; however, it could be done instead by the professional spray foam contractor when the field of the roof is done.

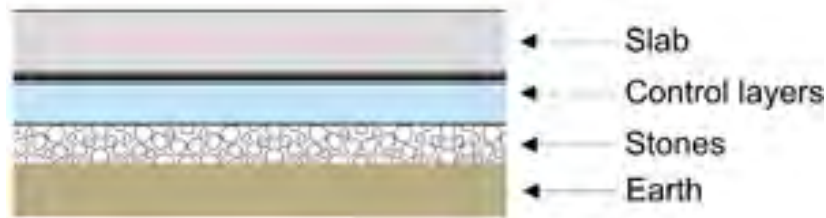
Figure 35. “Perfect slab,” showing polyethylene and insulation control layers
(Lstiburek/BSC 2007)

The ideal new construction slab design is shown in Figure 35, which is taken from Lstiburek (2007). It consists of (from bottom to top) some type of granular fill/gravel to create a capillary break from the earth below, a layer of moisture-insensitive insulation, an air and vapor impermeable membrane (such as polyethylene), and the concrete slab, cast directly onto the membrane.

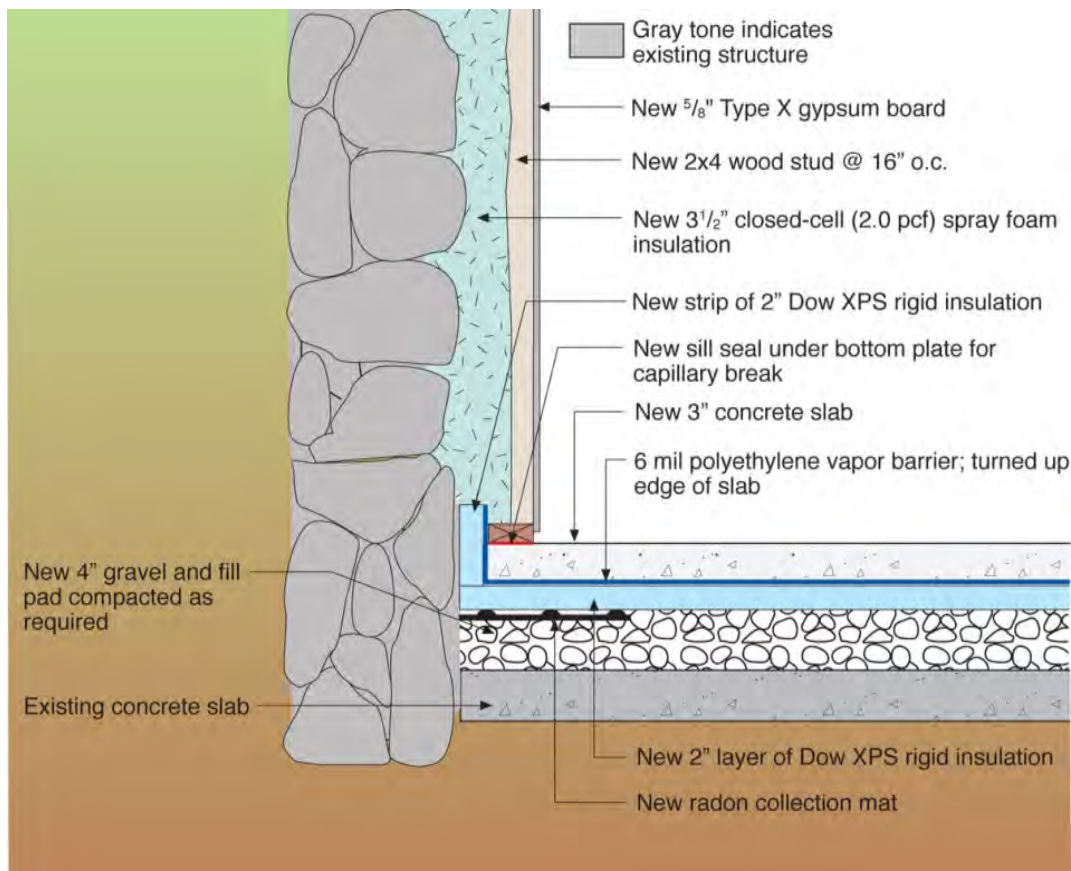
Figure 36. Typical basement slab and bottom of wall detail

The detail also shows the installation of a subslab radon collection system. No testing was done to indicate that radon is a known problem; however, the team decided to install the system. This is due to the fact that installing the subslab components is a simple change prior to casting of the slab, but prohibitively expensive as a retrofit. The system is currently planned as a passive stack vented through the roof, but a powered radon mitigation fan can be retrofitted if high radon levels are found in service.

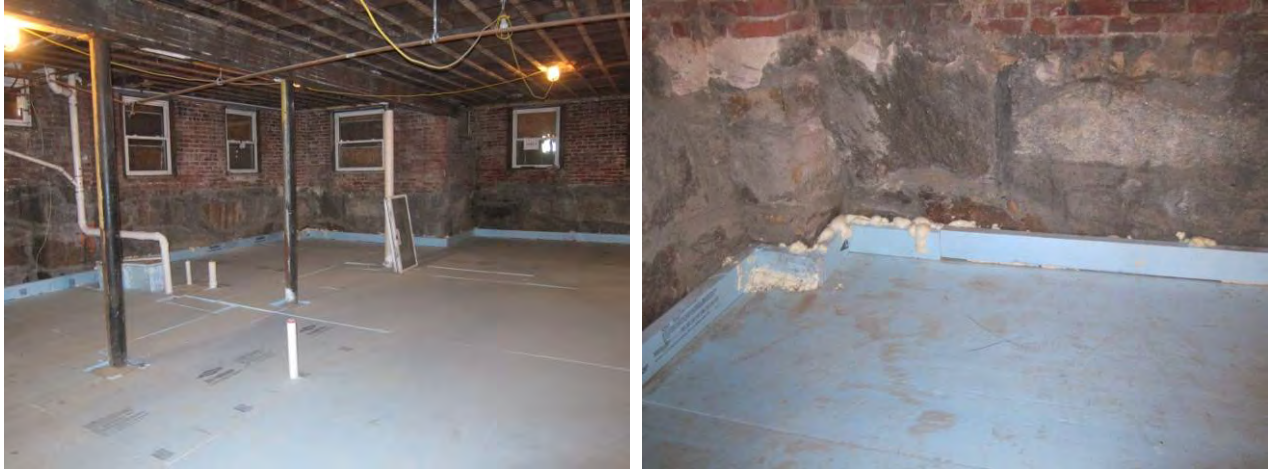
Figure 39. (L) Installed subslab insulation at basement; (R) detail of slab edge insulation

The completed slab insulation work (prior to installation of polyethylene) is shown in Figure 39; the slab edge insulation is temporarily held in place by one-component polyurethane adhesive (Figure 39, right).

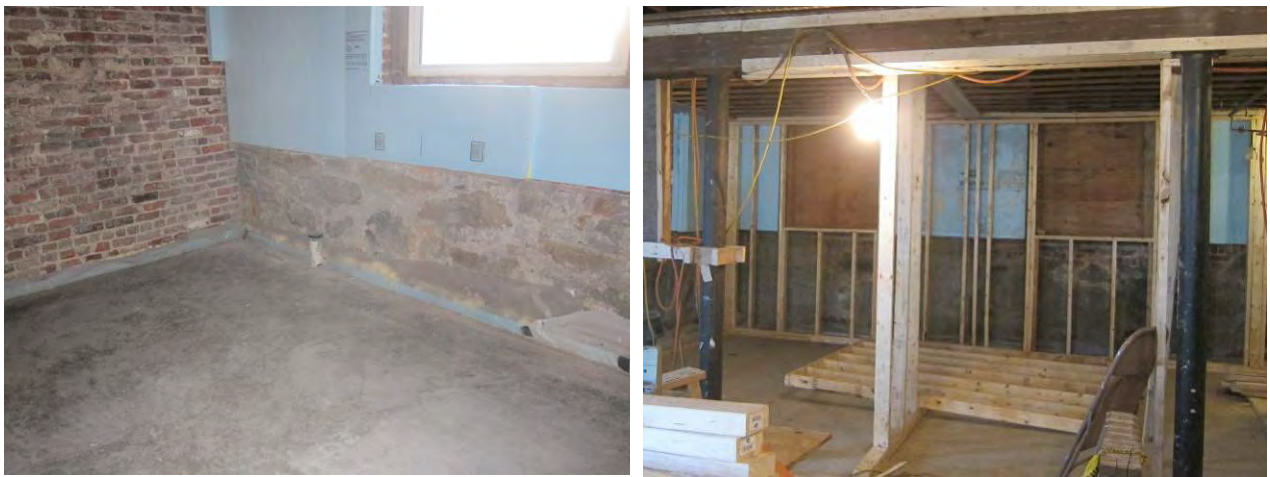
Figure 40. (L) Edge detail after casting of slab; (R) installation of interior framing

The condition of the edge detail after the casting of the slab is shown in Figure 40 (left); the polyethylene “flap” is available for an air barrier connection to the spray foam used at the bottom of the wall (at the rubble stone section at the base of the wall). Interior framing installation is shown in Figure 40 (right).

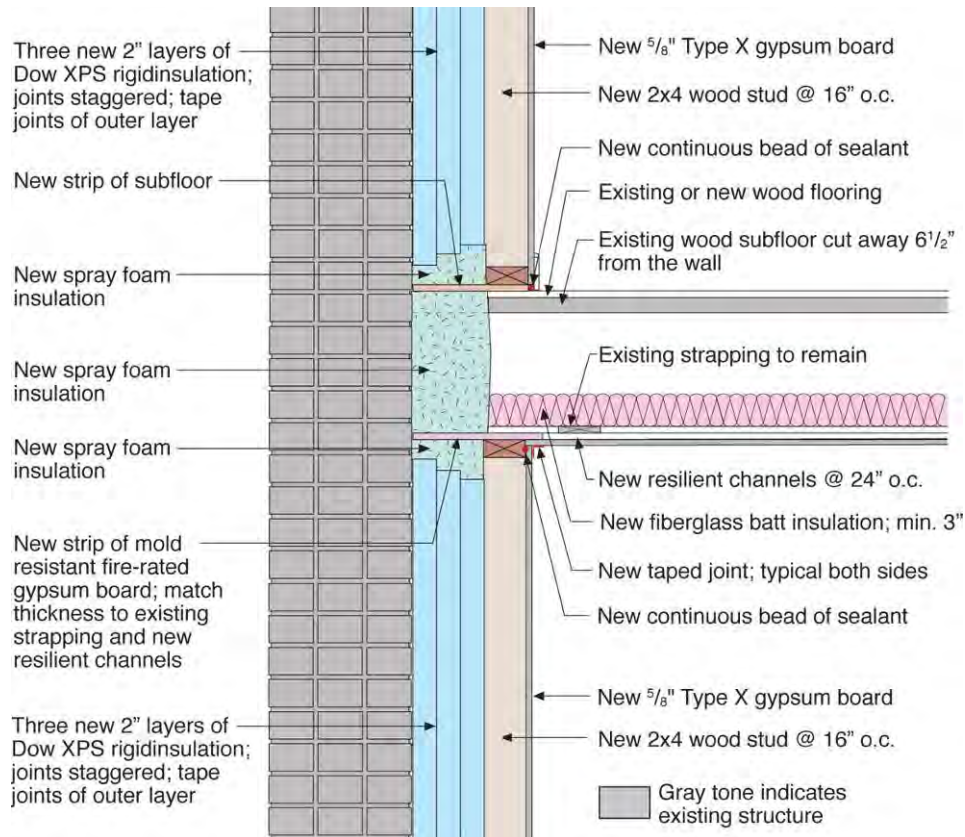
Figure 42. Unit-to-unit floor/ceiling assembly at exterior wall; joists perpendicular to wall

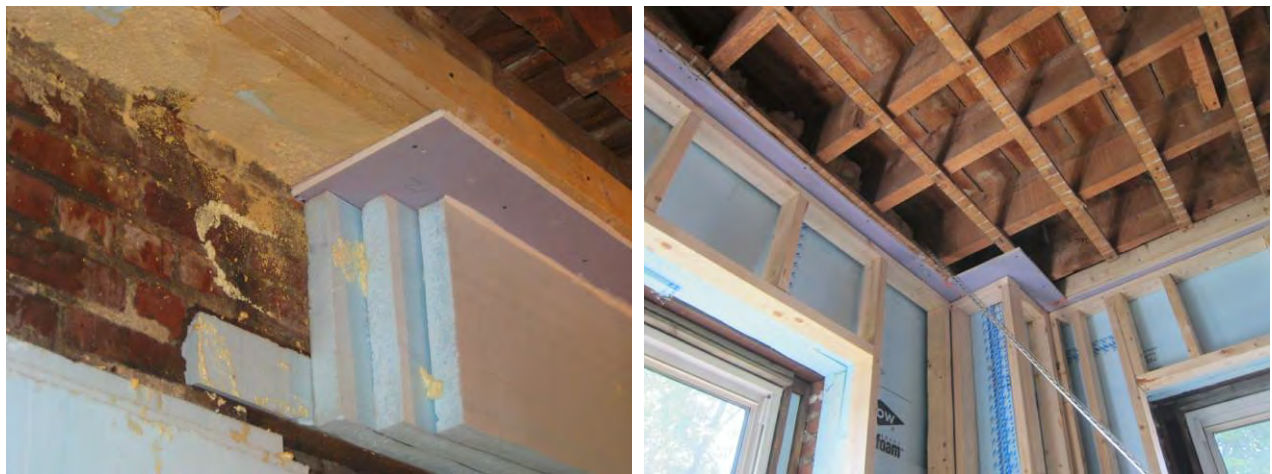
Figure 43. (L) Floor/ceiling fire separation gypsum board; (R) conditions after interior framing

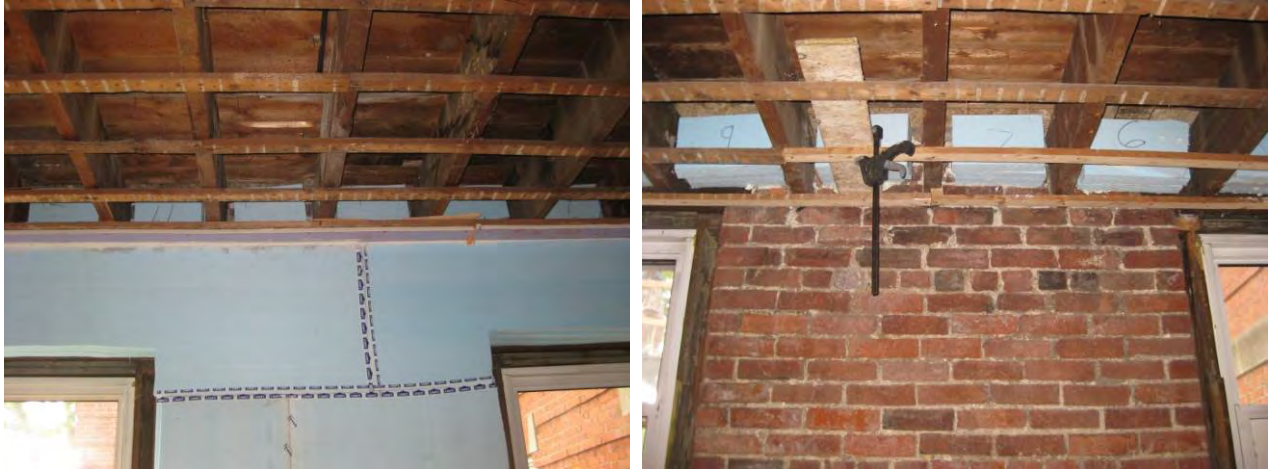
Figure 44. (L) Rim joist foam blocks; (R) close-up showing clamping jig

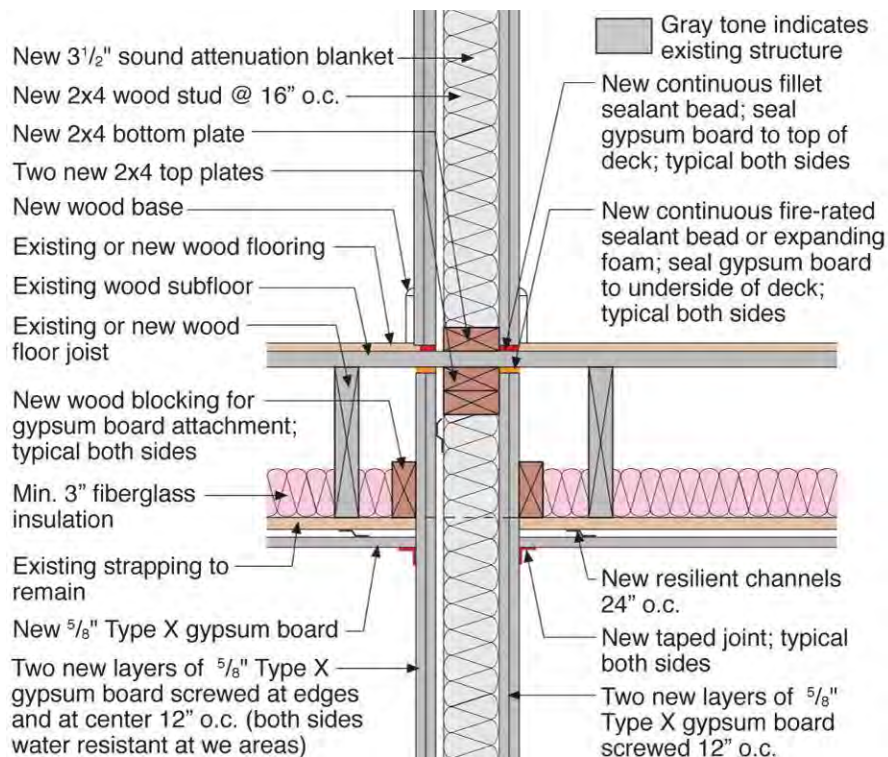
Figure 49. Unit-to-unit (rated) floor-to-ceiling assembly at demising wall; joists parallel to wall
