Retrofit of a Multifamily Mass Masonry Building in New England

K. Ueno, P. Kerrigan, Jr., H. Wytrykowska,
and R. Van Straaten
Building Science Corporation

August 2013

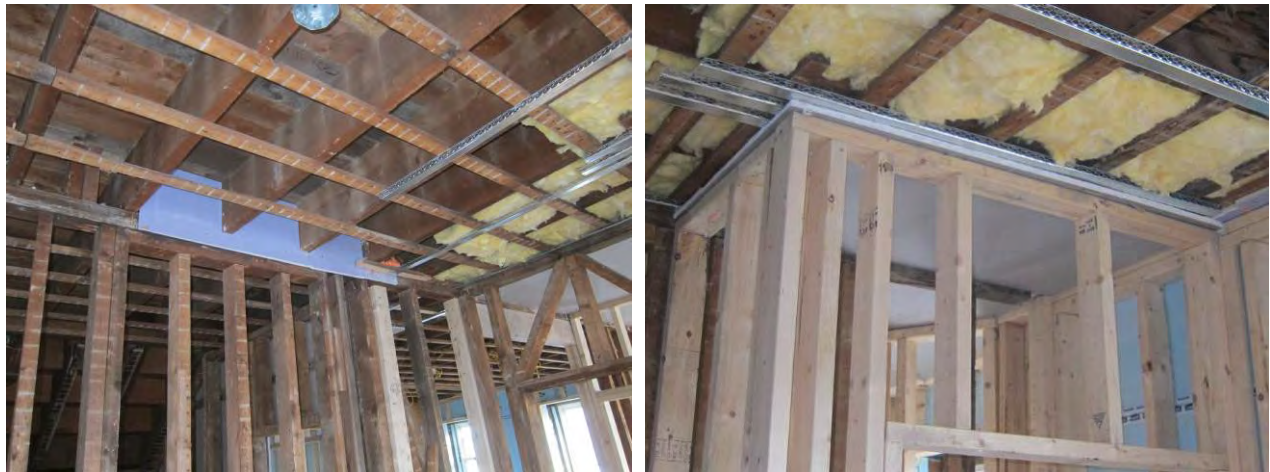
Figure 50. (L) Notched gypsum board at demising wall; (R) ceiling gypsum board continuous over unit interior partition walls

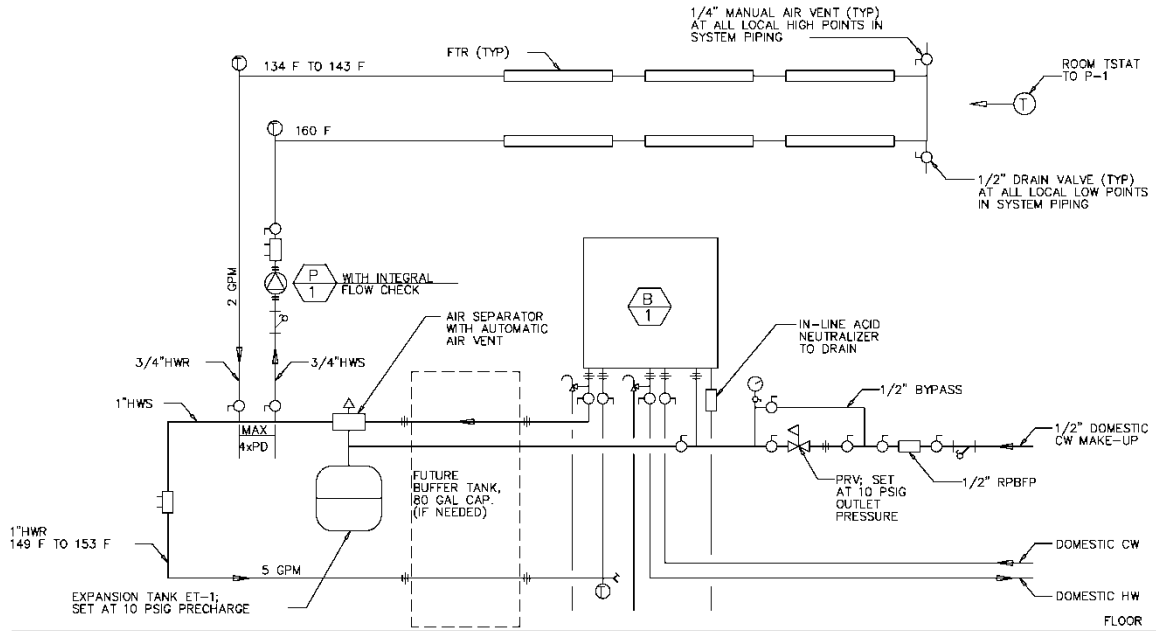
Figure 51. Original apartment hydronic schematic

Figure 51 shows the original heating system schematic.

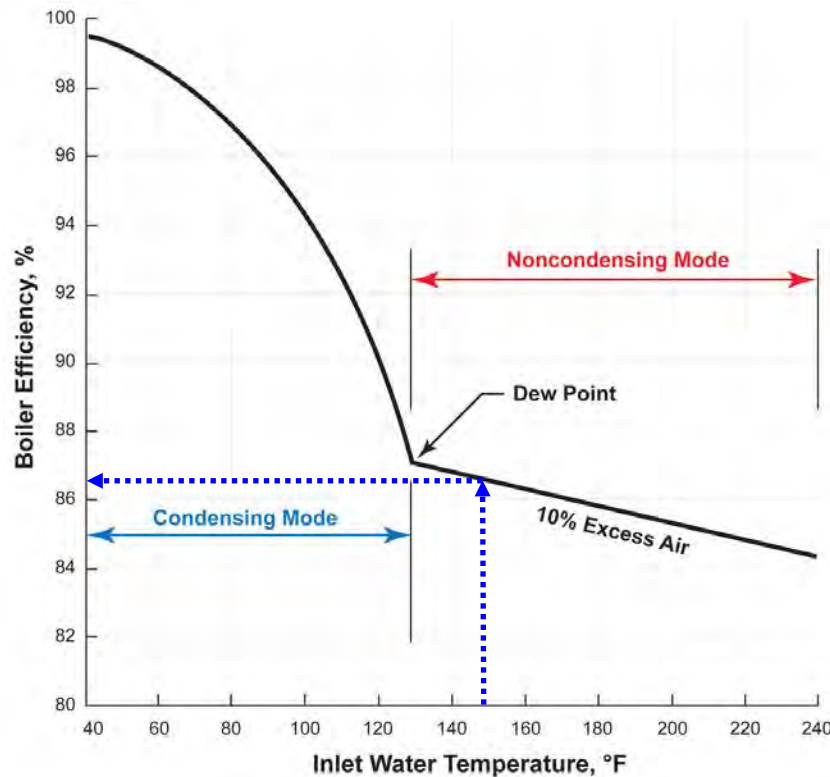
Figure 52: Thermal efficiency plot as a function of inlet water temperature

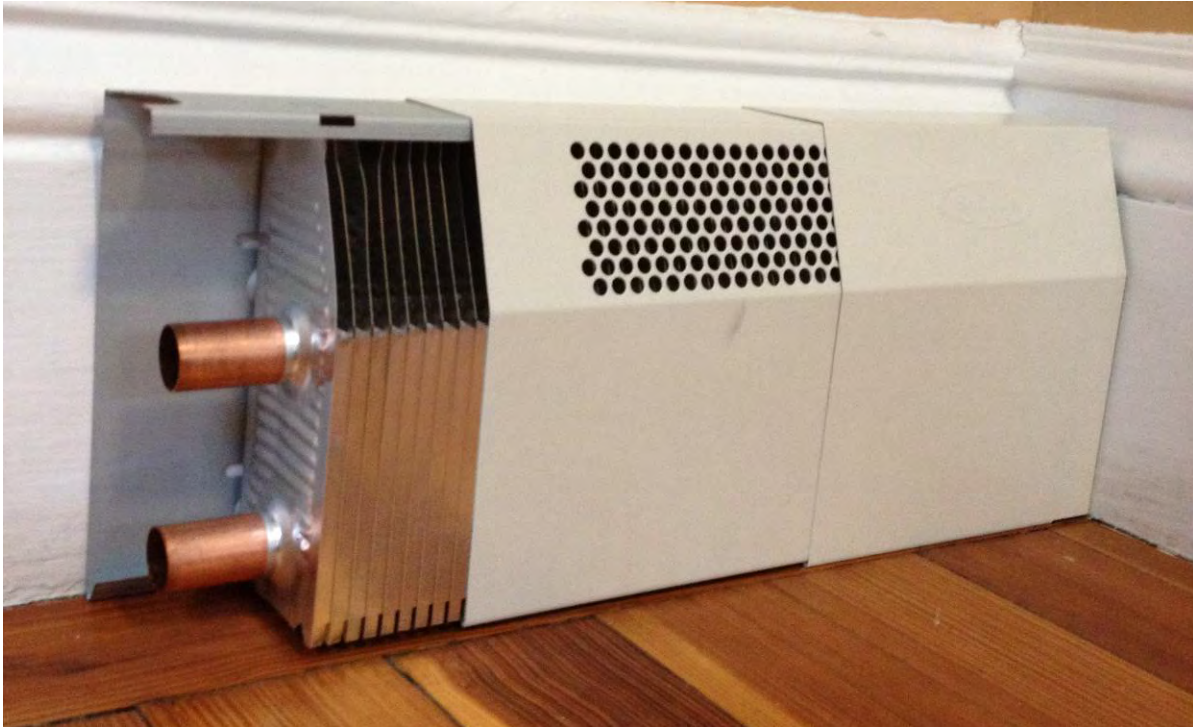
Figure 53. Smith Environmental HE2 high-capacity hybrid element

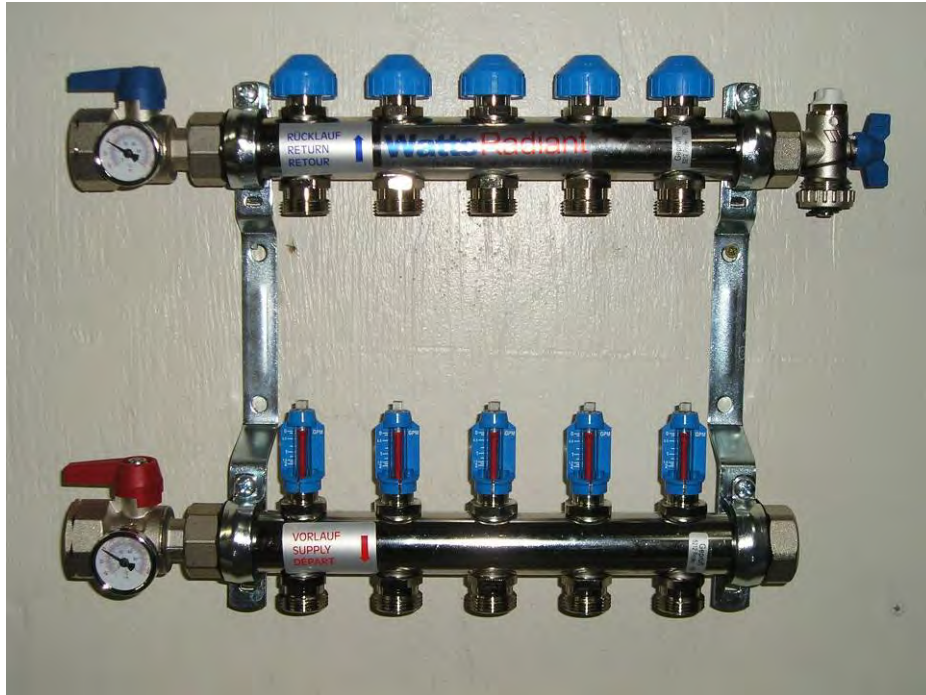
Figure 54. Watts manifold with flow meters and balancing valves at each tap

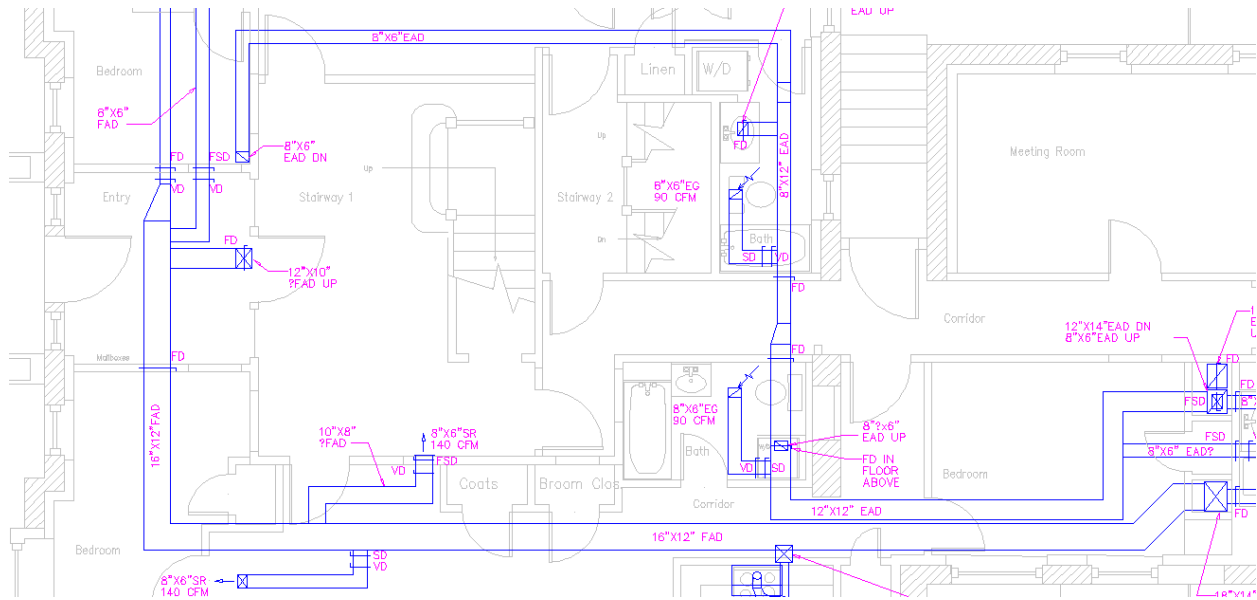
Figure 57. Existing ventilation design at Unit 4

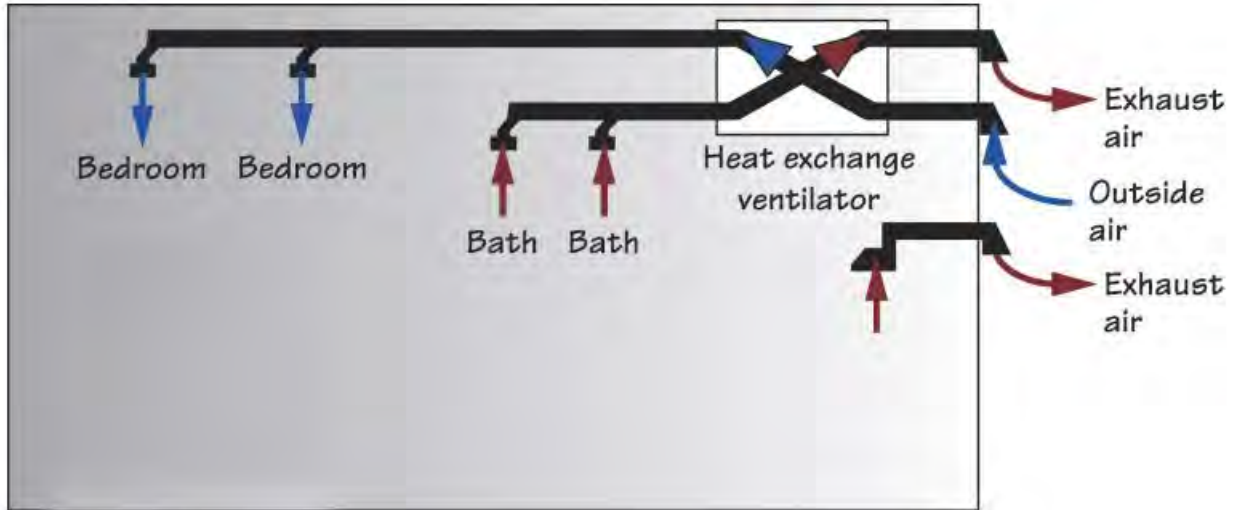
Figure 58. Ventilation strategy schematic

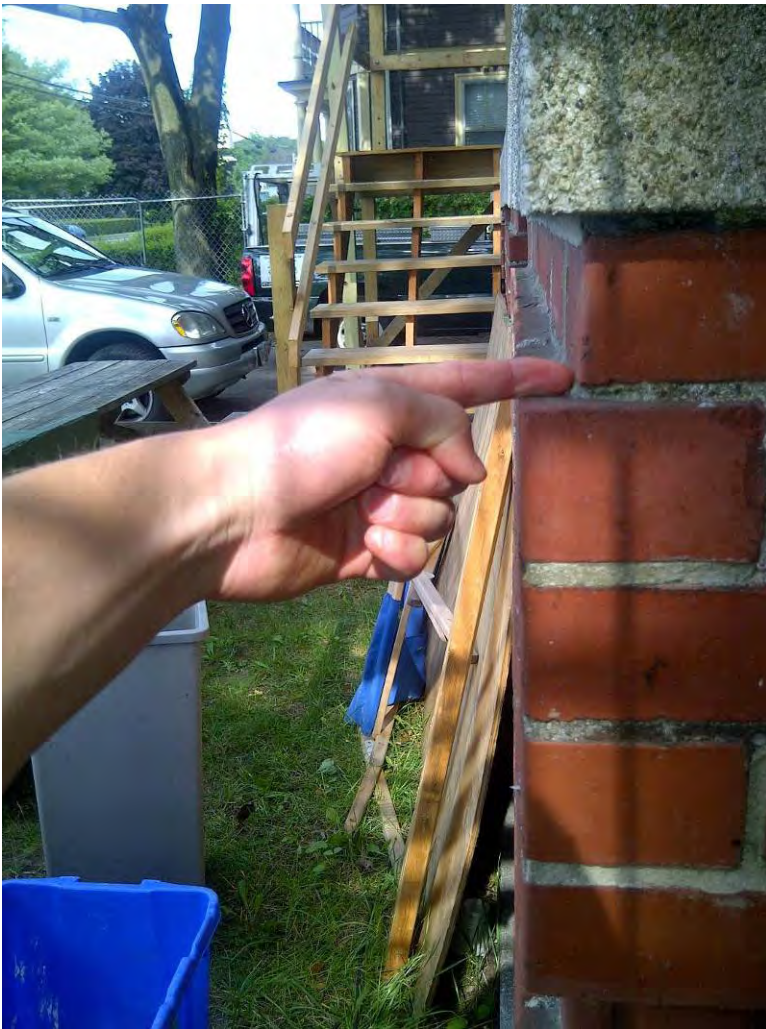
Figure 5: Original building – close up of brick courses

- Every fifth course of bricks is inset an inch.

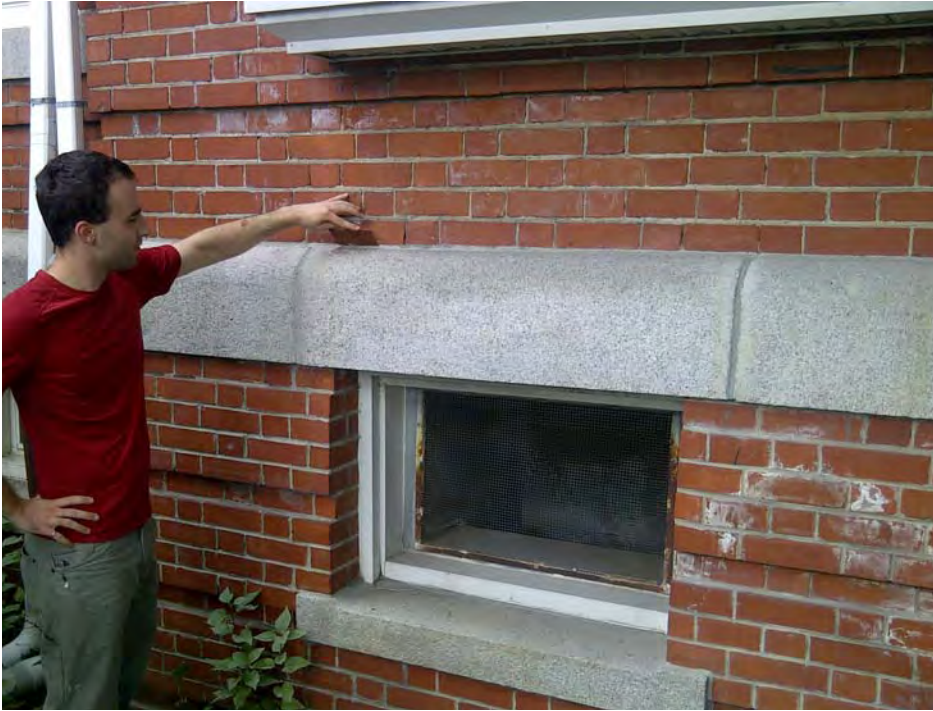
Figure 7: Original building: brickwork spalling and surface efflorescence

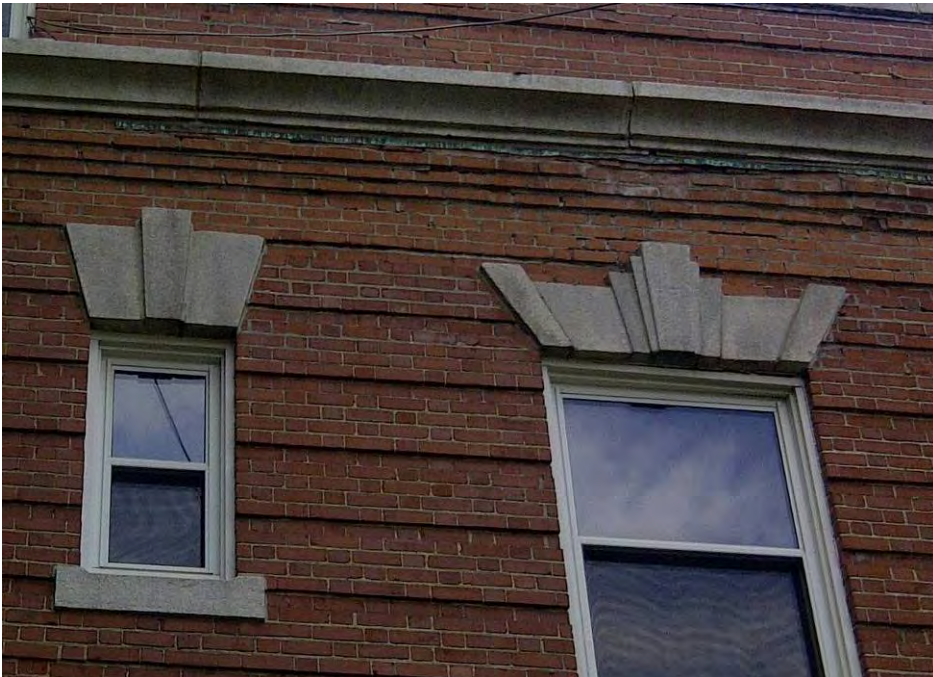
Figure 8: Original building: brickwork and mortar damage below belt course

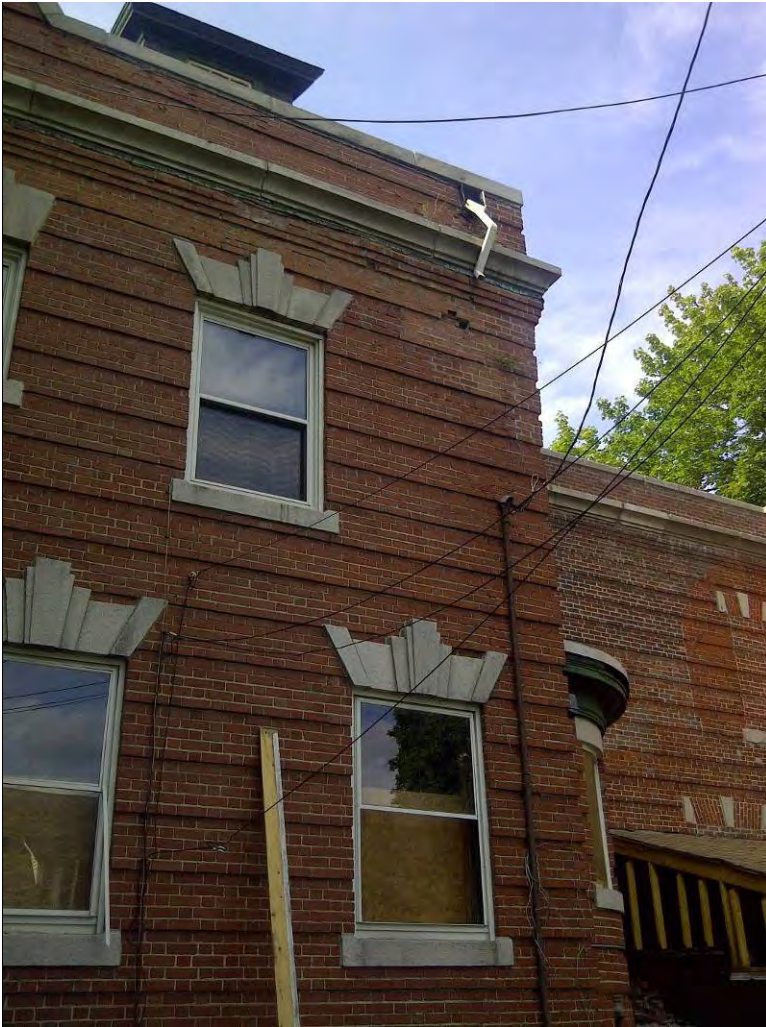
Figure 9: Original building – missing downspout

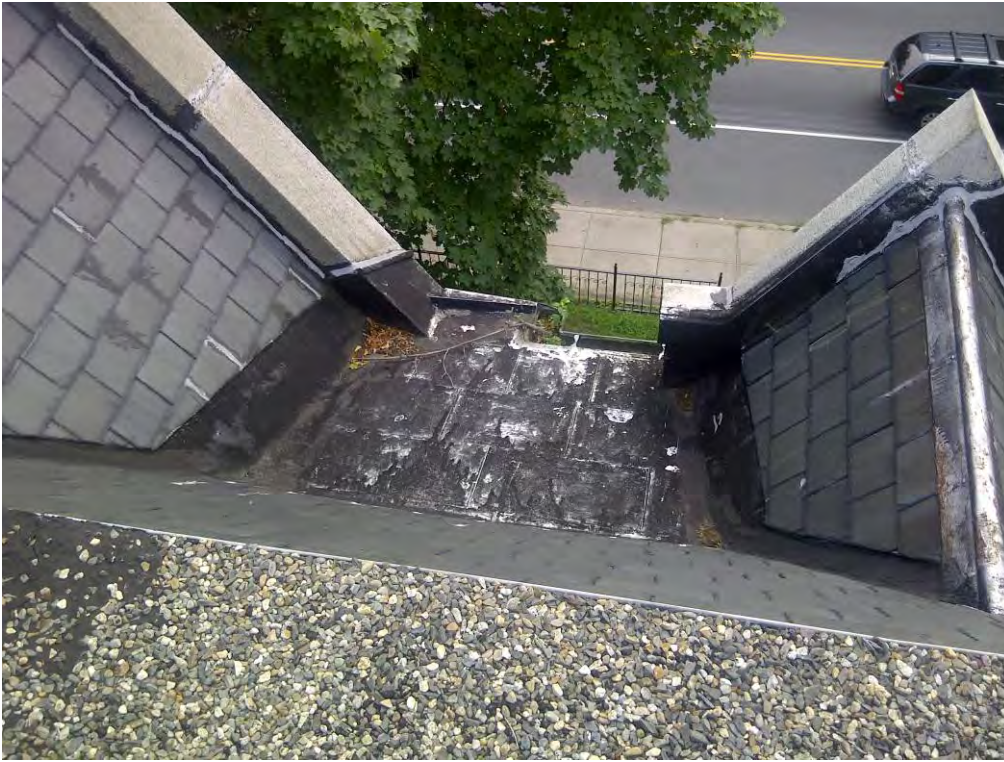
Figure 12: Roof drain filled with debris

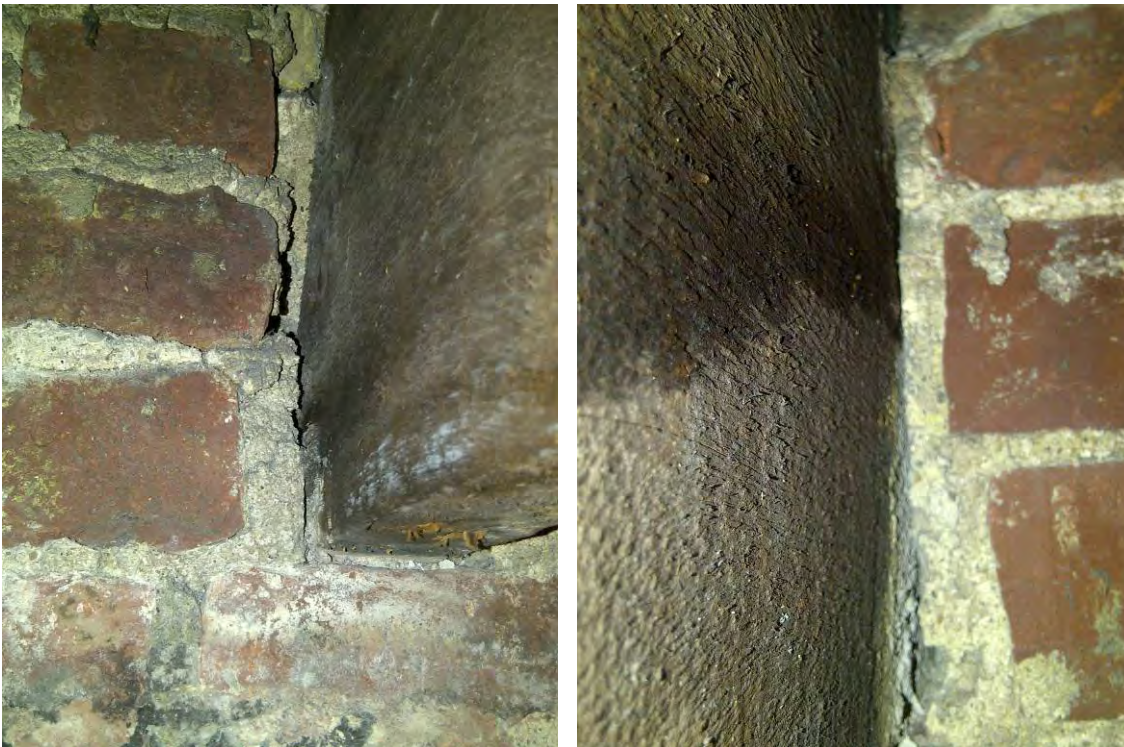
Figure 14: Original building - floor joist to masonry wall interface

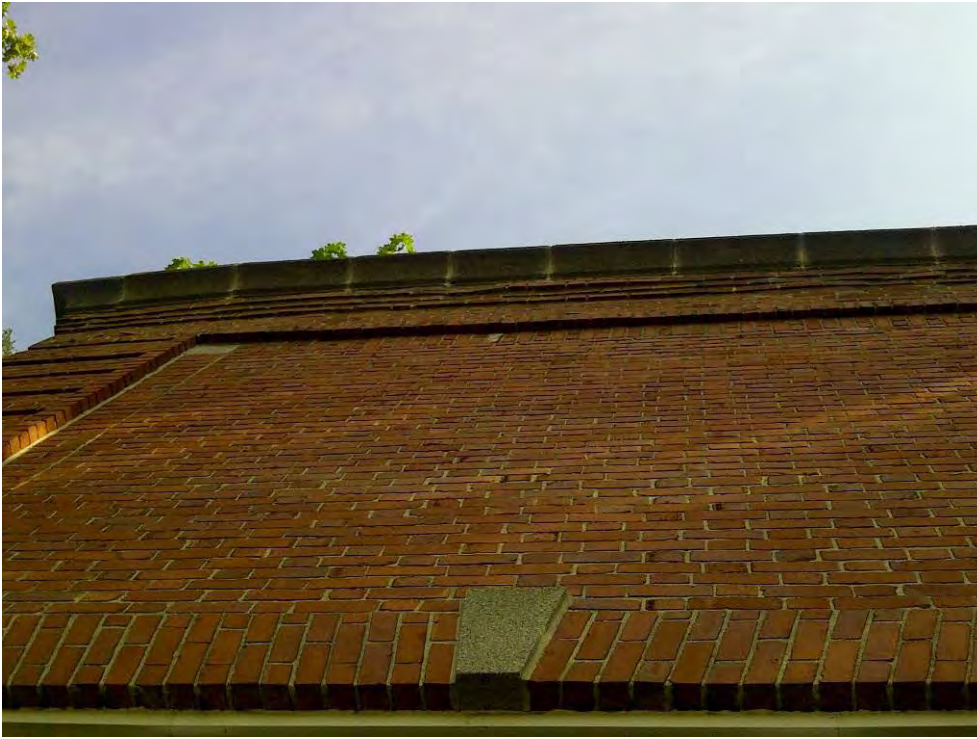
Figure 20: Bricks and belt course pushing out on north façade

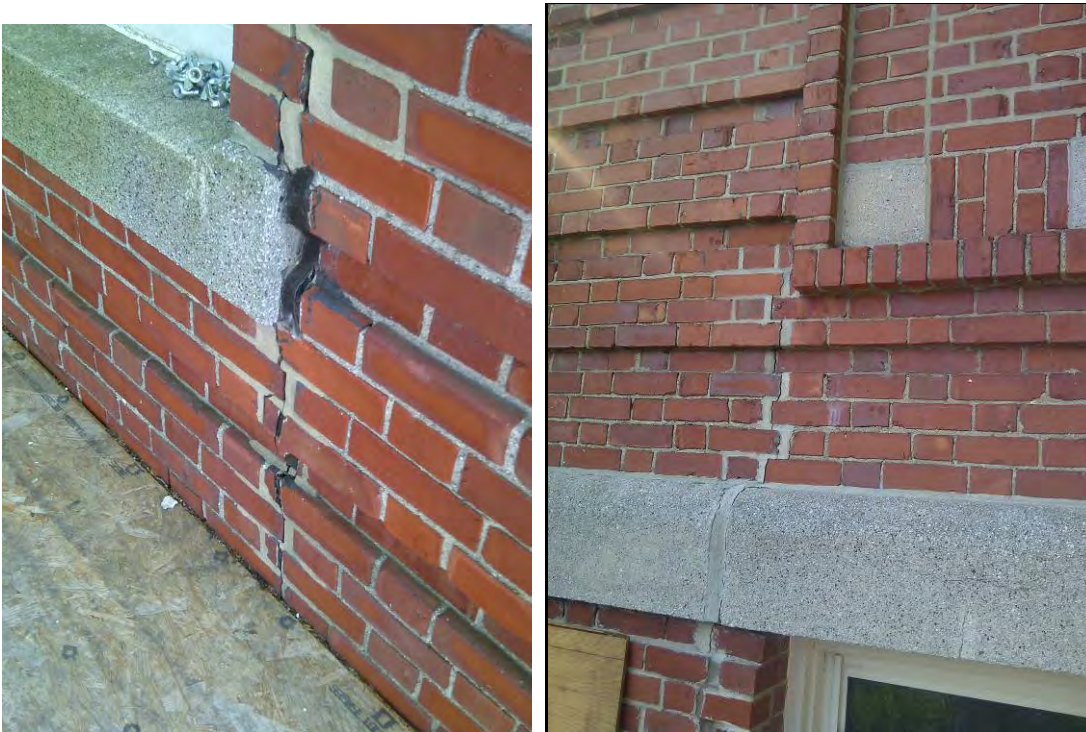
Figure 21: Addition: cracks in brickwork

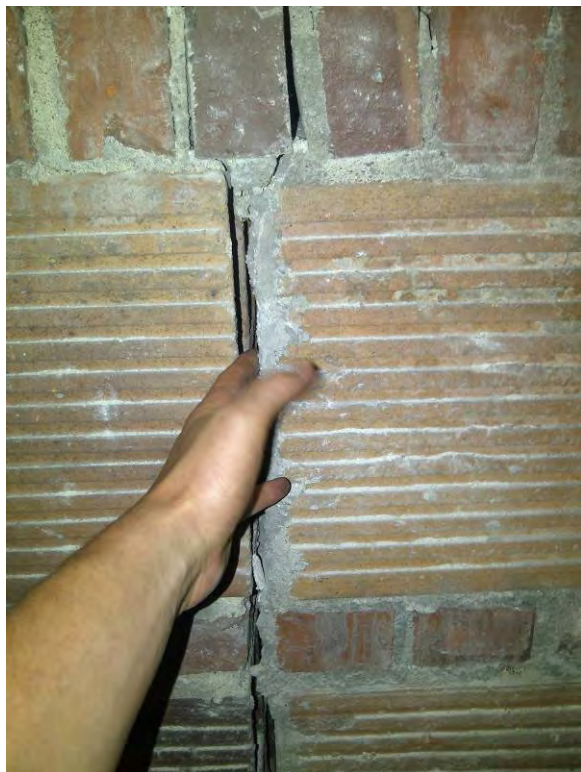
Figure 28: Addition – interior view of a crack in the masonry mass wall
