## Building America Case Study Whole-House Solutions for Existing Homes

# 56th and Walnut: A Philly Gut Rehab Development

Philadelphia, Pennsylvania

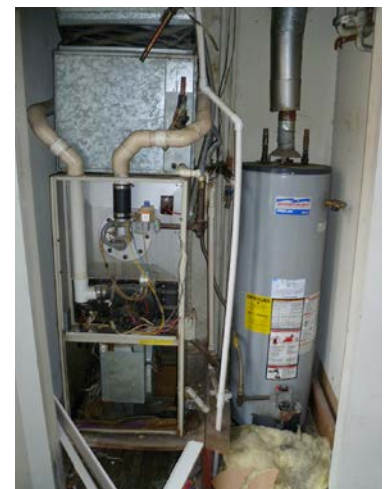
With a high amount of air leakage around the return plenum platform, there was the potential for the return to cause the mechanical closet to be depressurized and lead to back-drafting of the water heater due to return side duct leakage. All equipment was replaced with sealed combustion or direct vented units.

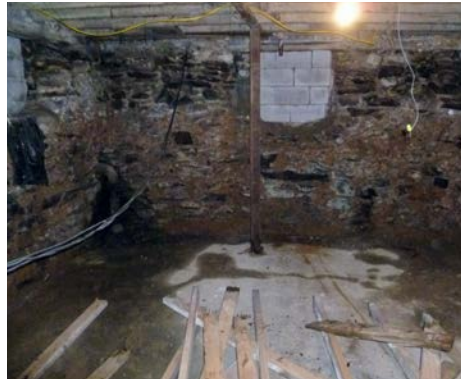
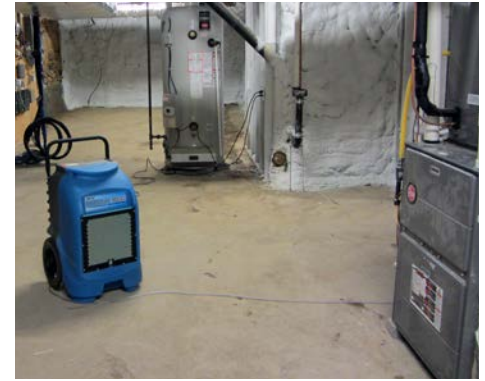
(Left) Pre-retrofit wet basement. (Right) Post-retrofit dry basement through the use of ccSPF against the stone foundation and a stand-alone dehumidifier. Ideally a sub-slab capillary break would be incorporated as well.

- With a non-damp-proofed stone foundation, no drainage layer or capillary break below the basement slab, and a high local water table, water entry and high relative humidity are systemic and chronic in these types of buildings. To button up a high-performance enclosure above a wet basement could lead to high interior moisture levels and all the associated problems. Therefore, it was imperative that the basement moisture problems be managed, if not eliminated, as part of the energy improvement package, and the costs of doing so were included in the overall cost of the retrofit.
