## Building America Case Study

# Stand-Off Furring in Deep Energy Retrofits

Syracuse, New York

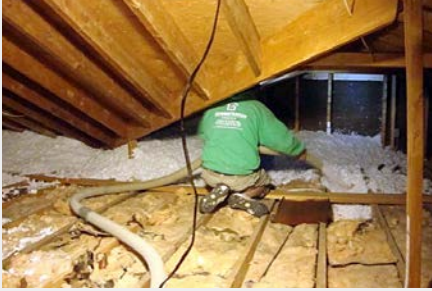
Contractors install blown insulation in the attic.

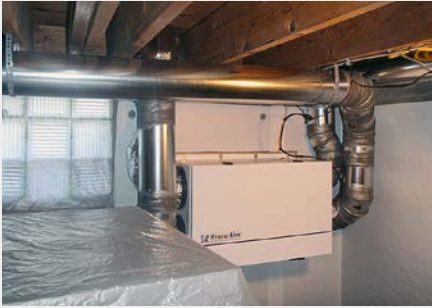
The team also installed a new energy recovery ventilator in the basement and used spray foam to insulate the rim band joists.

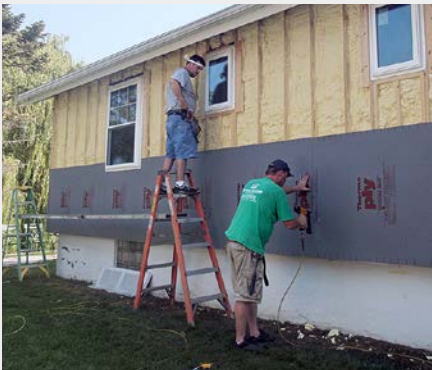
The framing is in place, spray foam is installed, and T-Ply is being installed. The next step is new siding.

- The new wall build-out can tend to be wavy due to the state of the existing siding. Contractors need to compensate for that during wall build-out.
- Bracket stability could be an issue. Instead of using only one bracket at the top and bottom of each 2 × 4, three brackets could be used to keep the 2 × 4 stable. Another option would be to use one bracket on the left of the 2 × 4 at the top and one on the right of the 2 × 4 at the bottom. Finally, “picture framing” the spray foam will help with the rigidity of the 2 × 4s and help keep them in place.
