Exterior Insulation Implications for Heating and Cooling Systems in Cold Climates

Anastasia Herk and Andrew Poerschke
IBACOS, Inc.

April 2015

On behalf of the U.S. Department of Energy's Building America Program

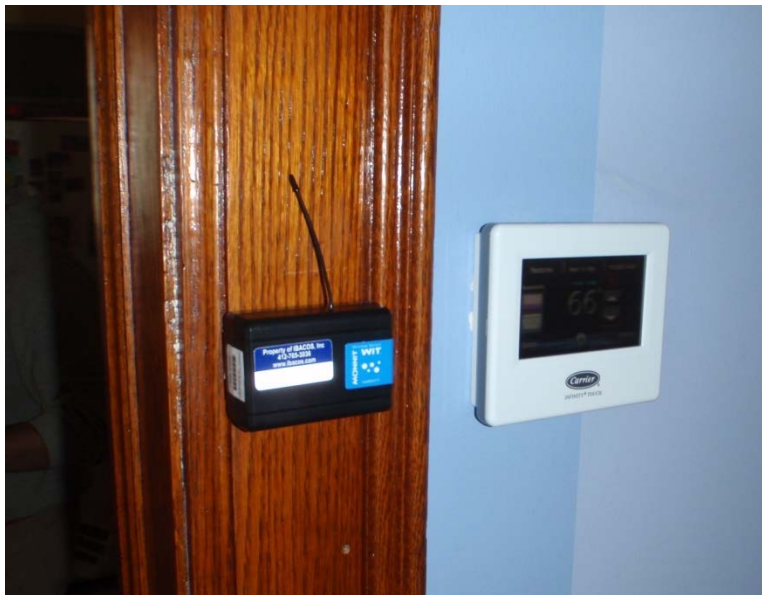
Figure 9. Wireless temperature and RH sensor at the thermostat in Test House 2

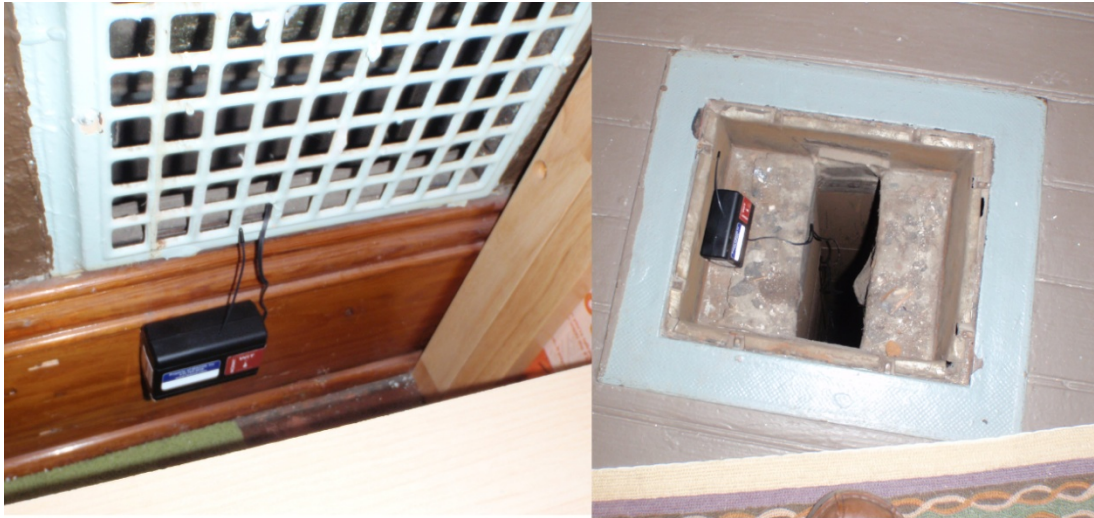
Figure 10. Temperature sensors at the register of the longest duct runs in Test House 2

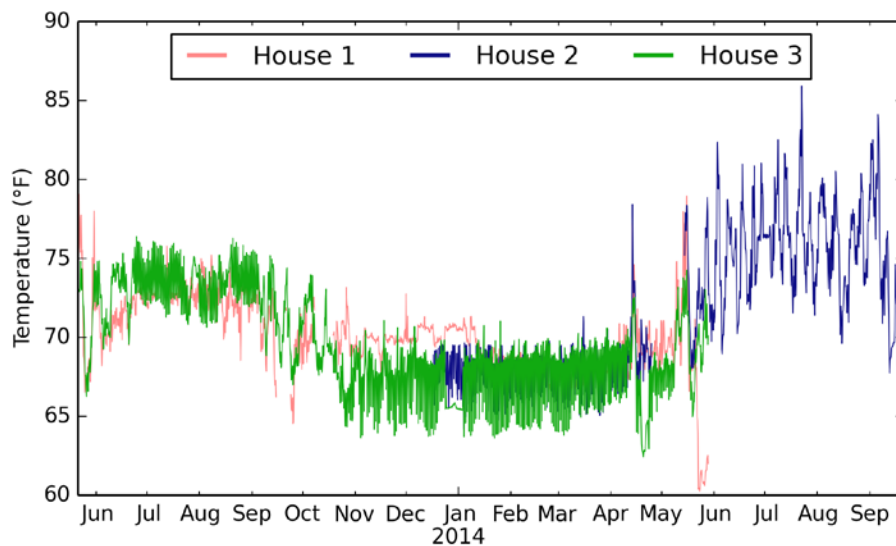
Figure 11. Thermostat temperature averaged every 6 hours for each test house

The single point of regular human interface with the HVAC system is the thermostat. To gain a baseline understanding of the operation and performance of the evaluated systems, the average temperature recorded at the thermostat was plotted for the duration of the study, as shown in Figure 11. To capture the detail of system setbacks but to filter individual system cycles, minute data were resampled to 6-hour averages. The average thermostat temperature was plotted as shown in Figure 11.

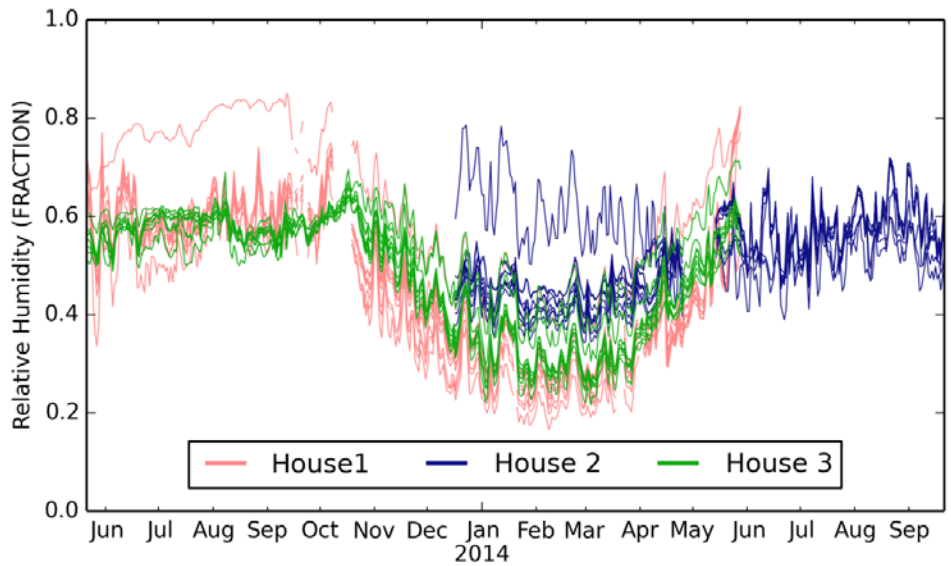
Figure 12. Conditioned space RH averaged every day for each test house

In the climate zone of the test houses (IECC climate zone 5), humidity control is not as problematic as it is in other climate zones. To determine if any significant humidity excursions warranted further analysis, all humidity values were plotted for each test house. The daily average humidity in each zone was plotted as shown in Figure 12, with all zones in each test house sharing one color. This graphic shows a few excursions above 60% RH; however, these were relatively brief. The basements in Test House 1 and Test House 2 show elevated levels of humidity.

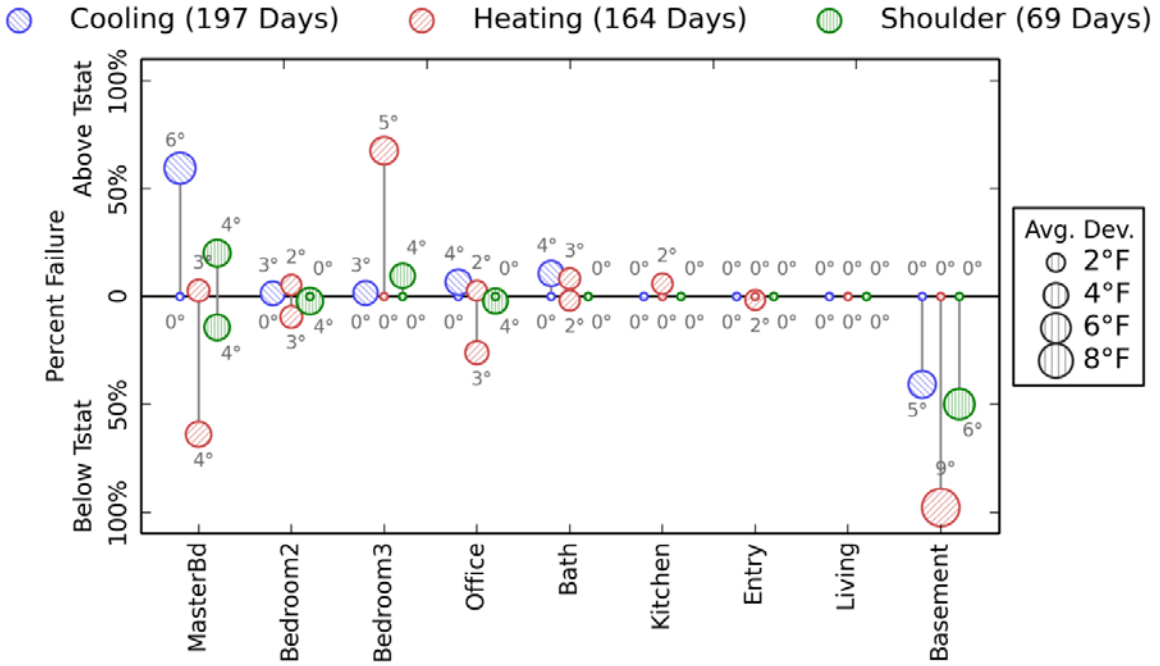
Figure 13. House 1: Room-to-thermostat temperature variability

In Figure 13 through Figure 15, several pieces of information are encoded for each test house. The most important number is the percentage of time a room is outside the comfort band as defined by ACCA Manual RS ($\pm 2^{\circ}\text{F}$ in heating mode and $\pm 3^{\circ}\text{F}$ in cooling mode) (Rutkowski 1997). The positive Y-axis represents the percentage of time the room was above the comfort band; the negative Y-axis represents the percentage of time the room was below the comfort band. Days were broken down into heating mode, cooling mode, and shoulder days when the air handler did not operate. The number of days fitting into each category is listed beside the mode. The total number of days in each category was calculated based on actual system operation. As a result, the number of days varied among test cases.

For each test house, the area of each room’s set of circles is scaled according to the average magnitude of failures, and a label specifies the numeric value of the average deviation during failure. The color of the dot and the direction of the hatch lines indicate whether the system was in cooling mode, heating mode, or shoulder days with no system operation.

Test House 1 had significant excursions in the third-floor master bedroom, which are evident in Figure 13. These excursions occurred during both heating and cooling modes. The master bedroom was underheated during winter and undercooled during summer. The most significant cause of this problem is the insufficient CFM of air supplied to the room. As specified in Table 8, the bedroom should have received 119 CFM during heating but received only 65 CFM; it should have received 114 CFM during cooling but received only 40 CFM. Low airflow, coupled with the fact that this room is the most removed from the rest of the house, resulted in many extended periods of temperature measured beyond the comfort zones. Bedroom 3 showed frequent overheating during the winter. During the installation of monitoring equipment, the team noted a portable space heater in this room, which may have been the cause.

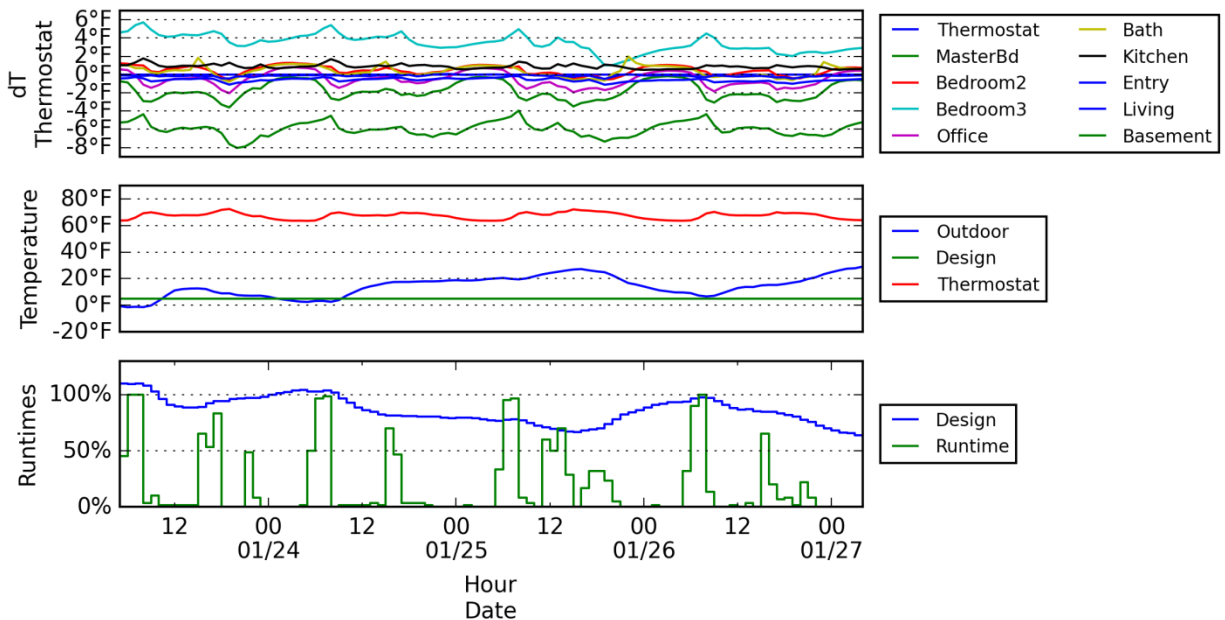
Figure 17. Test House 1: Operation during peak winter conditions

To dig deeper, the team plotted temperature and system operation data during peak load conditions for each test house. These data are shown in Figure 16 through Figure 21. Three consecutive days were selected, which contained the top and bottom five outdoor temperature percentiles for hot and cold days, respectively. Each graphic contains several subplots: the temperature difference between each room and the thermostat, the outdoor temperature, the thermostat temperature, the design temperature, and finally the percentage runtime and outdoor temperature as a percentage of design temperature. The team calculated the outdoor temperature as a percentage of design temperature by dividing the instantaneous indoor-to-outdoor temperature difference by the design indoor-to-outdoor temperature difference. Temperatures are represented as hourly averages of minute data, plotted with linear interpolation; percentages are

represented as stepped hourly averages. This graphic allows direct comparison between the outdoor temperature and system runtime and the effect of system runtime on room-to-room temperature differentials. A system designed to perfectly match the load should run 100% of the time when the outdoor temperature is 100% design conditions. In Figure 16 through Figure 21, the “design” label is the outdoor temperature as a percentage of design.

None of the test houses had appropriately sized HVAC systems based on ACCA Manual J recommendations (Rutkowski 2006). This is apparent in the runtime calculations presented in Figure 16 through Figure 21. Test House 1 had regular thermostat setbacks; considering this, the only time the system ran 100% of an hour was during a return from setback. Otherwise, the system typically ran less than 50% of the time in heating and cooling modes. The data presented in Figure 18 from Test House 2 contained a period of two peak cooling days with no apparent modifications to the thermostat setting. During excursions of 150% of the design temperature, the system ran 50% of an hour. This runtime aligns well with the design capacity being only 36% of the installed capacity. The installed capacity of the systems in Test House 3 was closest to the design capacity. Figure 20 and Figure 21 do not show a user-controlled thermostat setback. Through the peak summer conditions, the system runtime in Test House 3 was typically 50% to 60% of an hour. Similar runtime was seen during peak winter conditions.

setback. Humidity control is not a primary concern in the test climate; however, for energy retrofit projects in other climates, correct cooling sizing is critical to provide adequate dehumidification. Through the winter peak conditions, system operation peaked only during return from thermostat setback, again indicating the system was oversized.

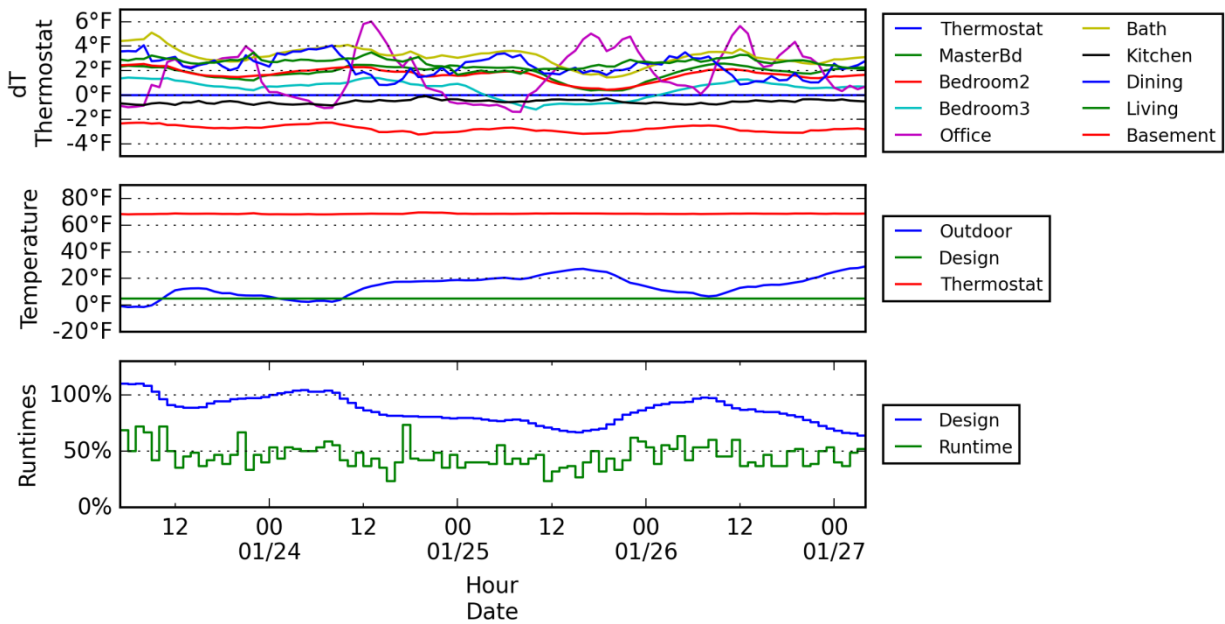
Figure 21. Test House 3: Operation during peak winter conditions

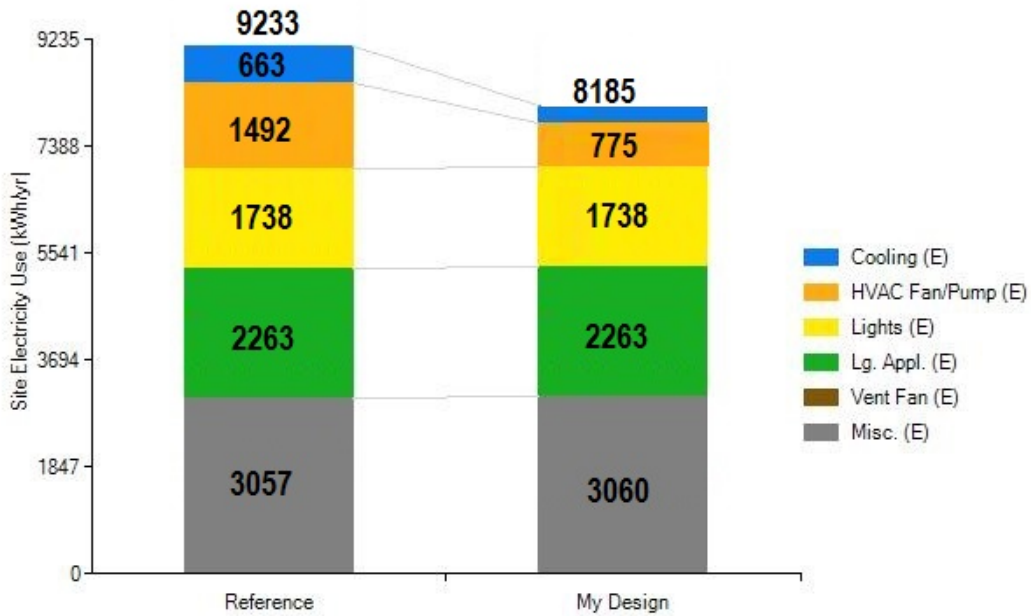
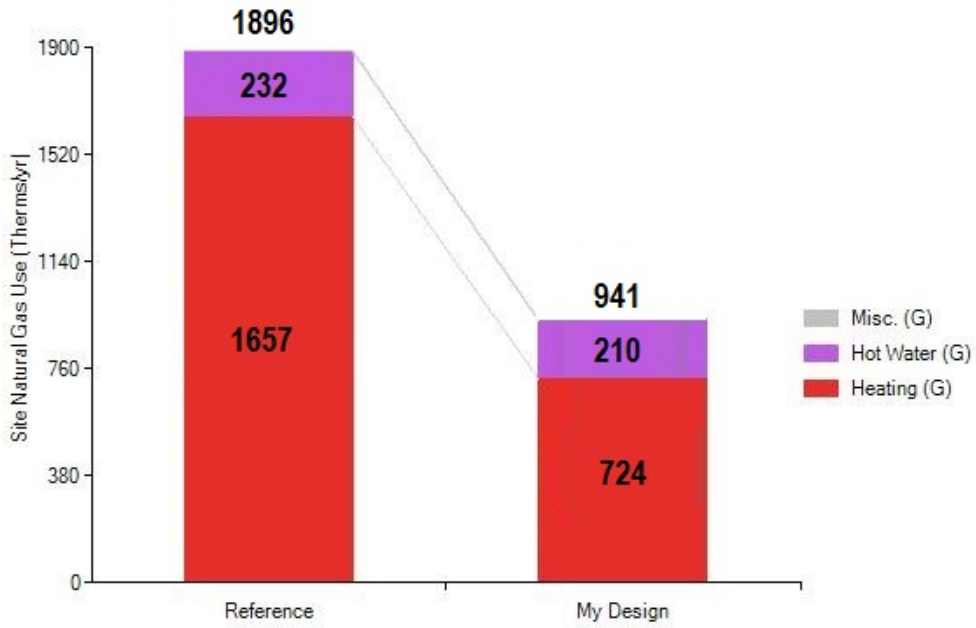
Figure 28. Test House 3: Electricity

Figure 29. Test House 3: Natural gas

Figure 30. Test House 3: Source energy

The following charts show the information that was input into the BEopt models for each of the three test houses. The graphs in Figure 22 through Figure 33 show the differences between the pre- and post-retrofit models.
