Using Retrofit Nail Base Panels to Expand the Market for Wall Upgrades

M. Del Bianco and J. Wiehagen
Partnership for Home Innovation

February 2016

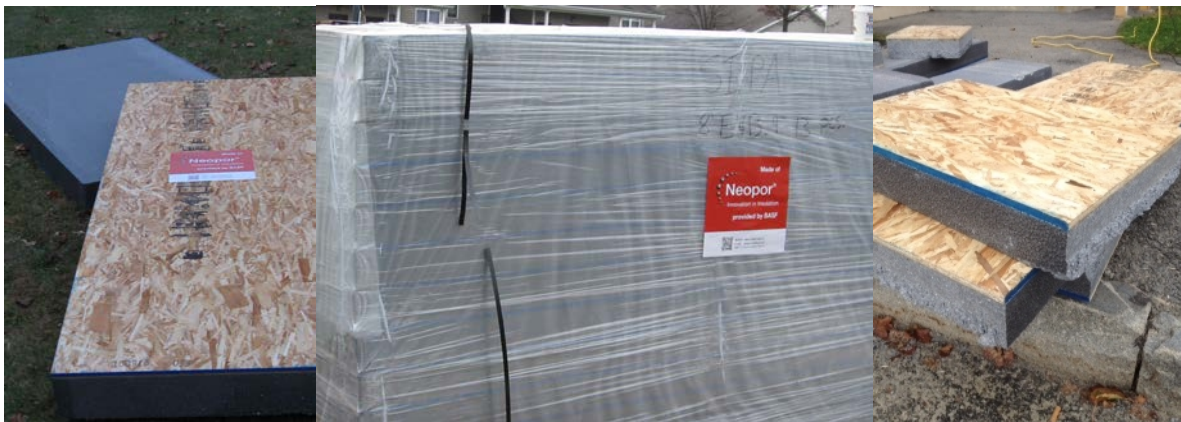
Figure 1. Retrofit insulated panels

The U.S. Department of Energy Building America research team Partnership for Home Innovation (PHI) undertook an investigation into the cost and constructability of a single product, a retrofit insulated panel, also called a *nail base*, to support overall research goals to sustain the increased thermal performance of walls in existing buildings and as the first step in a deep energy retrofit (DER) project sponsored by the New York State Energy Research and Development Authority (NYSERDA) (Figure 1). The panel component is a scalable wall insulation product formed by structural insulated panel (SIP) manufacturers that consists of an expanded polystyrene (EPS) core with one face of 7/16-in. oriented strand board (OSB); these panels are available in customizable thicknesses of even increments from 4 to 12 in.

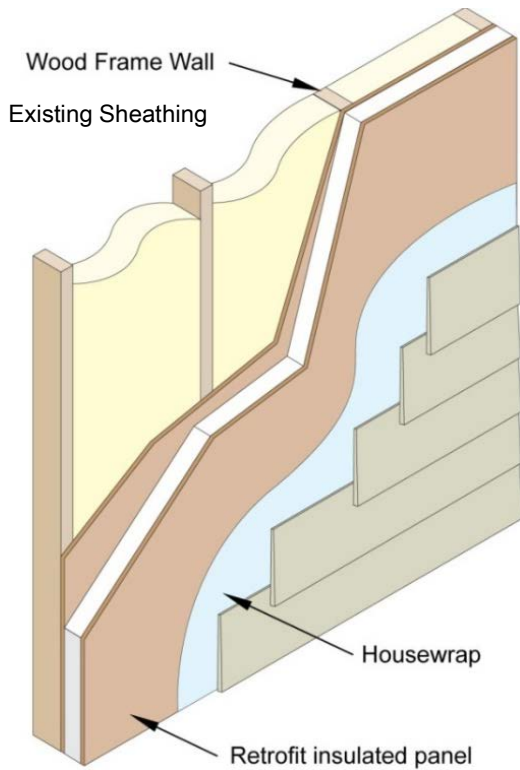
Figure 2. Layering of nail base panels and siding

Some excerpts from the guide include Figure 2, which indicates the sequence of attachment of retrofit panels, weather barrier, and cladding to the structure. Panels are sealed to each other with panel adhesive (mastic) or spray polyurethane foam. Panel edges at plane transitions, such as outside corners, are sealed with dimensional lumber and spray polyurethane foam (Figure 3). Retrofit panel layout typically begins at an inside corner because that is the hardest place to air seal. Panels at the bottom of the wall are placed on a ledger inset into the panel's foam that also acts as an insect guard (Figure 4).

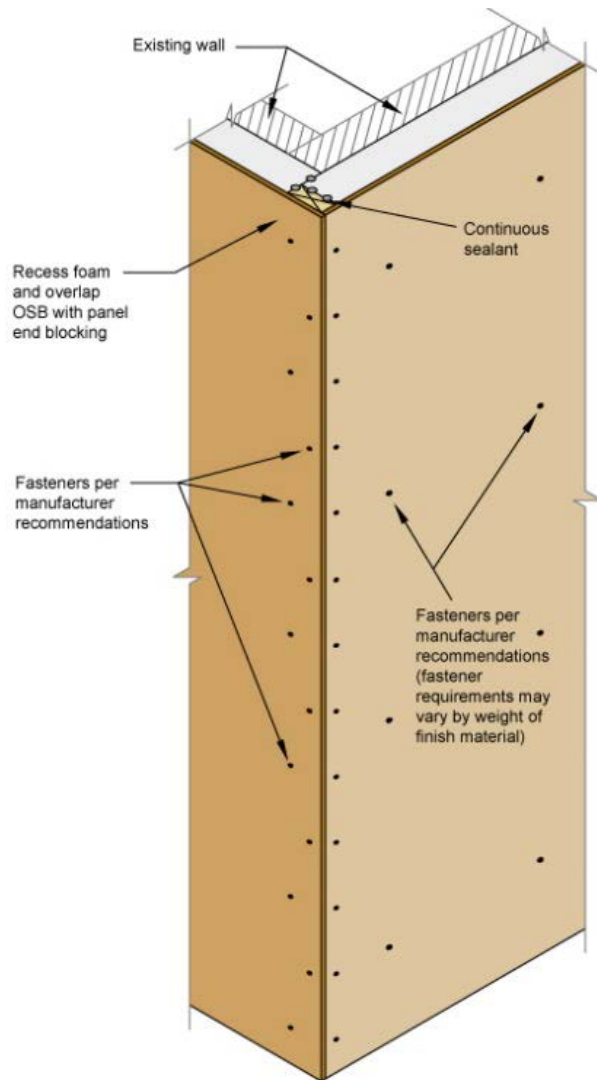
Figure 3. Outside corner detail

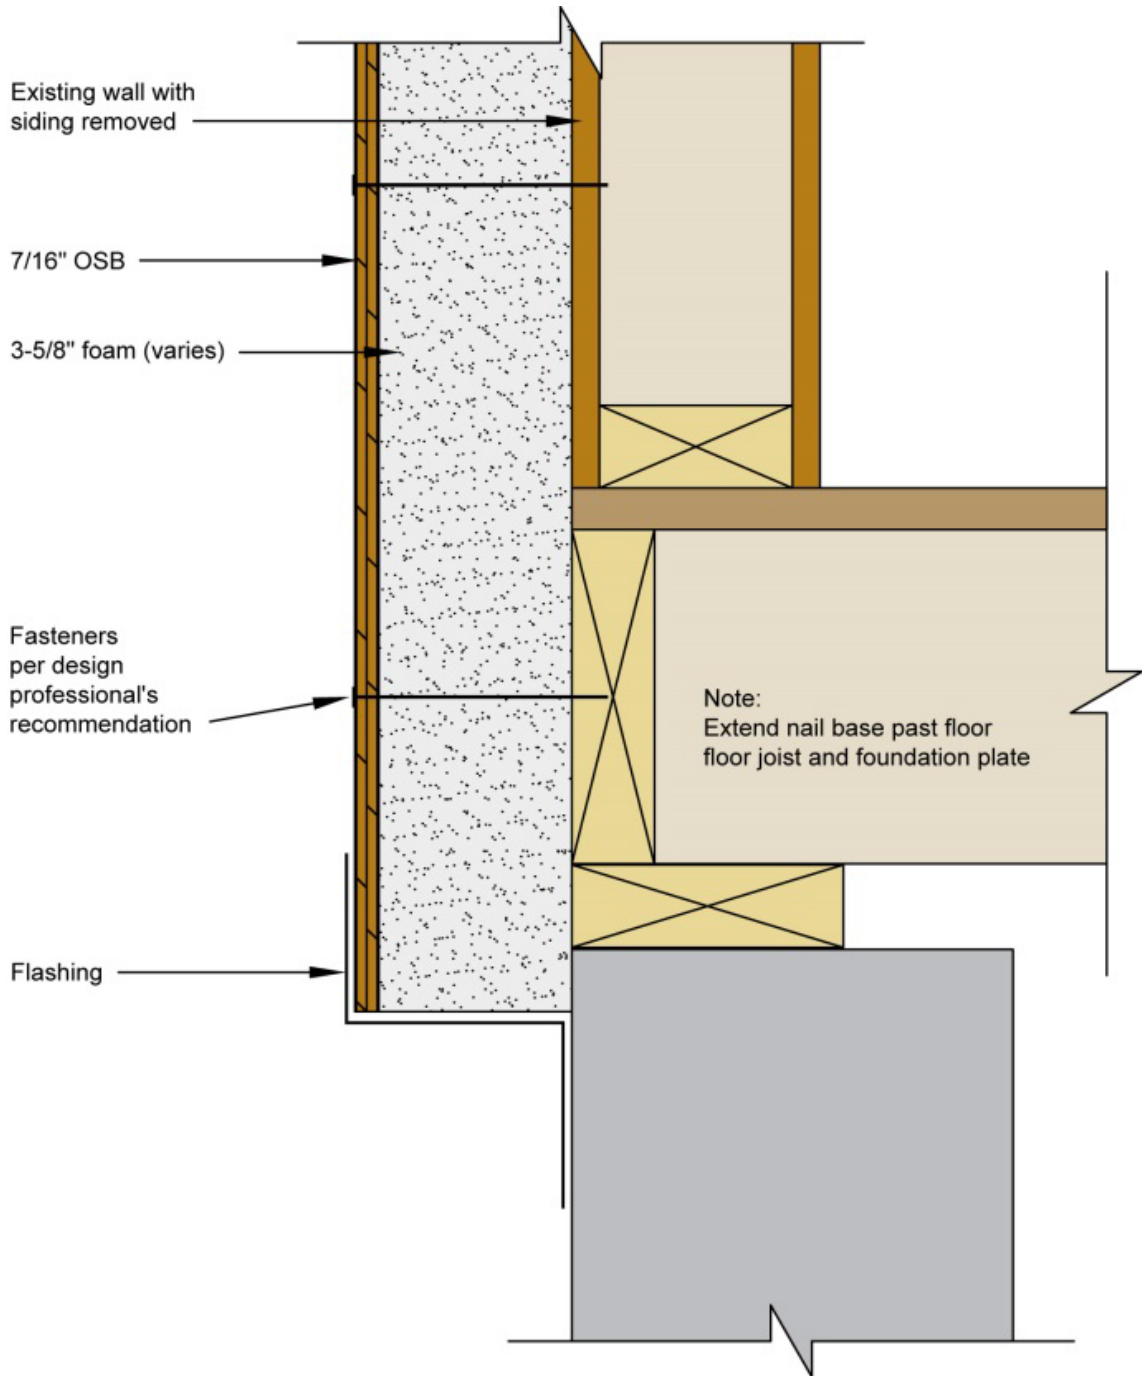
Figure 4. Foundation ledger for starting nail base panel installation

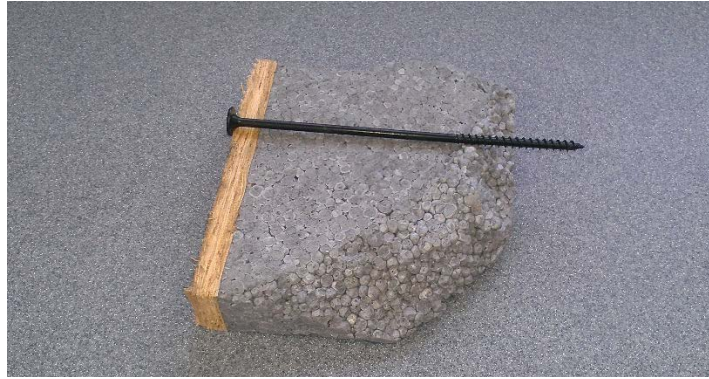
Figure 5. SIP screw and piece of 6-in. graphite-enhanced EPS nail base panel

Retrofit insulated panels are secured to the framing with long fasteners called *SIP screws* (Figure 5). This product was developed specifically for the remodeling market by SIP manufacturers.

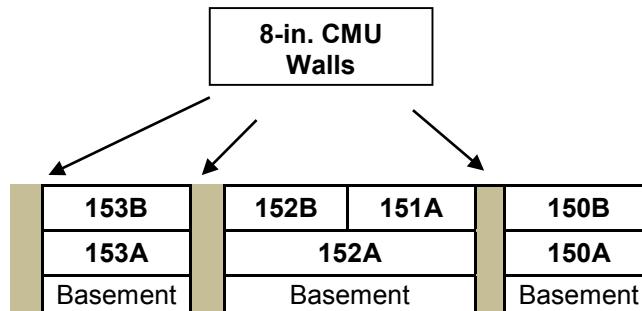
Figure 6. Unit layout and identification

The demonstration project was a two-story building with a 4-ft, in-ground basement in the front and a daylight basement in the rear in Climate Zone 5, Albany, New York. The seven-unit building consists of single-story units of two, three, or five bedrooms. Each has a kitchen, bath, and living area. Additional units, which had been located in the basements, were abandoned in a 1998 rehabilitation. The building is laid out as three row house/unit combinations separated by concrete masonry unit (CMU) walls. Two units stacked on each end and a single unit and two above comprise the middle section of the building. Figure 6 is a schematic of the layout of the seven units and the locations of the CMU walls. Figure 7 and Figure 8 are photographs of the building.

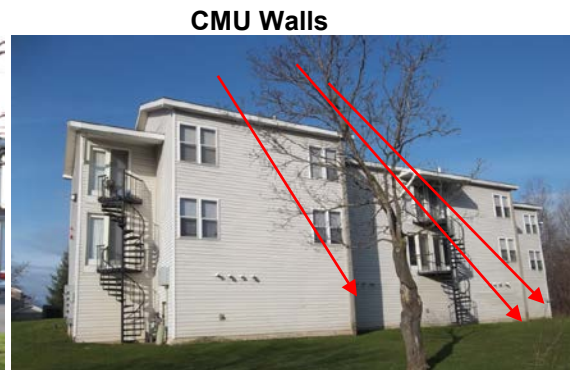
Figure 8. Building rear elevation, northeast

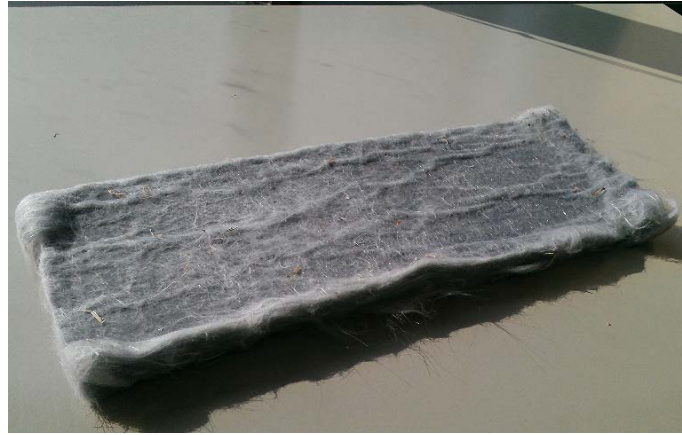
Figure 10. Aerogel insulation, 10 mm

One-piece rear stairways supported by a single pipe column welded to the landings and cast into concrete footings at grade precluded removal of the rear stairways to access band boards below the patio doors. The band board area below the doors and behind the stair landings could not be fitted with nail base panels because of insufficient clearance. To add insulation in these areas, band boards behind rear stair landings were first covered with 2/5-in. Spaceloft aerogel fabric for thermal and moisture resistance,⁵ then counterflashed with a custom-fabricated pan flashing of break metal that redirected the drainage plane to the surface of the nail base panel. The aerogel fabric provides thermal resistance of R-4.8 and is water and fire resistant (Figure 10). Figure 11 shows the completed rear entryway.

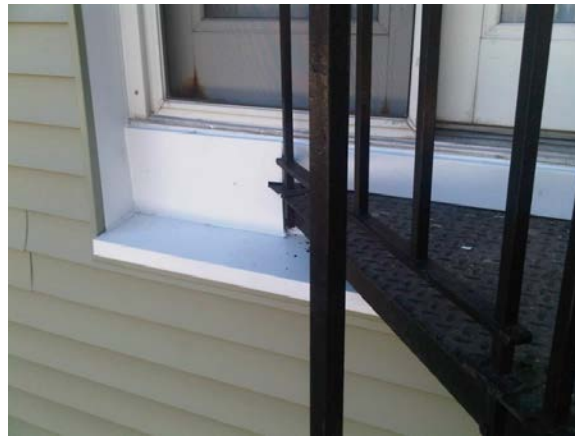
Figure 11. Completed rear entry at stair landing

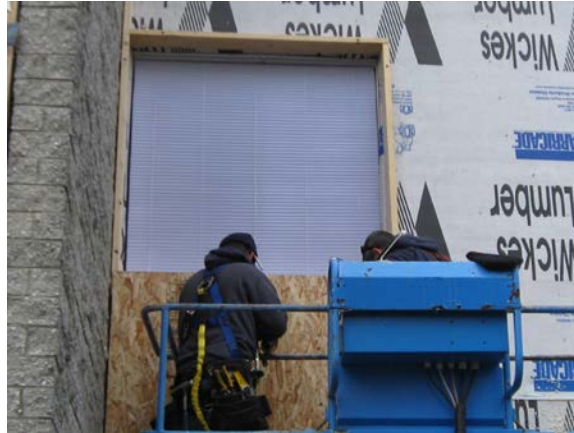
Figure 12. Framing installed around window opening

To simplify the drainage plane detail, windows were removed and reinstalled at the new exterior surface of the wall. Nail base panel thicknesses are sized for dimensional lumber inserts at panel edges; therefore, window frame extensions were fashioned with 2×4 or 2×6 dimensional lumber boxes set on edge against the wall framing and secured with SIP screws through the 1.5-in. edge of the board (Figure 12). The holes were predrilled and screws were fastened through the new window frame into the framing of the wall. A 1.5-in. recess was cut in the foam of the nail base panels adjacent to the window opening, and the OSB of the panel was set to overlap the new frame. The OSB was sealed and secured to the new window frame using the same method employed at building edges. Flashing and weather-resistant barrier were subsequently installed around the window by the same methods used in new construction (Figure 13 and Figure 14).

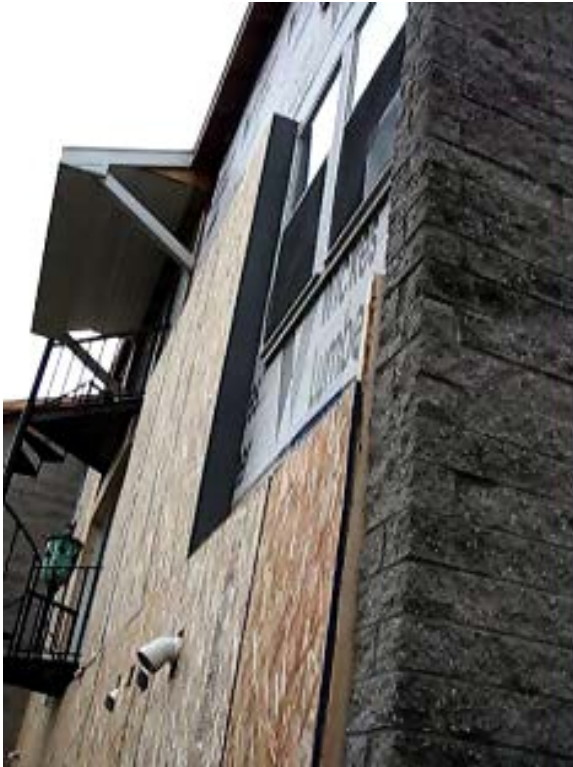
Figure 13. Rear windows prior to removal

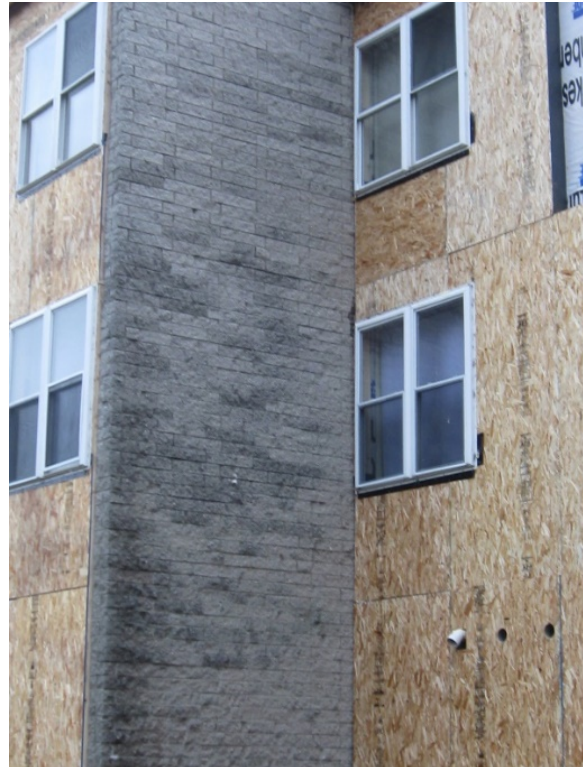
Figure 14. Rear windows after reinstallation

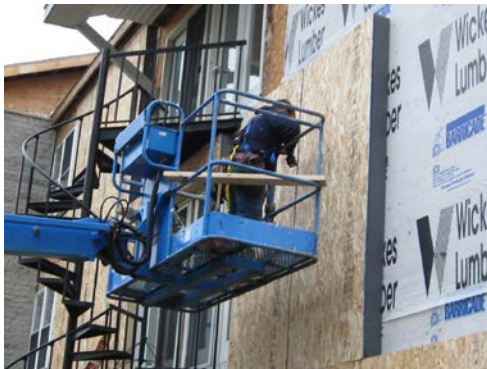
Figure 15. Installing a 6-in. retrofit panel

The house wrap was left in place in this project (Figure 15 and Figure 16). The house wrap helps protect the structure after the siding is removed and while the panels are being installed. Because most house wrap products are more vapor permeable than EPS foam insulation or OSB sheathing, the house wrap does not significantly change the moisture characteristics of the wall assembly. Leaving the house wrap in place is not required but it is the most cost-effective measure, partly because the product does not need to be disposed.

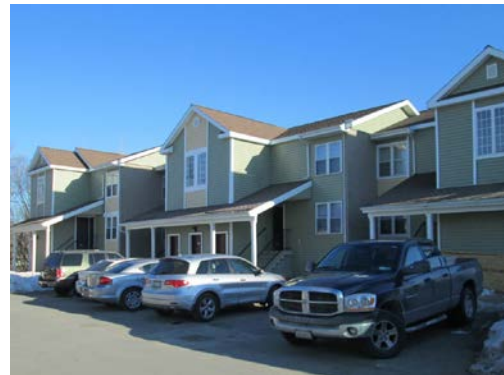
Figure 16. Building front after retrofit

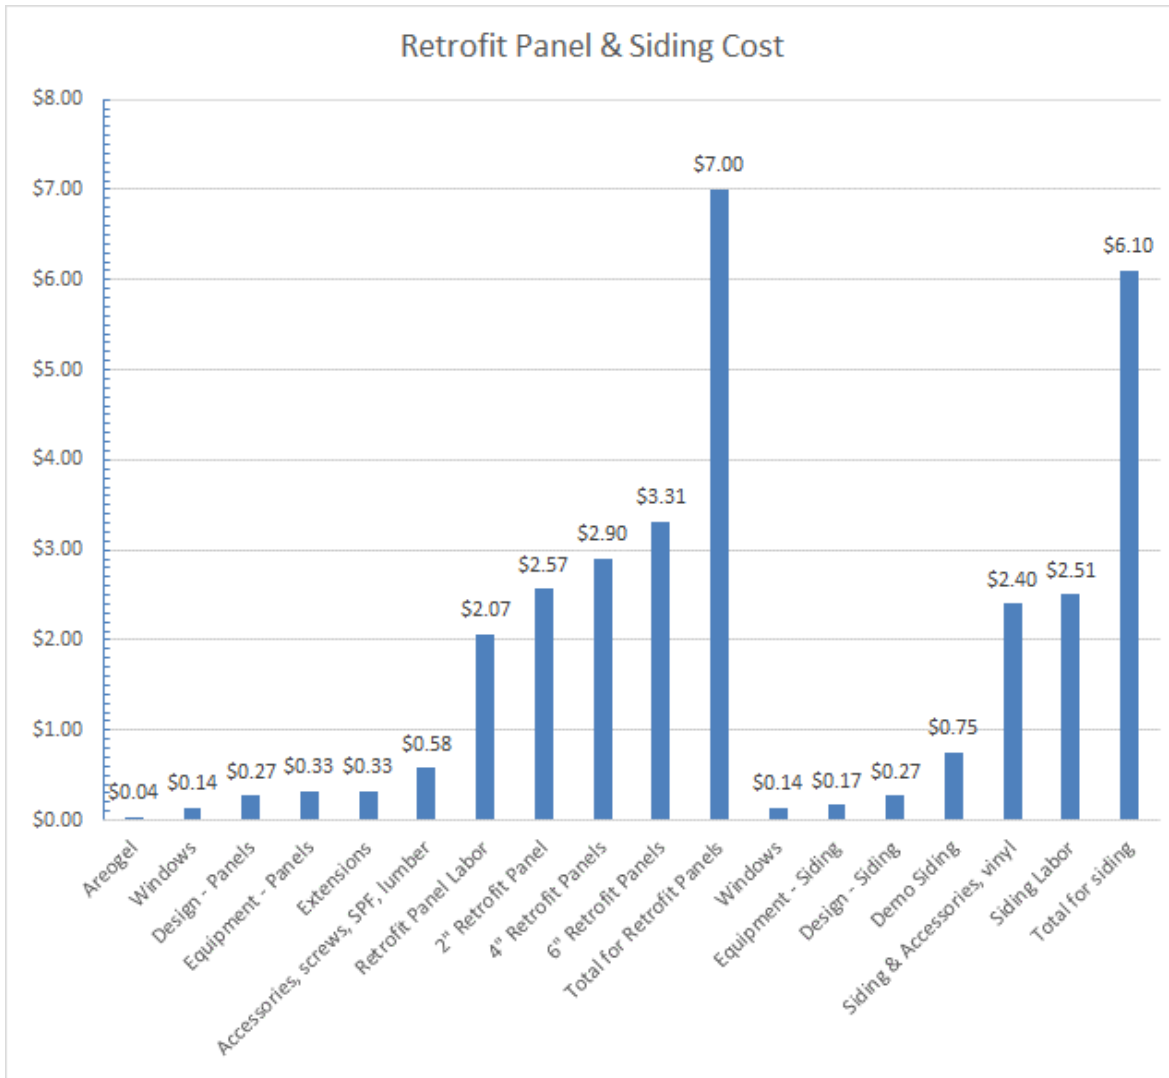
Figure 17. Comparison of costs for retrofit panels and costs associated with re-siding

A major goal of this project was to double the R-value of the walls for the same cost as re-siding the building. The result came within 15% of meeting that cost goal. The line item contribution of the project’s components to the total project cost is depicted in Figure 17.

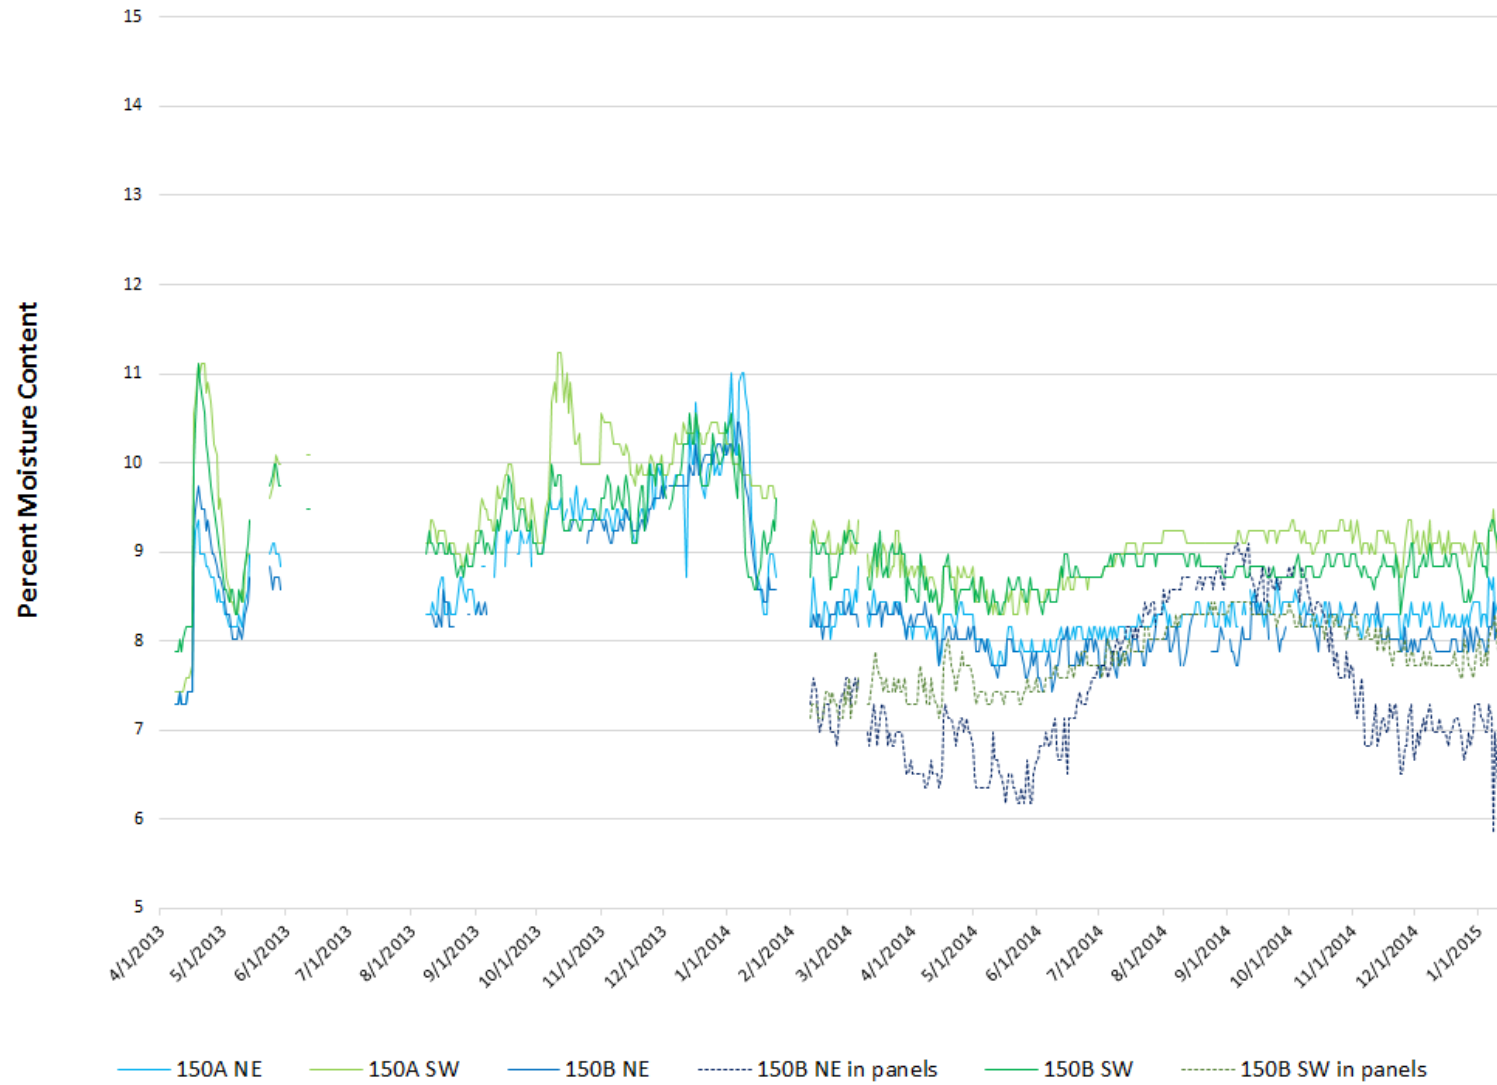
Figure 18. OSB moisture content—right section of building, units 150 basement, 150A, and 150B

A small but notable change occurred in the sheathing MC from before the retrofit panel installation to after. Before the retrofit, the MC readings generally ranged from approximately 9% to less than 15%, whereas after the retrofit, the MC readings ranged from around 6% to less than 10%. This result implies that no negative moisture effects are indicated with the addition of the retrofit panels.

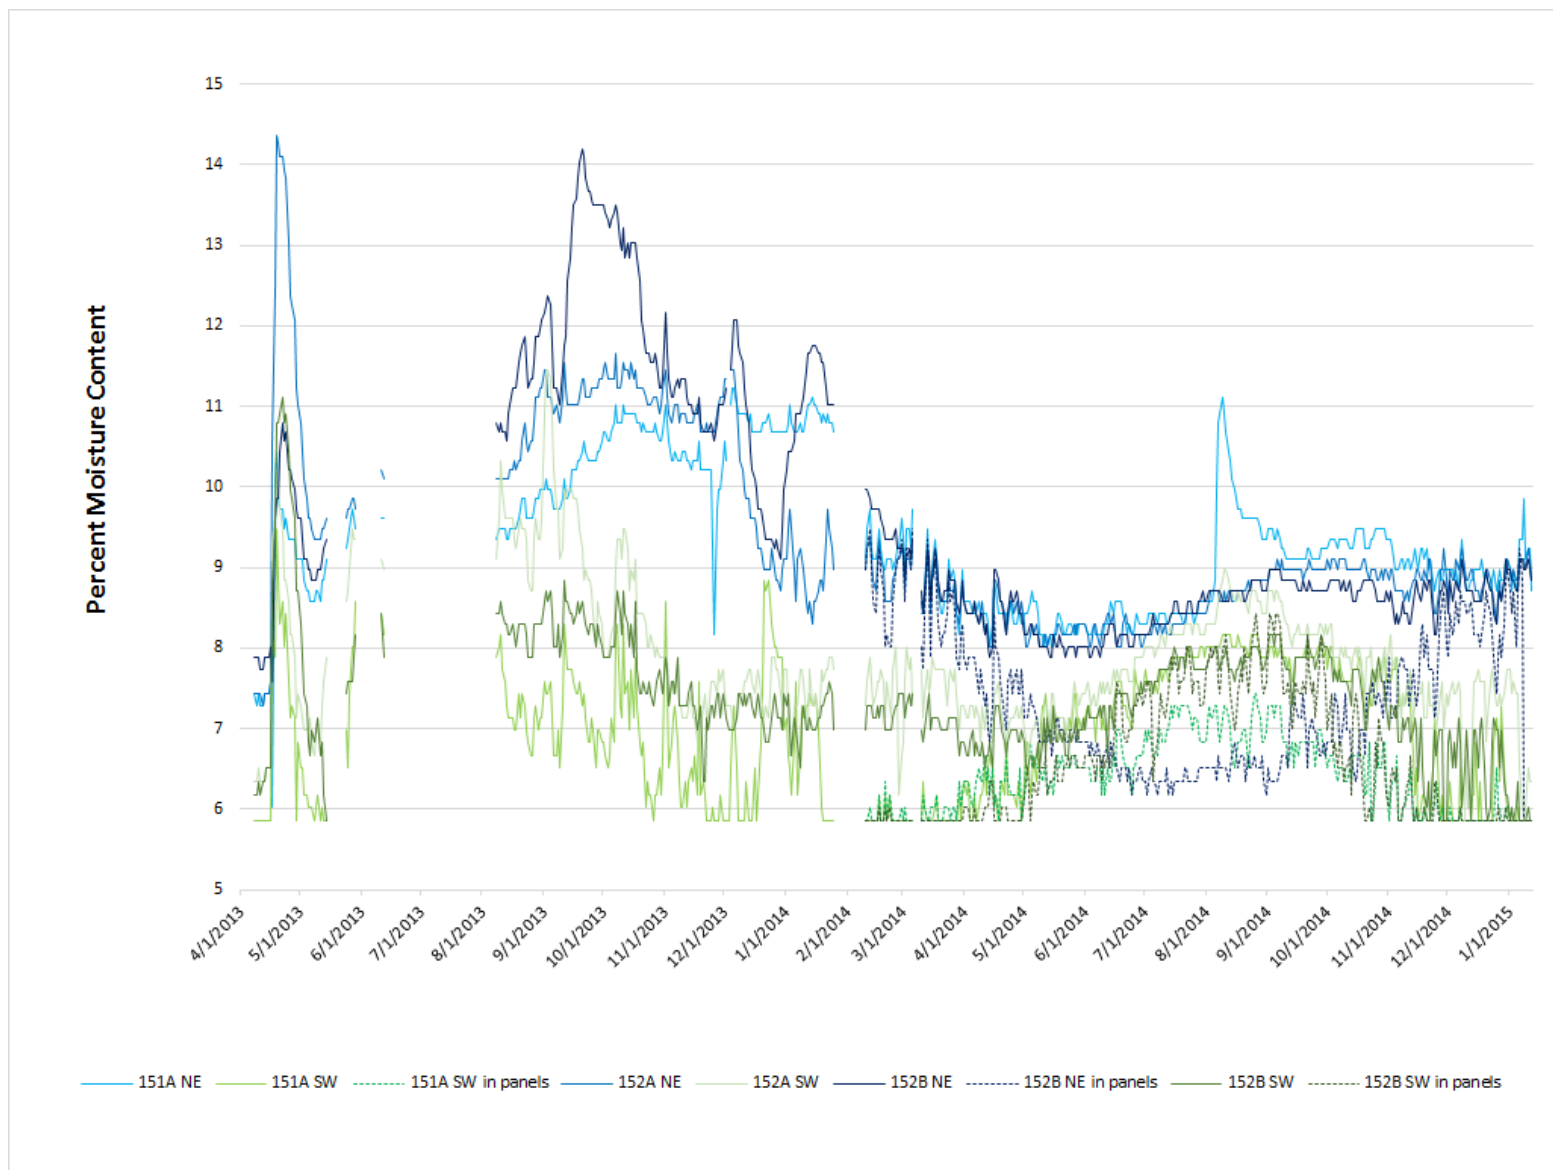
Figure 19. OSB moisture content—center section of building, units 152 basement, 152A, 152B, and 151A

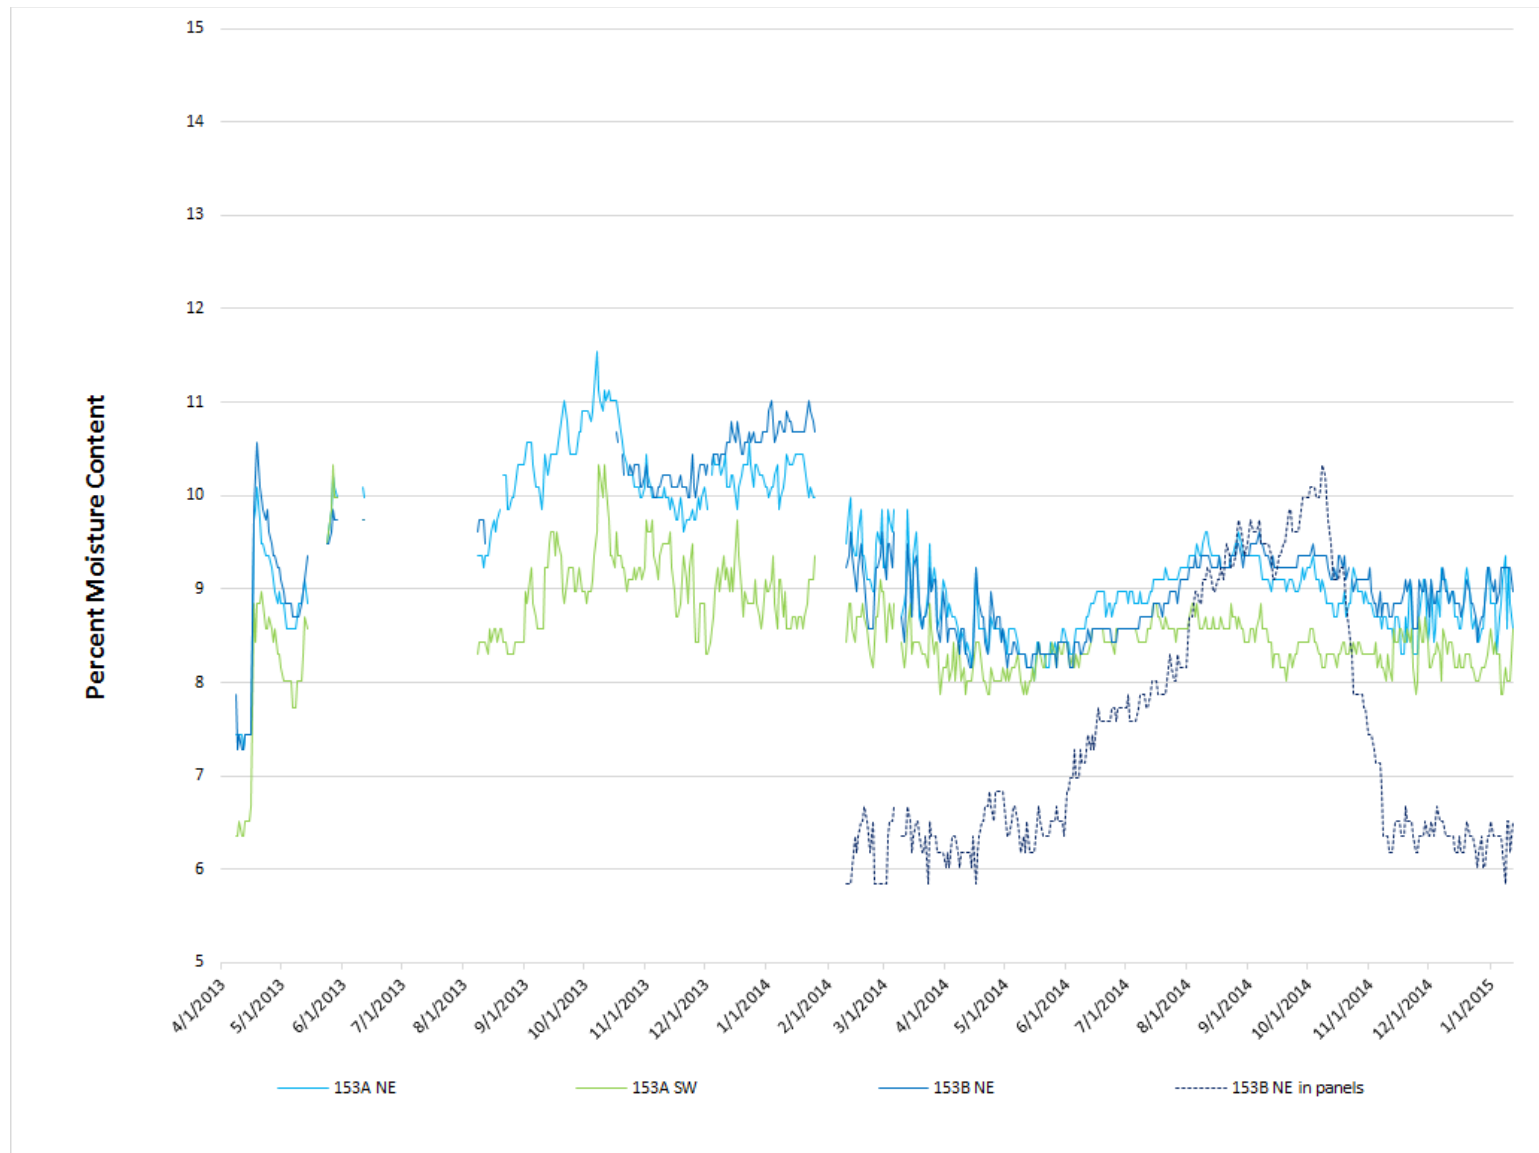
Figure 20. OSB moisture content—left section of building, units 153 basement, 153A, and 153B

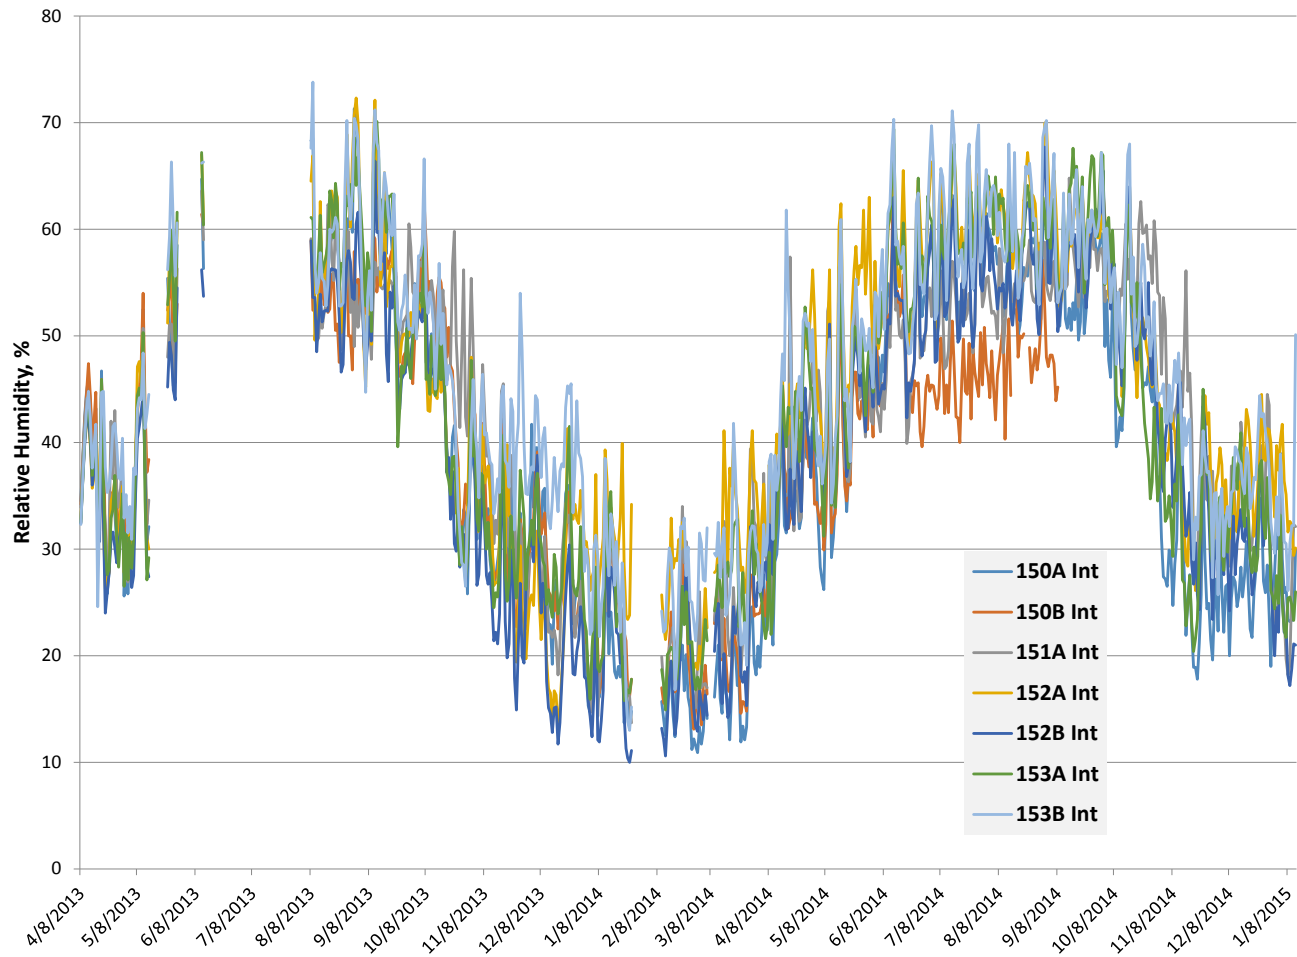
Figure 21. RH within the units

RH inside each unit generally remained lower than 40% during the heating season (Figure 21). ASHRAE (2015) indicates that an indoor RH range between 30% and 60% minimizes the indoor growth of allergenic or pathogenic organisms.

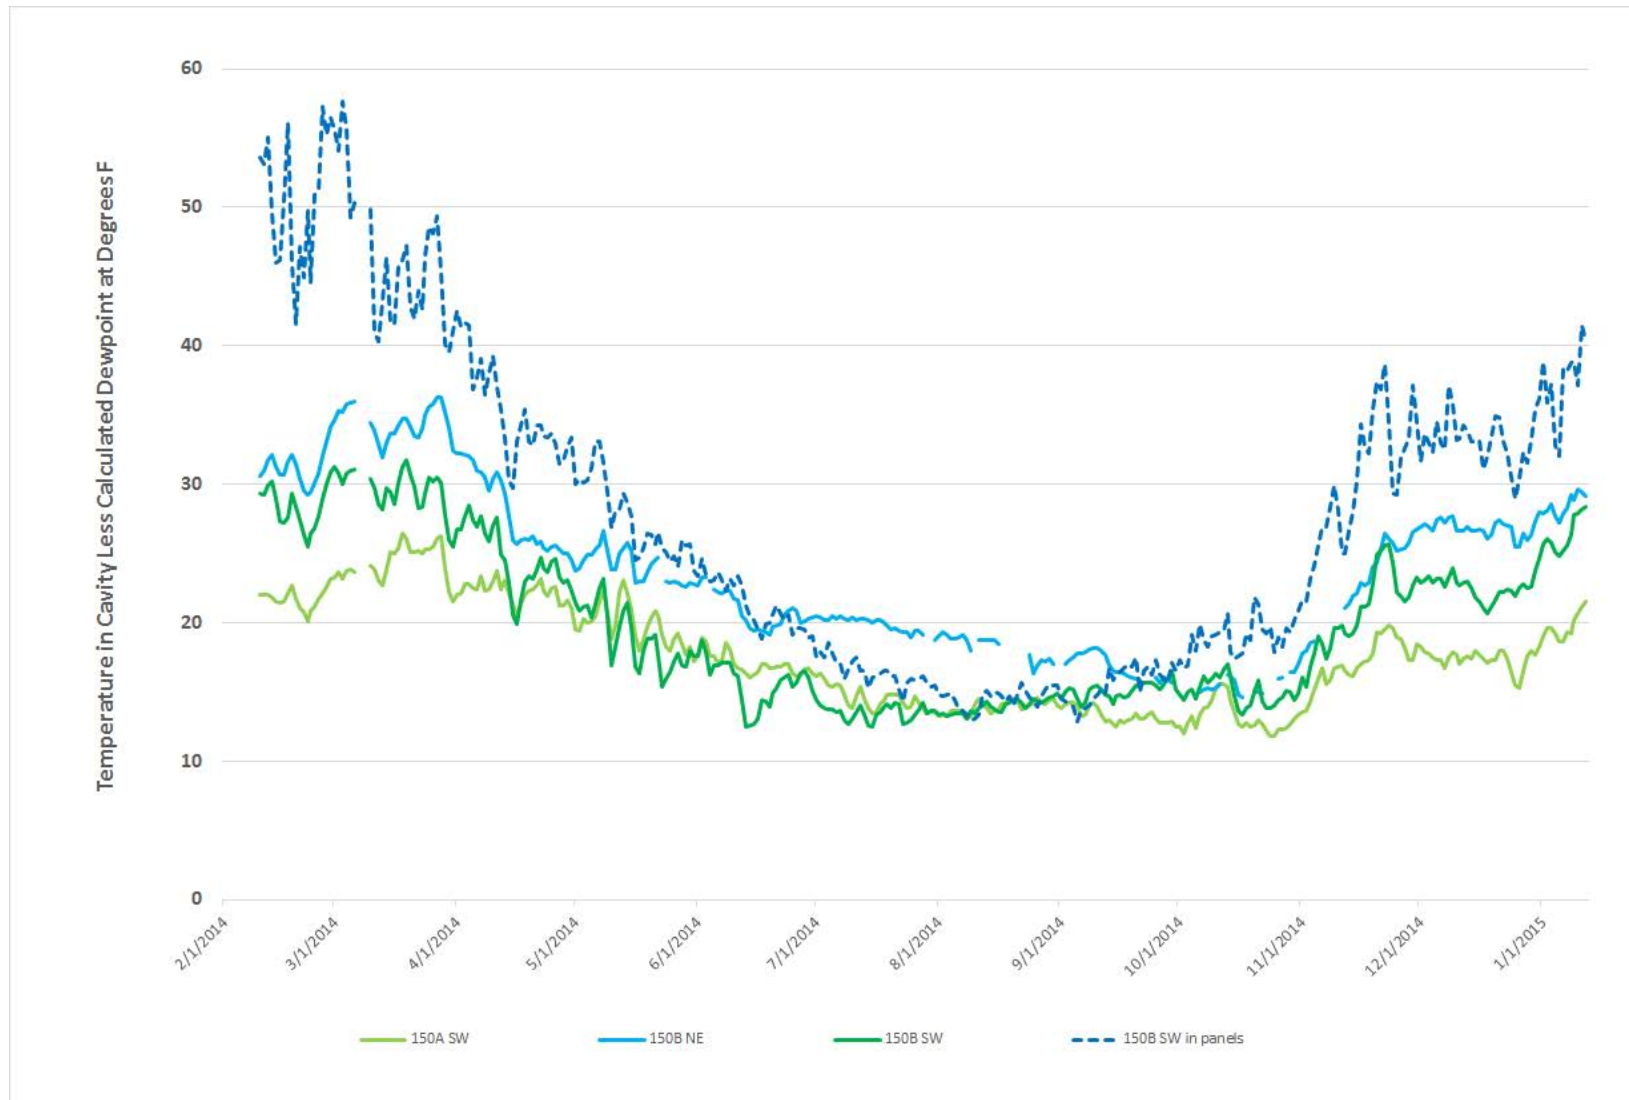
Figure 22. Condensation potential right section of building

RH is a meaningful performance metric because as it increases in a wall cavity, the potential for condensation of water vapor on the outermost surface of OSB panels also increases. As RH increases, the dew point temperature moves closer to the ambient temperature, which makes RH a suitable metric for condensation potential. Comparison plots for the sensors in the wall cavities and the temperature difference between the sheathing temperature and the dew point temperature are shown in Figure 22 through Figure 24. Negative chart values (when the dew point temperature exceeds the sheathing temperature) indicate a higher cavity dew point than cavity air temperature near the OSB sheathing, with a resultant likelihood of condensation. This case was not noted in any of the wall panels or cavities.

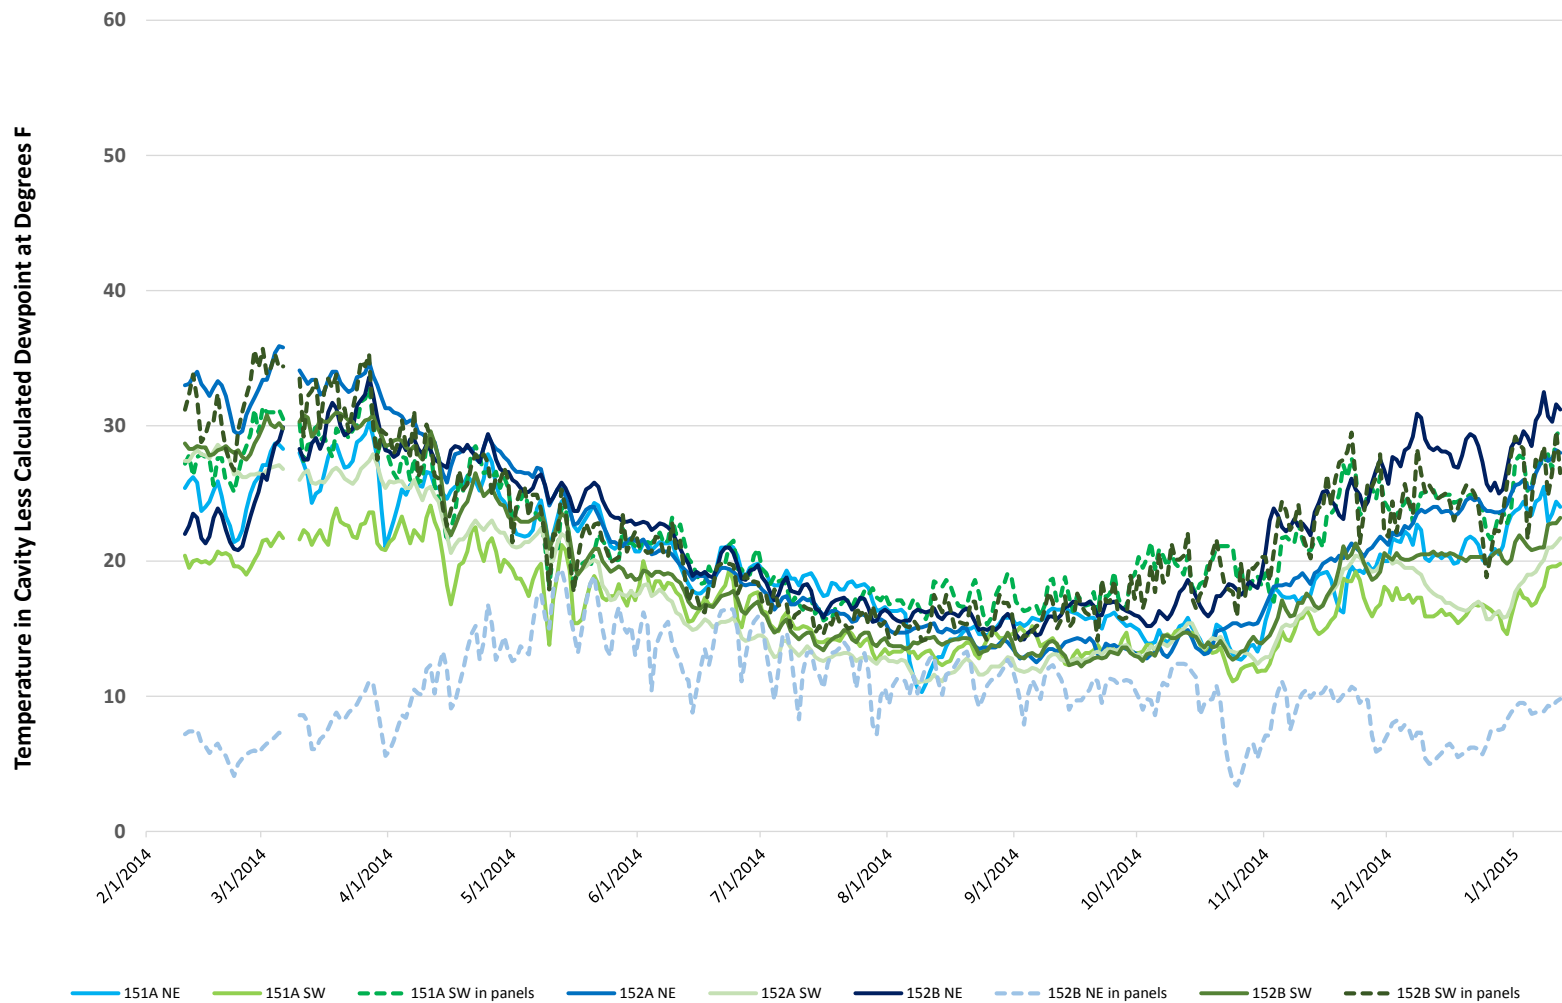
Figure 24. Condensation potential middle section of building

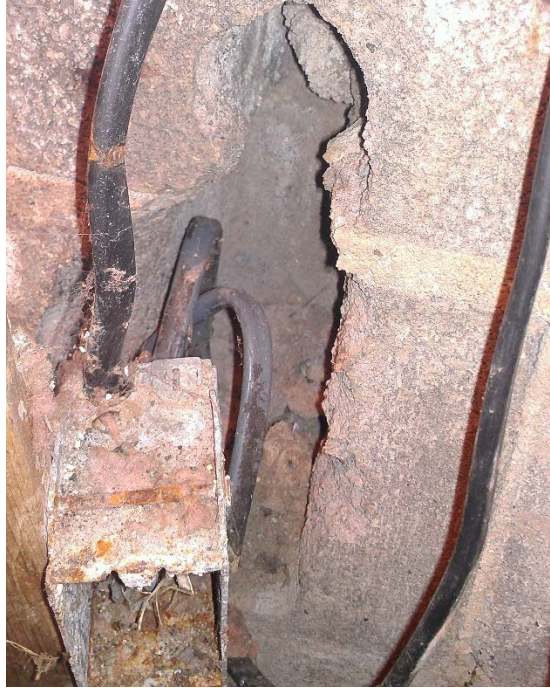
Figure 25. Abandoned basement receptacle at CMU wall

The blower door test zone consisted of three two- and three-unit towers separated by nongROUTED CMU block walls. Visual inspection from the abandoned basement units indicated that the CMU blocks had been penetrated by receptacle boxes installed in the party walls of all units (Figure 25).

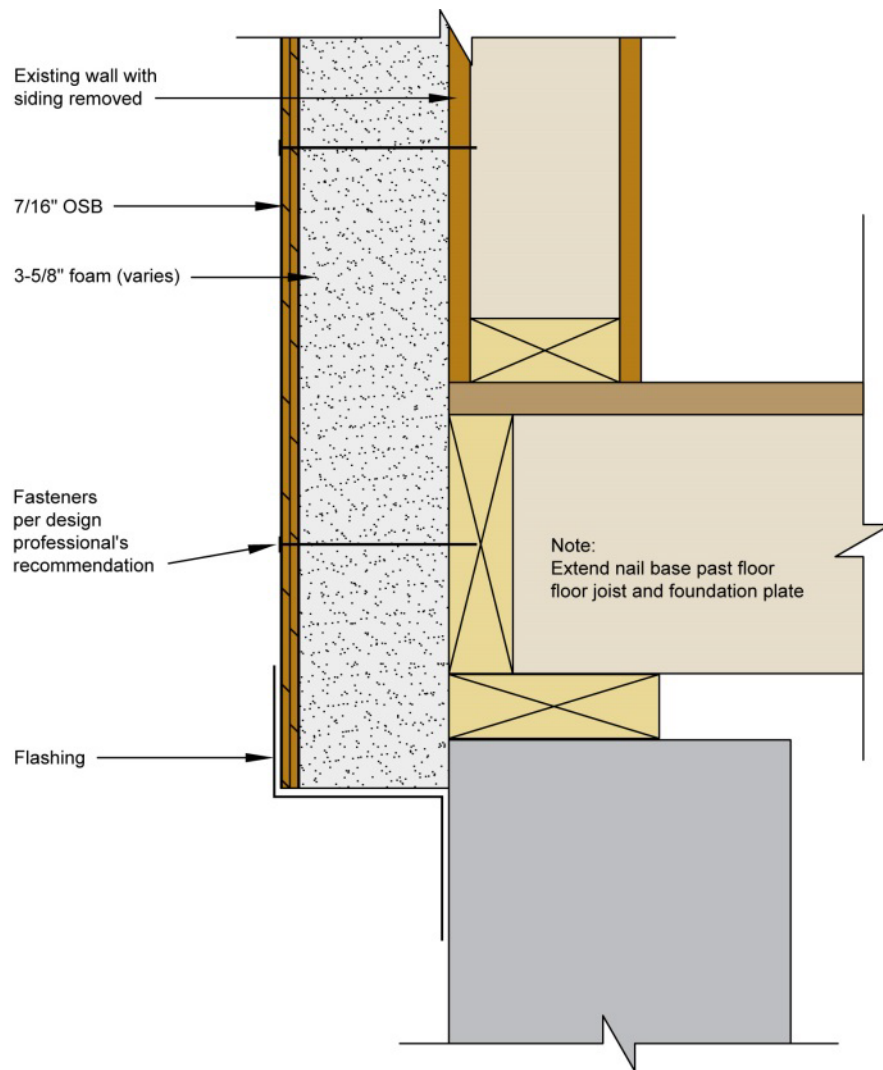
Figure A-1. Typical retrofit panel installation starting from bottom of building

When major renovations are undertaken to modernize or add curb appeal to existing buildings, an opportunity arises to significantly increase energy efficiency by improving the thermal performance of the building enclosure. Retrofit insulated panels (or retrofit panels or nail base panels) present a straightforward way to add continuous insulation and air sealing to older homes as part of a comprehensive energy retrofit plan or as an energy-efficiency measure when replacing siding. The composite panels consist of rigid insulating foam laminated to a single sheet of OSB structural sheathing (Figure A-1).

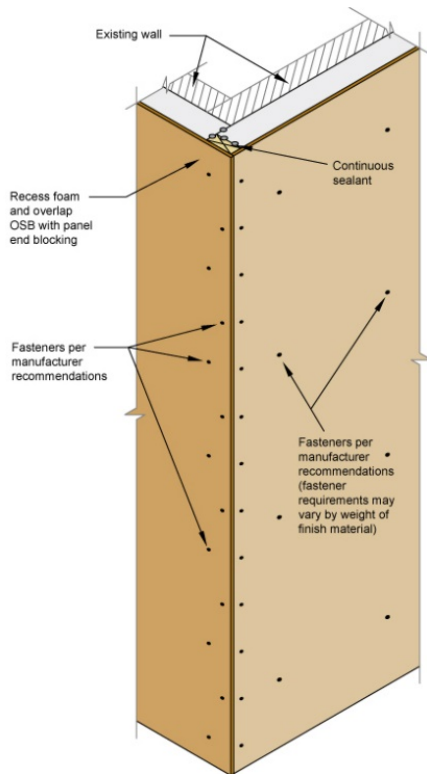
Figure A-2. Do not start the retrofit panel layout at an outside corner of the building

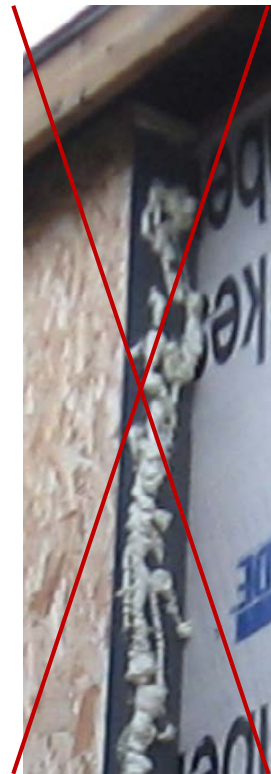
Figure A-3. Do not apply spray foam to panel edges as sealant in freezing weather conditions

The use of spray polyurethane foam at low temperatures is not advisable because spray foams rely on heat to generate a chemical reaction that expands the agents. Most manufacturers concur that ambient temperatures lower than 40°F are not conducive to expanding and curing the foam and likely result in an ineffective seal. Mastic products tend to have an even narrower recommended installation temperature range of 50°–85°F. Some of the OSB tapes; e.g., SIGA’s Wigluv 60 and Advantech’s zip system, can be installed in temperatures as low as 14°F or 20°F, respectively. These tested conditions, and the need to ensure the seal of the OSB, recommend that retrofits be timed with the seasons in cold climate zones and edge sealing products be selected wisely.
