The “GRC1.5”: Uptower Gearbox Testing to Investigate Bearing Axial Cracking

Drivetrain Reliability Workshop

Golden, Colorado
February 16, 2016

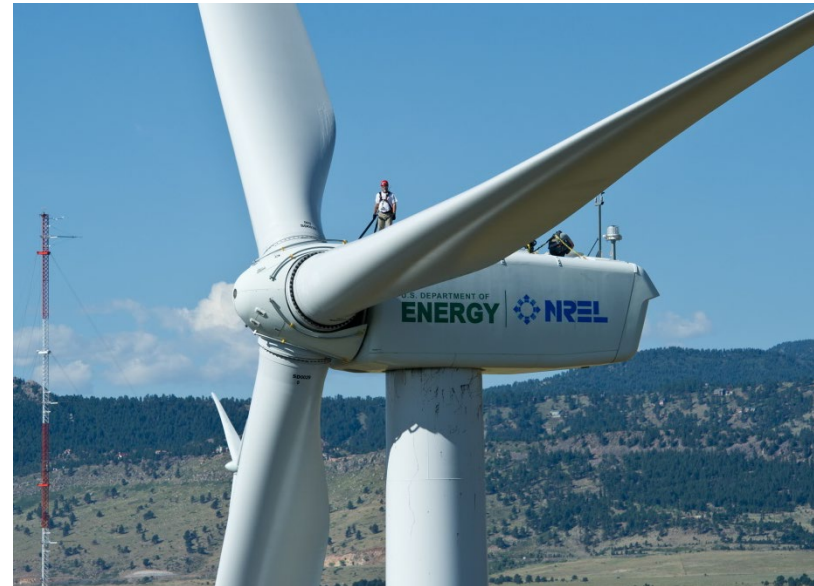
Photo by Dennis Schroeder, NREL 21864

- Investigate bearing axial cracking only
- Pros: site technicians, instrumentation without warranty concern, induce transients and grid events
- **Dynamometer**
 - Con: Pay for whole drivetrain
- **Uptower in U.S. Department of Energy (DOE)-owned GE1.5 SLE**
 - Con: Pay for crane services.

NREL completed an IEC 61400-13 mechanical loads test
<http://www.nrel.gov/docs/fy15osti/63679.pdf>

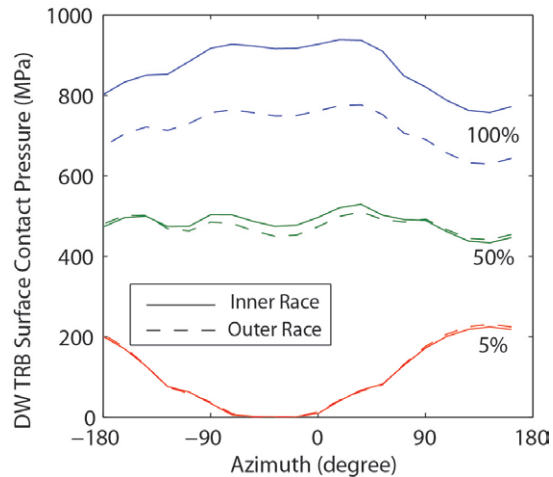
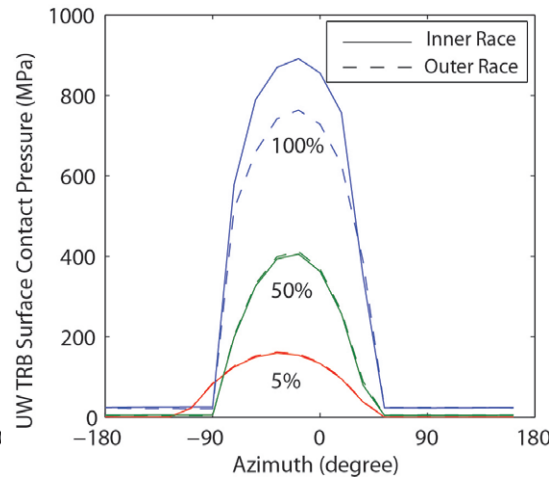
Measured bearing load zones correlate to model

Predicted bearing stresses, measured temperatures and sliding relate to failures

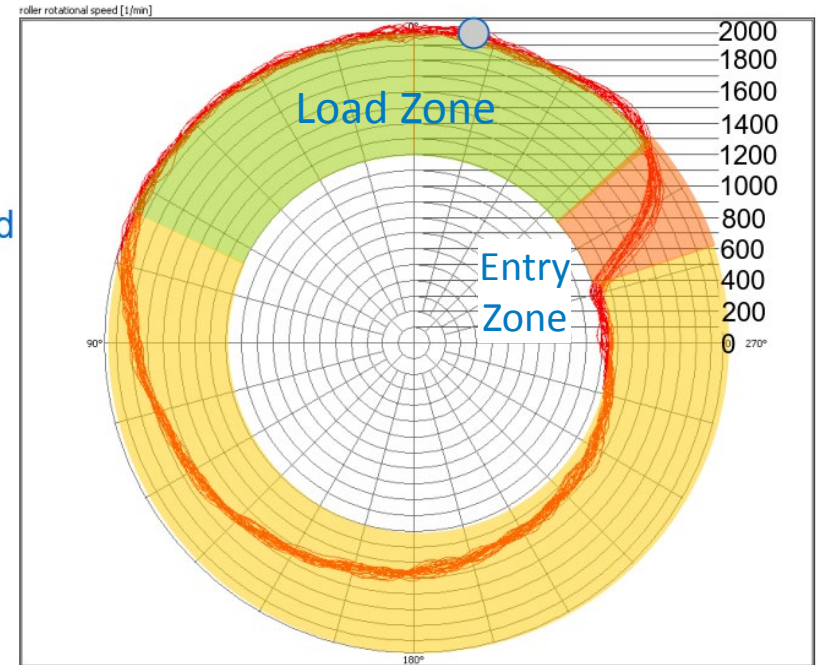
SKF Roller Speed Measurement

Source: M. Volkmuth, K. Stadler, R. Heemskerck, Slippage measurements in roller bearings, Antriebstechnisches Kolloquium ATK, Aachen, Germany, 2009.

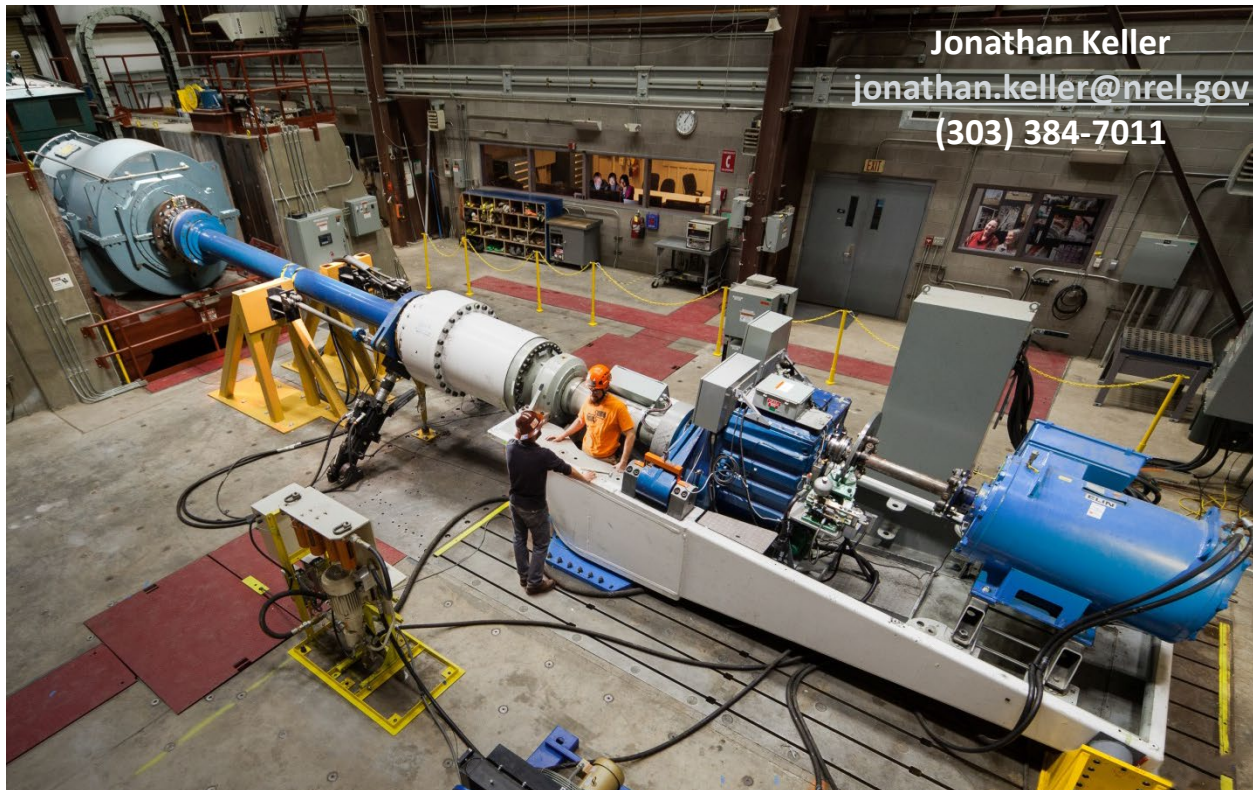
GRC dynamometer testing. *Mark McDade, NREL 32734*

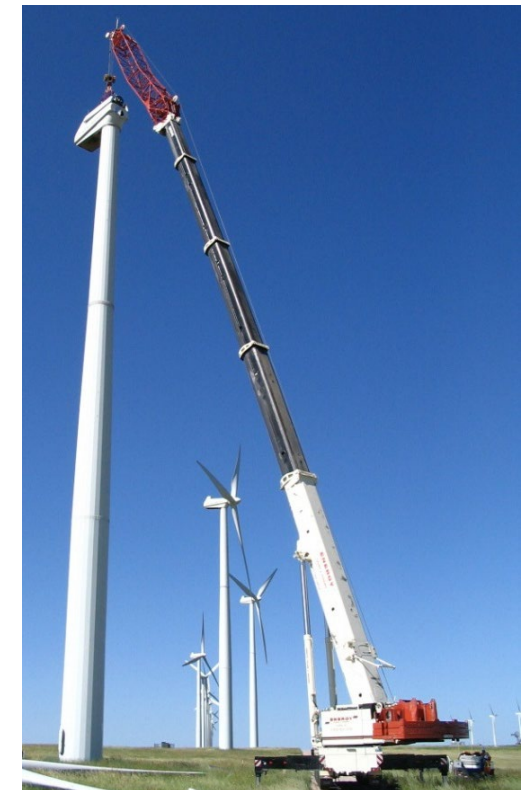
GRC field testing. *Jeroen van Dam, NREL 19257*
