Progress and Strategies for Testing of Materials for Solar Panels

Sarah Kurtz (NREL)
Photovoltaic Polymer International Conference
Shanghai, China

NREL/PR-5F00-68417

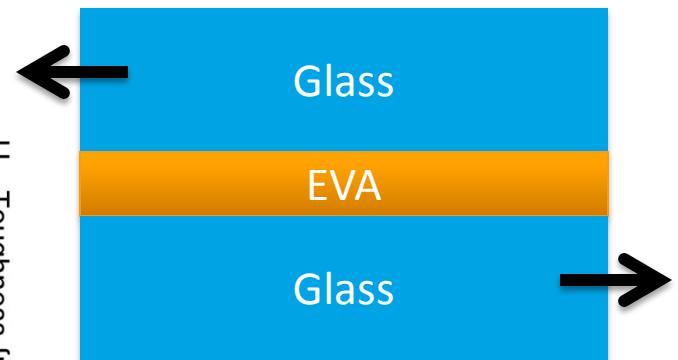
UV-exposure reduces shear strength

Study of encapsulant attachment as a function of weathering shows asymptotic behavior

Perhaps this is good news

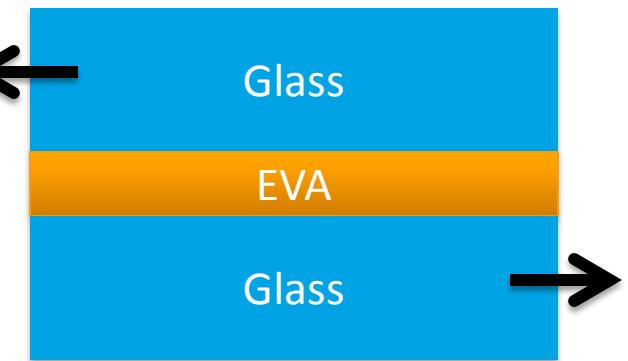
Moisture decreases shear strength

Wet preconditioning reduces shear strength
