Case Study of ISO/TS 6336-22 Micropitting Method

Preprint

Presented at American Gear Manufacturers Association (AGMA) 2020

Conference Paper
NREL/CP-5000-76776
September 2020

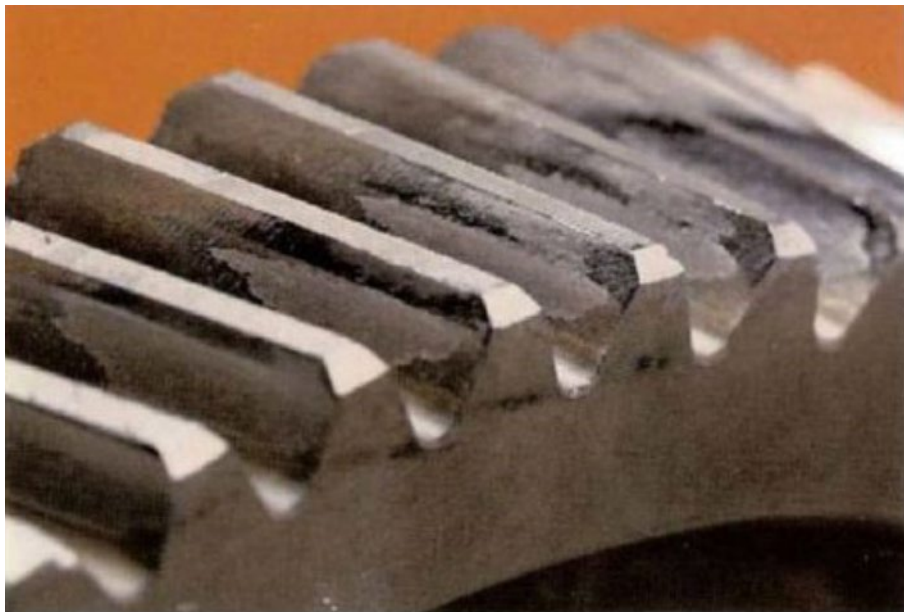
Figure 1 - Micropitting on a carburized gear (From ANSI/AGMA 1010-F14 [1])

Micropitting predominantly occurs on case-hardened gear teeth. Figure 1 illustrates the appearance of micropitting.

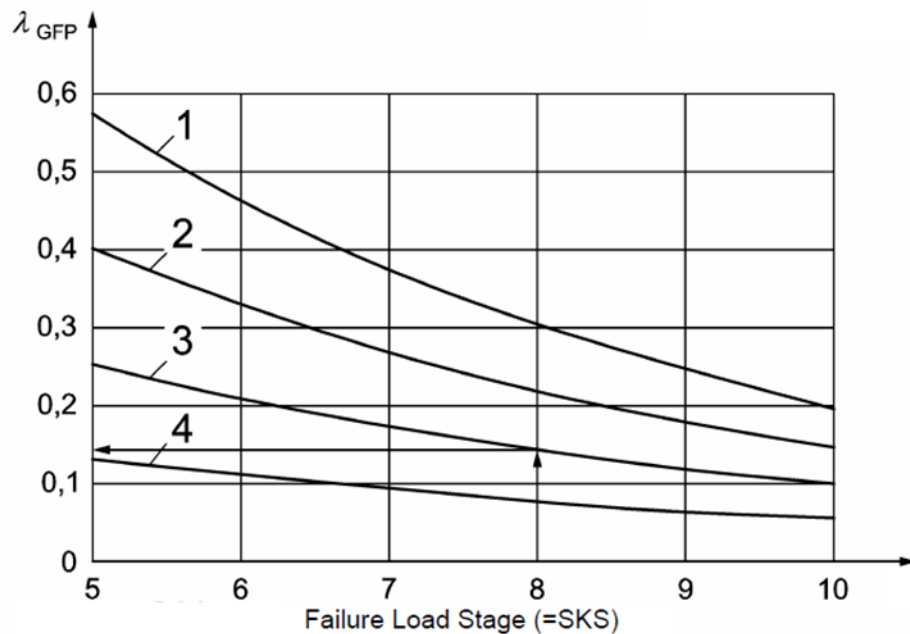
1 ISO VG 460

2 ISO VG 220

3 ISO VG 100

4 ISO VG 32

Figure 3 – ISO/TS 6336-22 Figure A.1 - Minimum permissible specific film thickness for mineral oils as a function of nominal lubricant viscosity and failure load stage in FVA-FZG micropitting tests.

If comparative testing cannot be performed (due to cost, timeline, test stand availability, etc.), the permissible specific film thickness can be generally determined from a simplified set of curves based on the lubricant's performance in FVA-FZG micropitting tests [4] and its viscosity. These curves are derived from mineral oils and are shown in Figure 3.

The permissible specific film thickness was calculated using the lubricant viscosity and failure load stage. The value determined from ISO/TS 6336-22, Figure A.1 was 0.157. This is consistent with the expectations of the performance of an ISO viscosity grade (vg) 32 mineral oil in an FVA-FZG micropitting test rig. By comparing the values of the minimum specific film thickness and the permissible value, a safety factor of 13.016 was calculated.

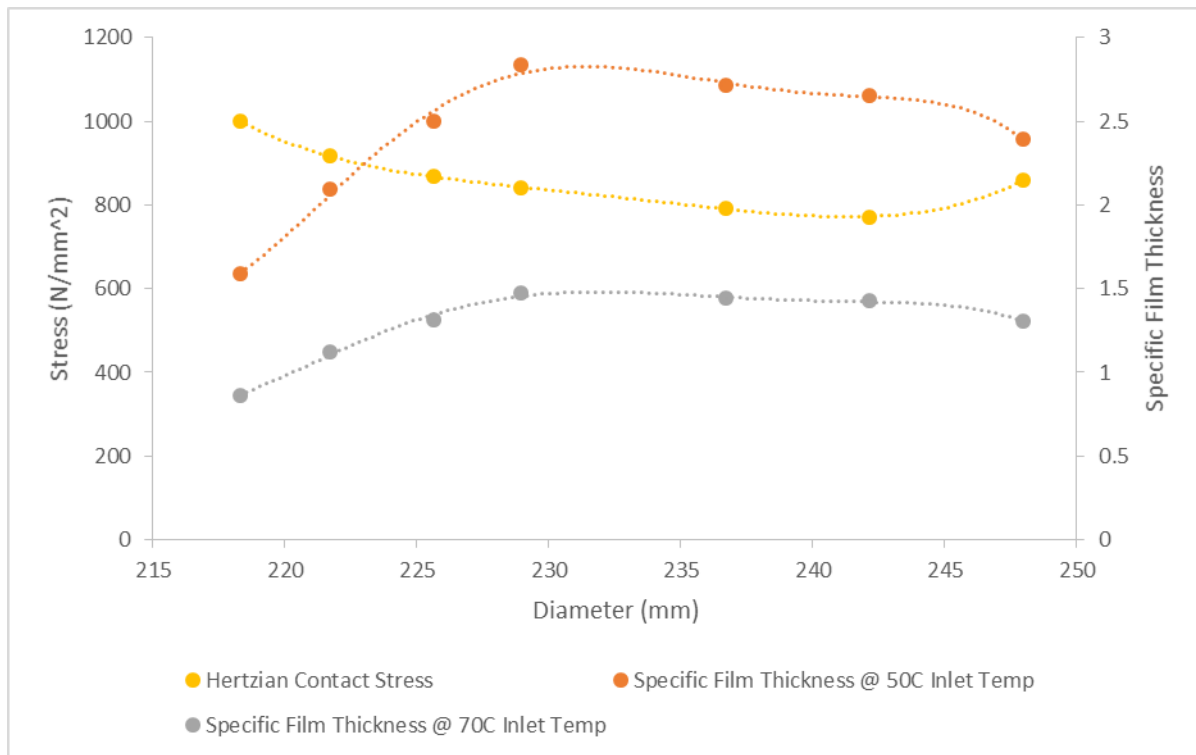
Figure 2 - Specific film thickness at the points along the line of action with inlet temperatures of 50°C and 70°C.

It was noted that the gear drive sump temperature averages 50°C, but can get as high as 70°C. To test the range of sump temperatures, the calculation was run again using 70°C as the lubricant inlet temperature. The thinner film thickness caused the curve of the specific film thickness over the contact points in the line of action to flatten, decreasing the safety factor to 3.614. This is shown in Figure 10.

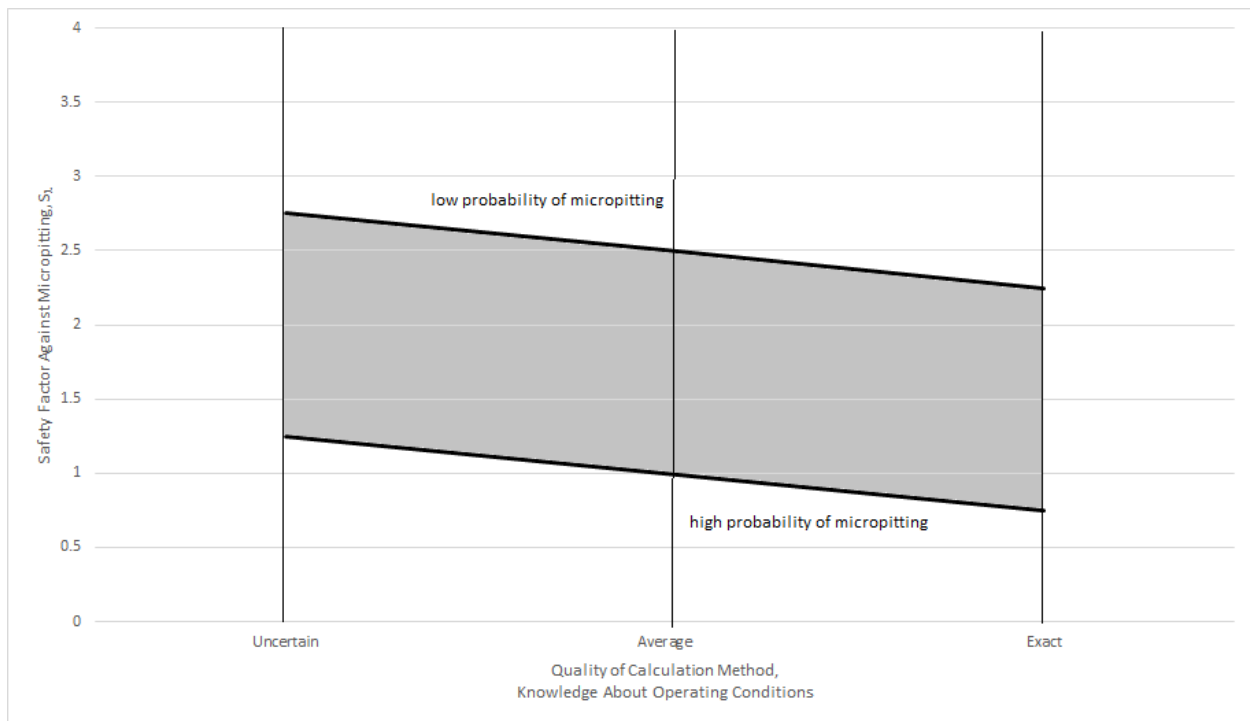
Figure 12 – Probability of micropitting as a function of calculation method and application knowledge

This is not an unusual result from ISO/TS 6336-22 and it has been reported in other papers. Both Pinnekamp [7] and Sagraloff [12] present graphs of safety factors calculated for various examples as functions of the quality of the calculations and knowledge of the operating conditions. These graphs are similar to Figure 12. Assuming that the calculations for this case are average, the results fit into the grey space in the chart.
