Case Study of ISO/TS 6336-22 Micropitting Calculations

ROBIN OLSON, REXNORD CORPORATION, MARK MICHAUD, REM SURFACE ENGINEERING,
AND JONATHAN KELLER, NATIONAL RENEWABLE ENERGY LABORATORY

2020 FALL TECHNICAL MEETING

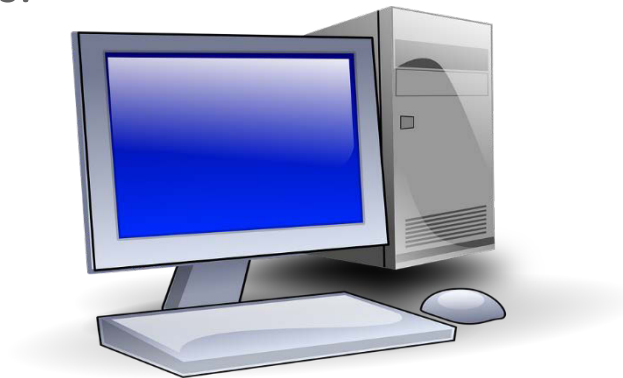
Method A – Detailed Calculation

Use a gear computing program to review the complete contact zone. Consider:

- Load distribution
- Normal and sliding velocity
- Service conditions.

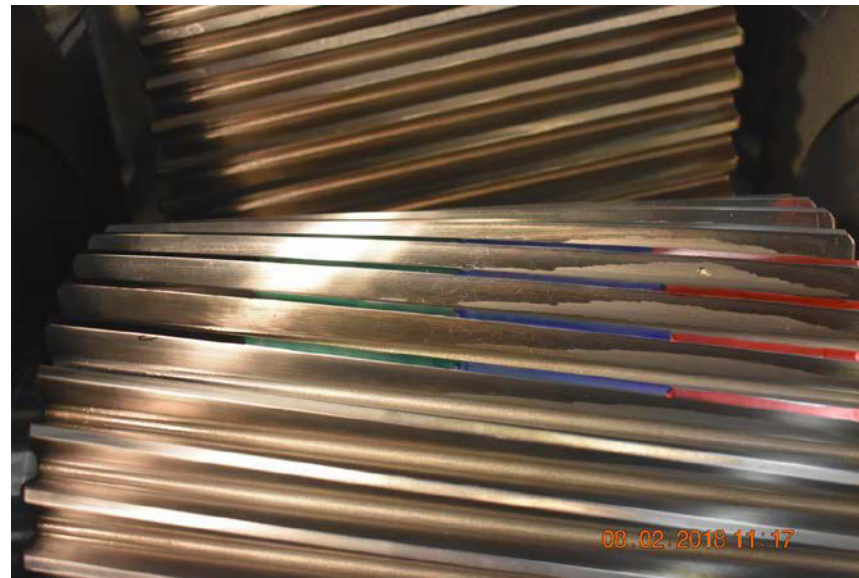
Speed increasing gear set from a centrifugal compressor

120,000 hours of operating life = 54.6×10^9 cycles

Micropitting was found on the pinion on the dedendum extending through the pitch line to the addendum, favoring the drive end; also on the gear around the pitch line

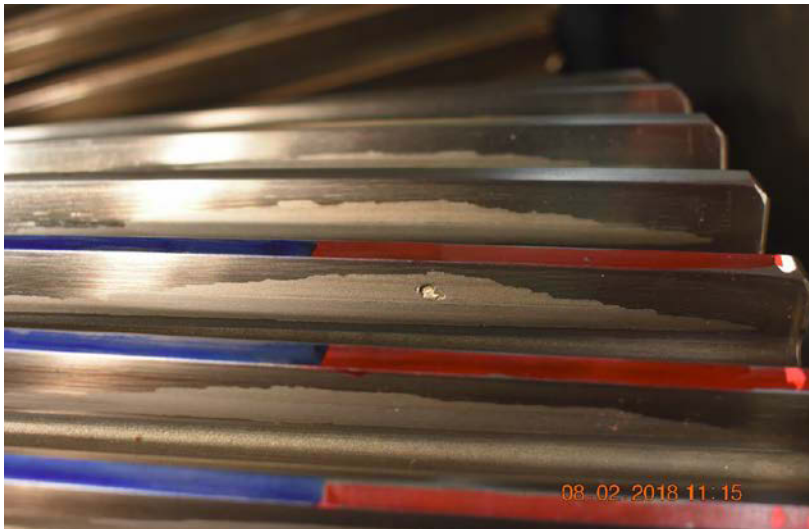
When specific film thickness is much greater than 1.0, there should be no contact between mating surfaces.

This is correct from the appearance of the nonmicropitted flanks of this gear set.

Micropitting is not predicted by film thickness in this case! The flank asperities fatigued due to accumulated loading cycles under full EHL operating regime. This may have been caused by hydraulic forces due to the contact pressure, lubricant viscosity, and shear forces.

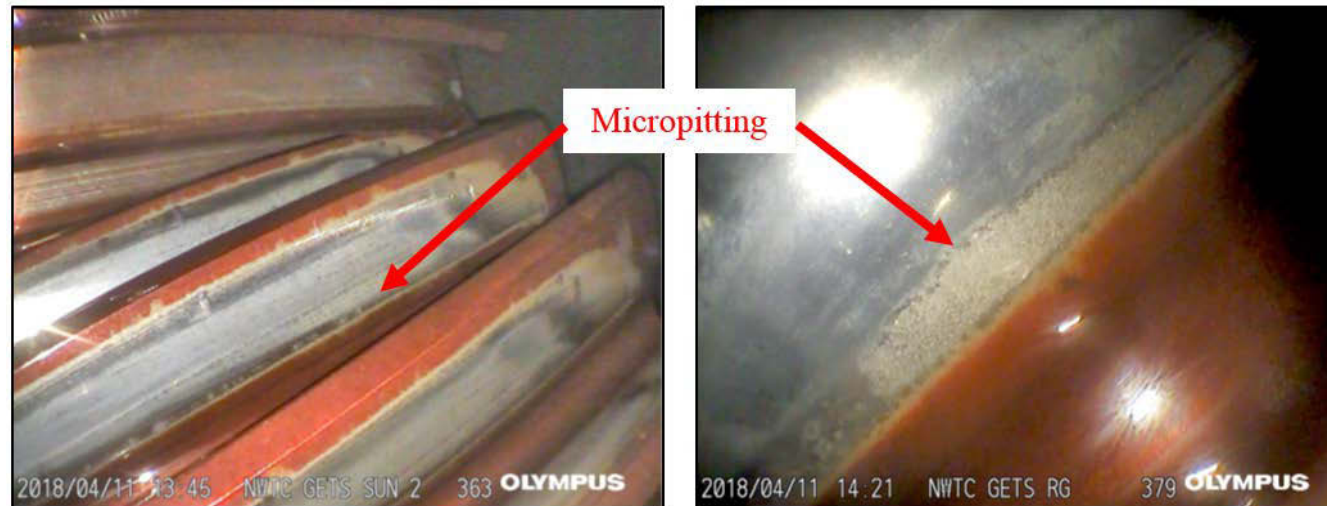
Micropitting was found in the start of active profile (SAP) of all the sun pinion teeth.

Micropitting and some abrasion were also found higher on the flanks of the sun pinion teeth.

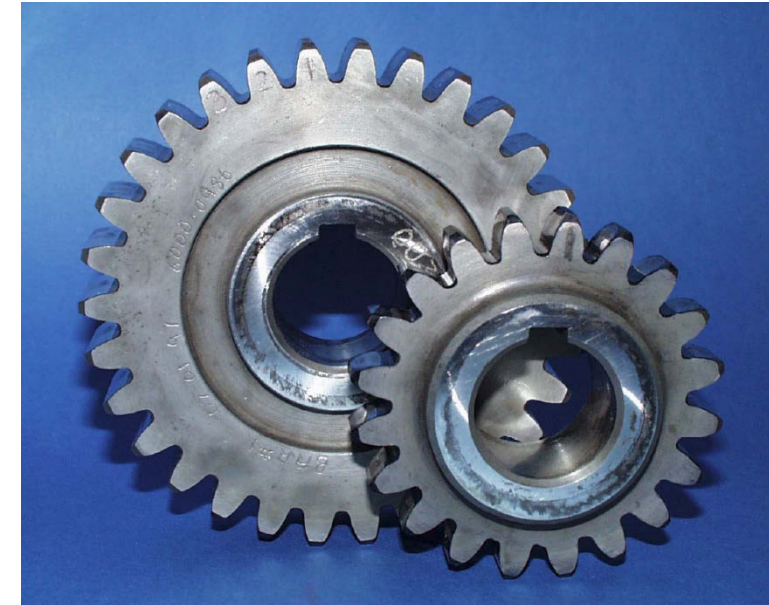
Gearing similar to FZG “C” test gearing, but with industrial gear characteristics

One hundred gear sets manufactured and run in a four-square FVA-FZG test rig

Tests were run with five different mineral lubricants from three viscosity grades (68, 220, and 640) and two additive packages (R&O and EP).

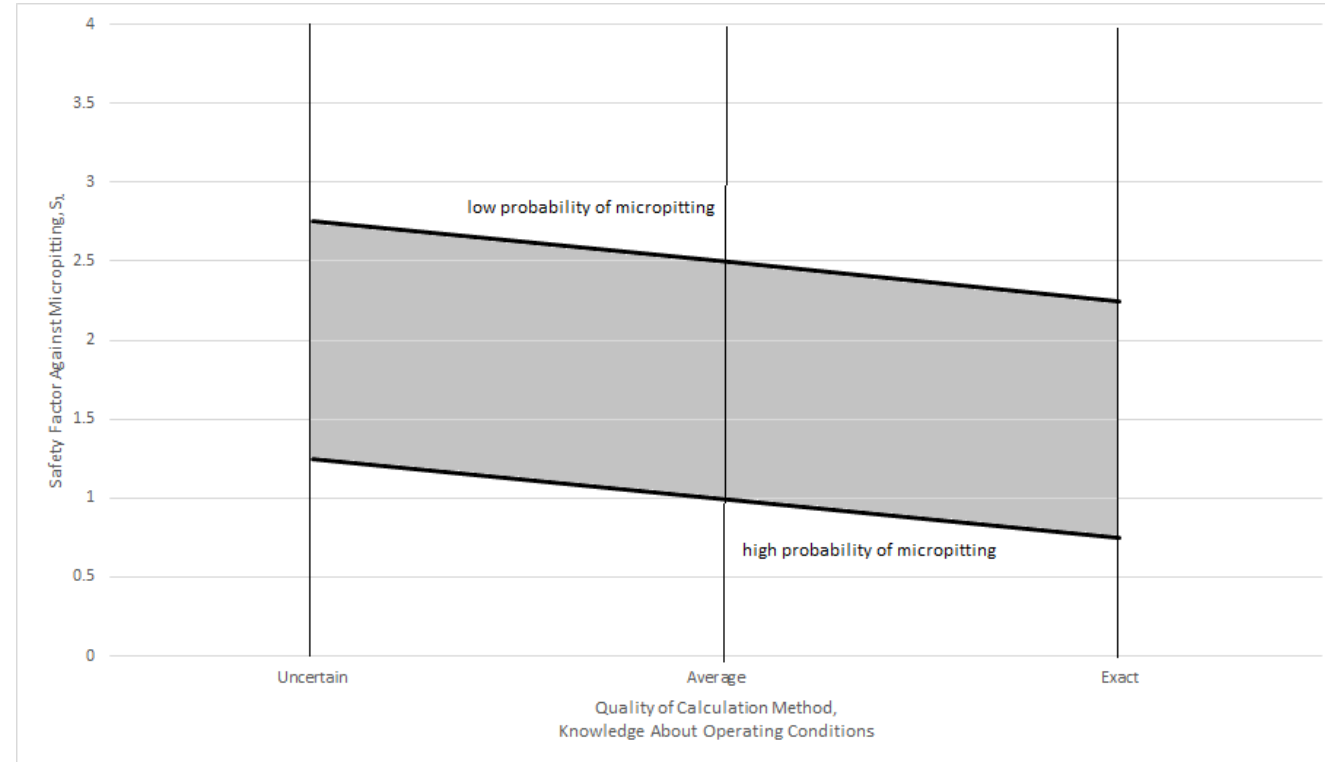
Other authors have proposed graphs to interpret safety factor based on quality of calculations and knowledge of operating conditions.

Probability of micropitting as a function of calculation method and application knowledge
