# Reliability Implications of Solder in Multiwire Modules under Dynamic Mechanical Loading

## Preprint

*Presented at the 48th IEEE Photovoltaic Specialists Conference (PVSC 48)  
June 20-25, 2021*

**Conference Paper**  
NREL/CP-5K00-78915  
July 2021

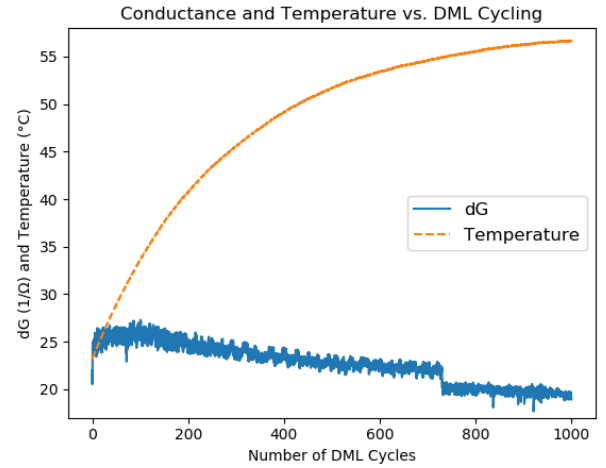
Fig. 1.  $dG$  (moving average) and module temperature throughout DML for the early generation module.

The moving average of the  $dG$  and the module temperature during DML cycling for the earlier multiwire technology is shown in Fig. 1. The gradual decline in  $dG$  is seen to correspond to the gradual increase in temperature. The sharper decrease in  $dG$  of about 10% around 750 cycles is irreversible and attributed to module damage. However, EL imaging after the module temperature returned to ambient showed no damage. The appearance of degradation in the EL images was found to be temperature-dependent, as shown in Fig. 2. At higher module temperatures, the degradation appears with more intensity (Fig. 2a) than at lower temperatures (Fig. 2b). A comparison of the I-V curves before and after 6900 cycles of DML demonstrated a 2.8% drop in maximum power due to a decrease in  $V_{max}$ , leading to I-V knee rounding.

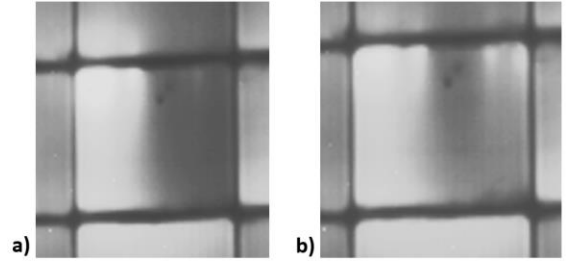
Fig. 2. In-situ EL images of one cell in the early generation module a) right after cycling,  $T=42^\circ\text{C}$  and b) after 15 mins. of cooling,  $T=32^\circ\text{C}$ .

Four wire/gridline intersections were cross-sectioned, and in all four it was found that the In-Sn solder consumed the Ag gridline. Three of the 4 cross-sections revealed cracks in the solder interface, whether the area cored was degraded or not. Additionally, broken interconnect wires between the cells were found to only explain a small part of the degraded areas.

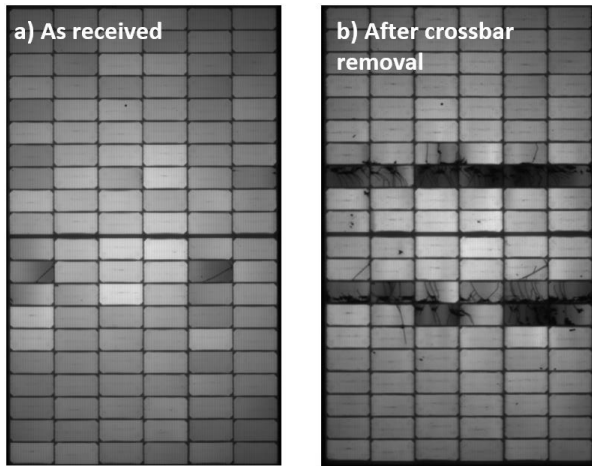
Fig. 3. EL images of the state-of-the-art module a) as received and b) after the crossbars were removed. The process of removing the crossbars damaged the module.

The state-of-the-art module had two crossbars mechanically supporting the backside. Initial DML cycles performed with these crossbars intact did not cause any observable degradation. A recoverable decline in  $dG$  with increasing module temperature was observed in this module, similar to the earlier generation module (Fig. 1). The crossbars were then removed from the module for better comparison to the earlier generation module. The process of removing the crossbars induced damage to the module as shown in the EL images in Fig. 3. An additional 5000 cycles were performed without the crossbars and no  $dG$  degradation was observed. Removal of the crossbars caused significant cracking, yet few additional cracks were initiated or propagated during subsequent DML. EL imaging detected no other degradation. Flash testing after crossbar removal and after subsequent DML revealed no additional performance losses. These results indicate that DML did not introduce damage to the module, with or without the additional mechanical support of the crossbars.

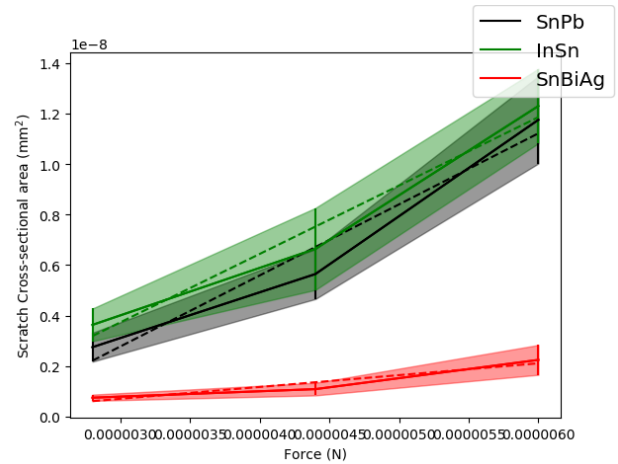
Fig. 4. Scratch area vs. force for conventional SnPb vs. two relevant low temperature solder alloys. The shaded regions indicate standard deviations of the four measurements and the dotted lines indicate lines of best fit.

The wear resistance of the solder alloys used in multiwire interconnects was assessed using AFM scratch testing. A silver gridline fired onto a cell was also subjected to scratch testing. Using Eq. (3), the gridlines were found to have much higher hardness values than any of the solders based on relative scratch widths. This indicates that the solder materials will wear against the gridlines. The cross-sectional area of the scratch versus scratch force is plotted in Fig 4. The slopes for InSn and SnPb are greater than that of the Sn-Bi alloy. As per Eq. (2), this demonstrates that that InSn and SnPb wear significantly more than the Sn-Bi alloy given the same loading conditions.
