Evaluating the Durability of Balance of Systems Components Using C-AST

DuraMAT Webinar, Monday, 2021/11/08

NREL/PR-5K00-81456

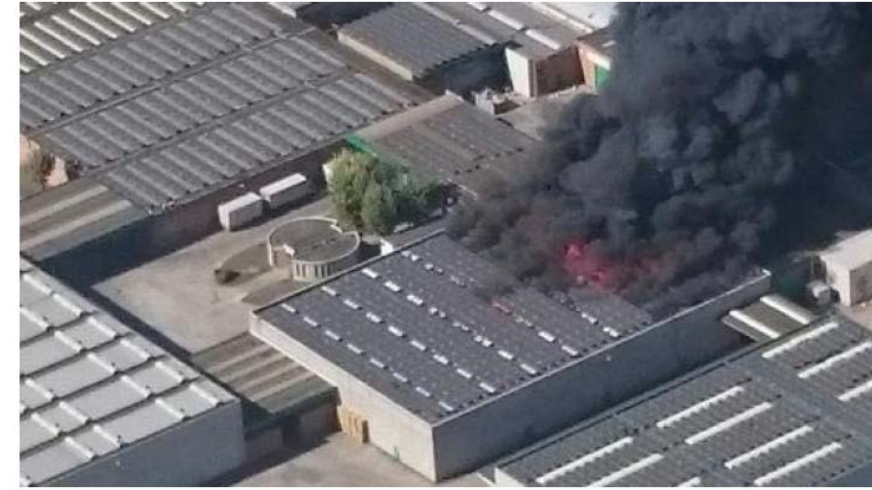
Example of PV fires in Italy.
Fiorentini et. al., PVRW 2020.

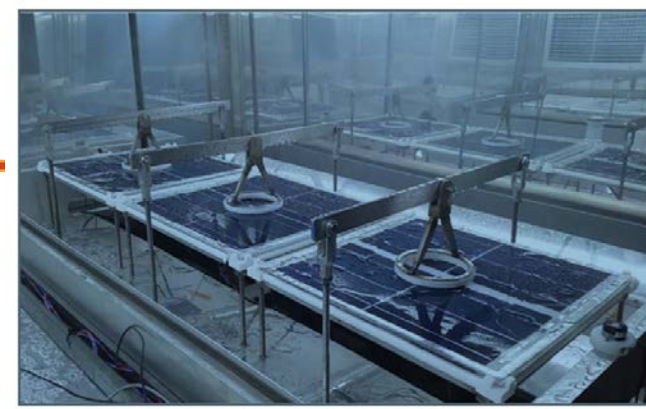
C-AST chamber during operation (MiMo test sites).

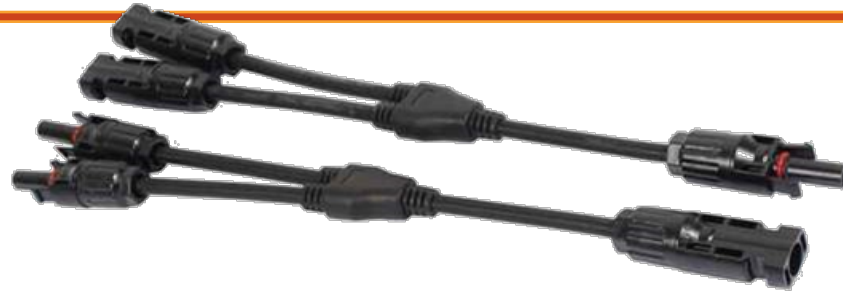
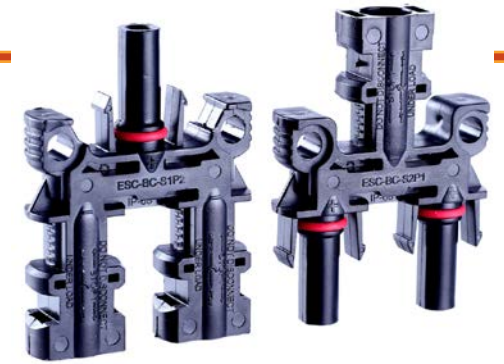
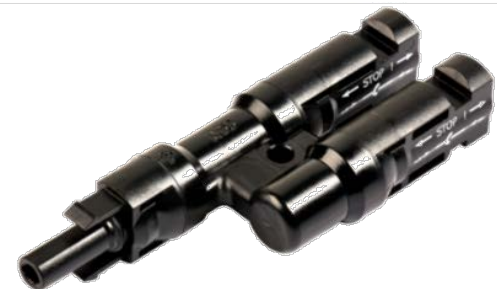
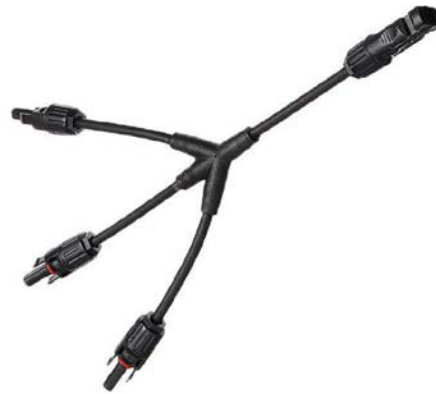
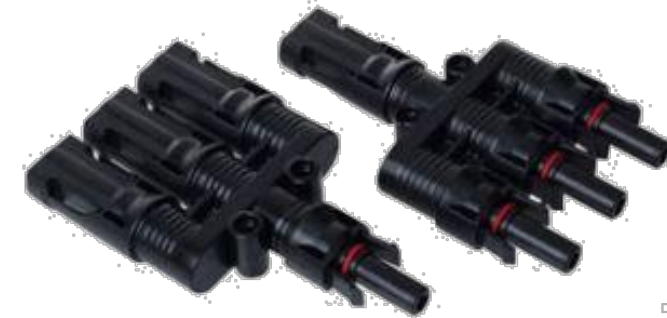
- Utility provider experiencing ~30% failure rate in their power transfer chain, attributed to branch connectors.
 - “Failure” means overheating, softening, physical distortion.
 - Observable ΔT in thermographic imaging.
 - Worst consequence: broken circuit, arc, fire.
- Component makes & models kept confidential in this presentation.

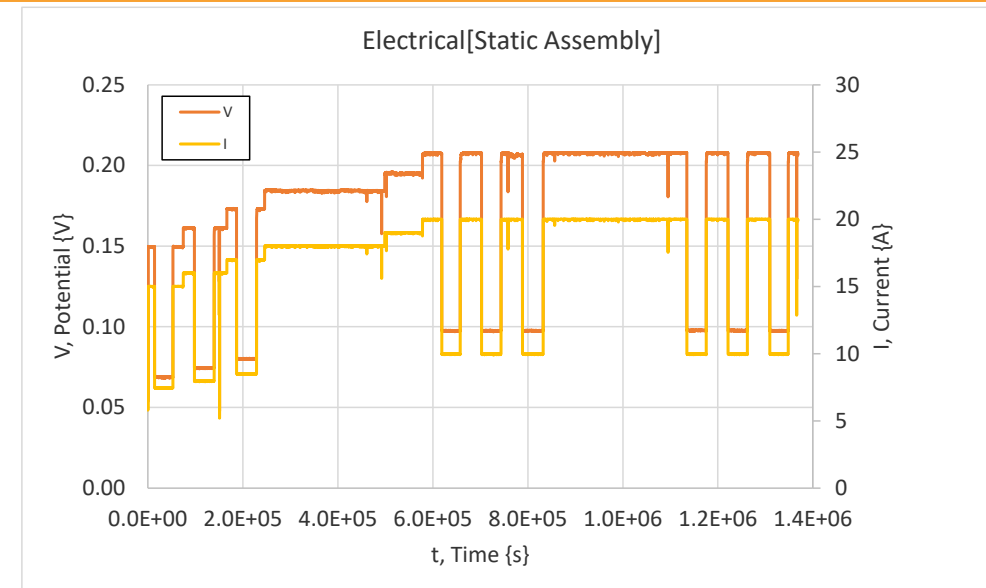
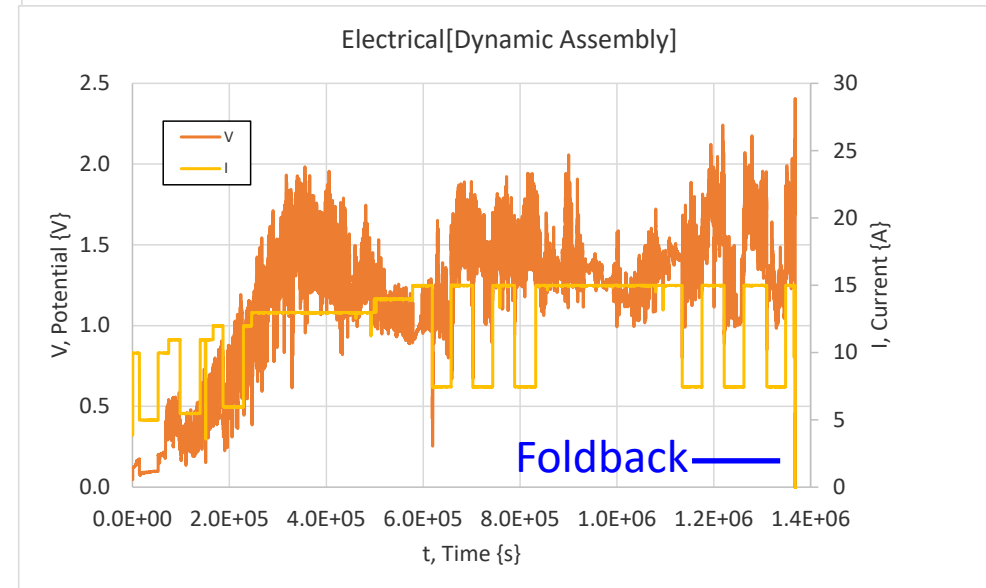
- LabView software for C-AST developed in benchtop experiments.
 - I, V are logged per sample assembly.
 - Data binned & analyzed in 1 minute intervals.
 - Optional “burst” mode to log @ 100 kHz.
-
- Example ($\delta=1$ mm) compares I, V for static & dynamic assemblies.
 - I, V scales (y-axis) are different, static vs. dynamic.
 - V quickly becomes more variable for dynamic.
-
- Foldback protection ($> V_{fb}$) was extended from 1 to 5 to 25 s.
 - Q: what would you use to simulate an inverter?

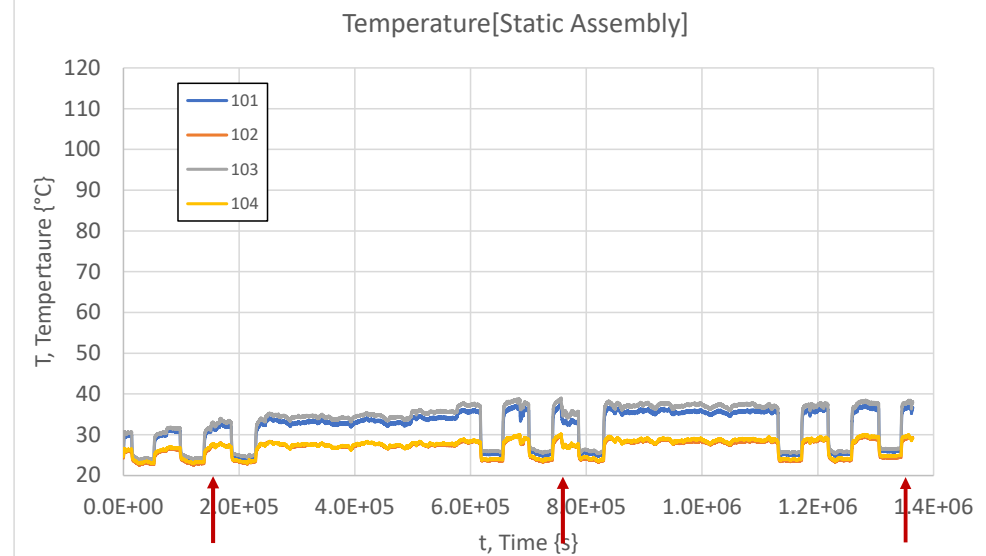
- Example ($\delta=1$ mm) compares T for static & dynamic assemblies.
 - Scale (y-axis) same for static & dynamic.
 - FLIR vs. TC: exact hottest spot difficult to predict.
 - Helpful to know: t_{onset} , what components affected.

Data from experiment 4. Red arrows indicate approximate read point for FLIR imaging.

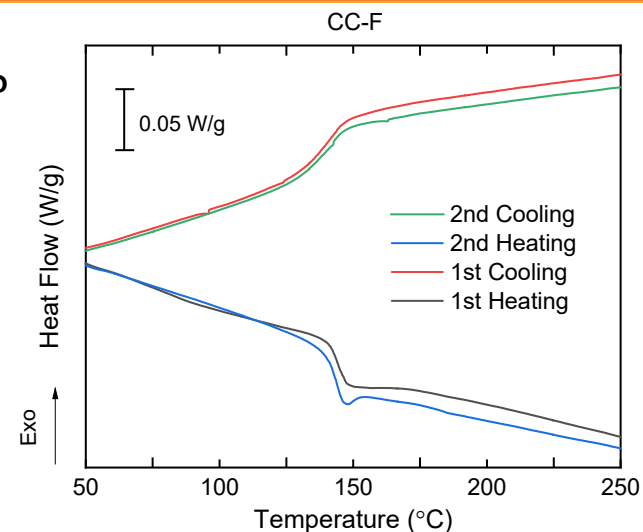
DSC for cable connector, female end (plastic).

- Suspect hard structural polymer (PC, ABS, etc) from handling samples.
- T_{glass} of $142 \pm 5^\circ\text{C}$ (AVG \pm 2 S.D.) suggests material is amorphous PC.
- All samples gave similar response (scans from $-90 - 200^\circ\text{C}$), including:
cable connector, branch connector, fuse connector ends.

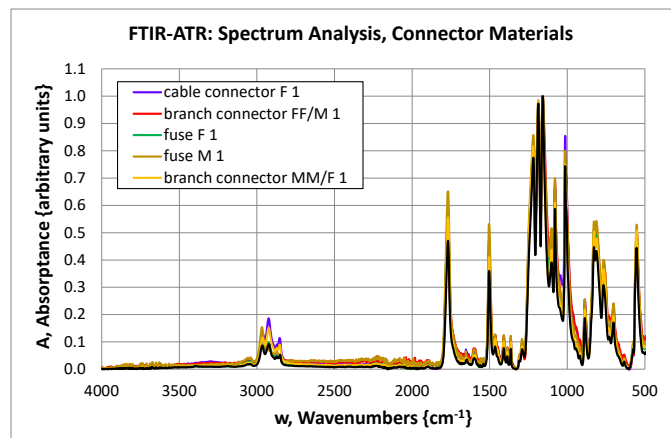
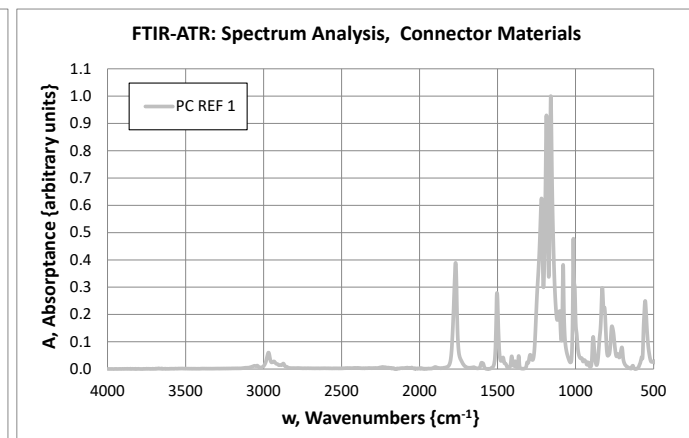
- Cable-, branch-, fuse- connectors have same FTIR spectra.
 - Similar to polycarbonate reference sample.
 - 2 measurements from separate pieces each component.
 - FTIR spectra verified on both F and M connector ends.

⇒ Suspect PC containing carbon black.

FTIR (left) for all component ends and (right) PC reference.

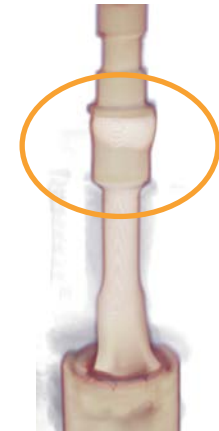
solder $\Rightarrow 220^{\circ}\text{C}$ realized in accelerated test.

Metal pins, benchtop $\delta = 3 \text{ mm}$.

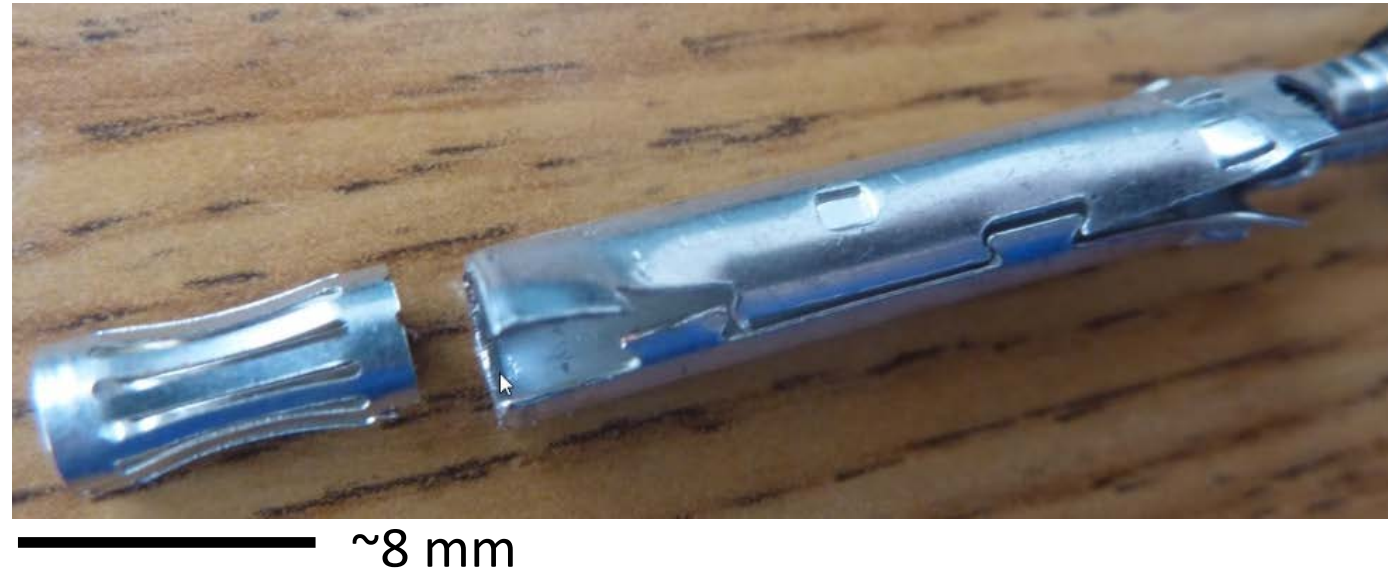
1. Remove (mill) external plastic.
 - Retain plastic for F/A (FTIR, DSC).
 - Inspect internal metal components relative to XCT.
 - Methods: camera, optical microscopy, SEM/EDX.
2. Extract (cut, unfold) convolute spring from F metal pins.
 - Inspection, methods as above.

convolute spring, extracted from unaged metal pin
