Life after 30 years—a PV system in Colorado

Dirk Jordan, Mike Kempe, Ingrid Repins– NREL John Bleem, Colorado State University Jeff Menard, Paul Davis, Platte River Power Authority 2/22/2021

PV system in Fort Collins, CO, USA

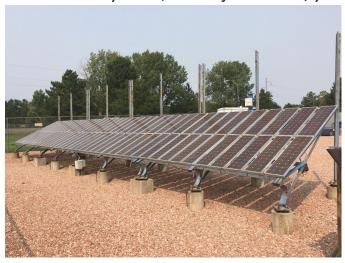
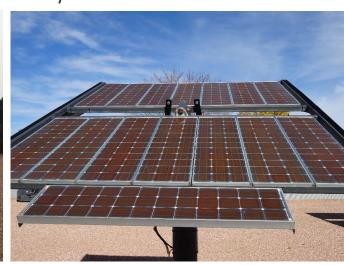
Fixed tilt system, tilt adjusted 2x /year

System size: 6.6 kW

Location: Fort Collins, CO, USA

Commissioned: 1987
Decommissioned: 2017
