# Evaluating the Durability of Balance of Systems Components Using Combined-Accelerated Stress Testing

**Conference Paper**  
NREL/CP-5K00-81666  
October 2022

**Abstract**—The degradation of photovoltaic (PV) balance of systems (BoS) components is not well-studied, but the consequences include offline modules, strings, and inverters; system shutdown; arc faults; and fires. A utility provider experienced a ~30% failure rate in their power transfer chain, originally attributed to branch connectors. Field-failed specimen assemblies were therefore examined, consisting of cable connector, branch connector, and discrete fuse components. In this study, unused field-vintage specimens are examined using combined-accelerated stress testing (C-AST) to clarify the most influential environmental stressors as well as the effect of external mechanical perturbation. A benchtop prototype fixture was used to develop the perturbation capability for the C-AST chamber. The benchtop experiments were also used to develop the in-situ data acquisition of specimen current, voltage, and temperature. A significant increase in operating temperature (~100°C from ~40°C) and a different failure mode were obser

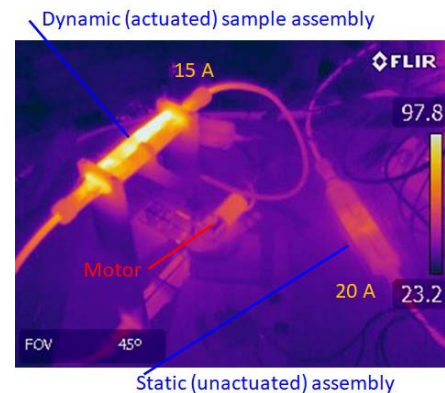
Fig. 1. Infrared image comparing sample assemblies in separate circuits. The maximum temperature of the dynamic sample ( $\sim 100^\circ\text{C}$ , for  $\delta = 1$  mm) is greater than that of the static sample ( $\delta = 0$  mm) with no external mechanical actuation ( $\sim 40^\circ\text{C}$ ), despite a greater DC current to the static sample.

Fig. 1 compares assemblies tested simultaneously, including those: with external mechanical perturbation using the benchtop test fixture prototype (“dynamic”); and those without actuation (“static”). The dynamic specimen temperature of  $\sim 100^\circ\text{C}$  is greater than the static specimen temperature of  $\sim 40^\circ\text{C}$  despite the greater DC current to the static assembly. In successive experiments, dynamic specimens failed at 15 A at the fuse/branch connector connection. Localized arcing is suspected based on observations including smoke, heterogeneous melting of plastic, discolored metal pins, and increased fuse resistance. In successive experiments, static specimens failed at 35 A, with the greatest heating observed at the filament-based cartridge at the center of the discrete fuses. No additional visible indication was observed for failed static specimens, but an open circuit was verified for at least one of the fuses in each failed assembly. Temperature and current behavior like in Fig. 1 were observed in two successive static specimens, then two successive dynamic specimens, then two side-by-side static and dynamic benchtop experiments.

The specimen temperatures shown in Fig. 1 and Fig. 2 readily identify the significance of external mechanical strain on

the durability of branch connector/fuse assemblies. Not only is the temperature greatly increased by mechanical perturbation, but the hottest location also occurs in a different component within the specimen assembly. The measured temperature in Fig. 2 identifies that the specimen temperature loses stability within the first day of the experiment. The data in Fig. 2 is the average temperature through 1 minute; binning and averaging reduce its variation relative to the instantaneous temperature. Temperature spikes are observed even when the current is not incremented, identifying the stochastic effect of mechanical perturbation. The temperatures in Fig. 2 are representative of the specimen temperature, but do not give the maximum specimen temperature because the thermocouples are positioned near but not exactly on the hottest location in each component.

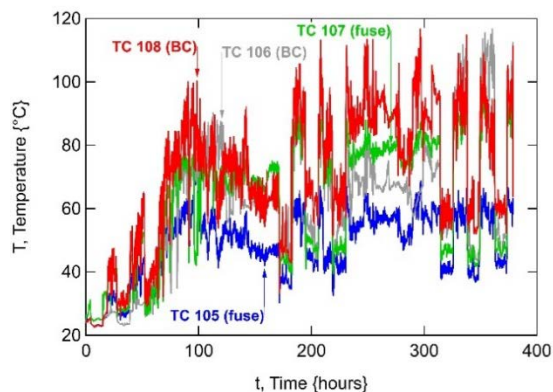
Fig. 2. Measured temperature for the dynamic sample assembly in Fig. 1. The thermocouples at the center of the discrete fuses (“fuse”) are compared to those of the branch connectors (“BC”), as the current was initially incremented in steps and modulated occasionally to simulate the effect of light-level variation.

The temperature history for the dynamic specimen in Fig. 1 is shown in Fig. 2. The branch connectors (TC 106 and TC 108) and the adjoining discrete fuse (TC 107) both occasionally exceeded  $100^\circ\text{C}$ . While the second discrete fuse (TC 105) remained coldest overall, the rank order of the temperature for the other three components varied through the experiment. Supplemental infrared imaging, which included the TCs and the adjacent sample regions, identified localized temperatures exceeding  $130^\circ\text{C}$ . The specimen temperature in Fig. 2 is irregular, with spikes and broader peaks that do not always correspond to the electrical current increments. The voltage drop across the current-controlled specimen assembly was also irregular (not shown), with peaks occurring corresponding to the temperature spikes in Fig. 2. The TC data for the static assembly (not shown) is more monotonic, with the greatest temperature approaching  $40^\circ\text{C}$  in the fuses and  $30^\circ\text{C}$  in the branch connectors.
