Extended Accelerated Stress Testing (EAST) of Glass/Glass, Glass/Backsheet and Glass/Transparent Backsheet PV Modules: Influence of EVA and POE Encapsulants

Presented at the 49th IEEE Photovoltaic Specialists Conference (PVSC 49)

Conference Paper
NREL/CP-5K00-83497
December 2022

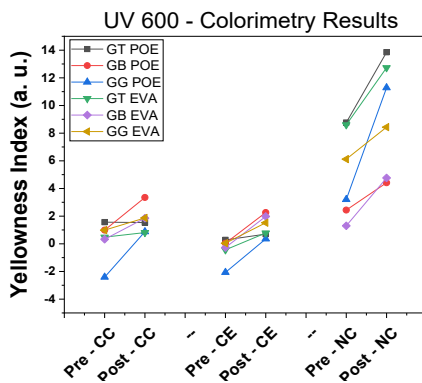
Fig 2. Pre- and post-UV600 colorimetry results of 6 modules performed at three different locations i) CC – Cell center ii) CE – Cell edge and iii) NC – non-cell location

Evidence of yellowing/browning after UV600 was also observed from colorimetry results as shown in Fig. 2. The test

was performed at three different locations in the module i) CC-cell center ii) CE- cell edge iii) NC- non-cell. As shown in Fig. 2, the non-cell area displayed the highest increase in YI and the cell-center and cell-edge areas showed only small increase in YI. Additional analysis on the colorimetry results will be presented in the full paper.

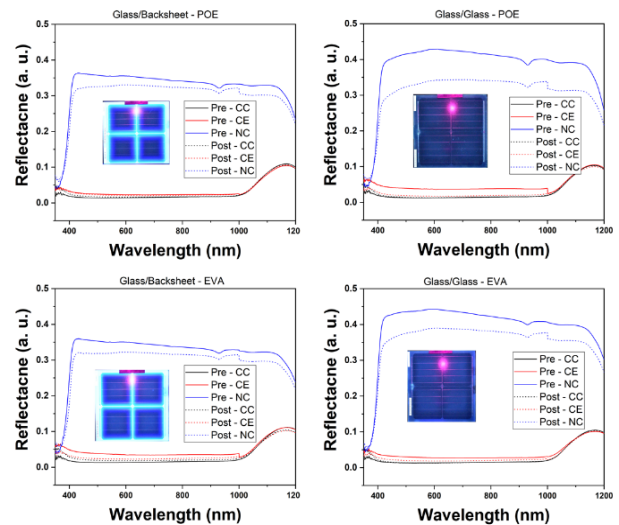
During intermittent characterization, one module, GT/POE, shattered due to handling issue and hence the results of GT modules are not presented for the DH2000 test. The reflectance spectrophotometry was performed at same location as colorimetry. The results, as shown in Fig. 3 (inset pictures of UVF images after DH2000), indicate little or no reflectance change on the cell-center areas (bandgap absorption only) and a significant decrease in reflectance at non-cell area and cell-edge

Fig 3. Reflectance results of GB and GG modules from three different locations i) CC- cell center ii) CE- cell edge iii) NC- non-cell for pre and post DH 2000 h (85 °C, 85 % RH). Inset showing the UVF images after DH2000

area in all the modules. The decrease in reflectance could be due to ingress of water vapor into the polymeric encapsulant. Moisture ingress through backsheet and/or the edges of the

laminates could be associated with reflection reduction during the DH2000 test

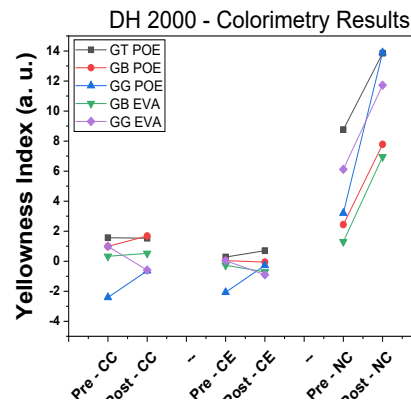
Fig 4. Pre- and post-DH2000 colorimetry results of 6 modules performed at three different locations i) CC – Cell center ii) CE – Cell edge and iii) NC – non-cell location

As shown in Fig. 4, the non-cell area displayed the highest increase in YI and the cell-center and cell-edge areas showed only small increase in YI. Additional analysis on the colorimetry results will be presented in the full paper.
