Evaluating the Durability of Balance of Systems Components Using Combined-Accelerated Stress Testing

David Miller*, Greg Perrin, Kent Terwilliger, Joshua Morse, Chuanxiao Xiao, Bobby To, Soňa Uličná, Chun-Sheng Jiang, Laura Schelhas, Peter Hacke

IEA PVPS Task 13 Meeting; Sub-Task 1.3: The impact of load factors; the future of accelerated testing

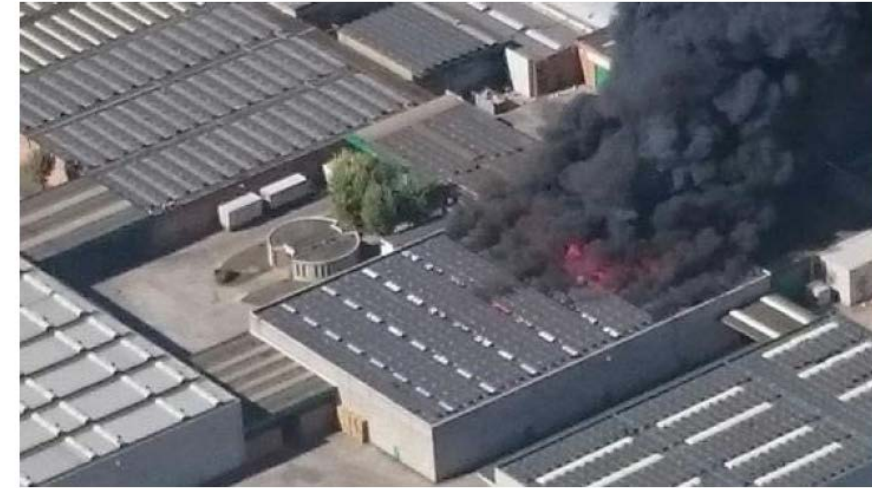
Example of PV fires in Italy.
Fiorentini et. al., PVRW 2020.

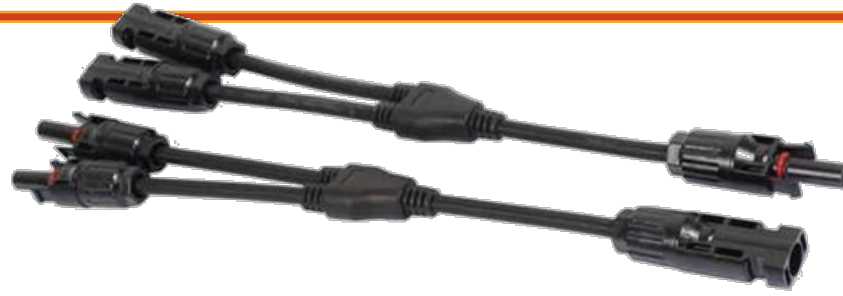
Examples of PV branch connectors.

- Utility provider experienced ~30% failure rate in their power transfer chain, attributed to branch connectors.
 - “Failure” means overheating, softening, physical distortion.
 - Distinct ΔT in thermographic imaging.
 - Worst consequences: broken circuit, arc, fire.
- Component makes & models kept confidential in this presentation.

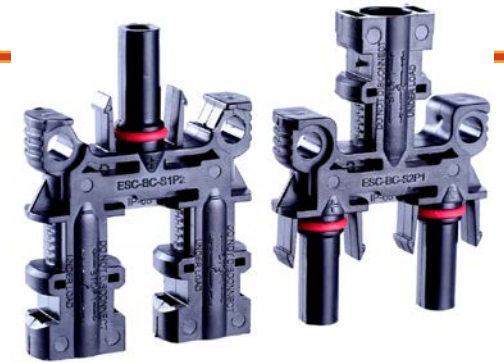
- Compare **C-AST** (here) to UL standard tests (Mike KEMPE).
- # and contribution of damage susceptible components unknown.
Evaluate all adjoining components: cable connectors, branch connectors, fuse.
- Develop fixture and software using benchtop experiments (1 replicate, previously).
- **Use custom C-AST fixture for mechanical actuation (6 replicates).**

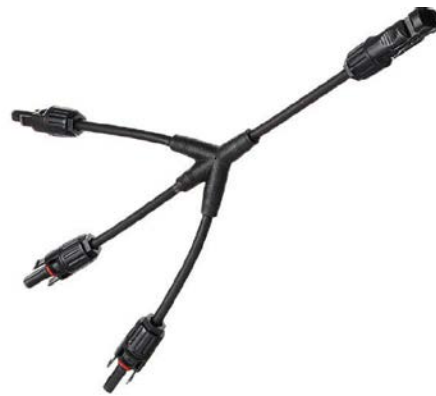
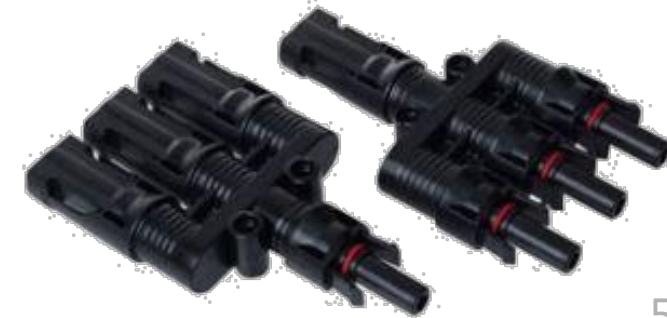
An Integrated Push/Pull Mechanical Fixture Was Used for “Dynamic” Specimens

- PV installations: cantilevered from cable → multiple DoF's.
- “Collar and push-rod” design concept selected.
- Deflection used: 3 mm (initial) → 1 mm (benchtopy) → 0.5 mm (C-AST, *this presentation*).
- Benchtopy version run with 0.27 Hz rotary DC motor.
- C-AST: perturbation depends on sequence.

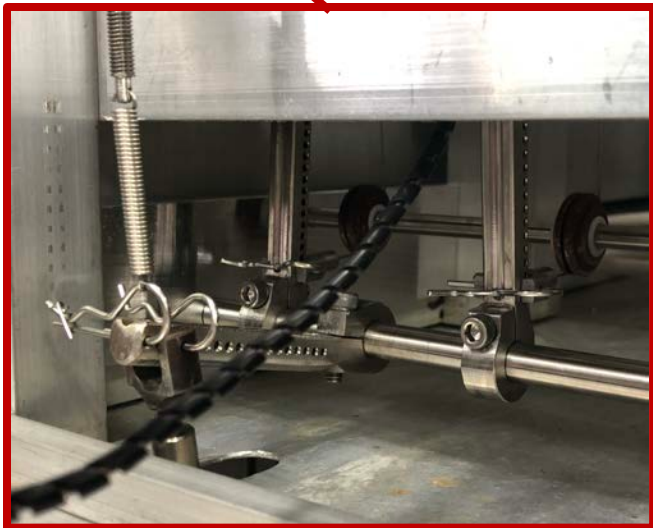
- Separate static and dynamic specimen runs, in same 1x6 fixture.
- Start at 10 A, in case of strong environmental effect.
- Repeat at 15 A (dynamic benchtop failure current).
- 4 complete C-AST runs (Winter → Spring → Tropical → Desert).
- Data sets: Live, binned, read point.

The 1x6 C-AST fixture uses a system of displacement adjustable pulleys.

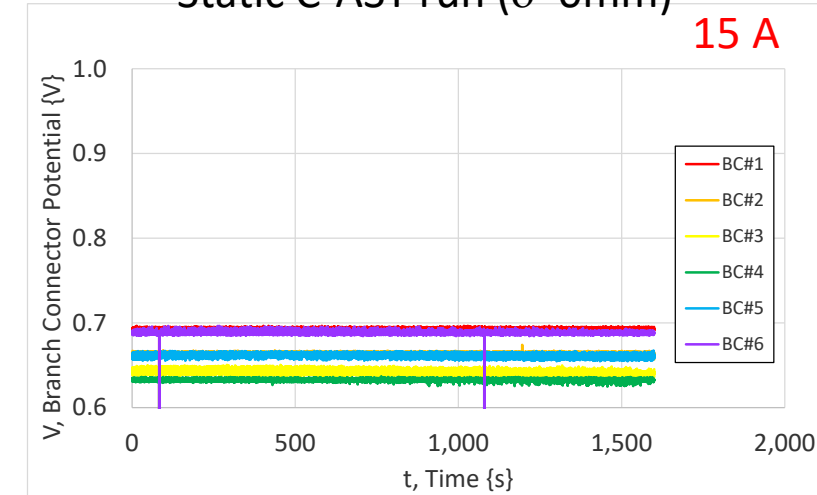
- Live measurements obtained at 10 Hz, 500 Hz, 10kHz.
- Voltage varied for current-controlled dynamic samples.
- Specimen temperature $\propto V$ (resistive heating).
- 2-3 assemblies typically ran hotter than others.
- *Transient* behavior observed for hottest specimens (10's of seconds).

Static C-AST run ($\delta=0\text{mm}$)

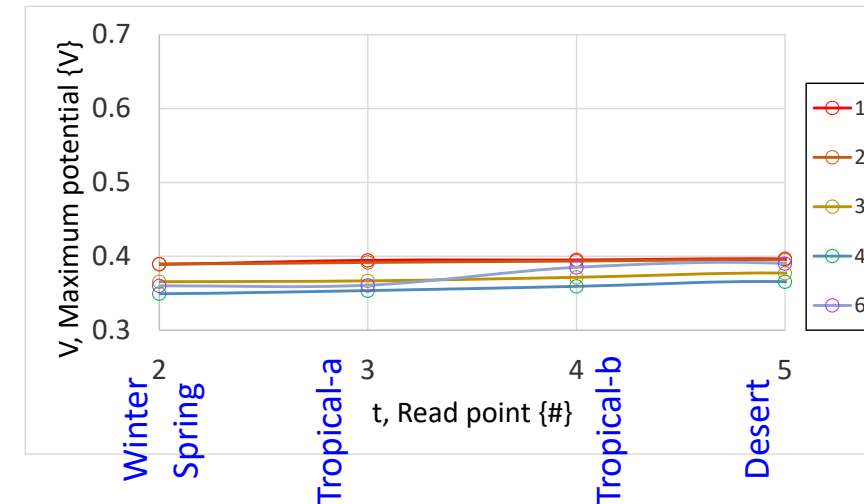
- In-situ monitoring analyzed in 1-minute bins.
 - Instantaneous (hottest) events not captured.
- *Stochastic*: V_{\max} varied with read point for specimen assemblies.
- Tropical & Desert sequences stand out.
 - Both: elevated T
 - Tropical: elevated RH %, water spray, greater # mechanical cycles
- Winter & Spring sequences give minimal effect.
 - Winter: no light (or current).
 - Spring: intermediate light (and current).

Static C-AST run ($\delta=0\text{mm}$) 10 A

Sensitivity to the combined factors of temperature and humidity (C-AST Tropical sequence) as well as elevated temperature (C-AST Desert sequence) are implied from the binned in-situ voltage monitoring.

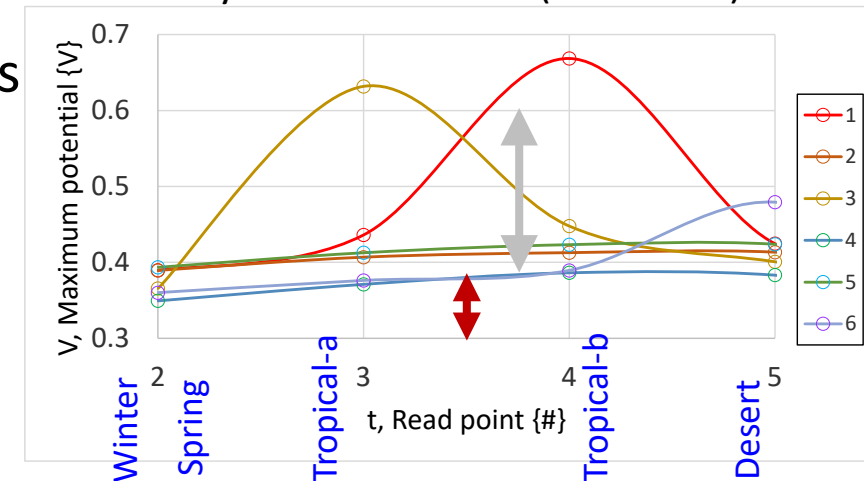
Dynamic C-AST run ($\delta=0.5\text{ mm}$) 10 A

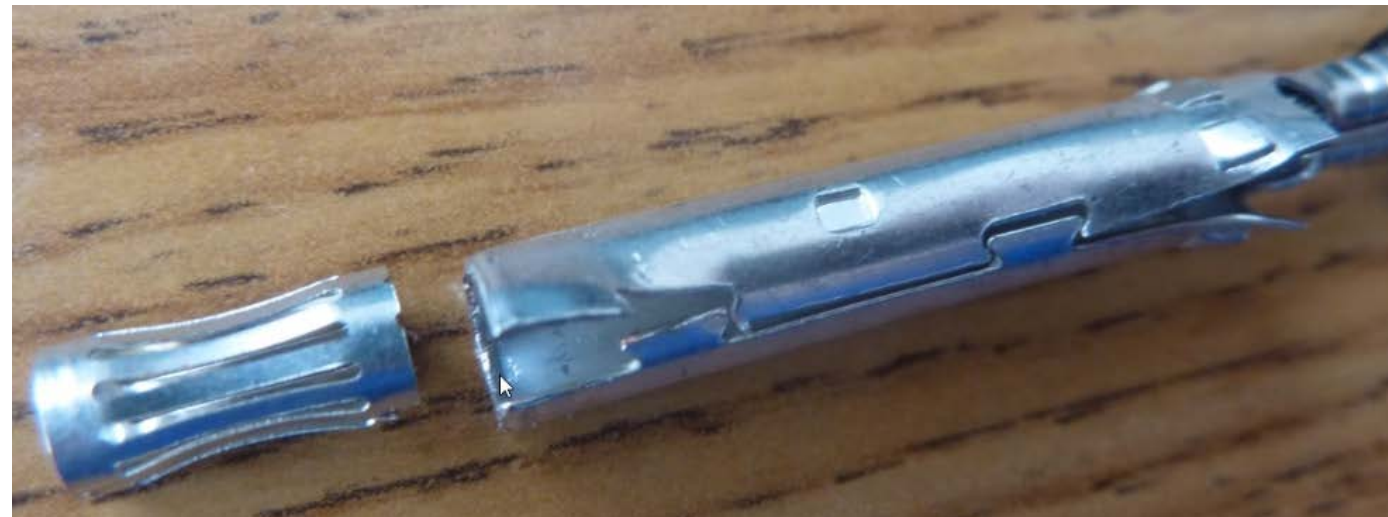
convolute spring, extracted from unaged metal pin

~8 mm

1. Remove (mill) external plastic.
 - Retain for polymer F/A (FTIR, DSC).
 - Inspect internal metal components relative to XCT.
 - Methods: camera, optical microscopy, SEM/EDS.
2. Extract (unfold) convolute spring from F metal pins.
 - Inspection, methods as above.

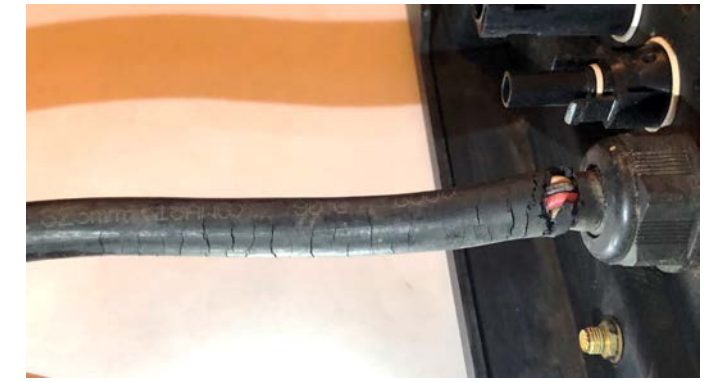
Cracking of tracker cable at the controller box.
