Evaluation of Envelope Energy in a High-Performance Manufactured Home in California

June 2023

Robert Hendron, James Haile, Stephen Becker, Stephen Chally
Frontier Energy

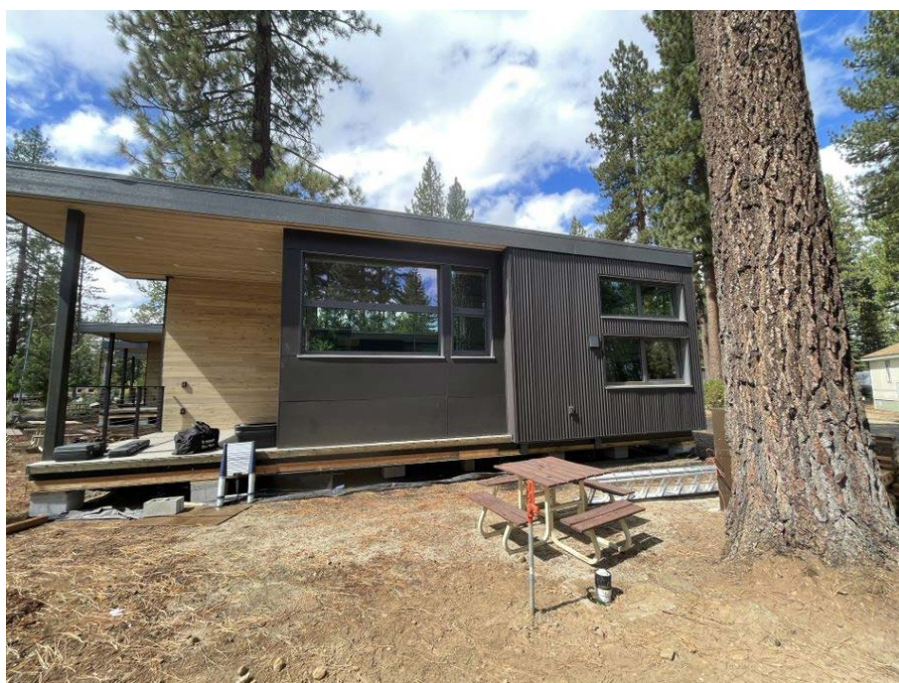
Figure ES-1. Test house in Truckee, California

The home was a Roberts model that remained unoccupied for two weeks while Frontier staff performed blower door and co-heating tests in an effort to determine the heat loss coefficient. During the tests, circuits for all space-conditioning equipment, ventilation, plug loads, and lighting were turned off. All vents were taped over to minimize infiltration caused by duct leakage to the outside. Nobody was allowed to enter the building during the test period except when adjustments were made to the instrumentation. A multipoint blower door test was performed to quantify the effective leakage area. This approach helped to minimize the number of unknowns, and focus the test on the thermal performance of the building envelope.

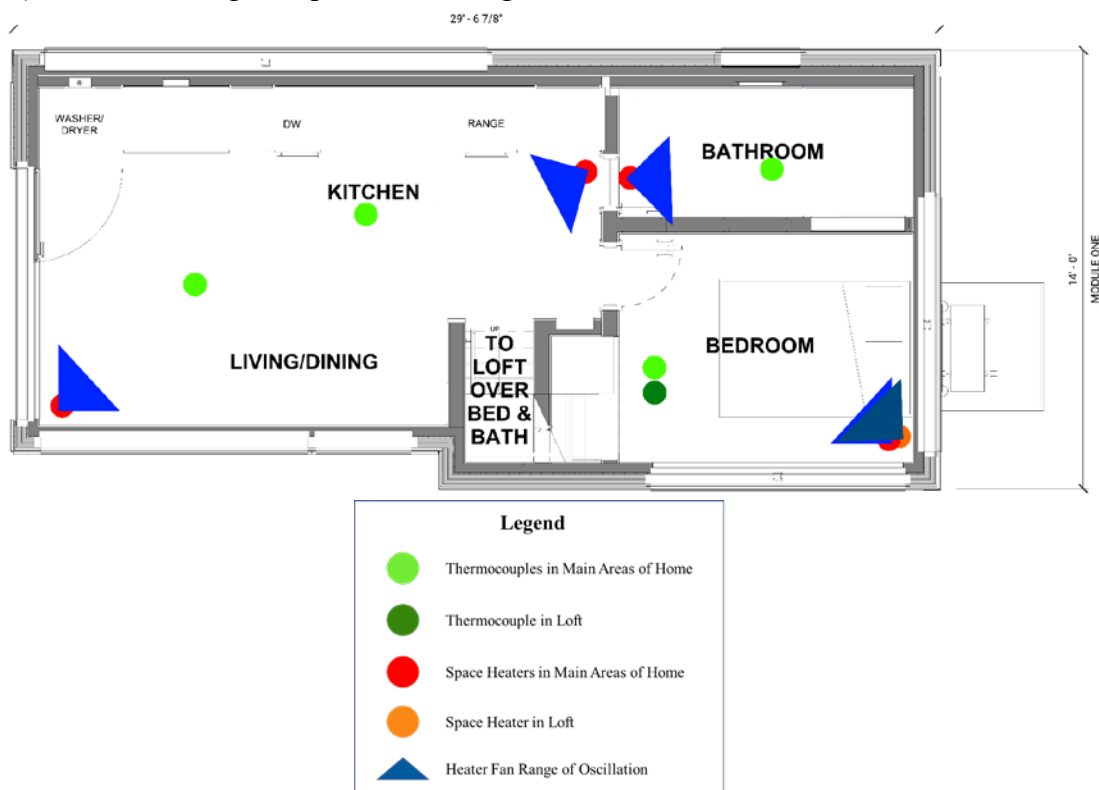
The space heaters had built-in oscillating fans and were controlled using relays and aspirated thermocouples placed throughout the house. Each heater and thermocouple pair were able to operate independently to maintain an even temperature through the entire interior space. Figure 8 shows the approximate locations for the space heaters and aspirated thermocouples. Light green circles represent the aspirated thermocouples (dark green circle is the aspirated thermocouple in the loft). Red circles represent the space heaters (the orange circle represents the space heater in the loft), and blue triangles represent the range of oscillation.

Figure 8. Layout of sensors and space heaters in the test home

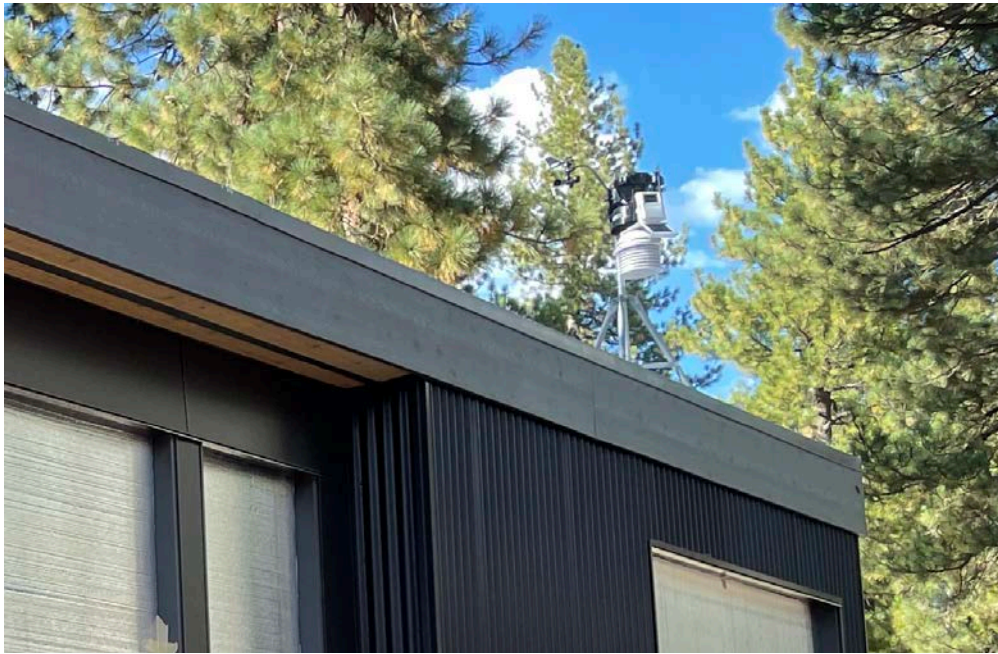
The weather station was installed on the roof of the home, in the northeast corner approximately 14 feet off the ground where it would provide clean readings of wind and solar radiation (Figure 9). The station included monitoring of outdoor temperature, relative humidity, wind speed and direction, ultraviolet radiation, and total global radiation. A closer view of the weather station at the Davis Laboratory is shown in Figure 10.

Figure 9. Weather station installed on top of the test home

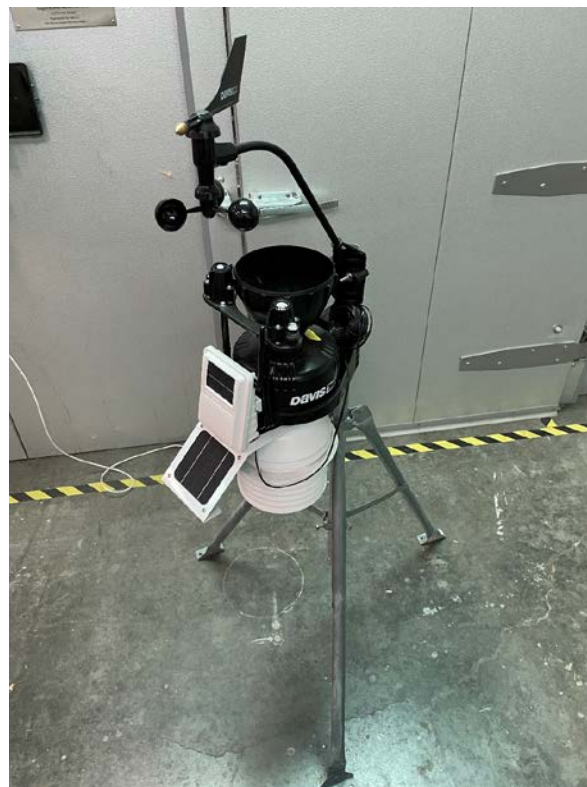
Figure 10. Davis Vantage Pro 2 weather station

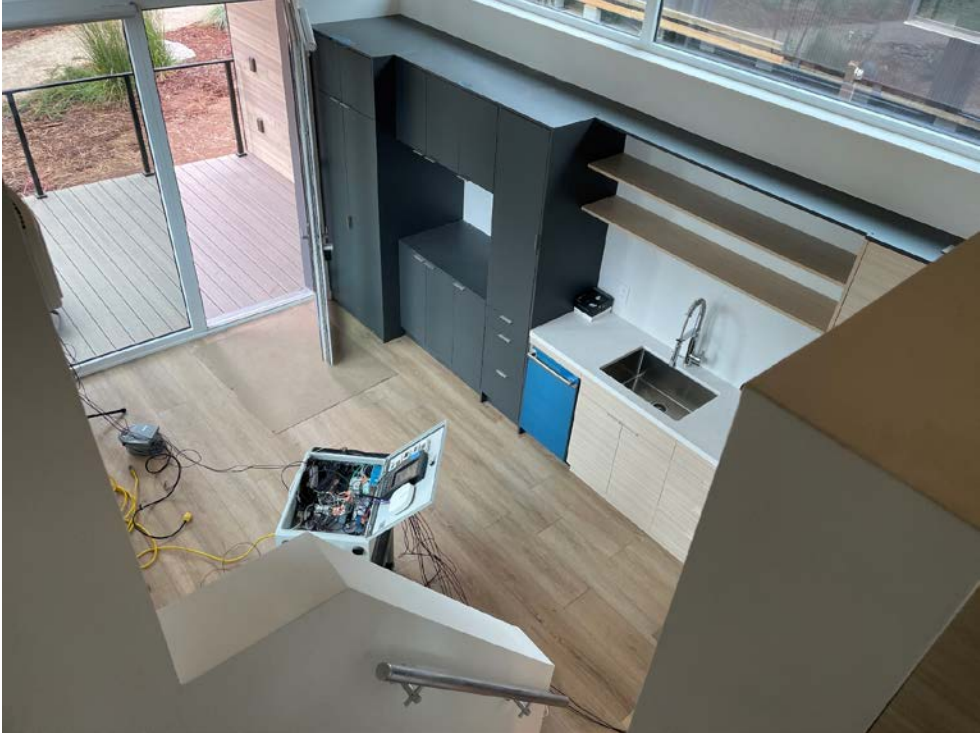
Figure 11. Monitoring and control system at the test home

The data monitoring system used to control the co-heating system and measure the indoor and outdoor thermal conditions is shown in Figure 11. The space heaters and aspirated thermocouples for the bedroom and loft are shown in Figure 12 and Figure 13, respectively. The

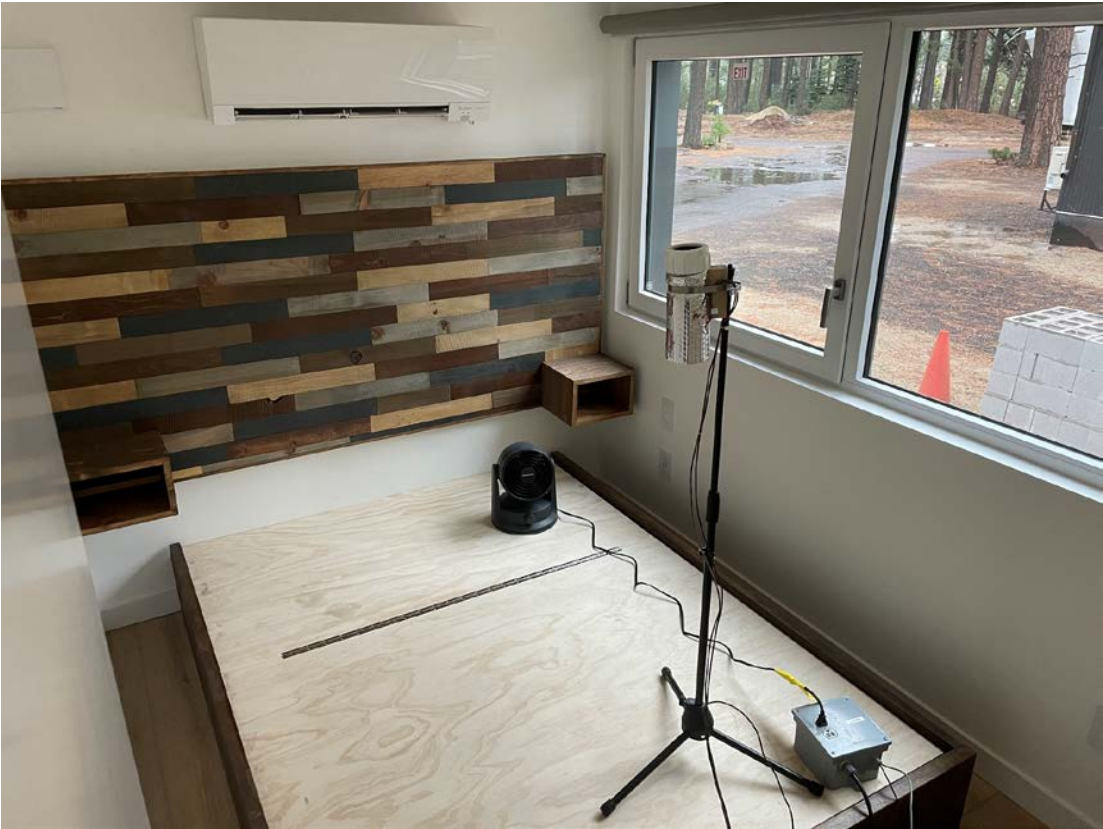
Figure 12. Space heater, controller/watt node, and aspirated thermocouple in the downstairs bedroom

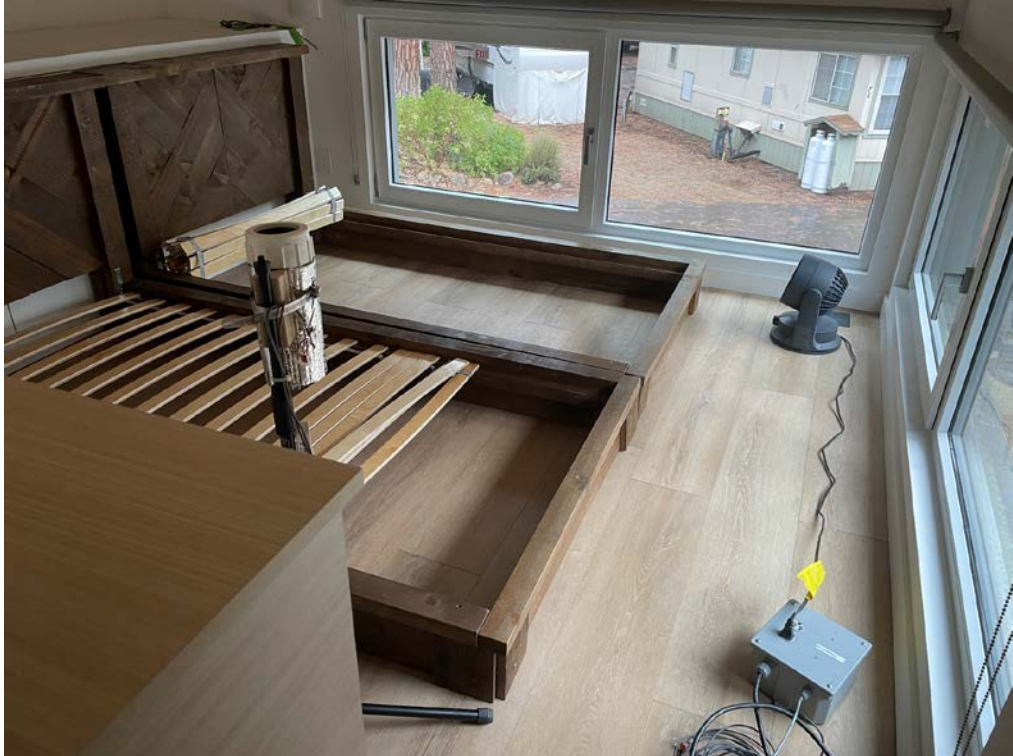
Figure 13. Space heater, controller/watt node, and aspirated thermocouple in the loft

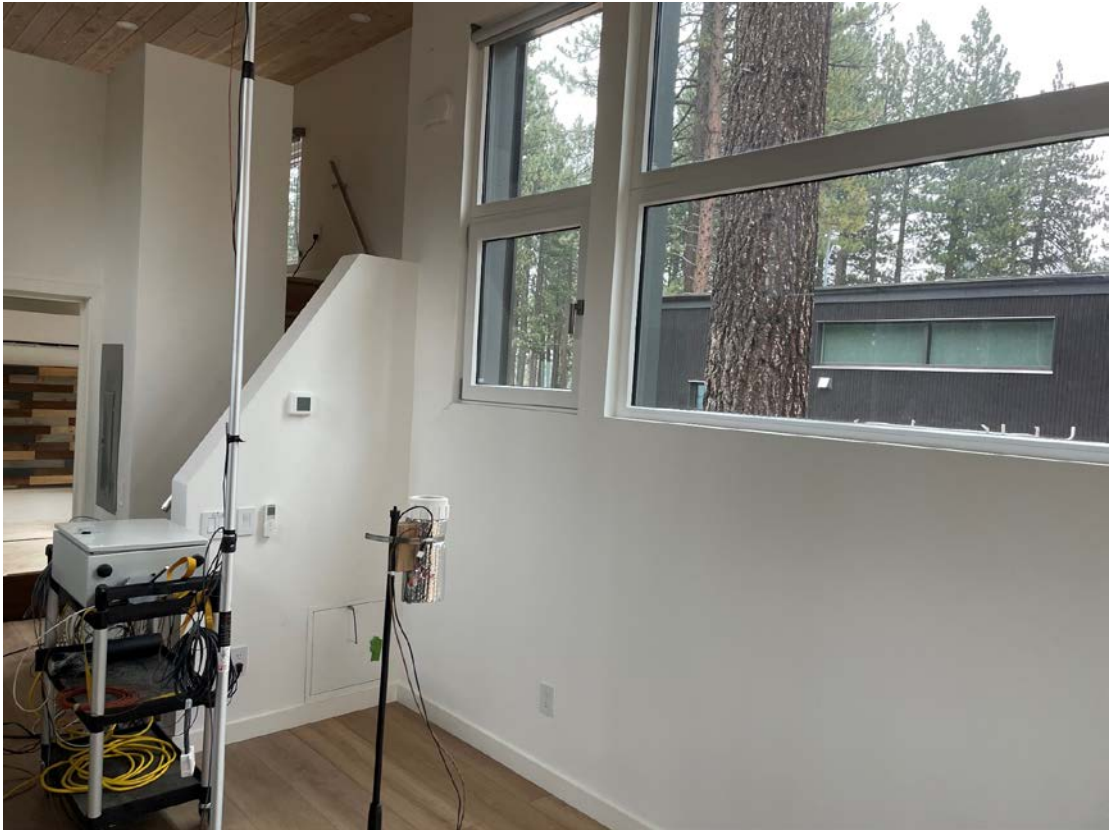
Figure 14. Thermocouple array for measuring thermal stratification (left) and aspirated thermocouple (center) in the main living area

test rig for monitoring temperature stratification is shown in Figure 14. The HOBO temperature and relative humidity sensors installed in the chassis area under the home are shown in Figure 15.

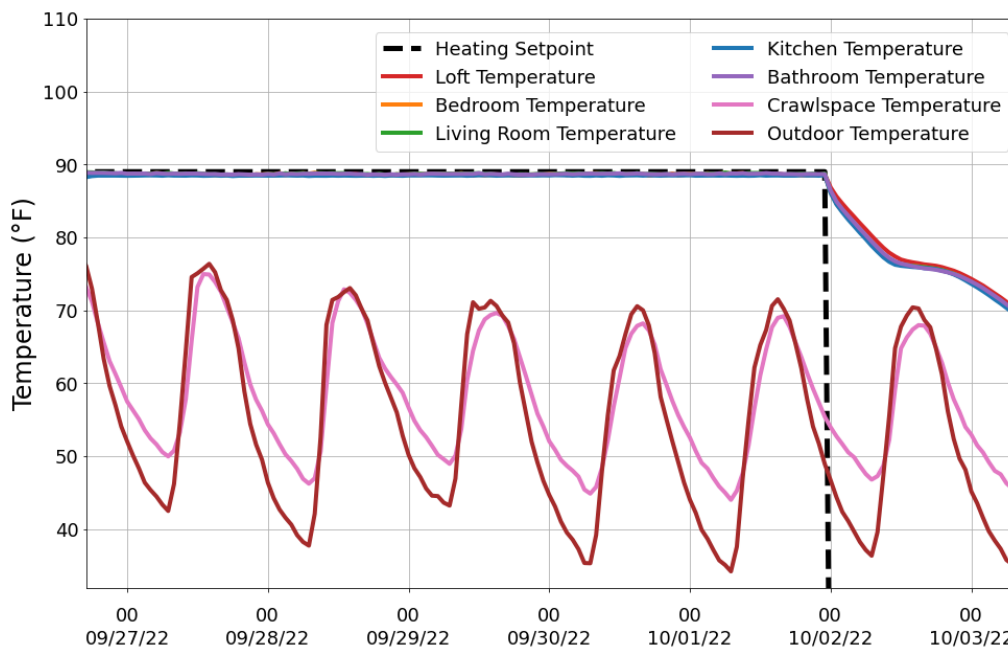
Prior to beginning the second week of testing, the loft heater was reconnected and the windows were covered with R-7.7 foam insulation with foil facing to minimize solar gains and simplify the calibration process during that period. The interior temperatures were more uniform during the second week, and the morning spike in interior temperature due to solar gains observed during Week 1 disappeared, most clearly shown during the floating period. These improvements made model calibration more viable during the second week. No issues with data communication, malfunctioning sensors, or visitors entering the home were encountered during the test period.

Figure 22. Indoor, outdoor, and crawlspace temperatures during Week 2

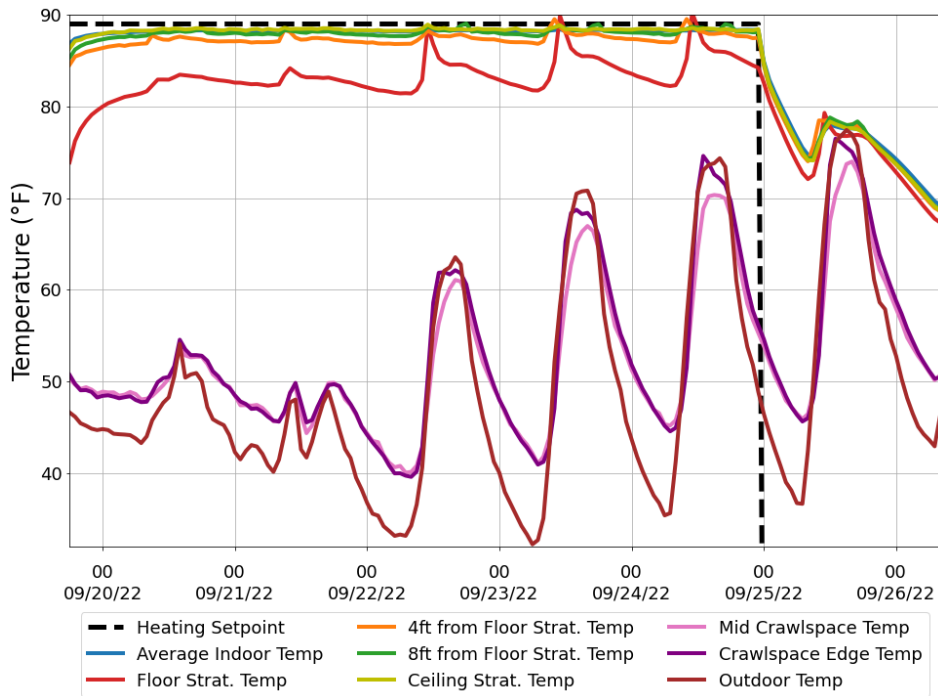
Additional temperature and relative humidity readings are shown in Figure 25 through Figure 28 for Week 1 and Week 2, respectively. Thermal stratification within the space was generally limited to 2°–3°F during Week 1, while the floor was 4°–6°F cooler than higher points in the space, except when the sun was directly striking it late in the morning. Stratification was greatly mitigated during Week 2 when the windows were covered, and was also smaller when the space heaters were turned off. Indoor relative humidity remained at 30%–35% throughout the test

Figure 25. Miscellaneous temperature readings during Week 1

The two temperature readings in the crawlspace (one in the middle and one near the perimeter) were very similar, indicating that one sensor would probably be adequate for future tests, although the addition of skirting could affect this conclusion. The crawlspace relative humidity approached 90% at times early in the test when it was cold and wet outside, but remained below 70% following several days of sunny, dry weather. Moisture potential could become a concern once skirting is added, but the current data shows the crawlspace relative humidity remaining within reasonable limits.

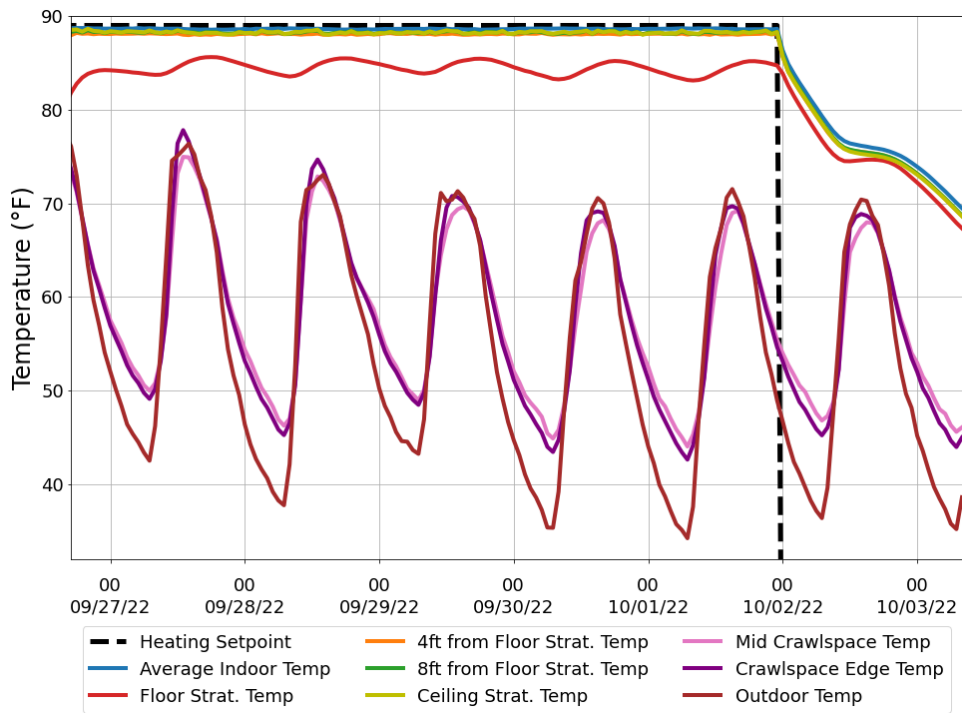
Figure 27. Miscellaneous temperature readings during Week 2

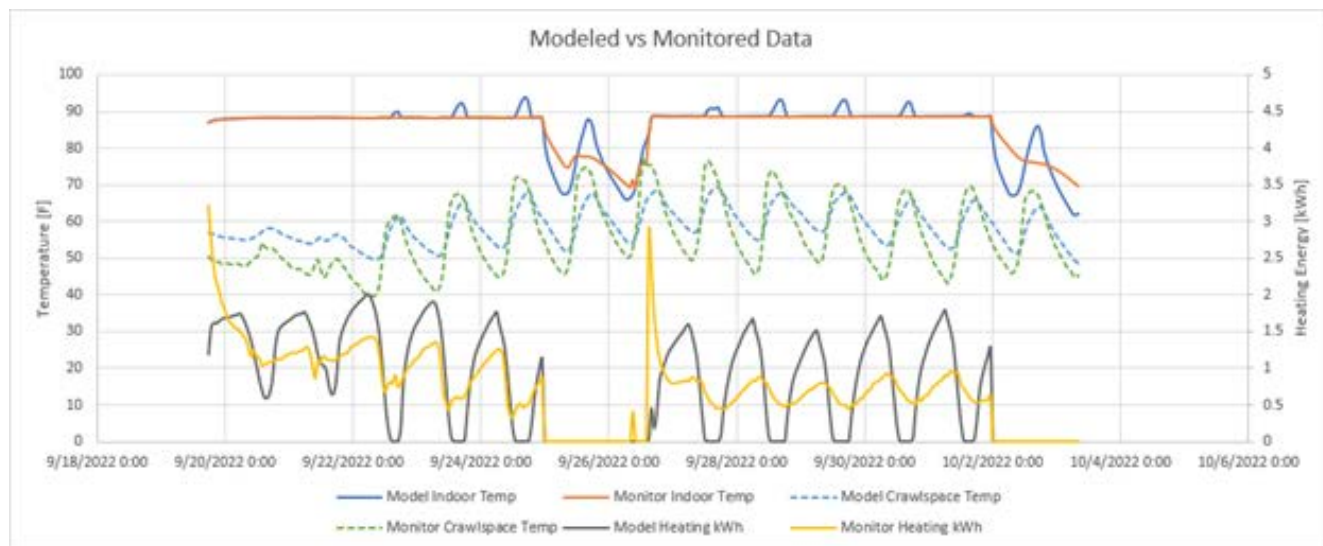
Initial modeling results using construction specifications combined with actual operating conditions as well as measured leakage area and weather conditions are presented in Figure 29. Although average values for all metrics were relatively consistent between the monitored and modeled data, the interior of the home was clearly much less responsive to weather changes than the model predicted. This strongly suggested that the initial estimate of thermal mass was far too low, and possibly the rate of heat transfer to and from the thermal mass was too high in the model. Conversely, the crawlspace temperature responded more quickly to weather changes than the model predicted, suggesting that the ventilation rate was much higher in reality than initial assumptions.

Figure 29. Initial comparison of modeled results to measured data prior to calibration

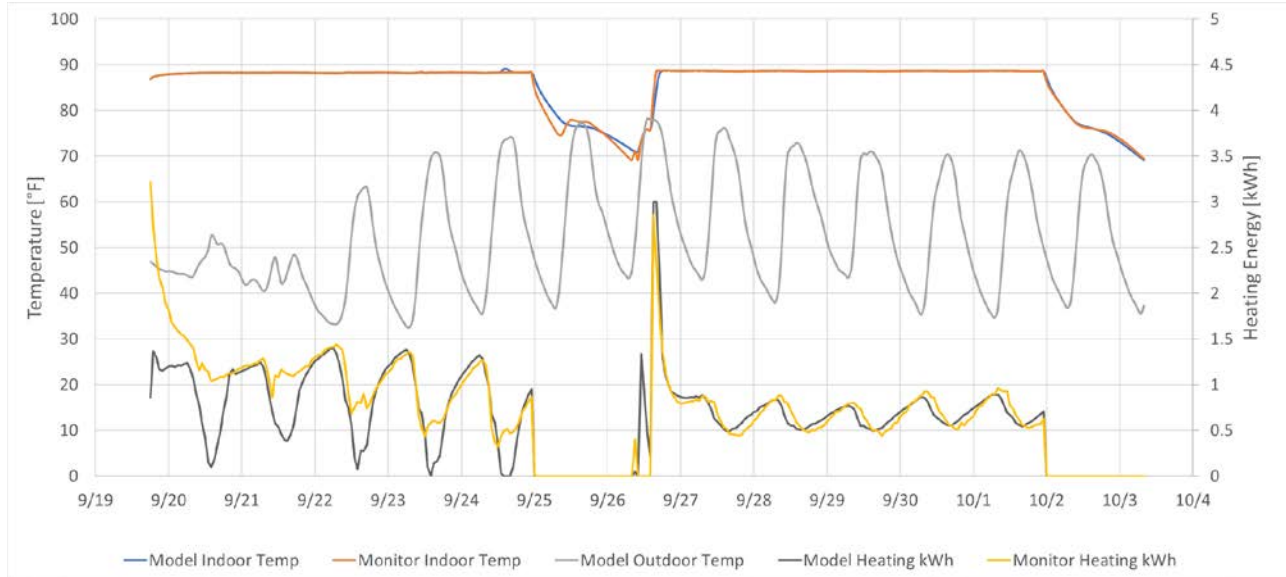
Figure 30 compares key measurements with the results of the final calibrated model. We did not attempt to calibrate the model during the first week because of the complicated shading provided by nearby trees and homes, along with the interior temperature nonuniformity caused by one of the space heaters not working. We therefore focused on the second week, where we were able to match the average envelope UA within 4% (21.4 W/°F in the model compared to 22.2 W/°F based on measurements) during the consistent weather period from Sept. 28 to Oct. 1. The maximum and minimum heating requirements also matched very closely, indicating the UA in the model was very accurate. Thermal mass in the final model also caused the floating temperatures to match measured data very closely from Oct. 2 to Oct. 3.

The wall and ceiling U-values were not changed from their nominal design specifications, because there was no indication from the calibration process that these components performed better or worse than expected. The house seemed to respond to outdoor temperature cycling more slowly than the model predicts, but overall thermal mass and UA seem accurate. Possible explanations could be the heat transfer rate to and from thermal mass, the proportion of thermal mass that is inside the house versus outside, and inaccurate modeling of air infiltration (e.g., crack size and location) as a function of weather. We will consider additional measurements or tests that could be performed using the vacuum-insulated panel prototypes to shed light on this difference between modeled and measured thermal response times. Tracer gas testing would have shed light on the responsiveness of the house to infiltration drivers such as temperature and wind speed, but was not affordable within the scope of this project. However, it may be necessary in future tests to minimize the uncertainty of infiltration as a function of weather.

Figure 30. Final comparison of modeled results to measured data after calibration
