Operating Conditions of a Main Bearing Contact in a Commercial Wind Turbine

Yi Guo, *Technical University of Denmark*

NREL/PR-5000-86519

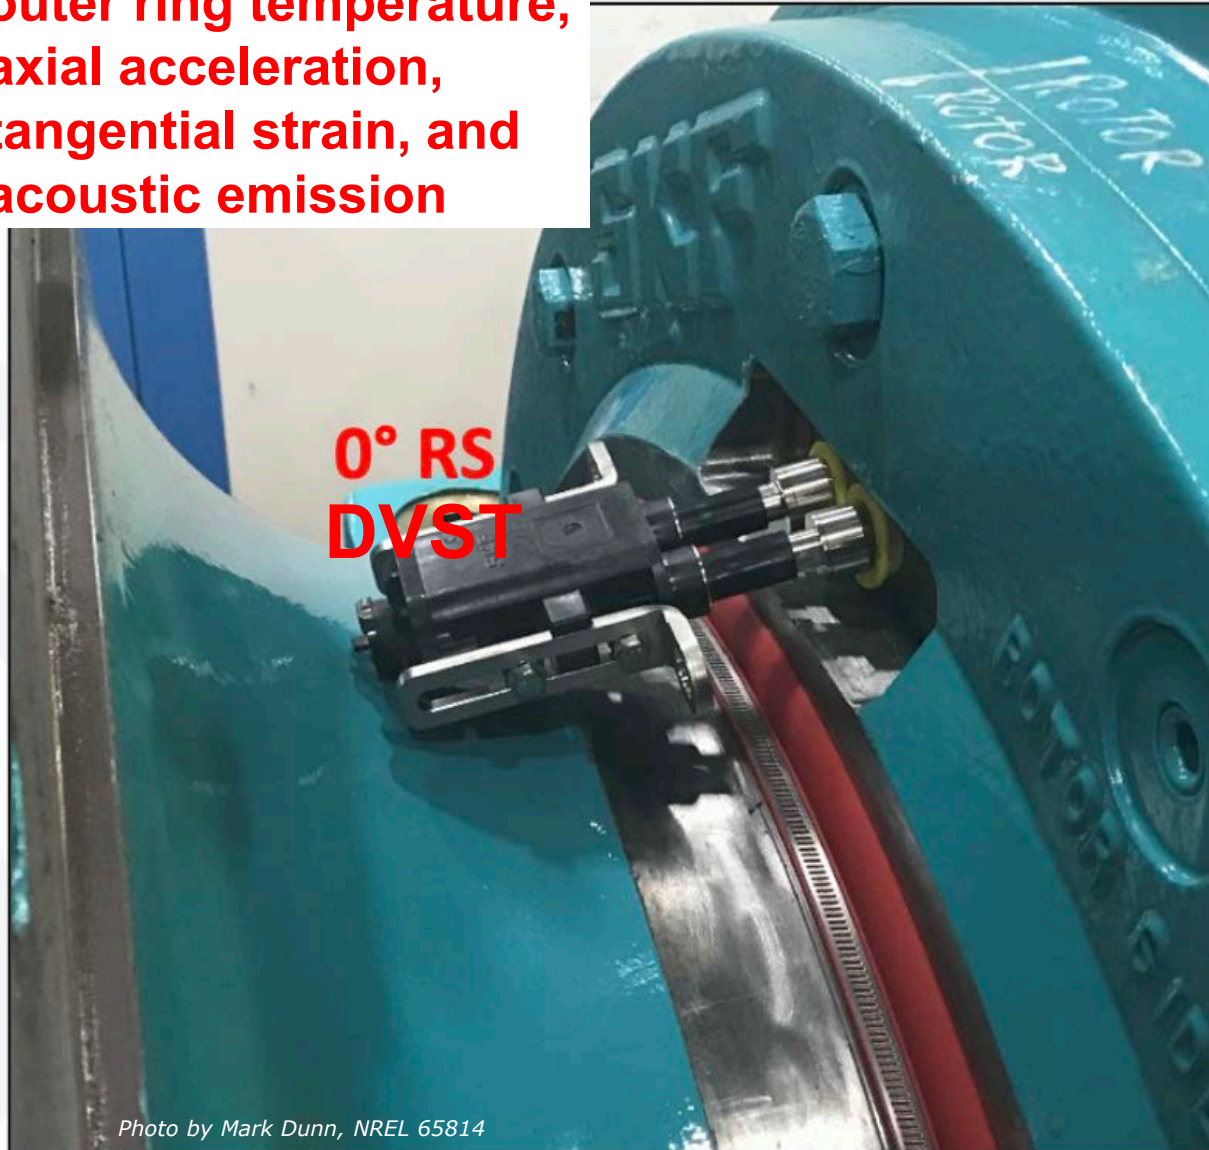
Generator-side (GS)

Rotor-side (RS)

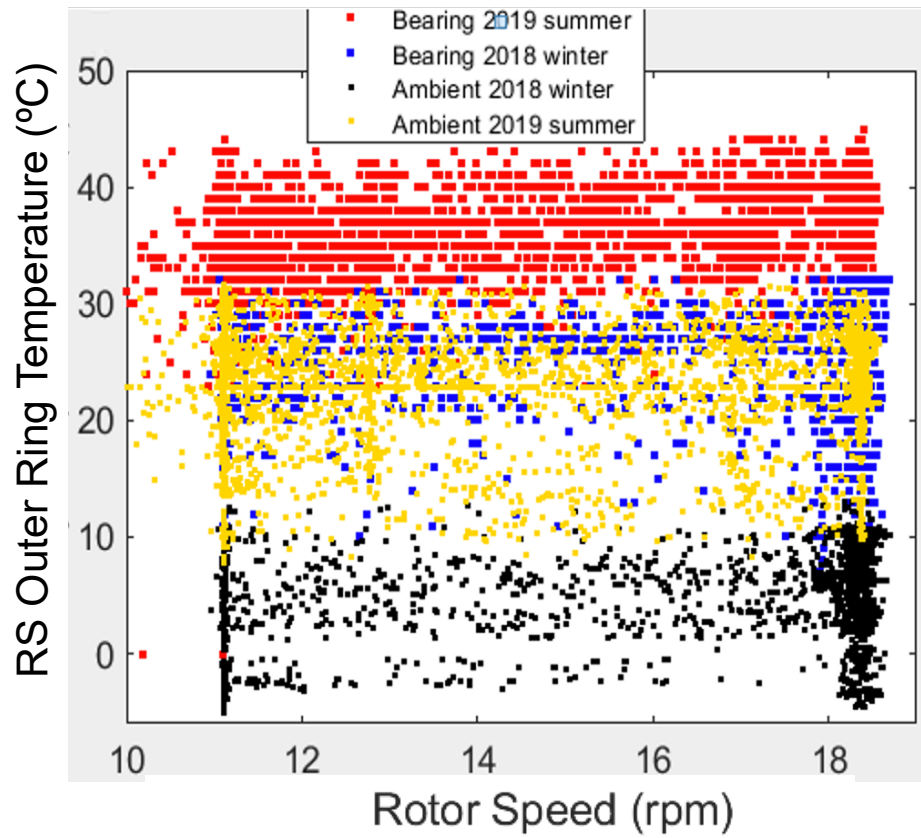
Operating Temperature of Main Bearing Outer Ring

- Operational temperatures of healthy main bearings are typically between 5°C and 47°C
- Bearing temperature approximately 20°C to 25°C higher than ambient
- In summer, bearing temperature roughly 15°C higher than winter
- Bearing temperature does not increase meaningfully with rotational speed

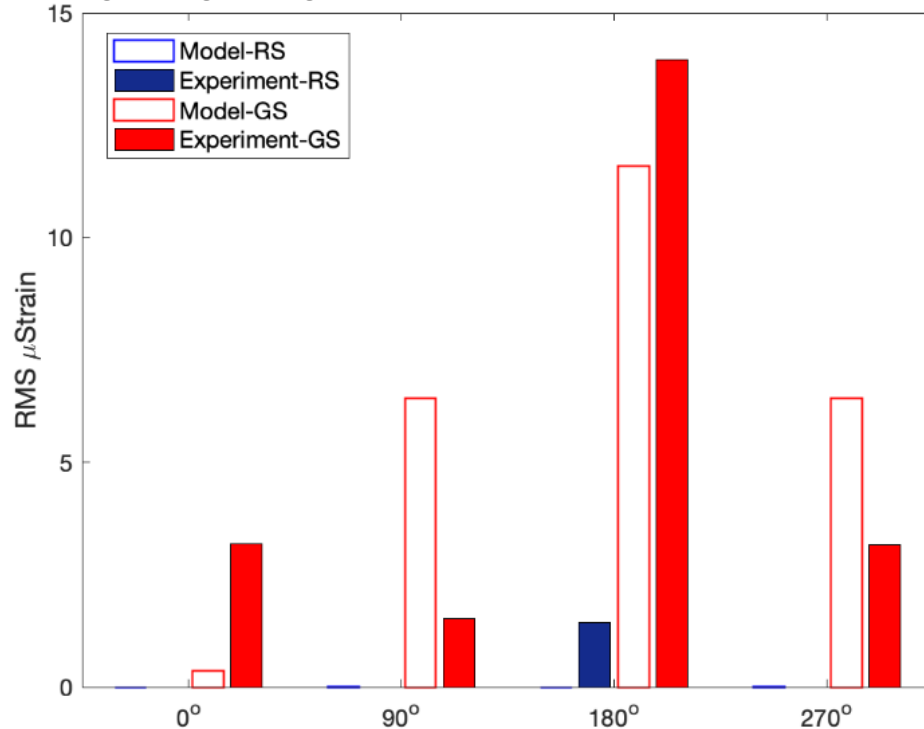
Bearing Ring Tangential Strain at Rated Wind Speed

- Agreement between experimental and modeling results reasonably good
 - Nature of the contact (rather than bonded) strain gauge – data drifting might occur
 - Lack of bedplate and other model details
- Highest strain occurs at 180° when load highest
- Rotor-side bearing row almost unloaded

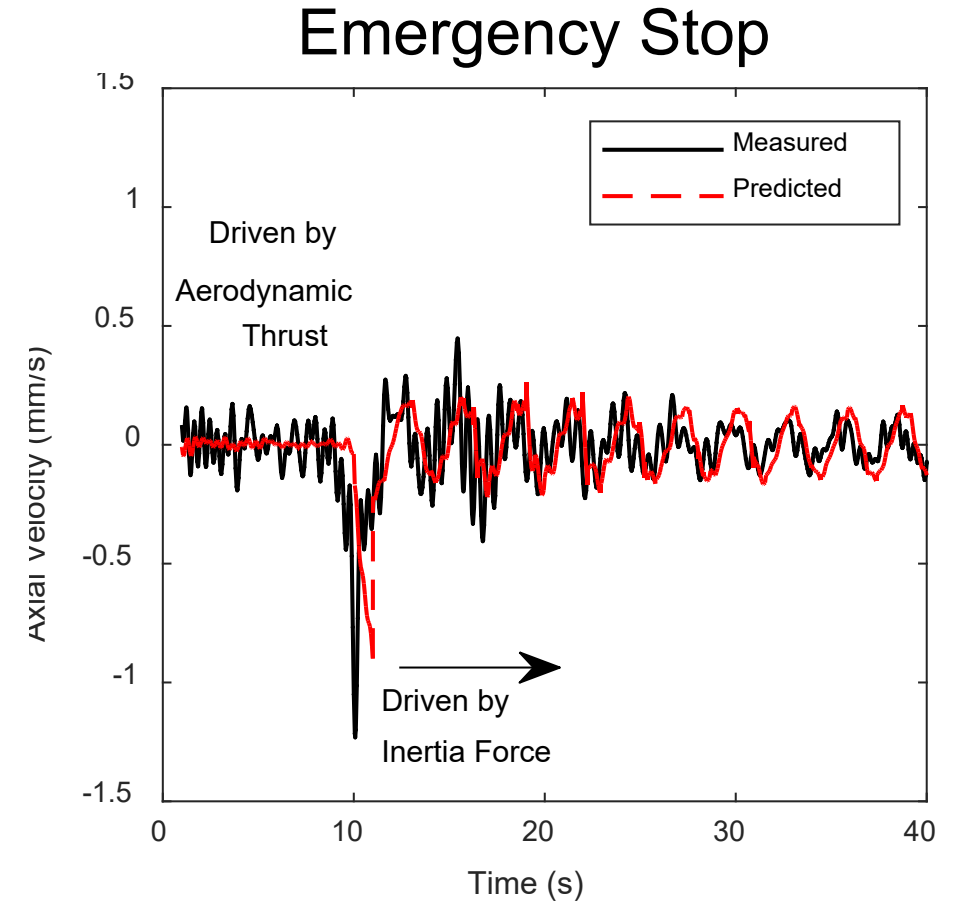
Relative Axial Velocity Between Bearing Rings

- Axial motion within axial clearance in spherical roller bearings – up to several millimeters
- When axial velocity < 10% of speed of rolling (352 mm/s), no appreciable effects on lubrication film (threshold based on SKF experiments)
- Measured maximum axial velocity < 1.5 mm/s during emergency stop – lubrication film deterioration not anticipated
- Generally good agreement between model and experimental results

- *Does axial roller/raceway motion damage main bearing?*
 - *Relative axial velocity between bearing rings much lower than speed of rolling – lubrication film deterioration not anticipated*
- *Does the bearing cage slip during operation?*
 - *No appreciable cage slip discovered for the generator-side row*
 - *No cage slip anticipated for the rotor-side row because of shared cage*
 - *Roller slip might still exist*
- *Is there metal-to-metal contact between the rollers and raceways?*
 - *Spikes and elevated values of the acoustic emissions present during operations*
 - *Lubricant film might not be sufficient to prevent asperity contacts in some conditions*

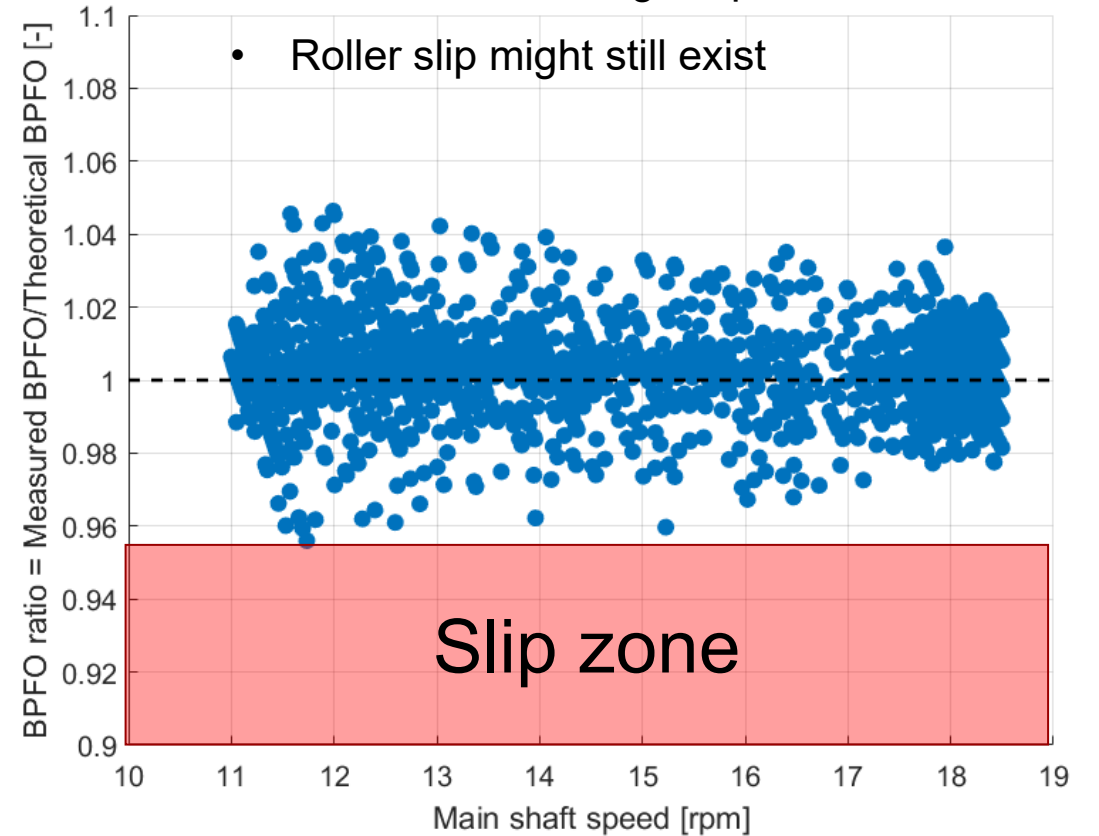
- No evidence of cage slip!
- Roller slip might still exist

BPF0 = ball-pass frequency for the outer ring

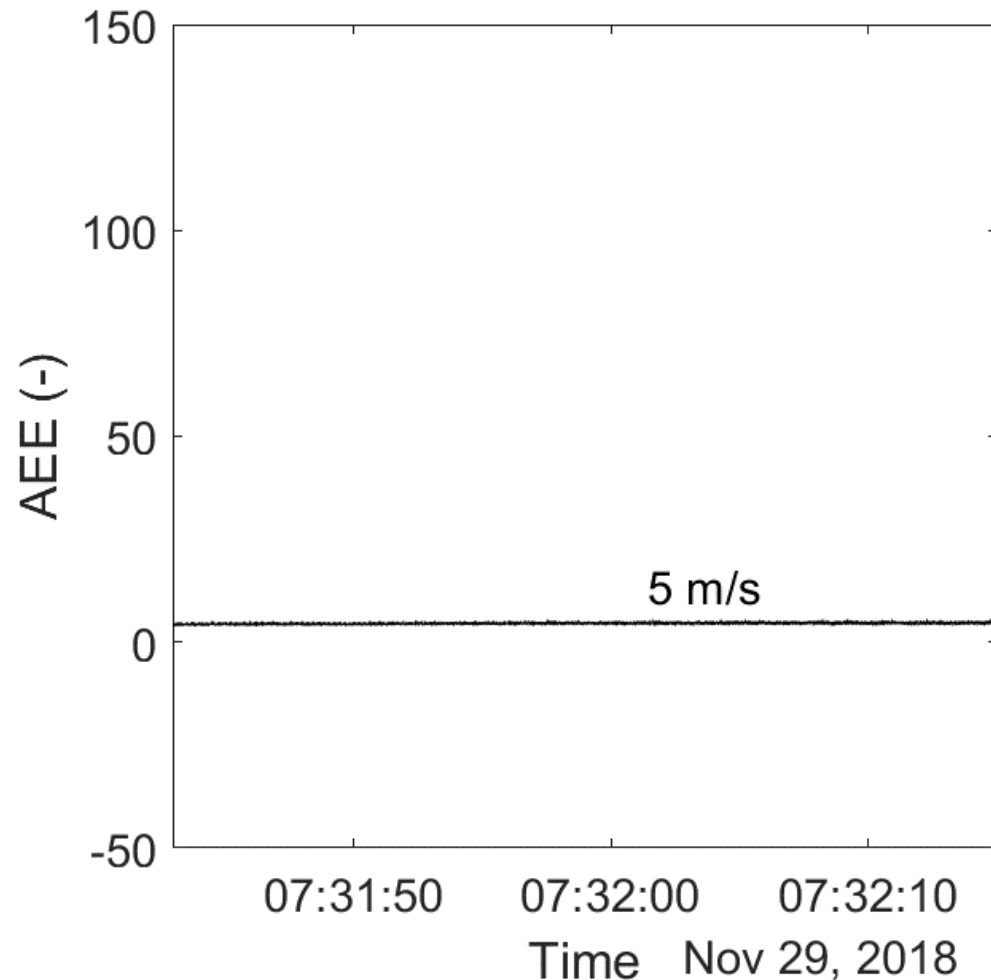
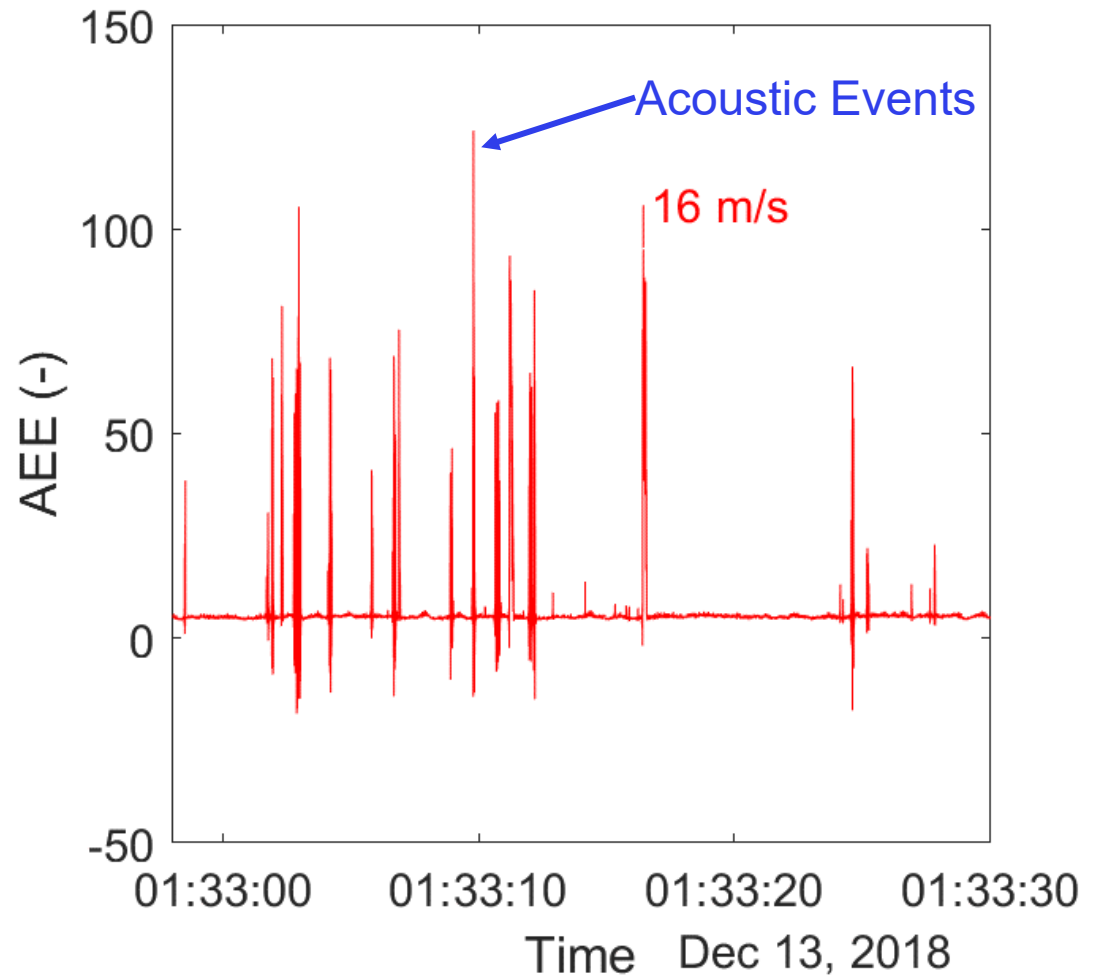
Measurement Results – AEE Wave Forms (Rectified and Enveloped)

**Is there metal-to-metal contact
between bearing surfaces?**

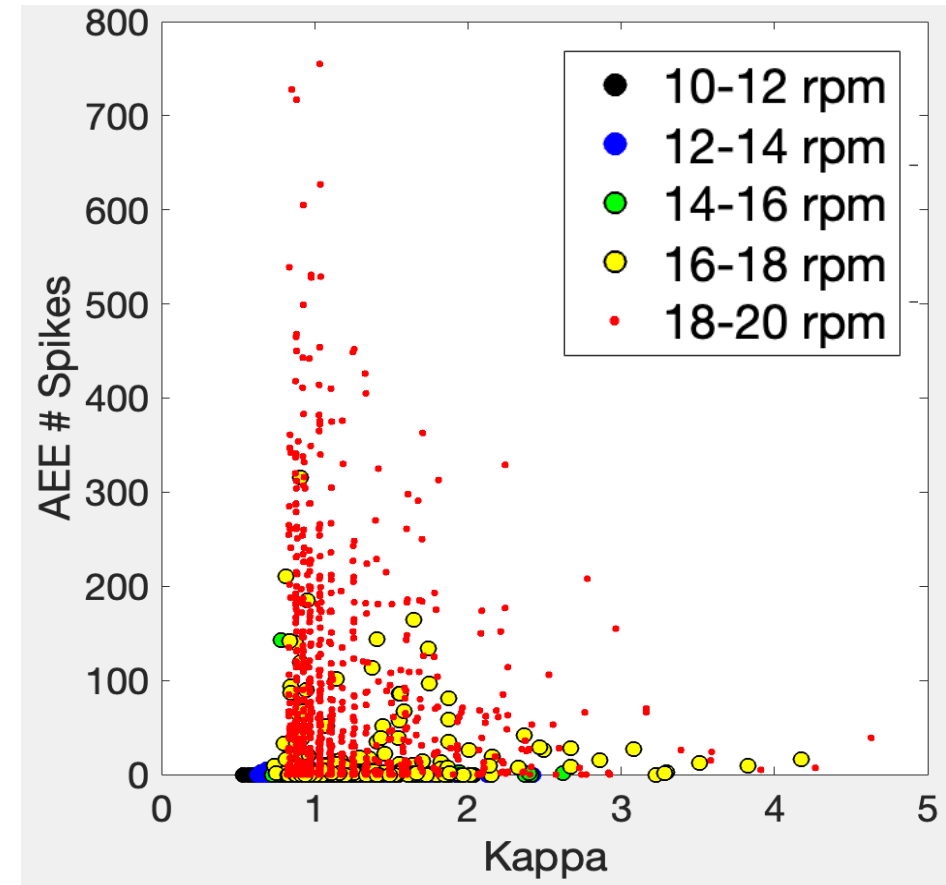
Acoustic Emission vs. Kappa (Viscosity Ratio)

- Kappa can indicate lubricant conditions, with a typical desired range from 1 to 4
- When Kappa is less than 1, risk of roller/raceway asperity contact present
- Main bearing is often under mixed lubrication during normal operation
- Elevated AEE spikes combined with low Kappa may indicate roller/raceway asperity contact
 - Kappa ≈ 1 and main shaft speed ≥ 18 rpm
