Mechanical Failure Risk Management for In-Service CSP Nitrate Hot Tanks

Timothy Pickle,¹ Chad Augustine,² and Zhenzhen Yu¹

**Technical Report
NREL/TP-5700-87615
February 2024**

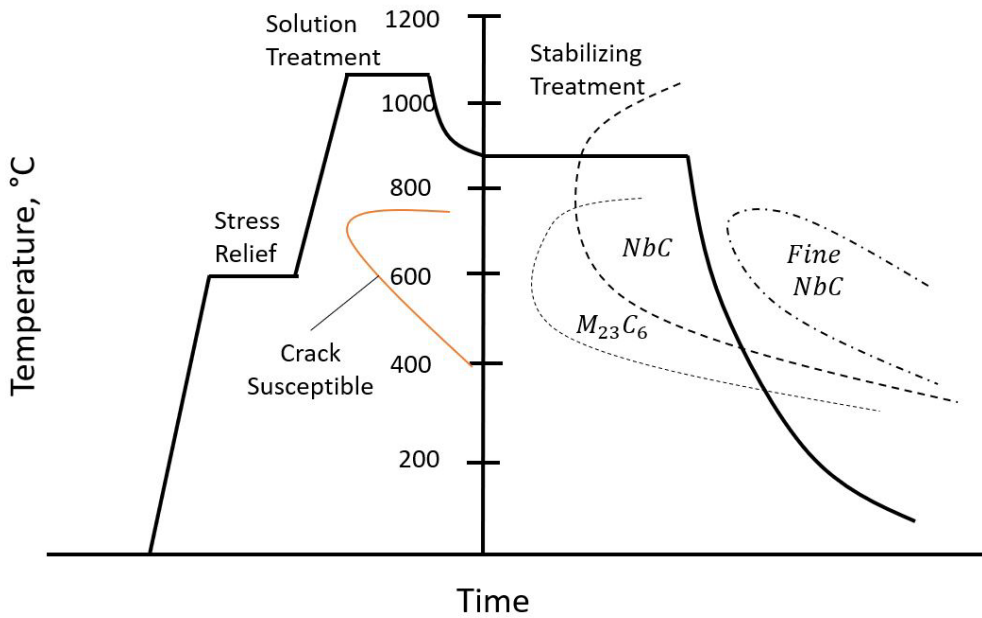
Figure 2. Multi-step PWHT overlaid on cracking and precipitation c-curves (adapted from [8])

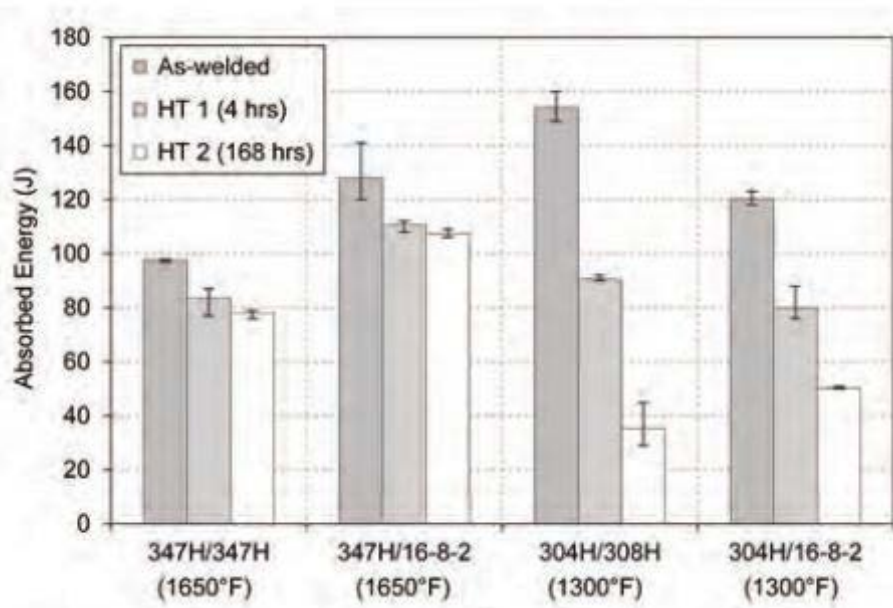
Figure 5. Demonstration of improvement in Charpy v notch toughness (absorbed energy) when using 16-8-2 as a weld filler for both 347H and 304H SS welds.

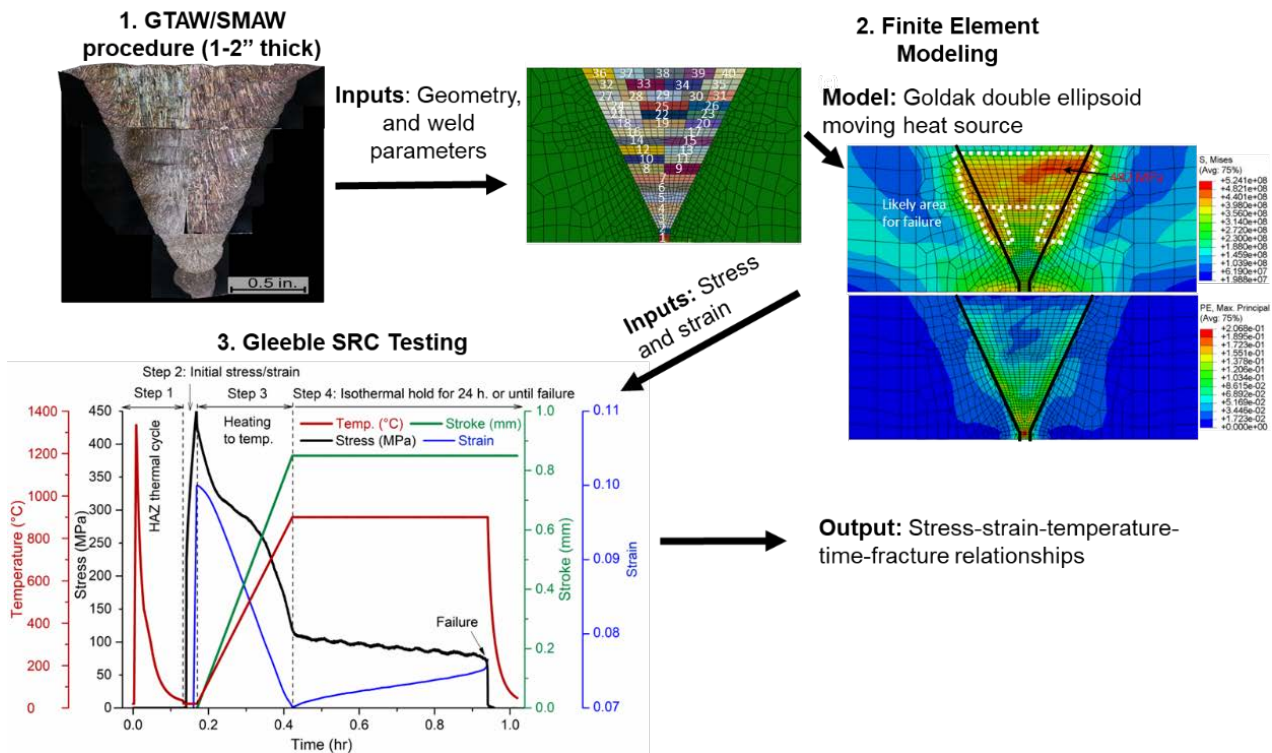
Figure 6. Flow chart of work completed in project 33458, including welding experiments, FEM, and Gleeble SRC testing

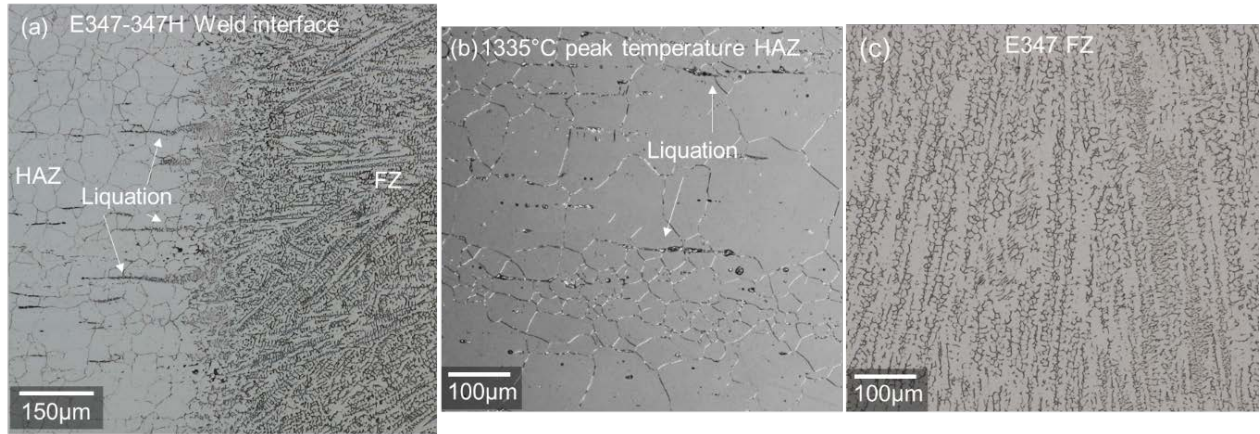
Figure 7. Light optical microscopy of weld microstructures of (a) weld FZ boundary region showing HAZ and FZ, (b) Gleeble 3500 physically simulated HAZ microstructure with 1,335°C peak temperature and (c) E347 FZ microstructure

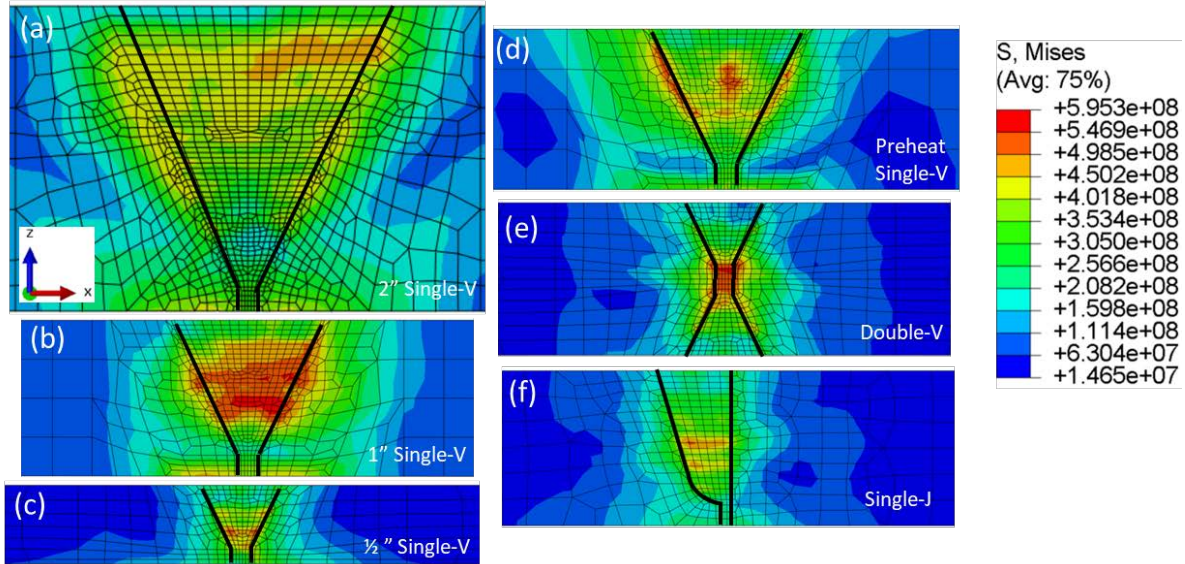
Figure 9. Effect of weld joint geometry, thickness, and preheat on von Mises residual stress. (a) 2" thick plate single V, (b) 1" thick plate single V, (c) ½" thick plate single V, (d) 1" thick single V w/ 232°C preheat and interpass temperature, (e) 1" thick plate double-V, and (f) 1" thick plate single J groove weld. (adapted from [36])

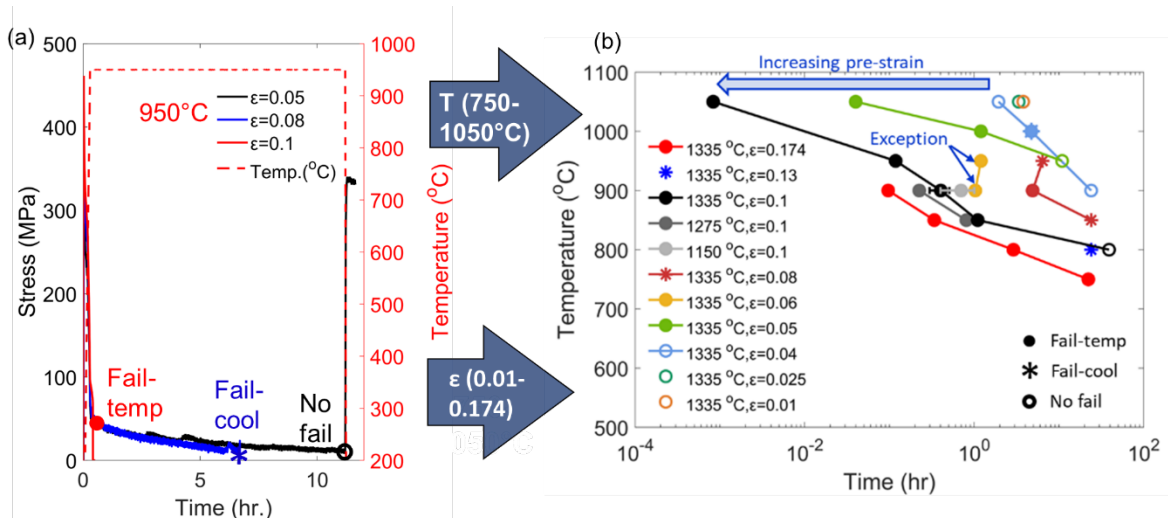
Figure 10. SRC curves for 950°C temperature condition as example and temperature-time plot grouped as a function of plastic strain for all 1,335°C HAZ tests

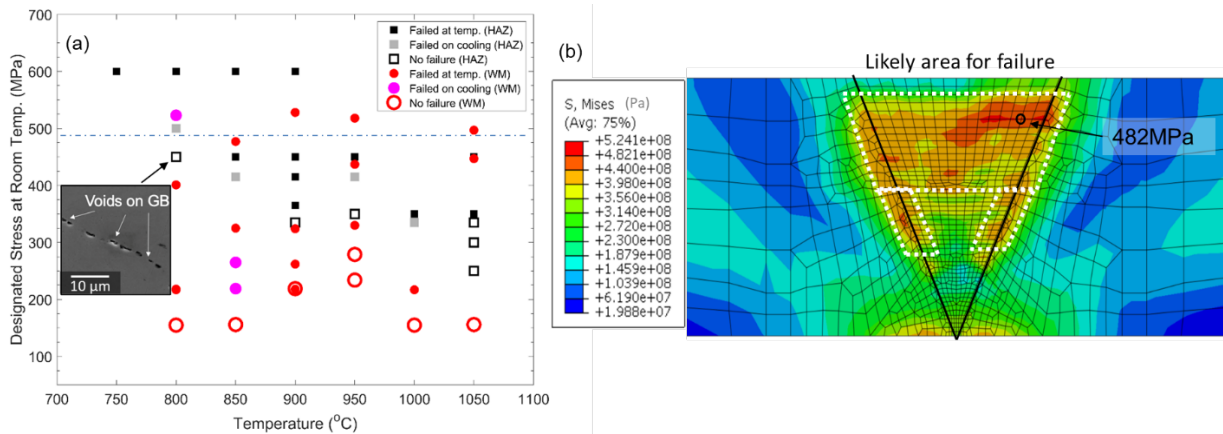
Figure 15. (a) Crack susceptibility map of initial applied stress as a function of test temperatures for 347H 1,335°C HAZ and E347-347H SS cross-welded samples with failure in the weld metal (WM) and (b) FE von Mises map of 2" thick single-V weld

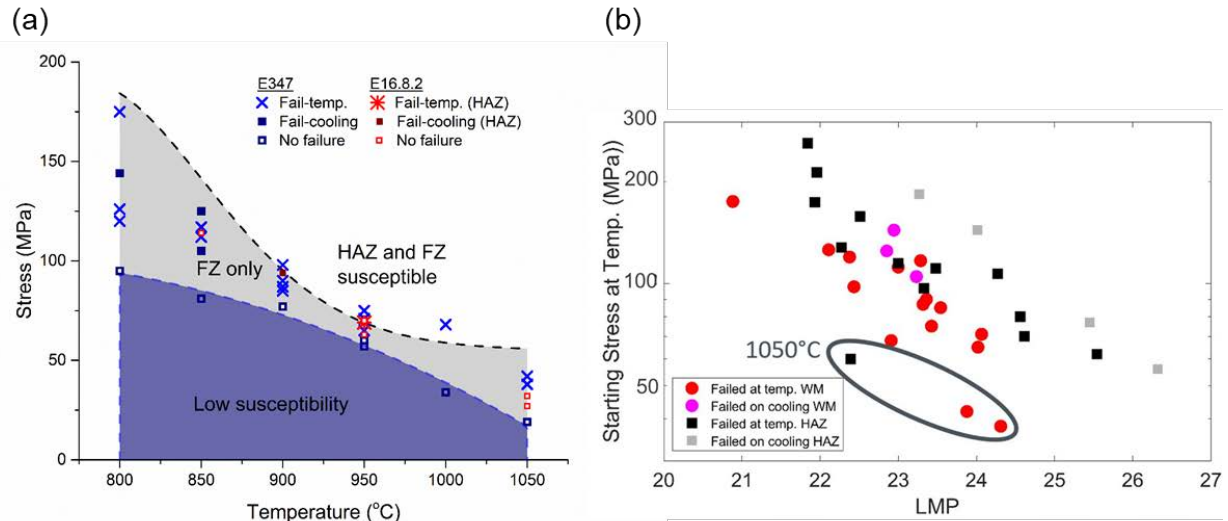
Figure 16. As-welded critical stress vs temperature for lab samples of 347H 1335°C HAZ, transverse E347 weld samples, and E16.8.2 weld samples; (b) Same stress values vs LMP of 347H HAZ and E347 weld metal

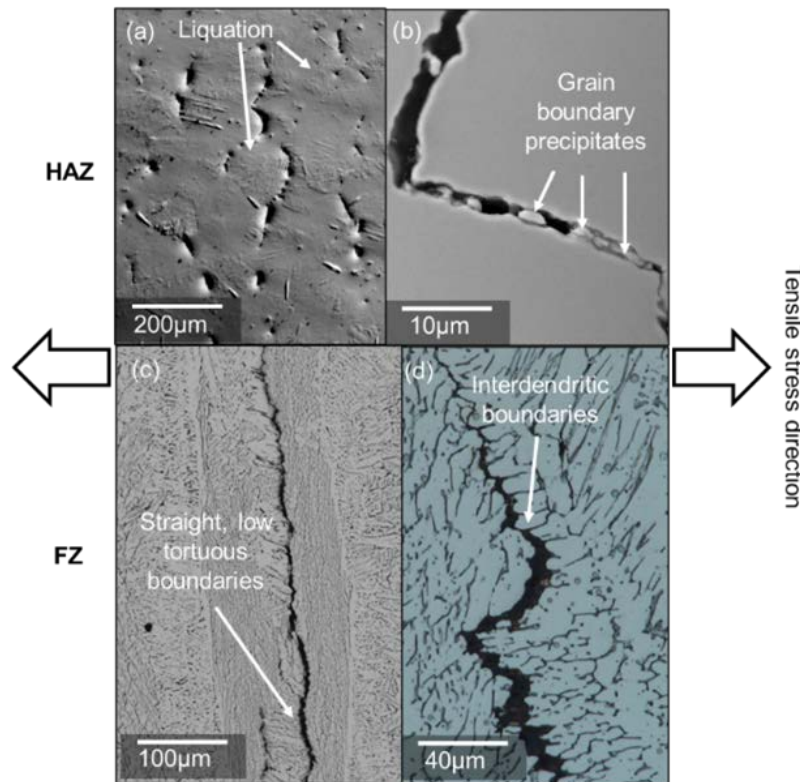
Figure 17. Secondary intergranular cracks in (a) HAZ with 800°C and 0.1 strain with polarized light in LOM, (b) SEI-SEM image of HAZ with 800°C and 0.174 strain, (c) LOM E347 FZ with 523°C and 800°C test temperature, and (d) LOM E347 FZ with 437 MPa initial stress and 950°C test temperature.

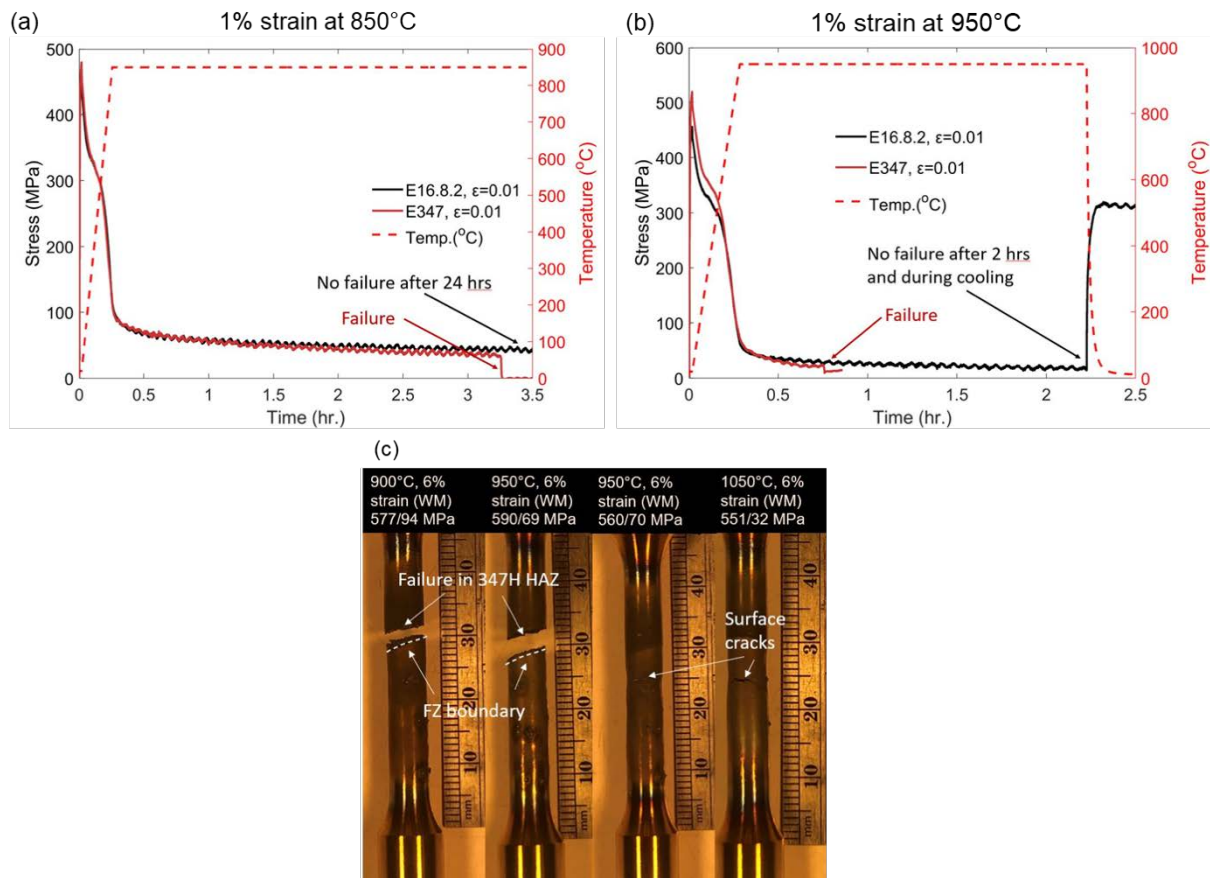
Figure 18. Comparison of SRC susceptibility between E347 and E16.8.2 FZ for (a) 1% strain at 850°C test condition (b) 1% strain at 950°C. (c) Demonstration of preferential cracking in 347H HAZ over E16.8.2 FZ for E16.8.2-347H SS cross weld samples.

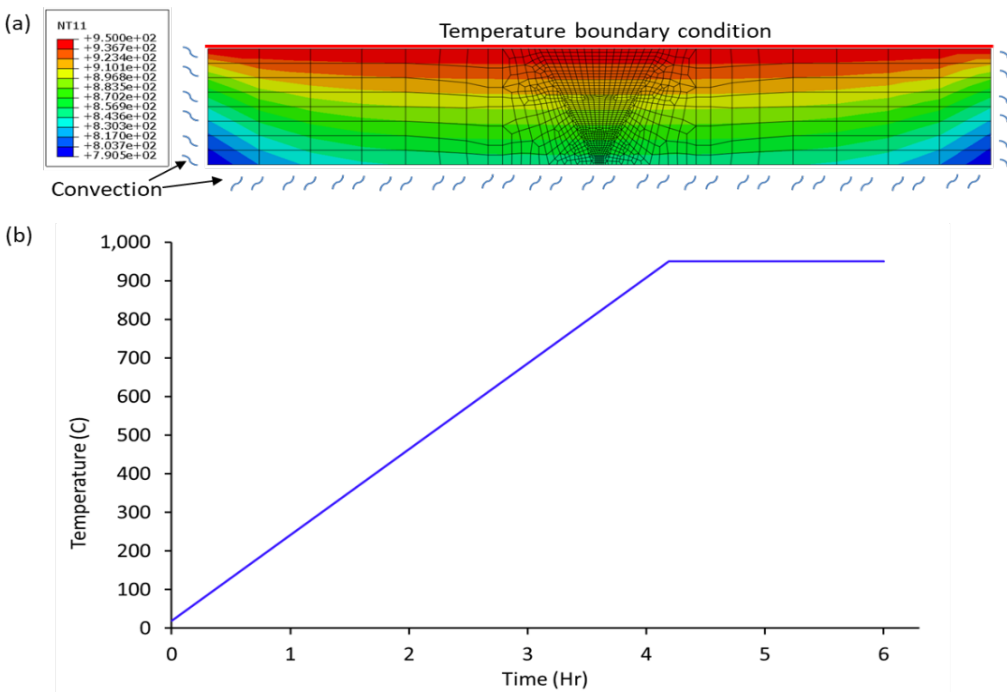
Figure 22. (a) PWHT heating boundary conditions and temperature field; (b) Top surface heating temperature boundary condition (222 C°/h)

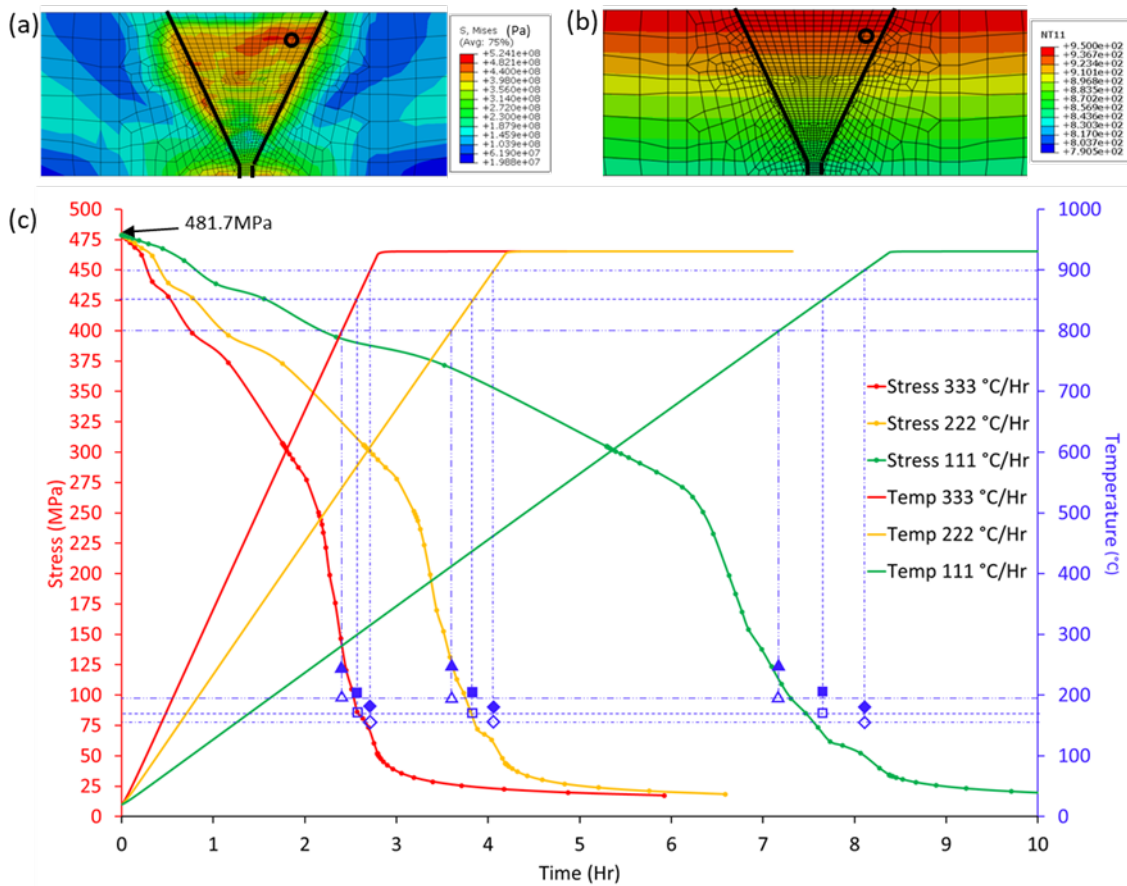
Figure 23. (a) Von Mises stress contour under as-welded condition after unclamping; (b) Temperature field after 4-hour holding at 950°C, (c) Stress relief along the heating with different heating rate. Solid and open symbols show failure and no failure at certain temperatures and stresses in experiment, respectively.

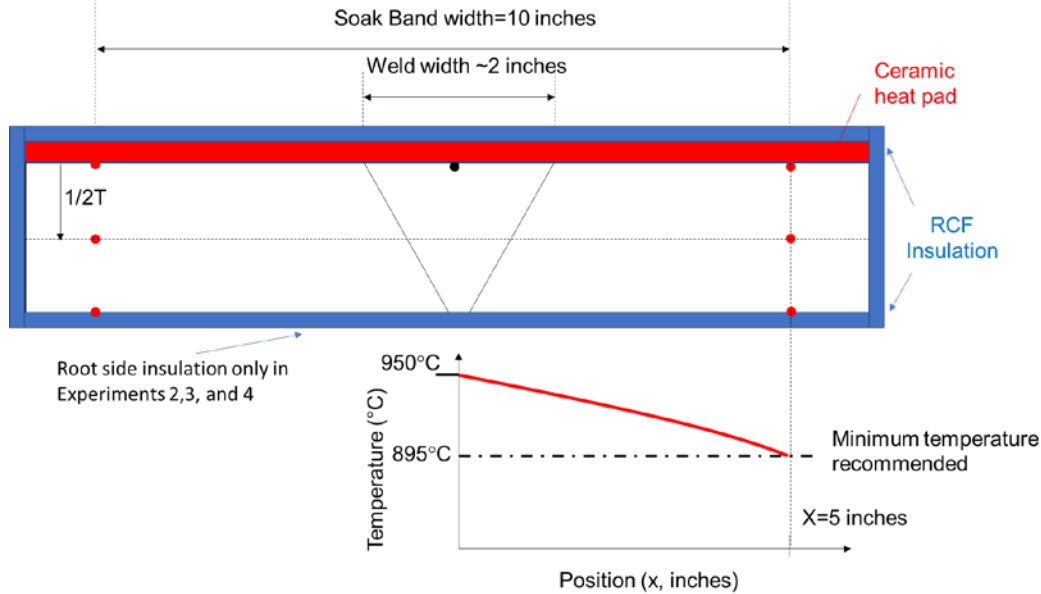
Figure 25. Schematic of thermocouple locations on a plate cross section with ceramic heating pad on top and RCF insulation layers surrounding the plates, except for Experiment 1 listed in Table 9, which has no backside insulation. The temperature difference over soak band width and thickness is not recommended to be below 55°C of the peak temperature (~895°C)

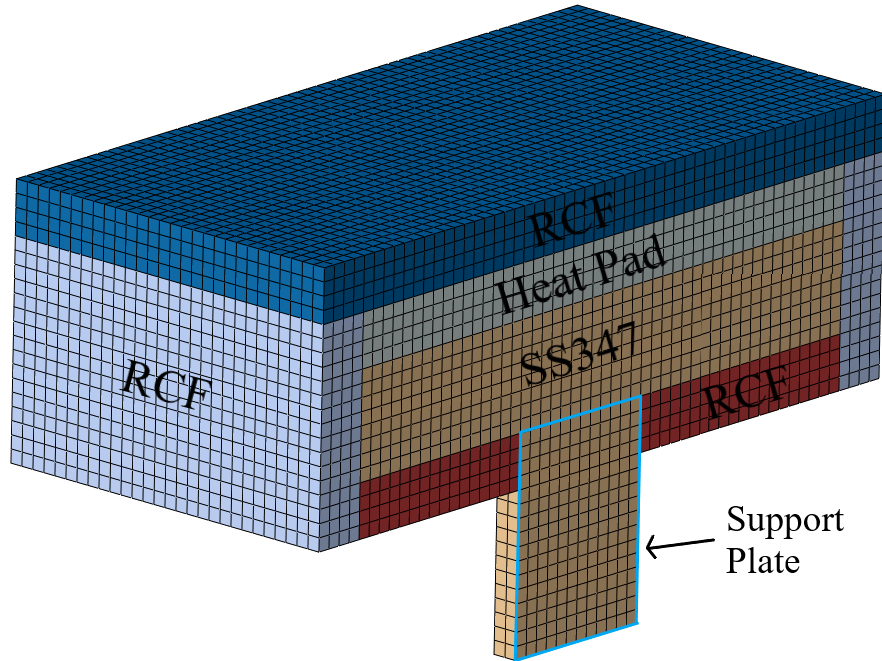
Figure 27. Model geometry color coded by element set: heat pad in blue, 347h plate in grey, and RCF in brown/white/red.

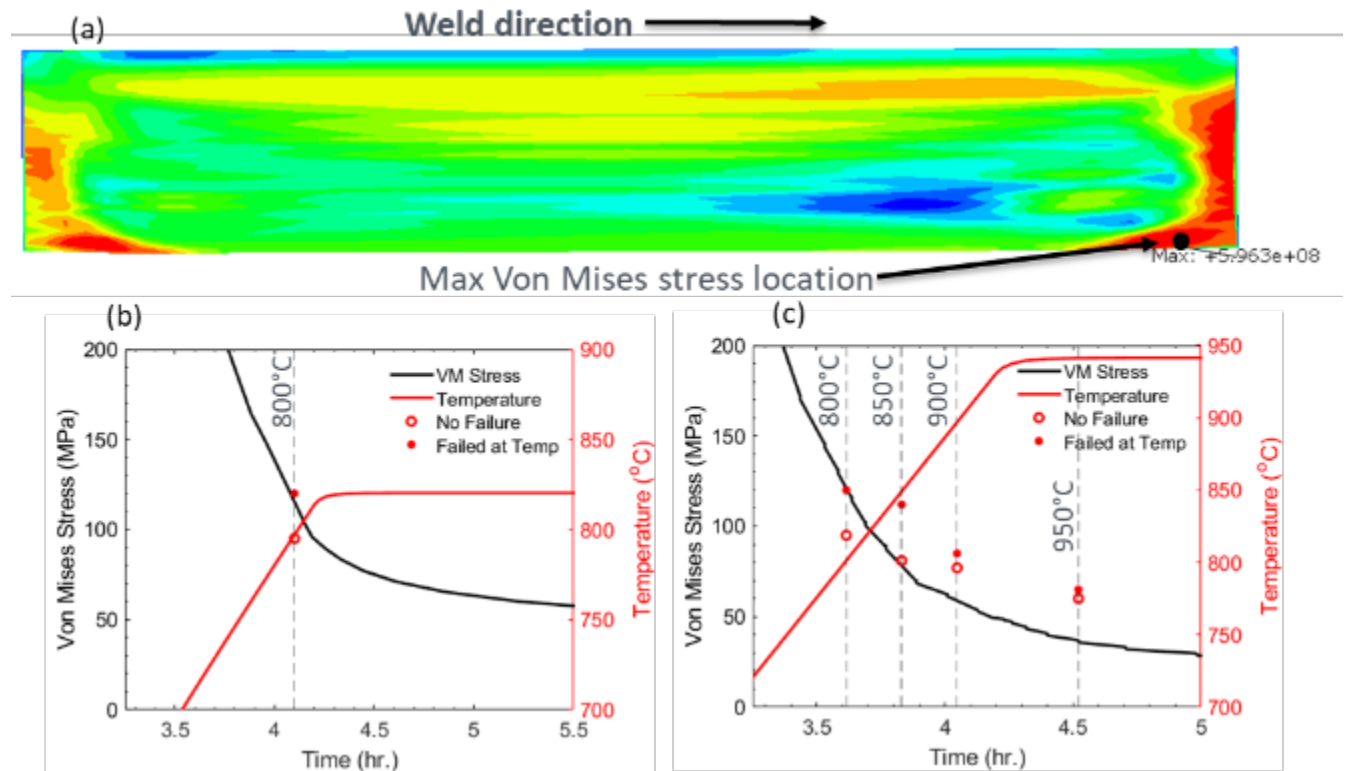
Figure 41. (a) Longitudinal cross section of as-welded FEM showing maximum von Mises stress location of 596 MPa on the back edge of the weld, (b) old PWHT model: no insulation showing stress relaxation as a function of time of maximum stress location in which the peak temperature reached no higher than 812°–820°C in maximum stress location, while (c) new model shows the stress relaxation below the threshold at 850°C and above and with peak temperatures of 928°–942°C

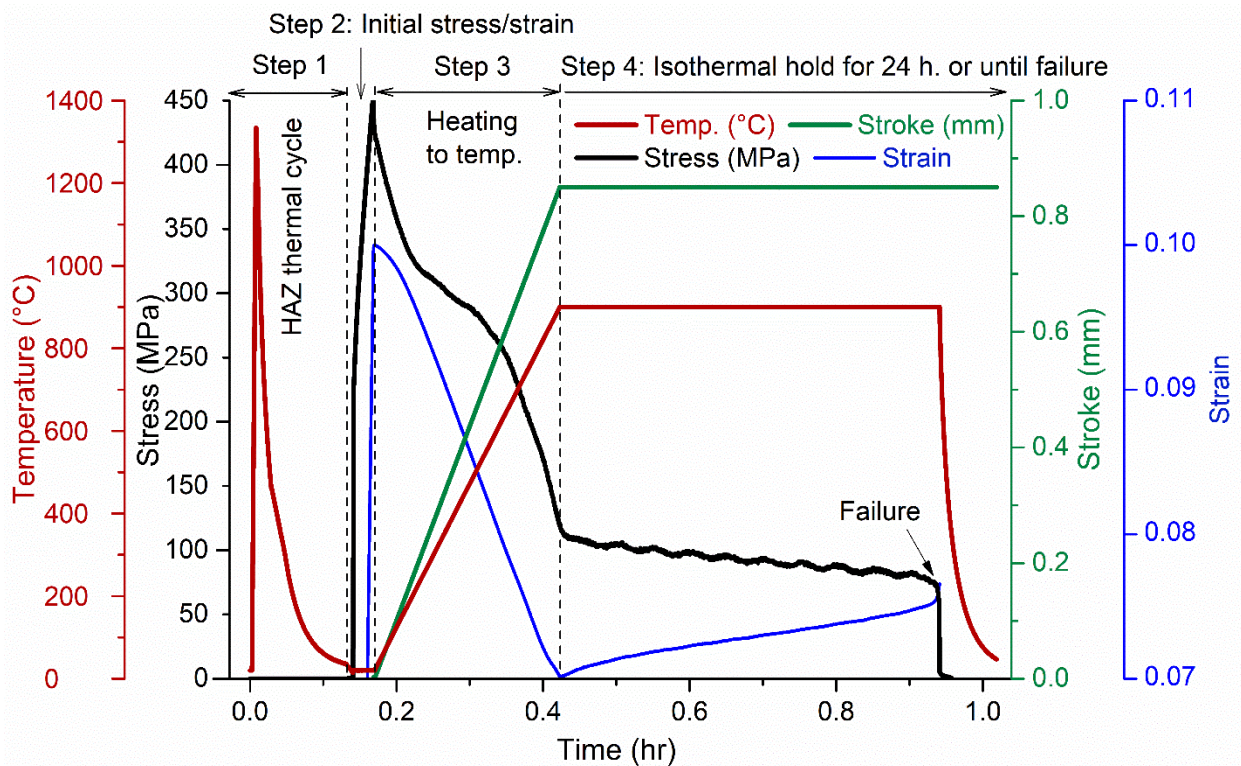
Figure 56. Gleeble four-step SRC procedure (e.g., 1335°C HAZ with 0.1 initial strain (450 MPa))

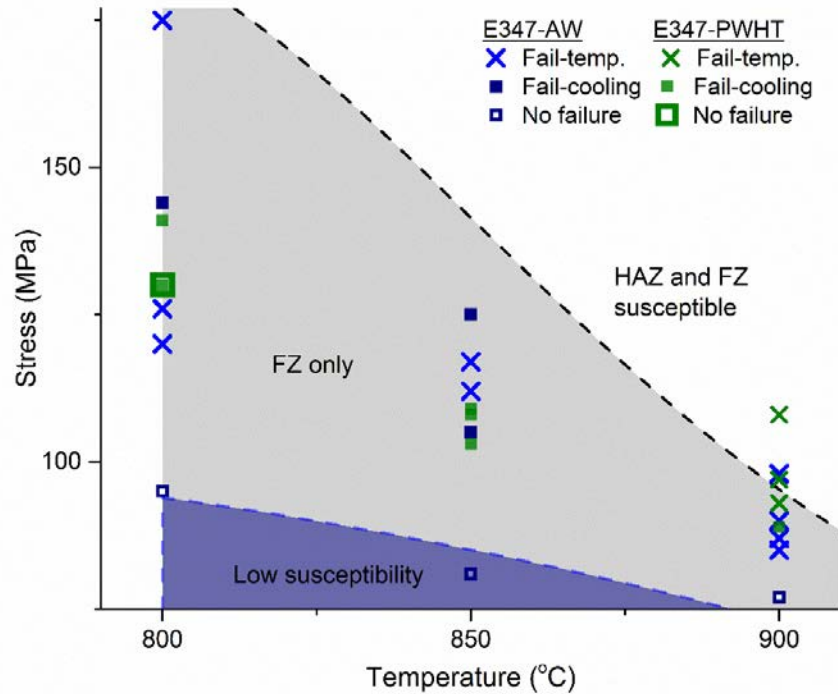
Figure 57. Starting stress at temperature as a function of temperature plot, including E347 as welded and PWHT (950°C/2h) test results. This figure is a blown-up image of Figure 16, but minus the E16.8.2 results for brevity and with included new PWHT data in green.

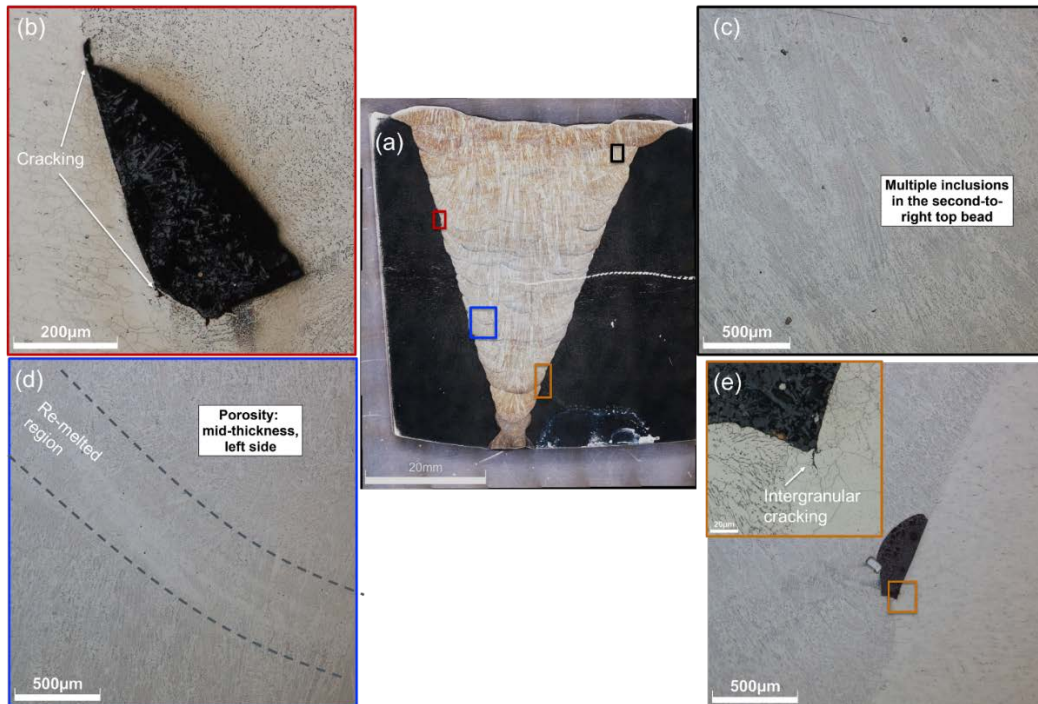
Figure 61. Weld defects in 2” thick 40 pass lab weld. Images taken after PWHT and NDE. (a) macro cross section, (b) slag inclusion and lack of fusion-indication #12 with length of 588µm, (c) smaller slag inclusions in upper right corner of weld, (d) appreciable porosity in re-melted region in the lower left half of the weld, and (e) slag inclusion and lack of fusion in lower right corner of weld with intergranular cracking initiation

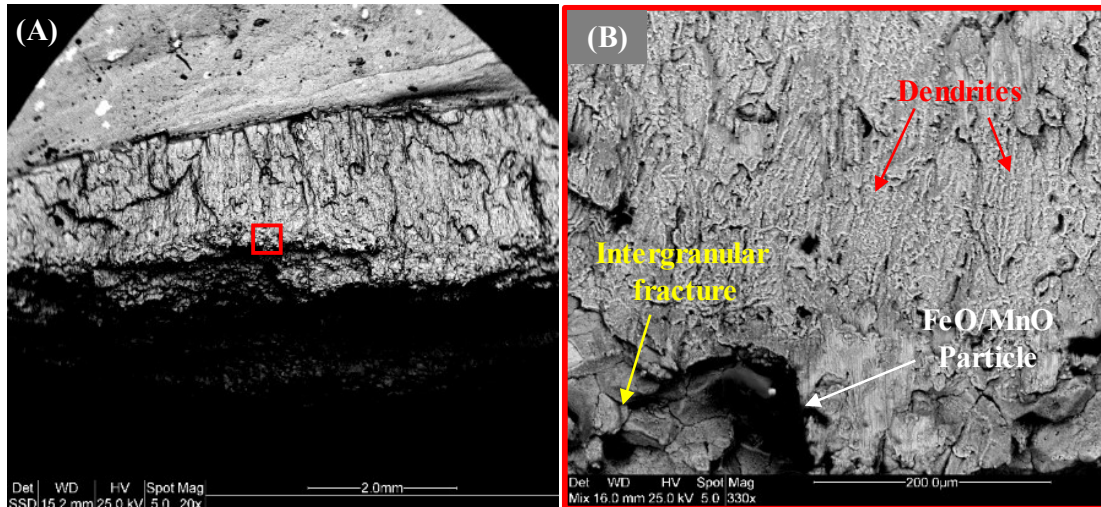
Figure 64. Images taken from the weld metal region of the fracture near the toe of a top-layer weld; A) low magnification backscatter electron image of top edge; B) blow-up image of the red highlighted region in A

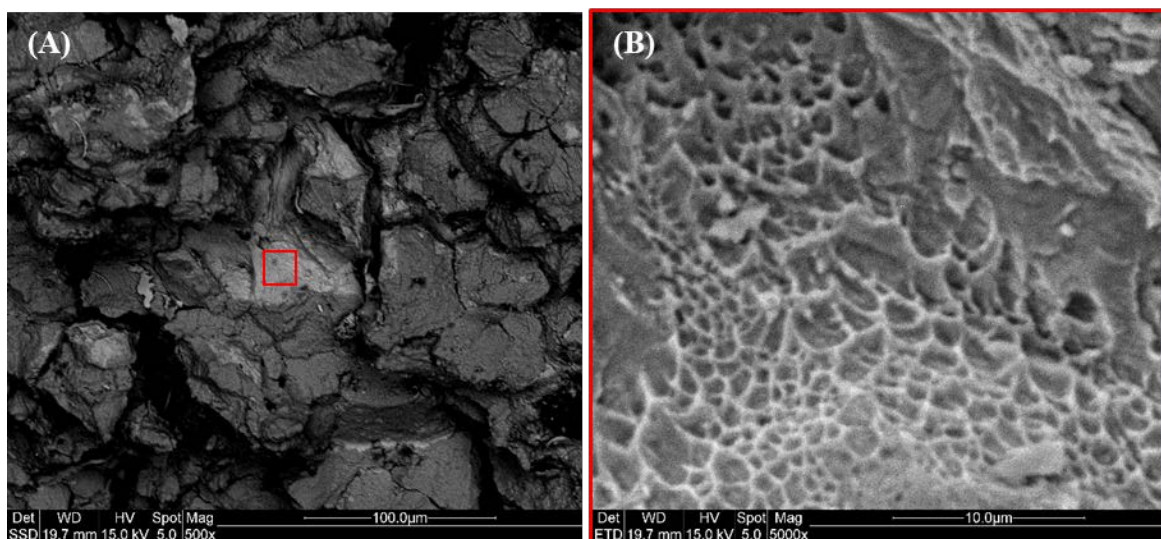
Figure 65. SEM images showing (A) micro-voids on the fracture surface of grains in the HAZ on the base metal side, and (B) ductile dimples on the grain facets in an enlarged view

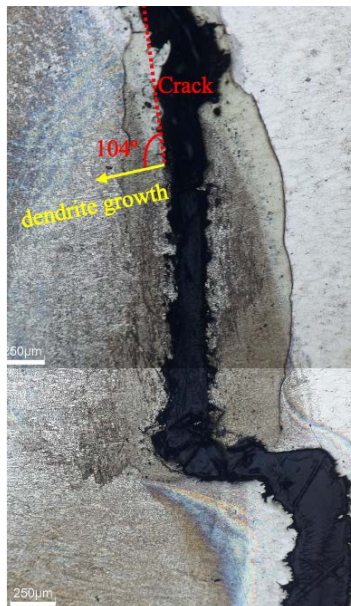
The second turn and entrance into the weld metal underneath OD surface initially still follow the cracking orientation in the HAZ above, as observed in Figure 66 (A) and (C). Figure 68 is the enlarged view of the second turn, which shows the crack intersects the weld metal at a $\sim 104^\circ$ angle from the direction of dendrite growth, according to measurements taken in ImageJ. This is nearly perpendicular to the dendrite growth direction. On the other end of the segment, the crack intersects the weld metal nearly in-line with the direction of dendrite growth and enters the coarse-grained HAZ again. In summary, the LOM examination indicates that the weld toe region with typical high stress concentration, the long straight columnar grain boundaries within the FZ, and the coarse-grained HAZ are the least resistant paths for crack propagation.

Figure 68. Second region of crack propagation into weld metal underneath OD surface with dendrite growth direction indicated

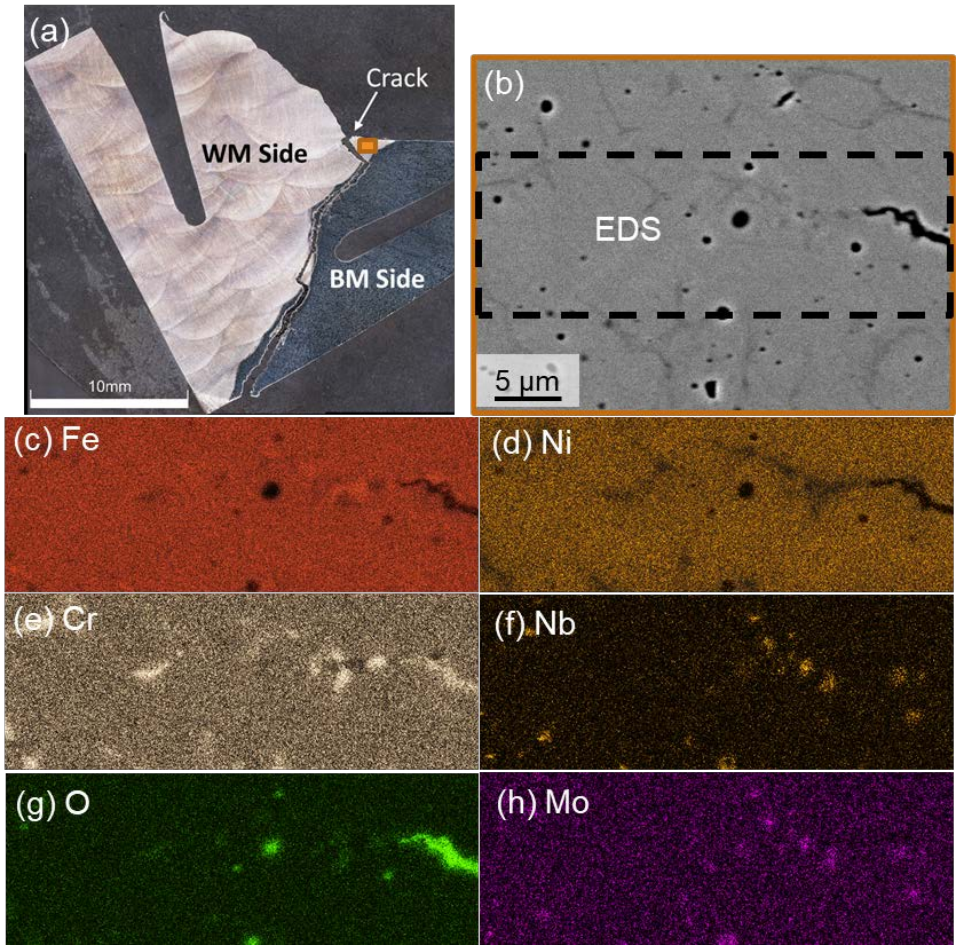
Figure 69. EDS maps of secondary crack in FZ ahead of the primary crack. (a) cross section of boat sample, (b) SEM-secondary electron image (SEI) image of EDS location indicating dendrite structure with secondary crack occurring along interdendritic δ -ferrite (Fe rich and Cr rich, Ni depleted), (c) Fe, (d) Ni, (e) Cr, (f) Nb, (g) O, and (h) Mo.

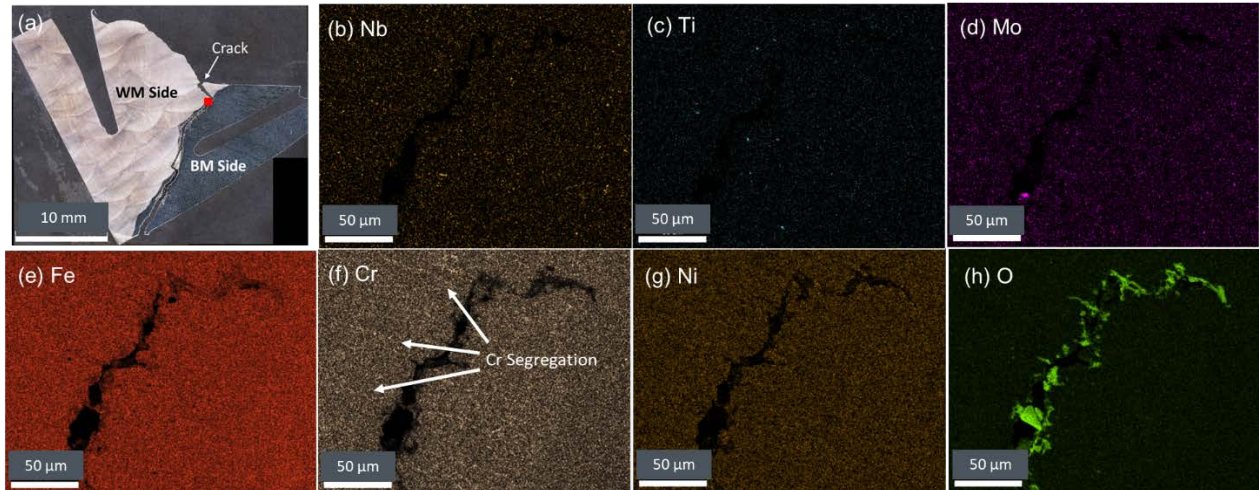
Figure 71. Microcrack propagating through HAZ at corner of primary crack with indications of Fe and Cr oxides within the crack and indications of Cr segregation within the HAZ substructure (not an indication of sensitization as this is a grain boundary phenomena)

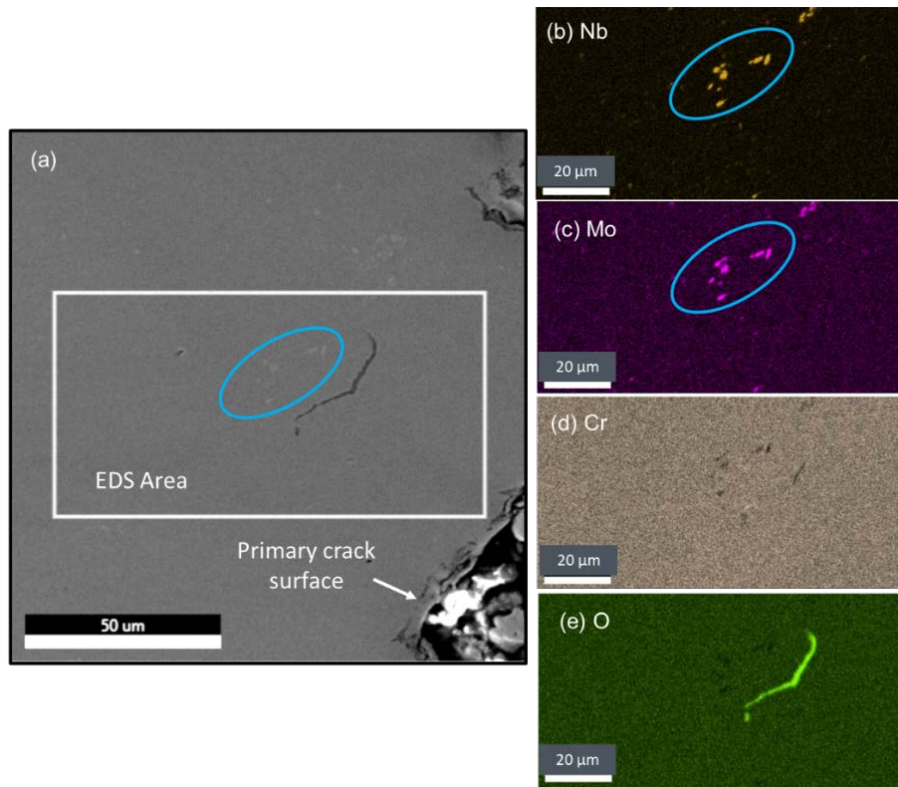
Figure 72. Microcrack in HAZ with surrounding Nb and Mo carbonitrides 3-7 μ m in size

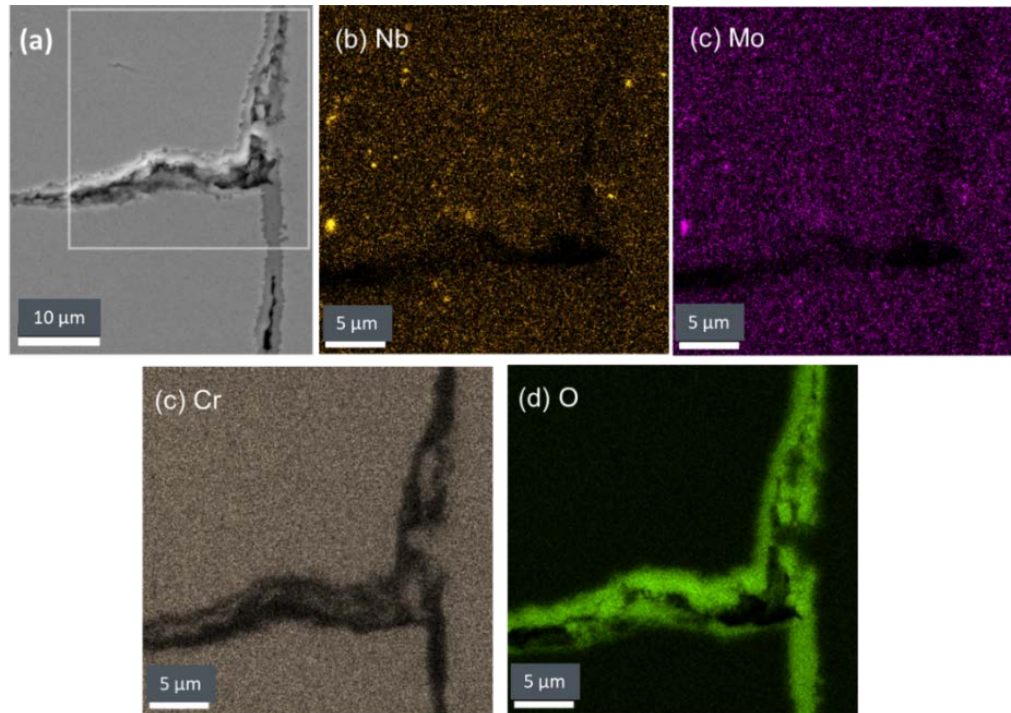
Figure 74. T-shape intergranular microcrack in HAZ with surrounding Nb and Mo carbonitrides 0.25-1 μ m in size

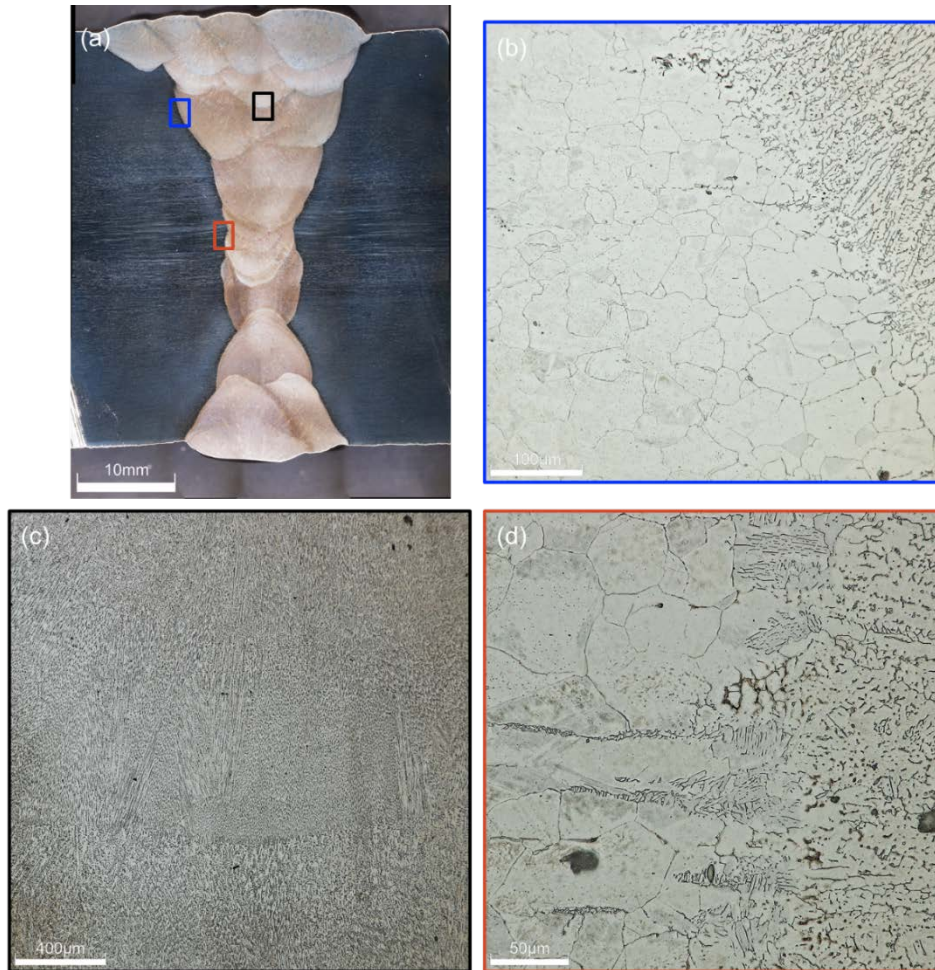
Figure 75. Microscopic examination of (a) seam wall weld (original wall weld), (b) HAZ/PMZ near top of weld, (c) FZ near top of welding showing a weld pass transition, and (d) HAZ/PMZ near weld root.

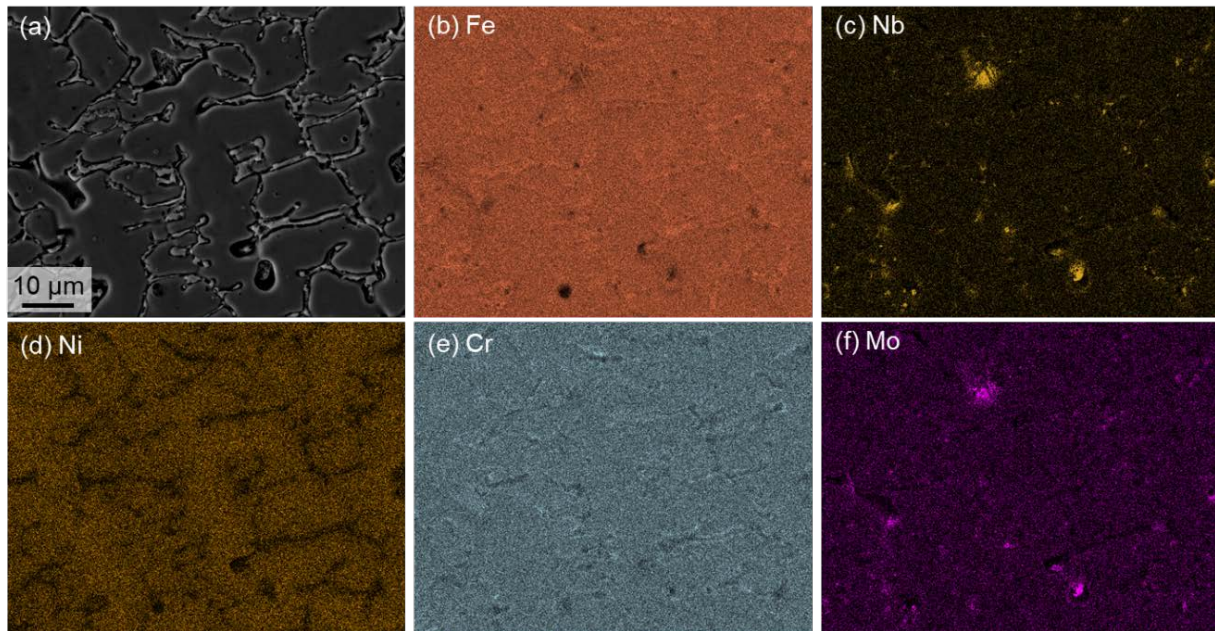
Figure 81. FZ location near bottom location of microhardness indents where microhardness is greater than 250 HV SEM-EDS map of E347-347H SS sample etched in electrolytical nitric acid solution (3V, 10 s) (a) field of view SEI, (b) Fe, (c) Nb, (d) Ni, (e) Cr, (f) Mo

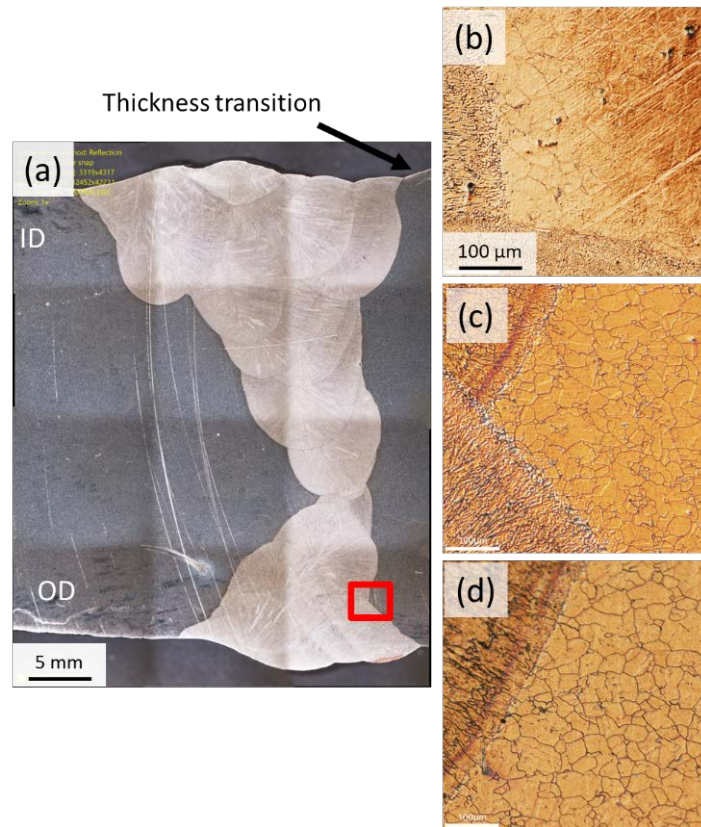
Figure 82. (a) Macro of girth wall-to-wall weld section showing thickness transition near the ID of the wall. Micrographs in the HAZ/FZ boundary beneath a cap of one of the passes near the OD for (b) no HT, (c) 950°C-1 hr soak, and (d) 950°C-2 hr soak time. Similar location to the boat-sample crack, the cracks went through this location as seen in the boat sample.

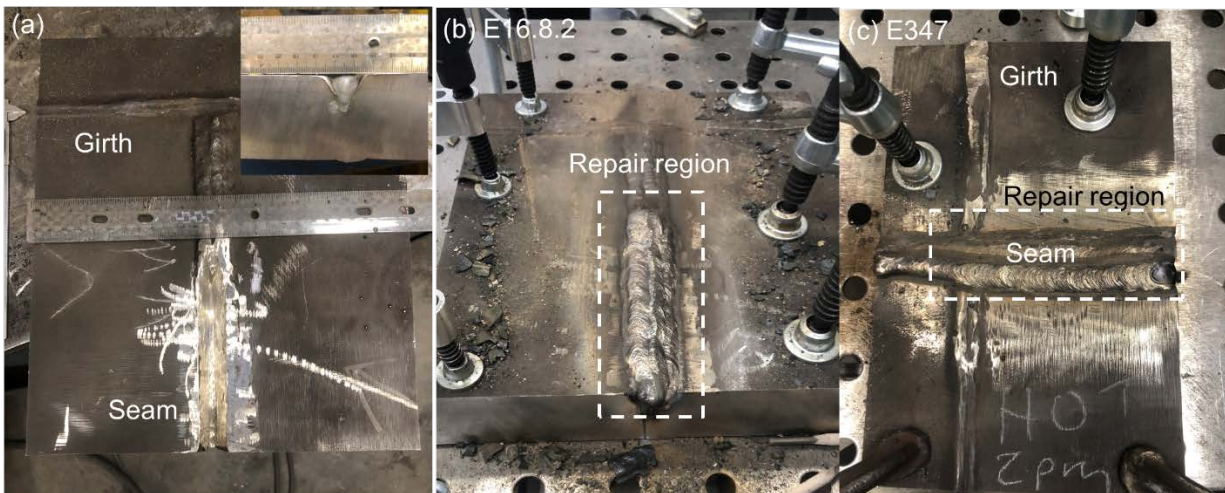
Figure 84. (a) Ground out single-V geometry form seam weld (b) after repair welding on seam weld using E16.8.2, and (c) after repair welding on seam weld using E347

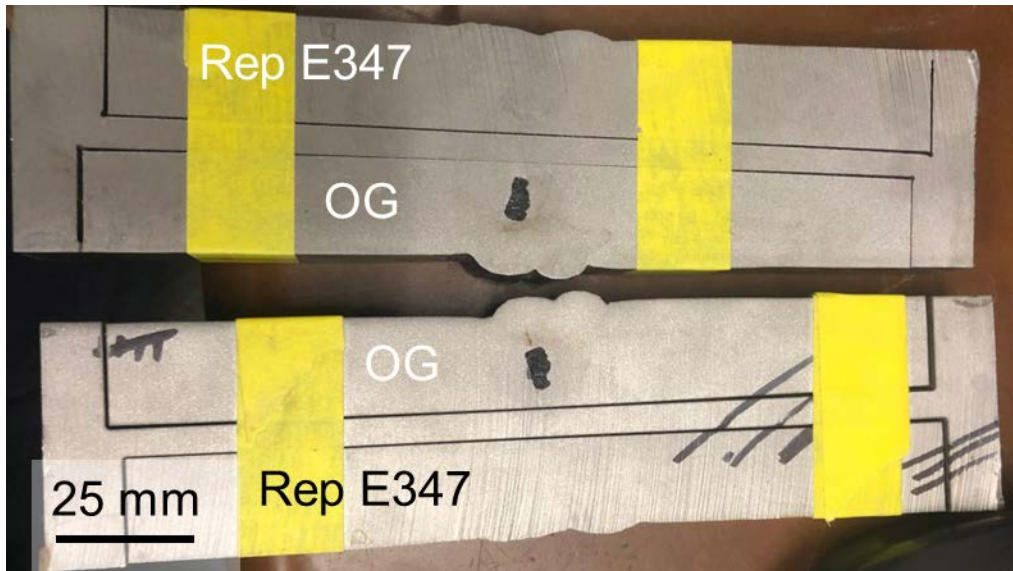
Figure 86. 8x5 mm slag inclusion/lack of fusion defect observed on side used for the intended OG samples. The defect extended to three 0.5” wide samples, indicating a 1-1.5” long defect along the weld direction. This was observed near the intersection and thickness transition between the seam and girth weld.
