Mechanical Failure Risk Management for In-Service CSP Nitrate Hot Tanks

Timothy Pickle,¹ Chad Augustine,² and Zhenzhen Yu¹

**Technical Report
NREL/TP-5700-87615
February 2024**

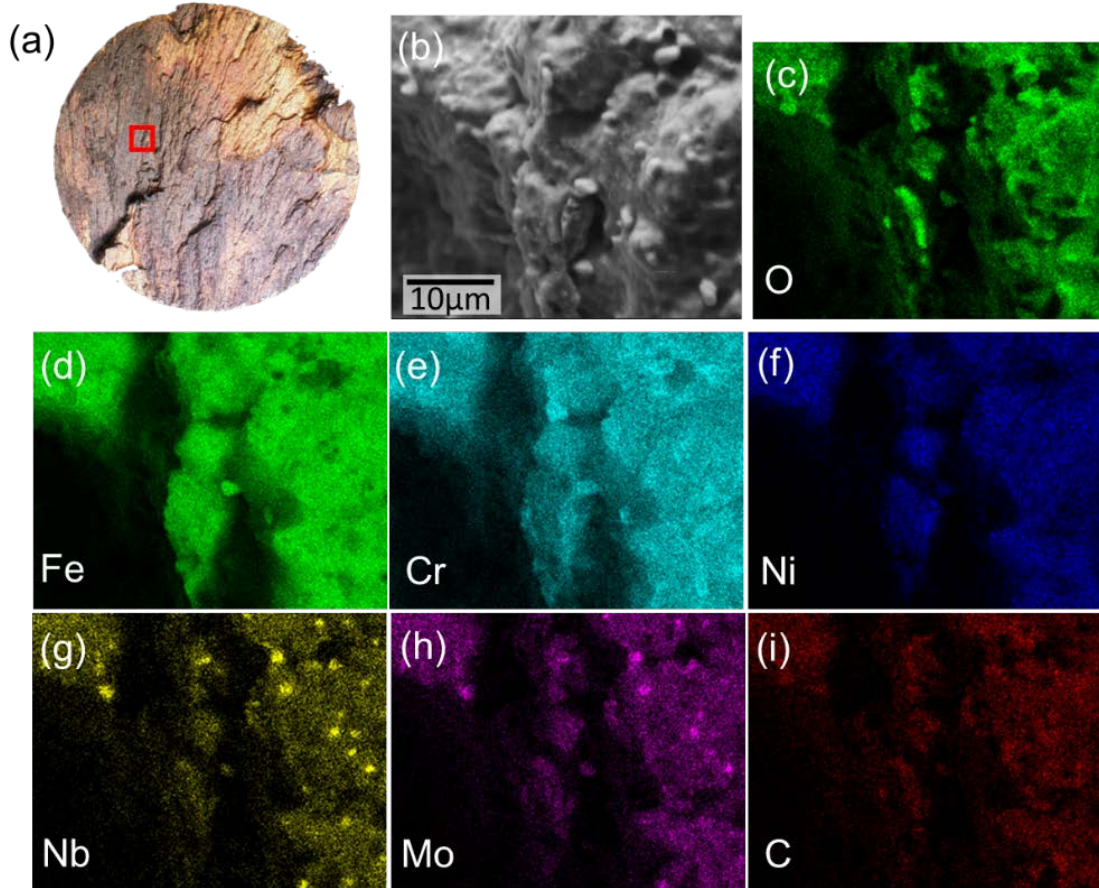
Figure 88. OG.3 (800°C/3.5 h.) Fracture surfaces integrated with SEM-EDS characterization showing Nb and Mo rich precipitates laced along the fracture surface

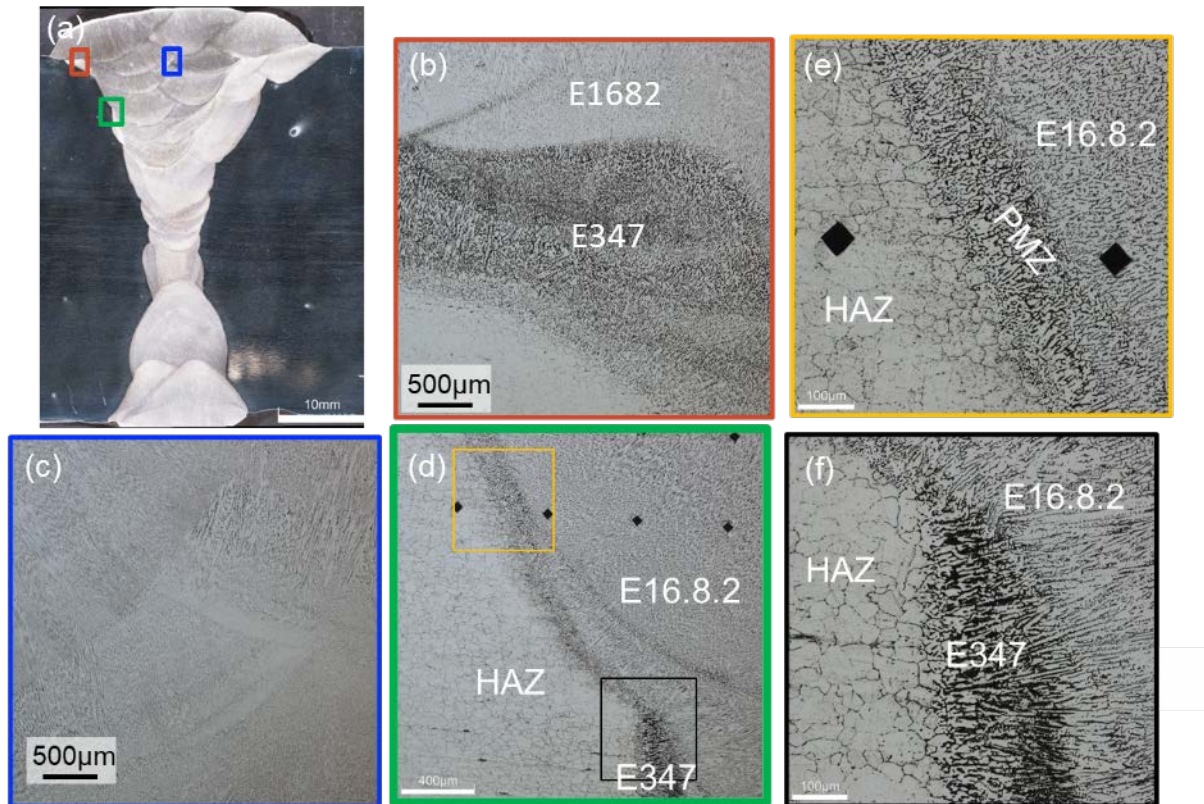
Figure 91. Repair weld on seam weld using E16,8,2 filler (a) macro graph after repair, (b) location where remnant E347 filler is observed with darker etch contrast, (c) reheat region intersection showing very little δ -ferrite content, and (d) HAZ/PMZ/FZ boundary with δ -ferrite stringers

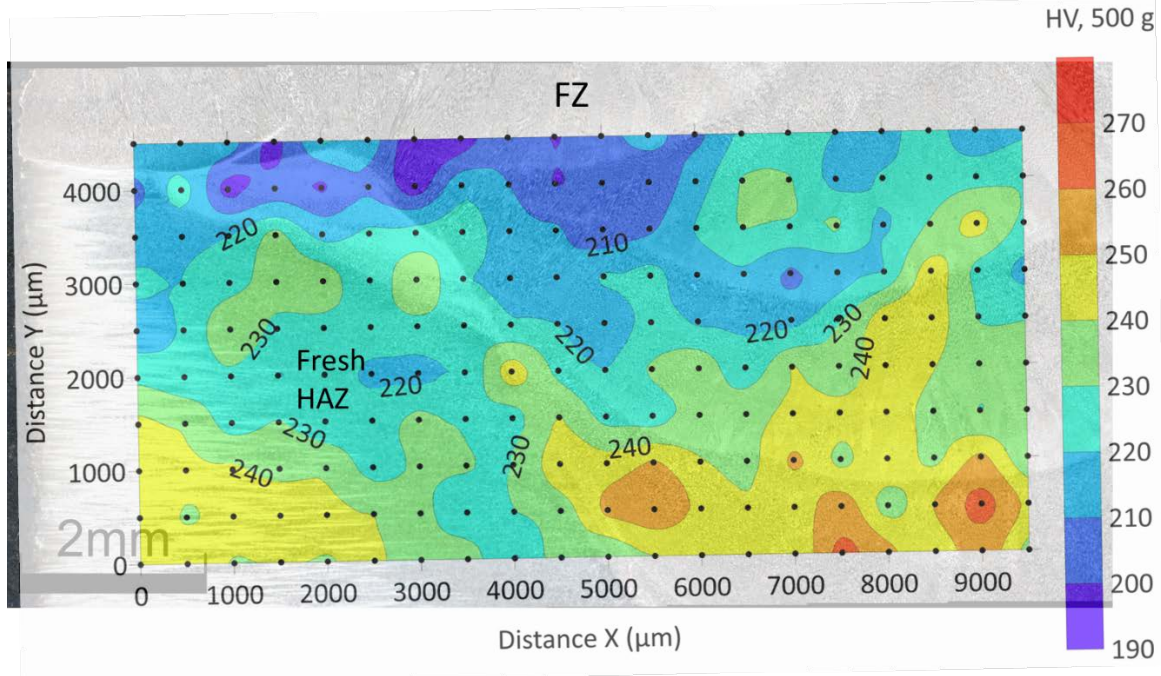
Figure 92. Microhardness map of repair seam weld (after 3 years of service) with E16.8.2 filler. FZ peaks at 270 HV, with fresh HAZ being softer than the base metal and FZ. Notice that hardness decreases closer to the top surface of the weld, as hardness is higher in passes closer to mid-thickness

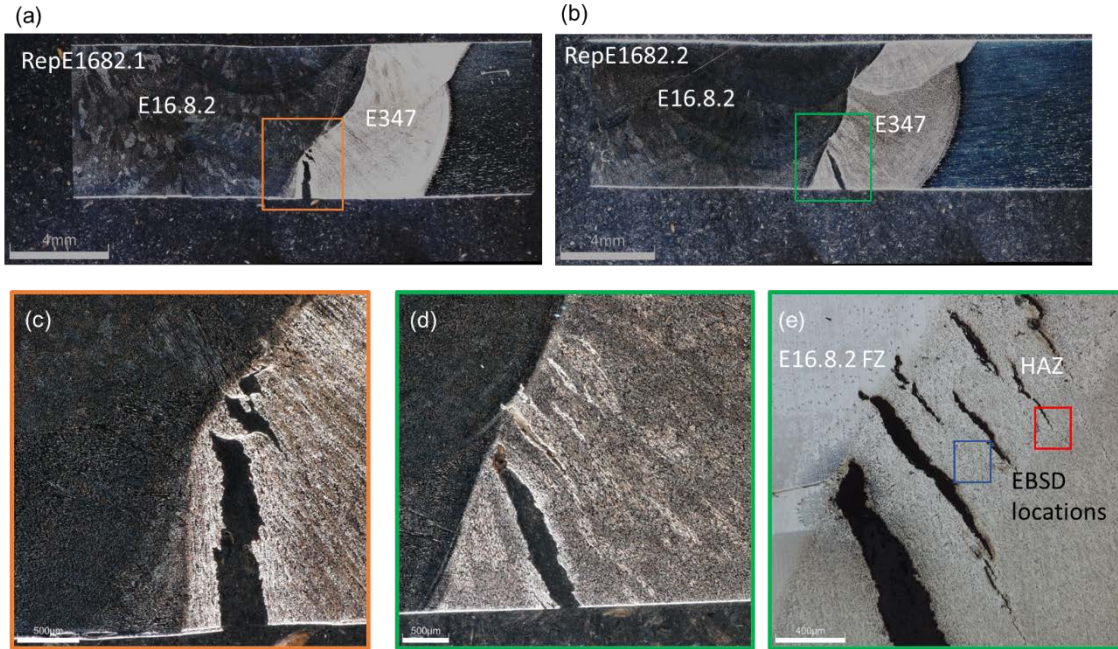
Figure 94. Cracks developed during cooling step in old E347 filler in repair welds using E16.8.2. (a) Rep E1682.1 (800°C), (b) Rep 1682.2 (850°C), (c) closer mag of cracks in Rep E1682.1 (800°C), (d) closer mag of cracks in Rep E1682.2 (850°C), and (e) LOM of same location with indication of EBSD locations within the original E347 filler (repair HAZ)

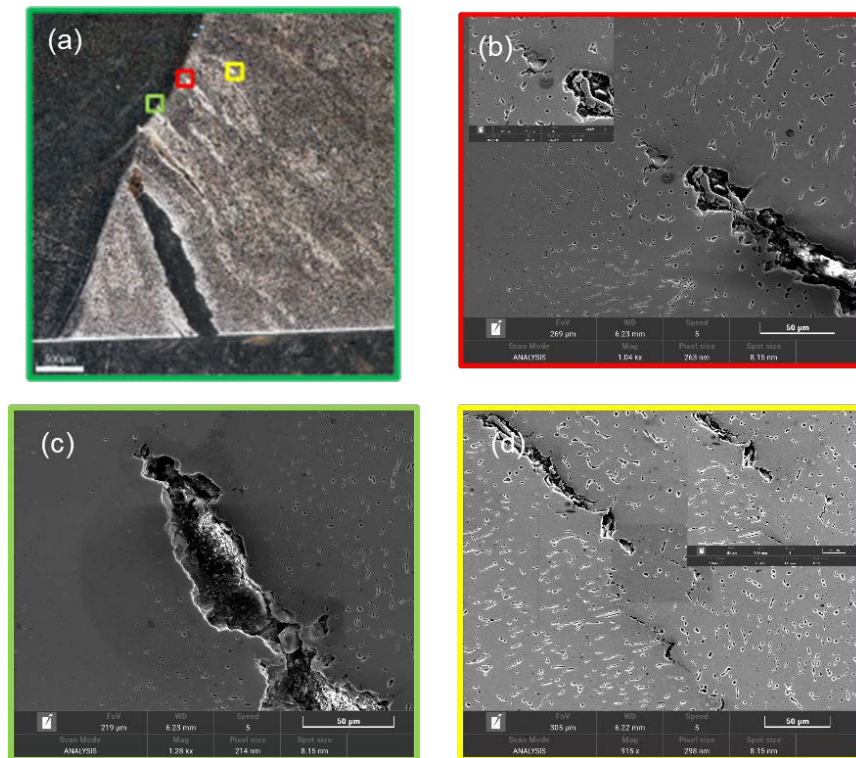
Figure 95. Rep E1682.2 SEM-EDS locations in the repair weld FZ boundary and HAZ (old E347 filler region) (a) general location of interest, (b) location 1 in E347 HAZ, (c) location 2 in FZ boundary, (d) location 3 farther in E347 HAZ

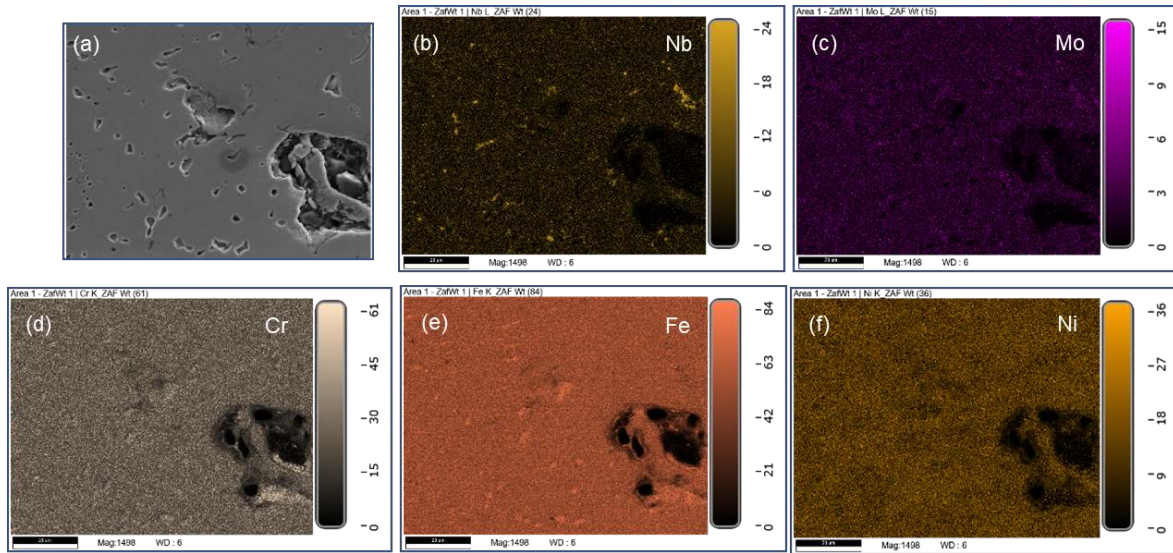
Figure 96. Rep E1682.2 SEM-EDS map (wt%) location 1 in the repair weld FZ boundary and HAZ (old E347 filler region) (a) general location of interest, (b) Nb, (c) Mo, (d) Cr, (e) Fe, and (f) Ni

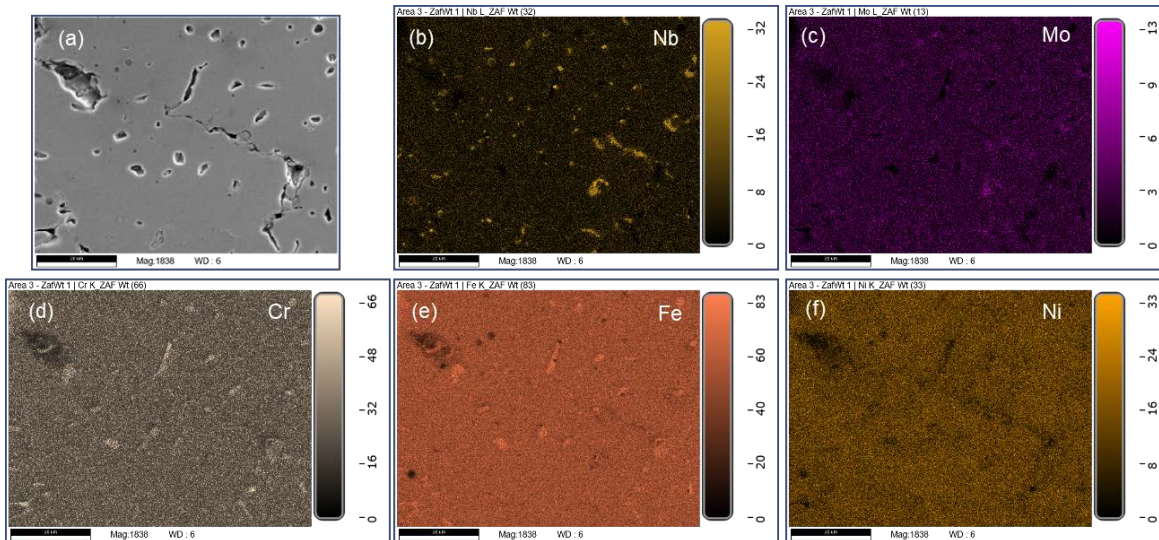
Figure 98. Rep E1682.2 SEM-EDS map (wt%) location 3 in the repair weld HAZ (old E347 filler region) (a) general location of interest, (b) Nb, (c) Mo, (d) Cr, (e) Fe, and (f) Ni

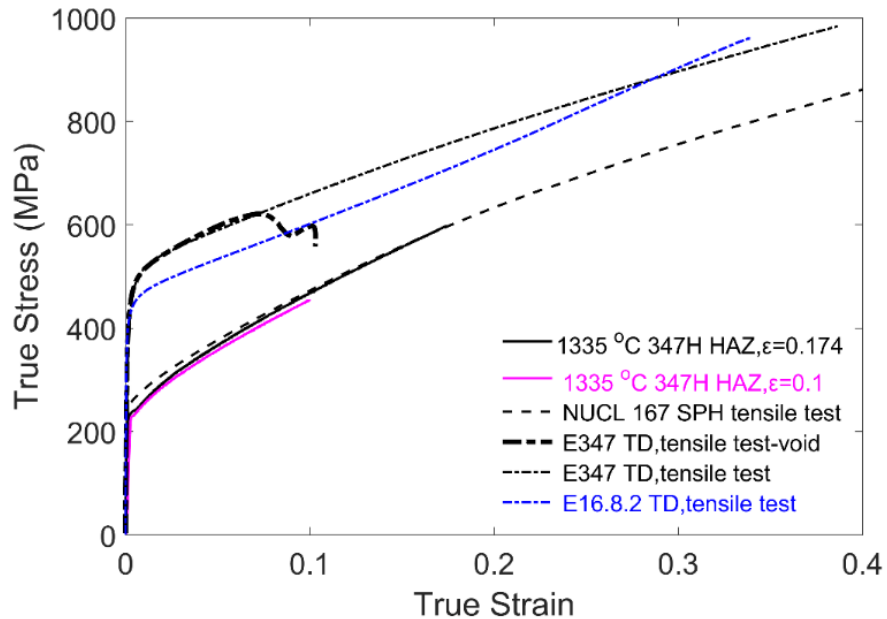
Figure 104. Room temperature tensile data from 347H HAZ, E347 FZ, and E16.8.2 FZ
