# Sunfolding NREL High Wind Test Site Project

**Cooperative Research and Development Final Report**

**Technical Report** NREL/TP-5000-89769 April 2024

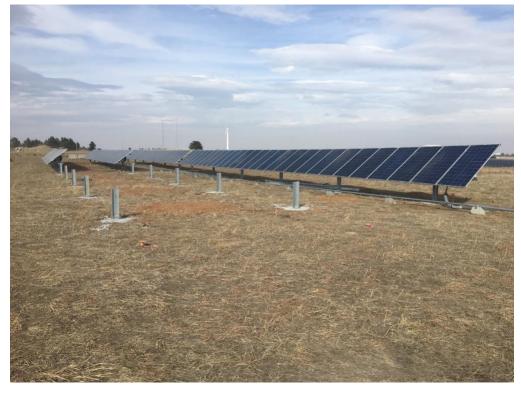
Figure 2. Initial array installation

Sunfolding initially installed four sections of PV trackers (piers were installed for a total of six trackers) at site 1.9 of the NREL Flatirons Campus (Figure 1 and Figure 2). NREL installed two cameras at the site (Figure 5 and Figure 6). NREL also has a PZT camera installed on the M-2 Meteorological tower which could be directed at the Sunfolding site during high wind events (Figure 7). All video cameras would maintain a two week circular buffer.

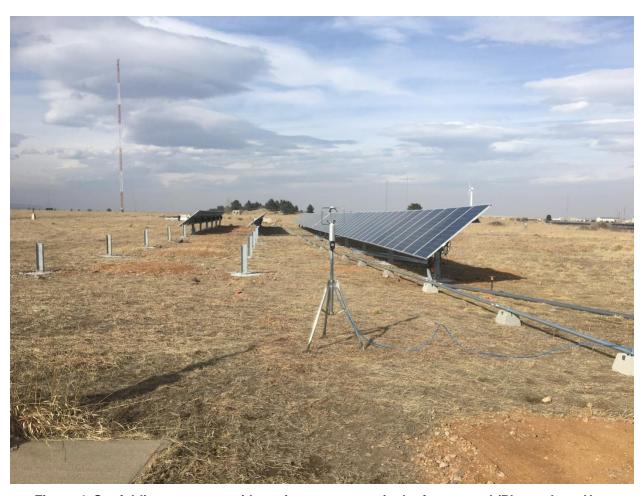
Figure 4. Sunfolding test array with sonic anemometer in the foreground (Photo: Jerry Hur, NREL))

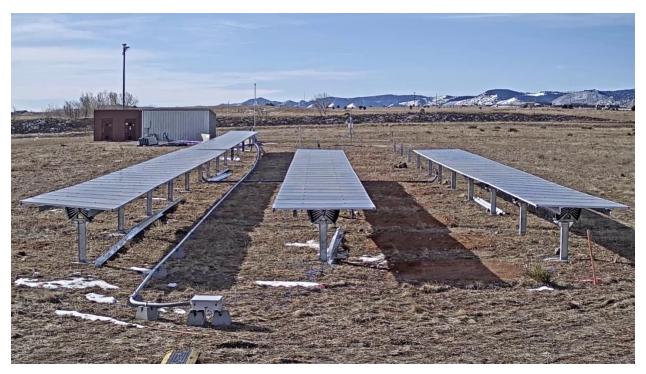
Figure 5. View from permanent North camera (Source: NREL)

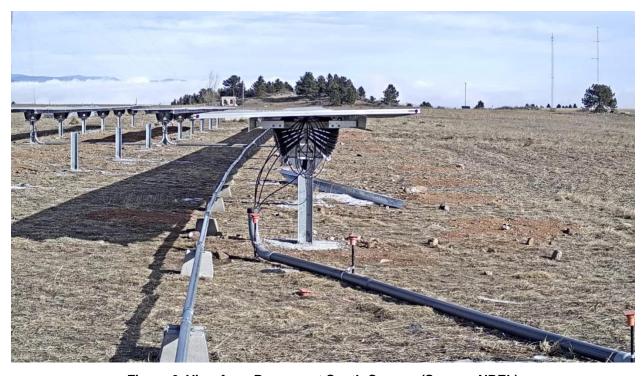
Figure 6. View from Permanent South Camera (Source: NREL)

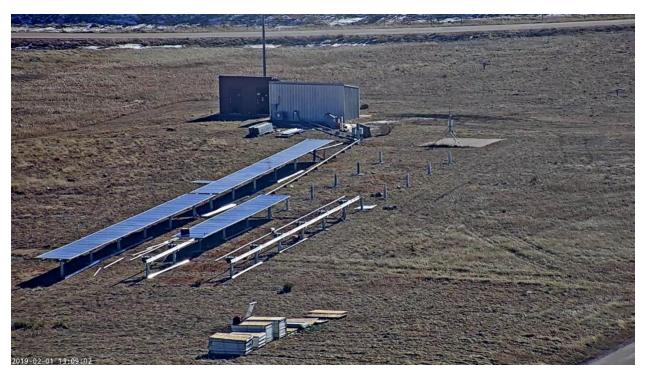
Figure 7. View from M2 PZT camera (Source: NREL)

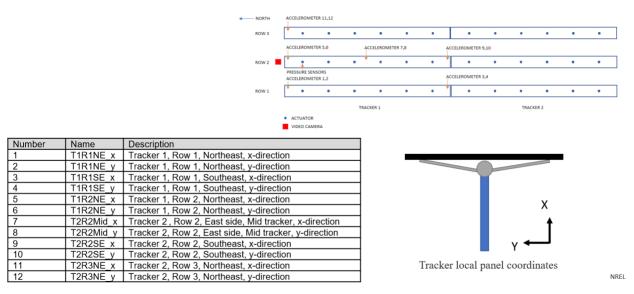
Figure 8. Initial accelerometer layout

NREL added a short meteorological tower with a Sonic anemometer and accelerometers were installed on the trackers (Figure 8). An EtherCAT based Data acquisition system was installed in the nearby datashed (Figure 9).

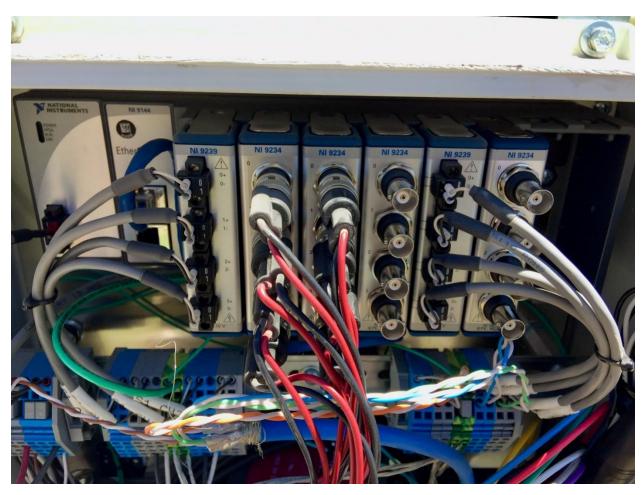
Figure 9. NRELs EtherCAT based data acquisition system used for the Sunfolding project. (Source: Jerry Hur, NREL)

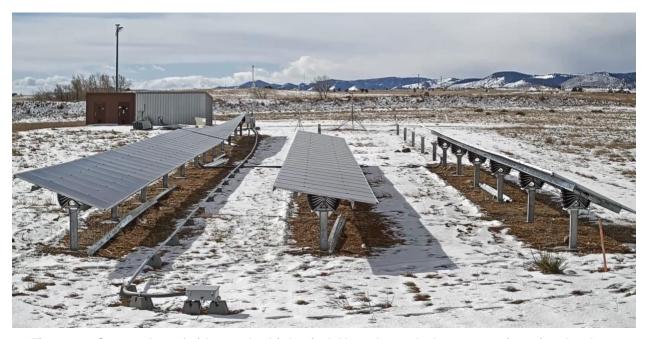
Figure 11. Screenshot of video under high wind. Note the early A90 generation of technology without dampers on top left showing deformed shaped due to dynamics under high wind (compare with Figure 5)

Through the work at NREL the team assessed that the addition of dampers to all of the generations resulted in substantially improved dynamic behavior, and dampers are now included in the build of all project sites. Partially by utilizing the data from NREL, the team was able to design, build, and test later generations (AX1 and AX2) that were substantially more resilient in high wind conditions (both static and dynamic) than the earlier A90 generation that was initially installed at NREL.

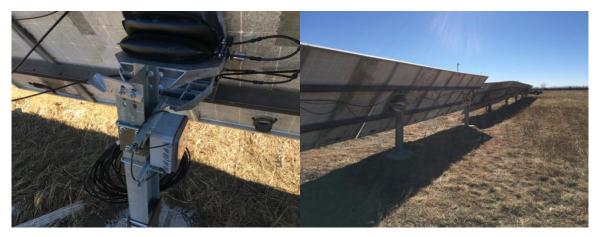
Figure 12. R&D prototype of locked actuator for extremely high wind applications. The concept showed some promise but needed extensive re-design due to results at HWTS.

In some cases, the team assessed early stage versions of new concepts at HWTS and due to failures at the site, made the decision to pivot the design in a different direction or to discontinue R&D work altogether. See Figure 11 for a locked actuator based R&D tracker that underperformed; this design was never deployed to a customer site.

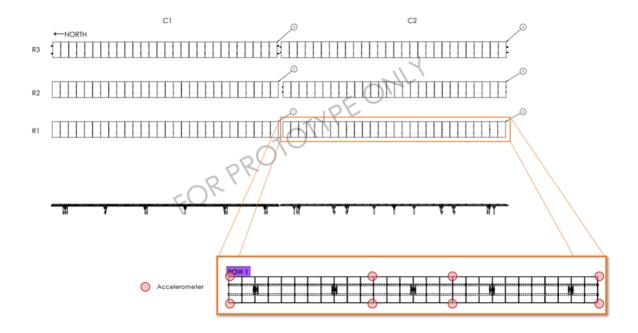
Figure 13. Instrumentation layout for added accelerometers as provided by Sunfolding

Figure 13 shows the layout of the additional accelerometer that NREL installed. Figure 14 shows a close up of one of the sets of accelerometers. Once installed NREL performed so called end-to-end checks to assure proper installation and configuration.

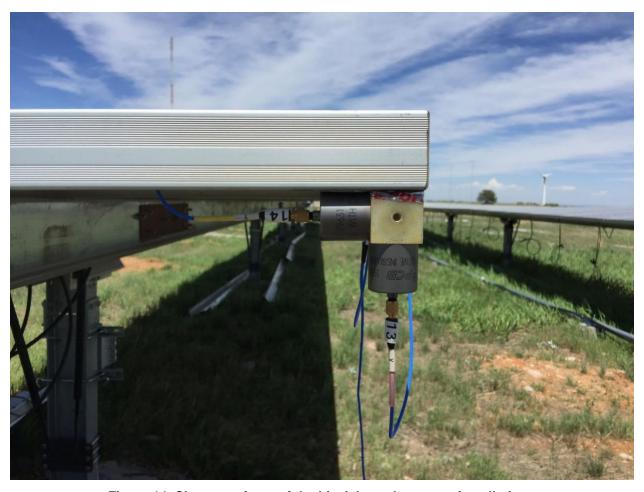
Figure 14. Close up of one of the biaxial accelerometer installations
