# Photovoltaic Cable Jackets: A Comparison of Representative Products Using Combined-Accelerated Stress Testing

National Renewable Energy Laboratory (NREL), Golden, CO

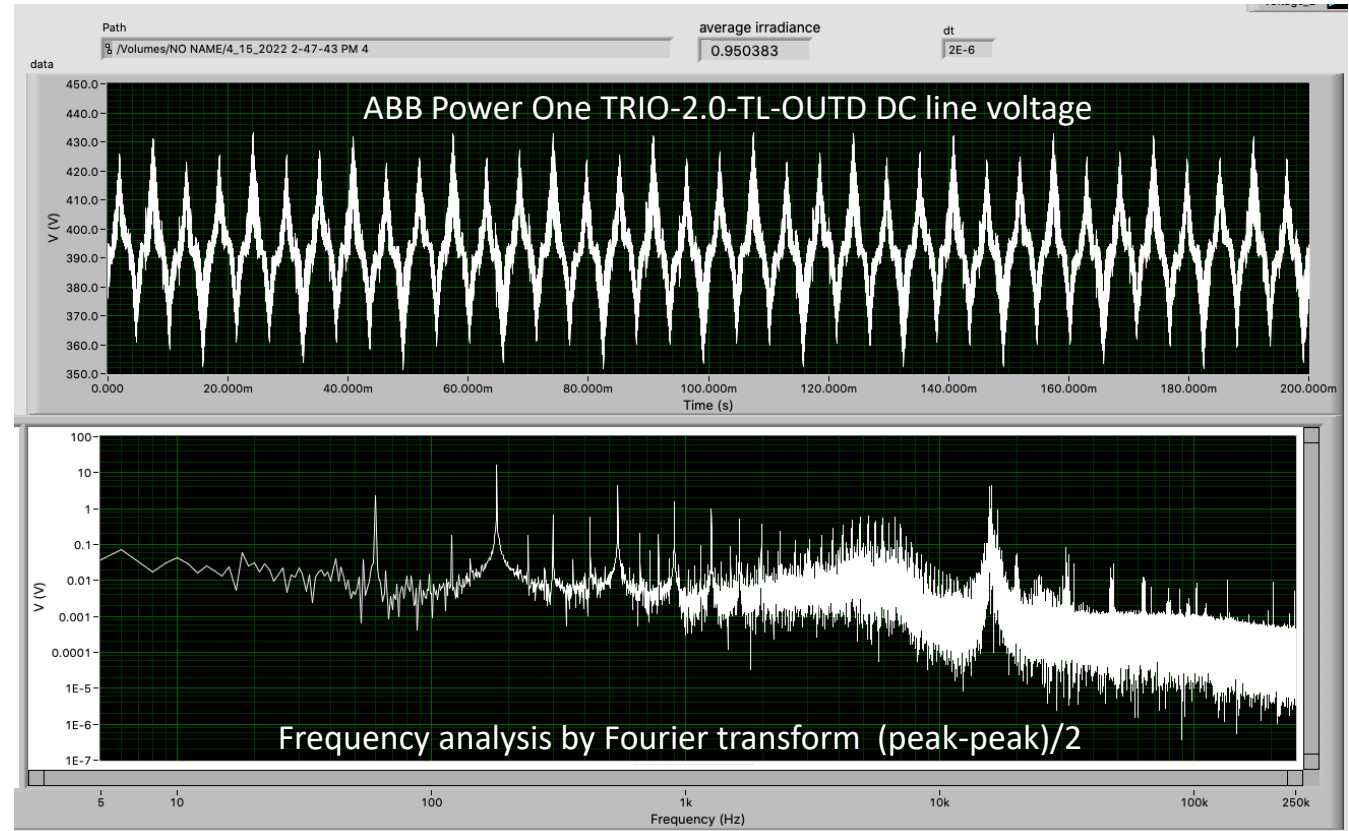
# Characterization of DC lines of module string

## Measurement equipment

### **Verivolt IsoBlock V-4c**

- 3 Way Galvanic isolation
- 1,500V sustained and 5,000V peak isolation (1 min)
- DC to 100kHz Bandwidth
- 1500 V in/10 V out

### **NI-9222**

±10 V, 500 kS/s/ch, 16-Bit,  
Simultaneous Input, 4-Channel

### **NI cDAQ 9178**

Into Laptop running **LabVIEW**

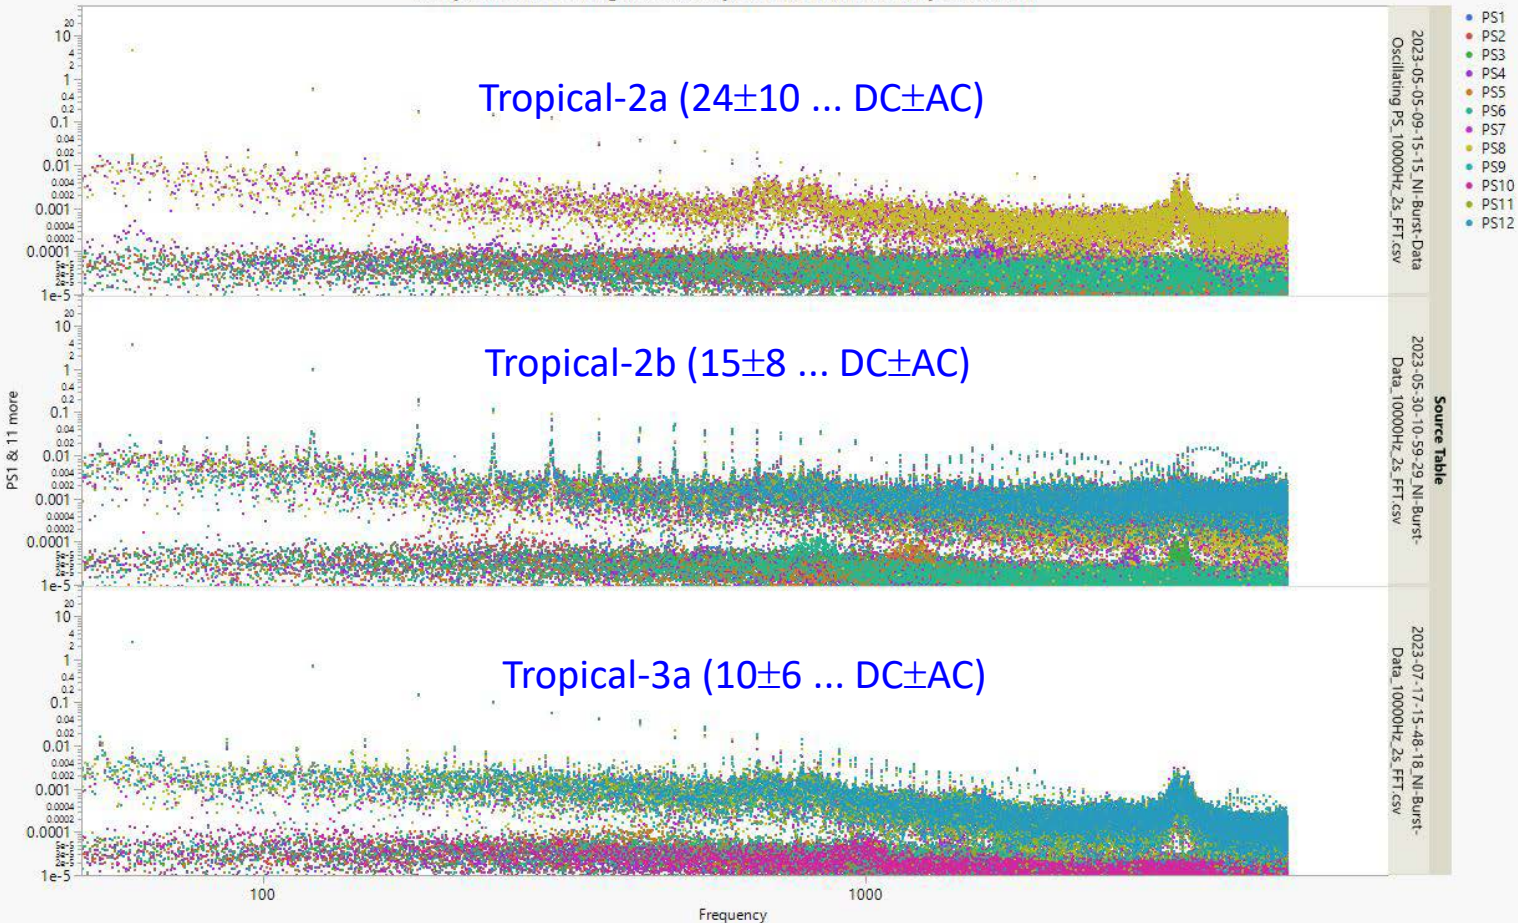
# DC+AC in C-AST D1 Experiment (Representative FFT's)

Comparison of FFT Magnitudes: Tropical 2A, 2B, and 3A (Top to Bottom)
