Building America Case Study

Field Testing of Compartmentalization Methods for Multifamily Construction

Construction: New construction

Builder: K. Hovnanian Homes, khov.com
Building Science Corporation,
buildingscience.com

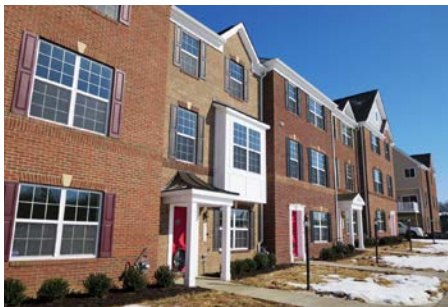
Fire-resistance rated (or area separation) wall assemblies present a great difficulty in air sealing/compartmentalization, particularly in townhouse construction. To address this challenge, the U.S. Department of Energy Building America team, Building Science Corporation (BSC), partnered with builder K. Hovnanian Homes to determine whether taping exterior sheathing details improves air sealing in townhouse and multifamily construction, and to better understand air leakage pathways.

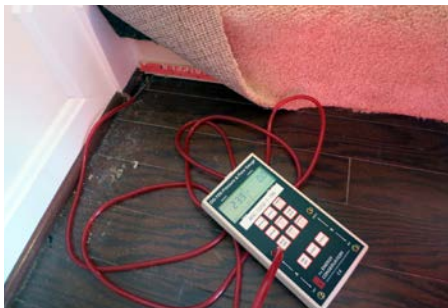
The team tested a building composed of five vertical townhomes, which were three-story, slab-on-grade units (1700–2000 ft²). Each has a rear-facing “tuck under” garage. The walls between units are area separation walls (Underwriters Laboratories U347), with a 2-hour fire resistance rating. This assembly has a 1-in. vertical air cavity on each side, which results in an airflow network that is connected over multiple floors (despite nominal draftstopping), and has potential connections to the outside.
