BACKFLIP: A Comparison of Emerging Non-Fluoropolymer-Based, Co-Extruded PV Backsheets to Industry-Benchmark Technologies

Comparison of market-benchmark BACKsheet technologies to novel non-FLuoro-based co-extruded materials and their correlation and ImPact on PV module degradation rates (BACKFLIP)

NREL/PR-5K00-80362

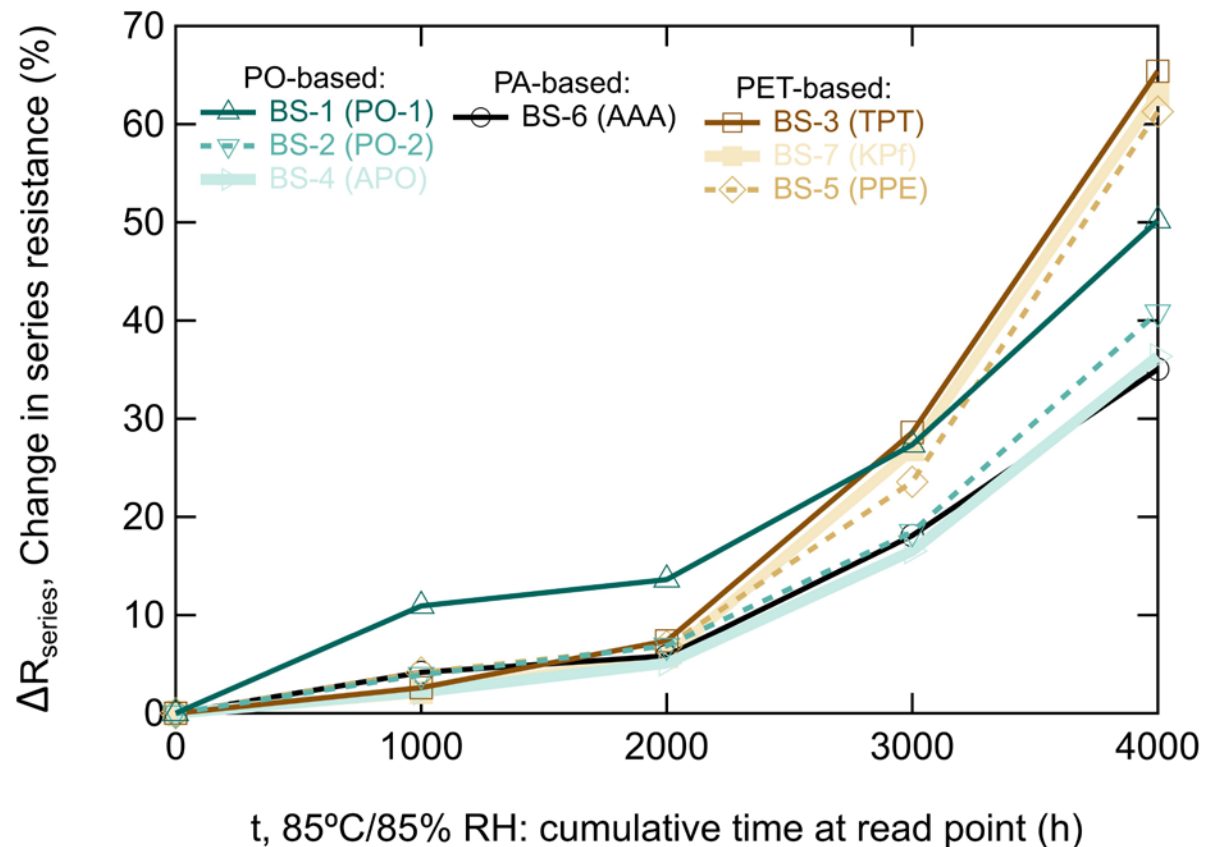
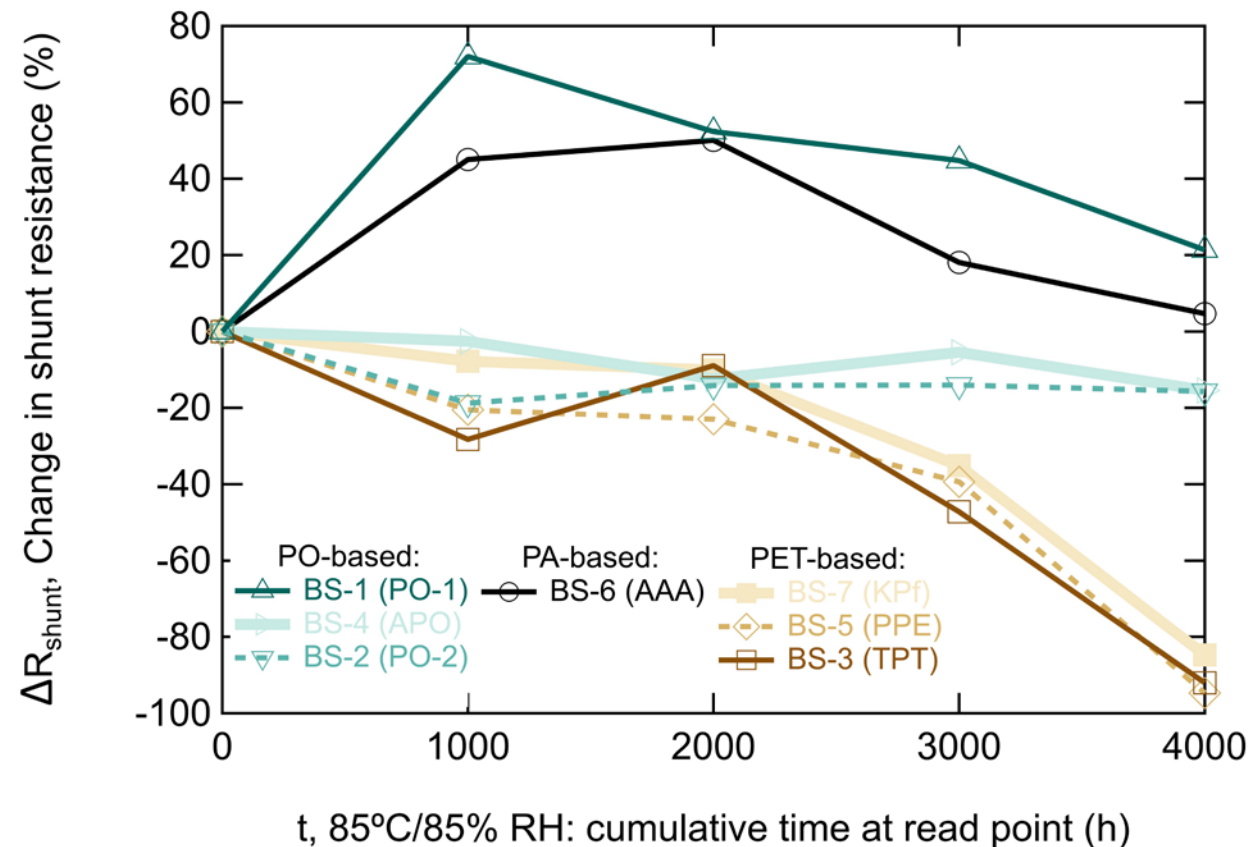
Analyzing the Loss of Power Through Damp Heat (85°C/85%RH)

- Suspect damage mechanism of hydrolysis (of PET core).
- Degradation affects PV performance.

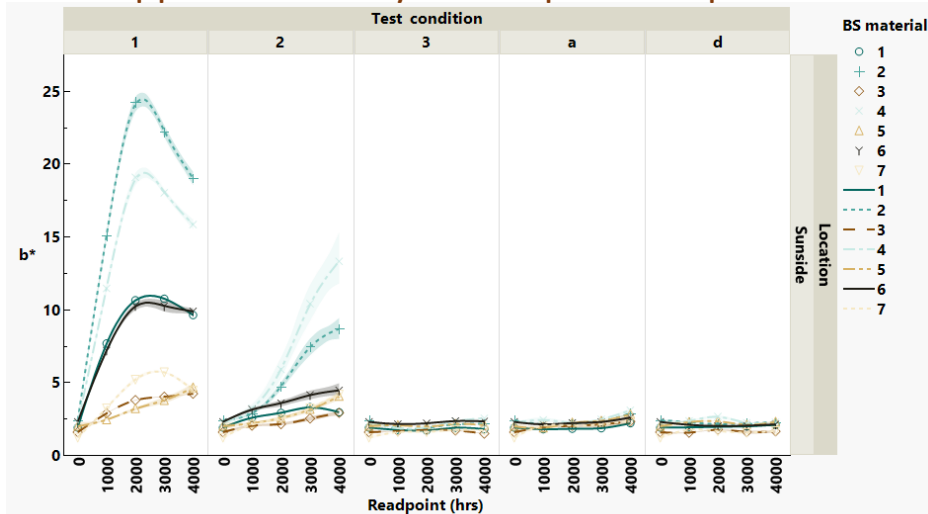
- Overt discoloration observed early ($\sim 300\text{h}$) in experiment 1: $85^\circ\text{C}/85\%$.
- Suspect interaction between EVA/backsheet or EVA/E-layer on backsheet.

MiMo appearance early in Damp Heat experiment.

Where((Test condition = 1, 2, 3, a, d) and (Location = Sunside))

Comparison of b^* (yellow-blue) for MiMo *sun side*.

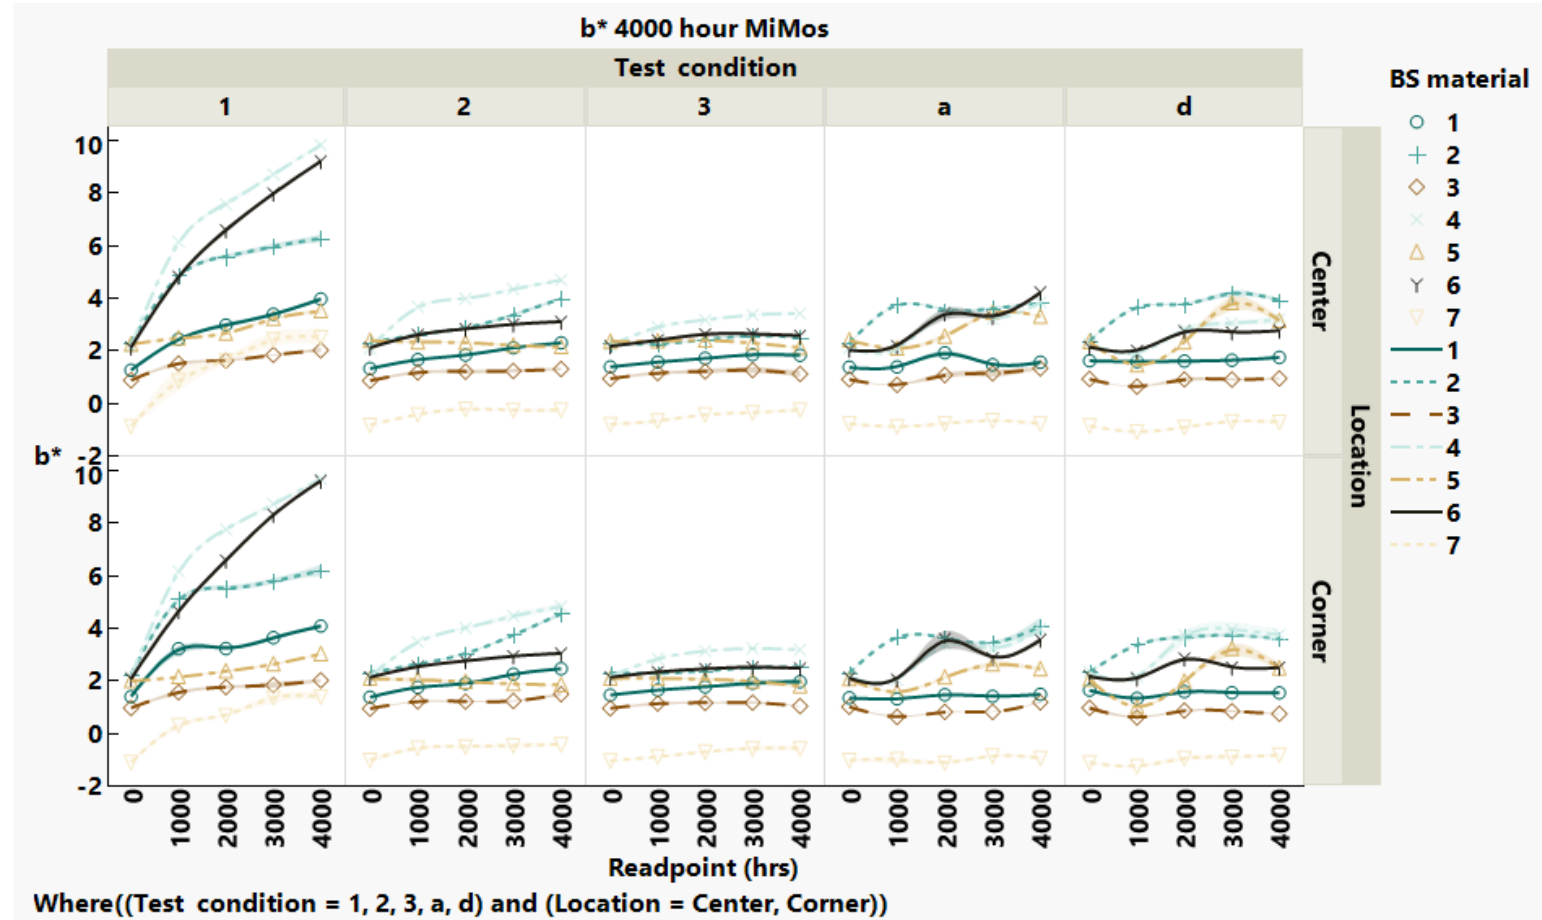
Where((Test condition = 1, 2, 3, a, d) and (Location = Center, Corner))

Comparison of b^* (yellow-blue) for MiMo *air side*, center and corner.

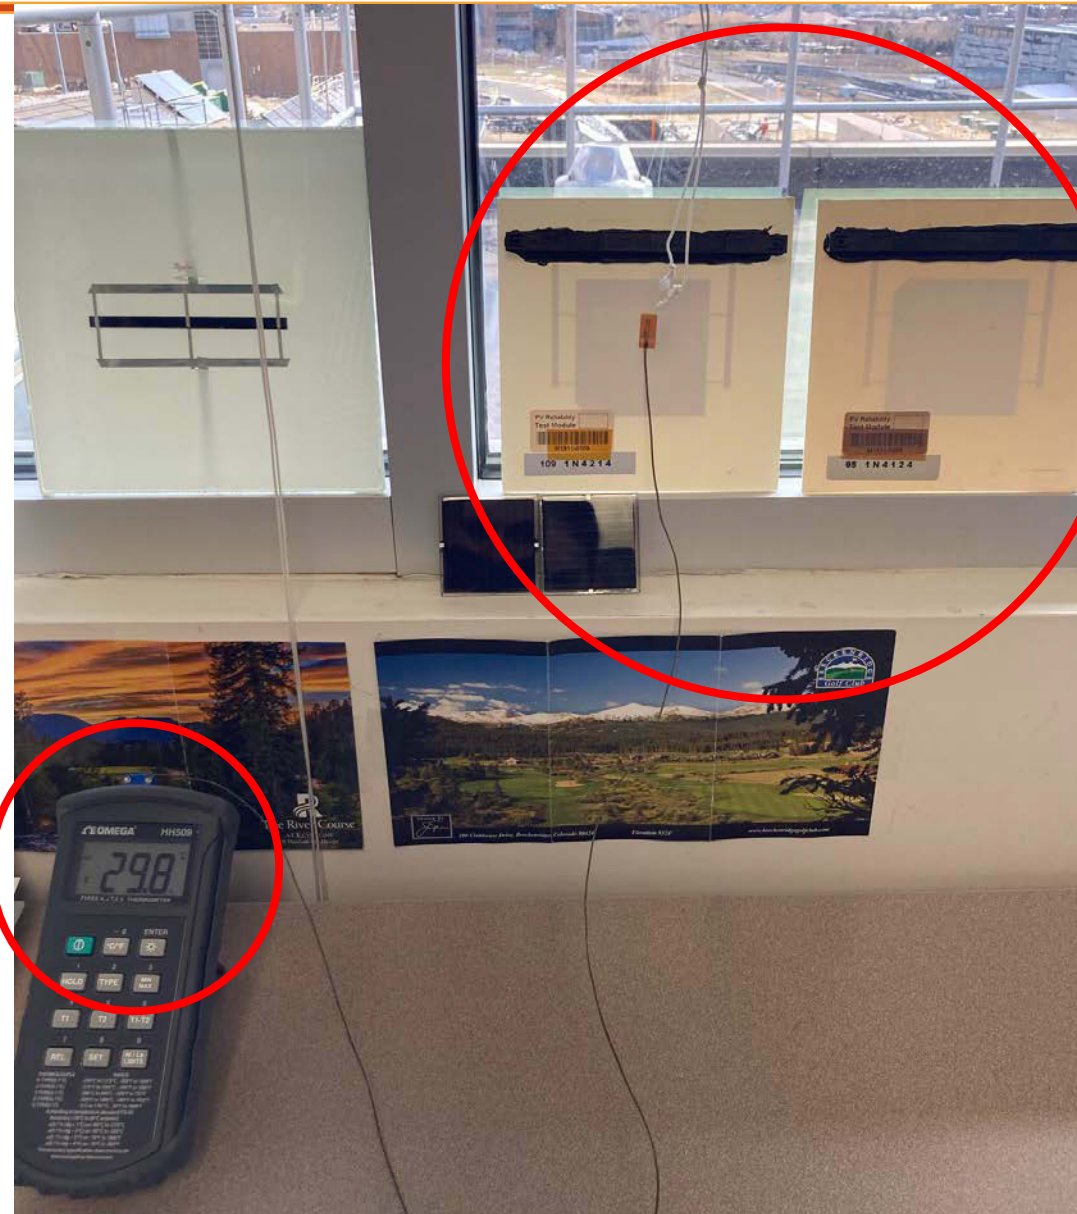
1 MiMo from 85 °C/85% and 65 °C/85% facing sun side out.

- Substantial photobleaching observed after accelerated testing.
- Both 85 °C/85% and 65 °C/85% affected.
- How close will final b^* approach initial color?
