# Photovoltaic Cable Connectors: A Comparative Assessment of the Present State of the Industry

National Renewable Energy Laboratory (NREL), Golden, CO

\*Updated from UL-NIST 2023, PVRW 2024 workshops

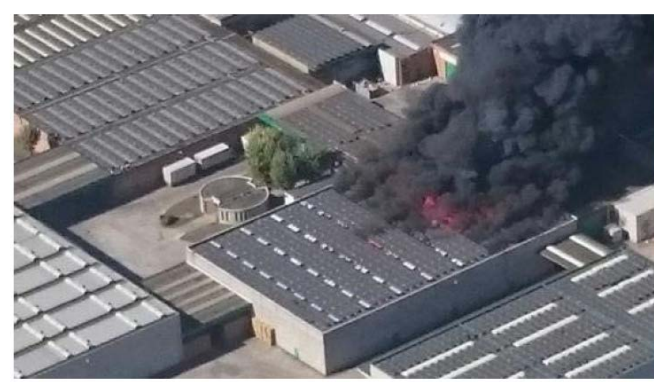
Example of PV fires in Italy.  
Fiorentini et. al., PVRW 2020.  
<https://www.nrel.gov/docs/fy21osti/80055.pdf>

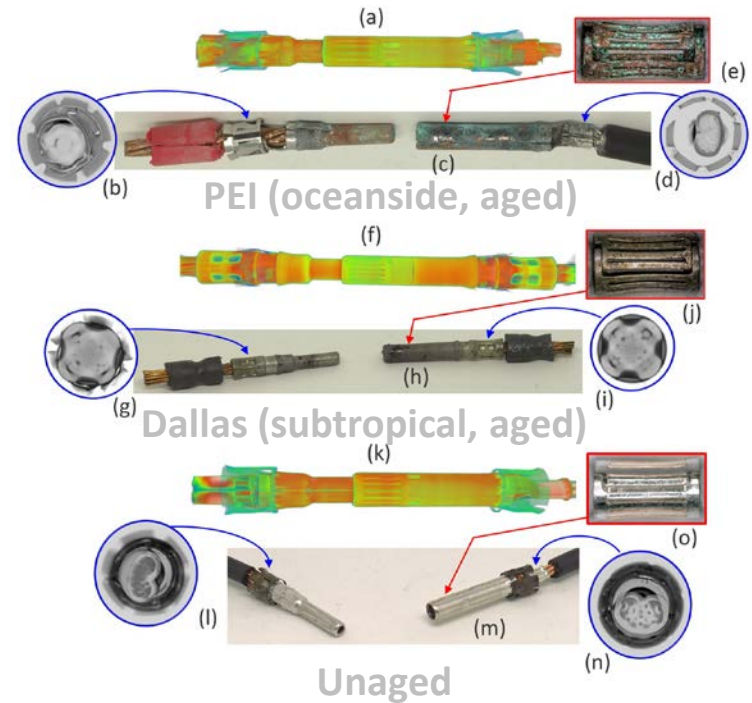
- Study of three connectors through destructive failure analysis.
- ~1y field use (where applicable).
- Metallic and polymeric components examined separately.
- Journal manuscript on F/A protocol and field degraded connectors in review.
- PEI: Incompatible connectors.  
Hermeticity compromised; corroded metal pins.
- Dallas: Scorched metal pins (common).
- We suspect improper field assembly (crimp, sizing, uncapped) is out there, but seldom identified in our specimens.

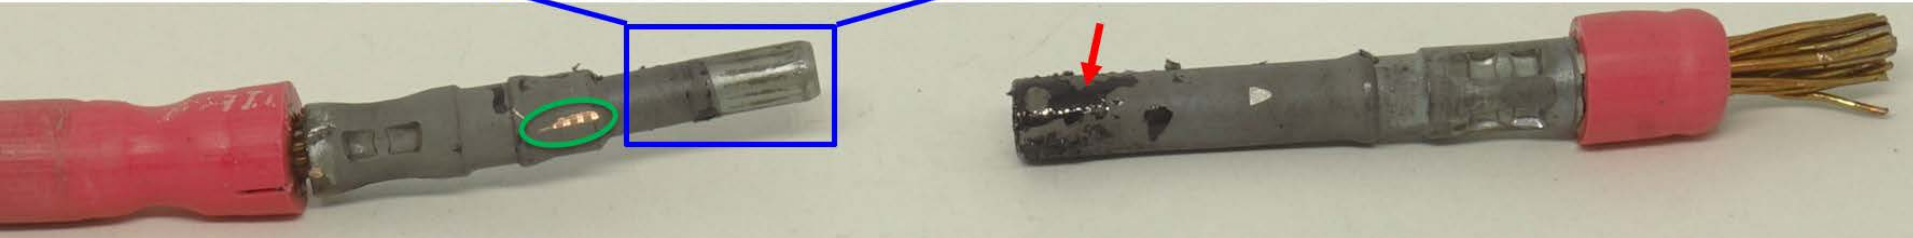
*A field-degraded connector: residual from convolute spring (inset); plastic from the connector body (red); artifact of milling (green)*
