Solar Photovoltaic (PV) Damage Assessment After Typhoon Mawar: Findings and Recommendations for Resilient PV on Guam

Technical Report
NREL/TP-5R00-89629
November 2024

A team from the National Renewable Energy Laboratory (NREL) visited Guam in August 2023 to assess failure modes of solar photovoltaic (PV) systems as a result of Category 4 Typhoon Mawar and to provide recommendations to increase the resilience of PV systems on Guam. The team visited 30 systems, all commercial and utility scale, comprised of rooftop, ground-mounted, and canopy/carport systems. The team observed systems with no apparent damage, as well as systems that were completely lost. Systems fared very well overall. The average damage to rooftop systems was 18%, with a median of 2%, meaning that few systems suffered total loss. Only 8 of the 25 rooftop systems suffered more than 5% damage. All ground-mounted systems suffered less than 0.5% damage. One carport had 16% damage. PV systems at Andersen Air Force Base suffered 5% damage on average, with a median of 0.6%. In almost all cases, damage was the result of:

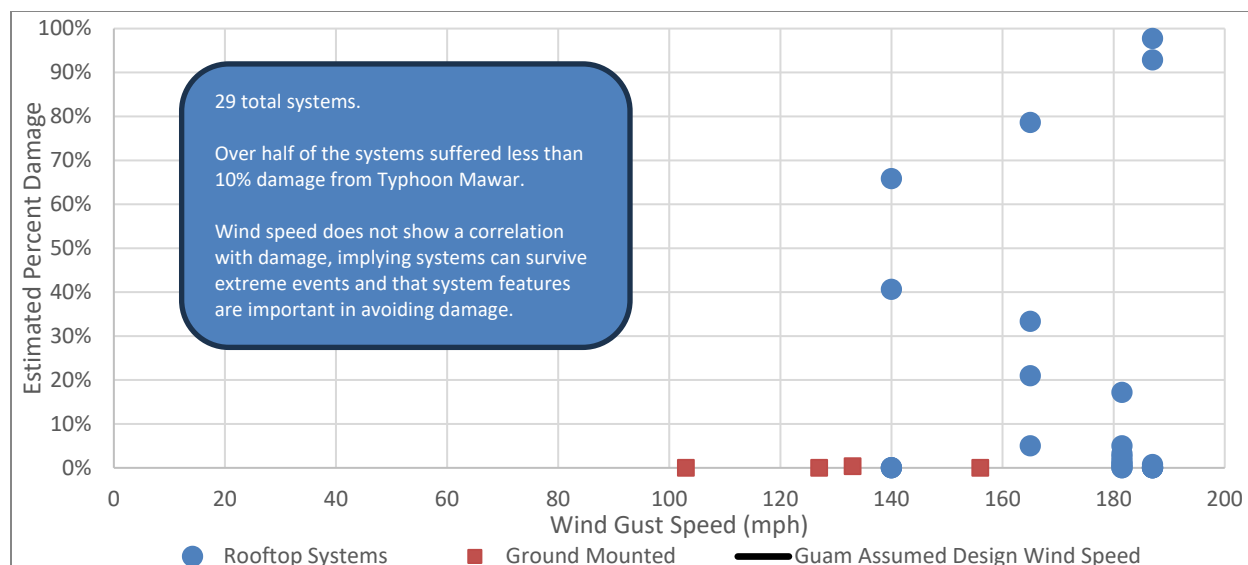
Wind speed does not appear to be a determining factor in how much damage systems suffered (Figure 8). Some systems experiencing gusts above 180 mph had no damage, while other systems that experienced 140 mph gusts were substantially damaged. No correlation between wind speed and damage can be made. This strongly implies that **system design and installation, rather than wind speed, determined the extent of damage.**

Figure 8. Wind gust speed does not appear to be a determining factor in predicting damage. Attempted curve fits showed no correlation. This implies that system design and installation ultimately determine damage, rather than the wind speed. An NWS post-typhoon analysis estimated wind gust speed. The carport system is not shown here.

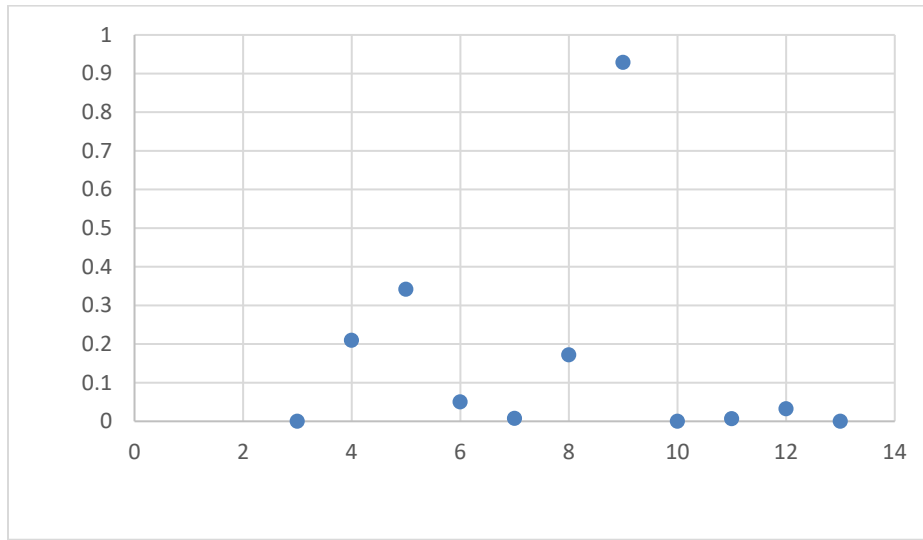
Figure 15 shows module rear test load ratings (in pascals) under standard conditions compared to percentage of damage to the modules. There is no correlation.

Figure 15. No correlation between module wind load (rear pressure) test ratings and damage suffered

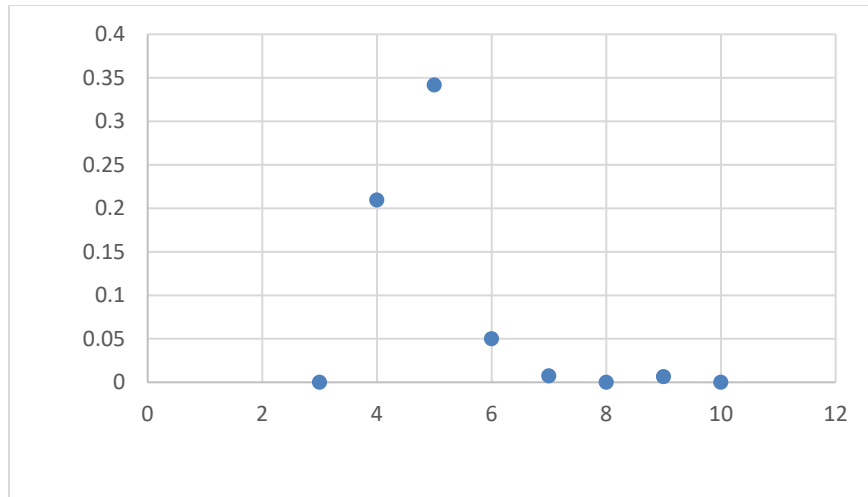
The largest panels seen on any system were on a 2.5-MW rooftop system that suffered extensive damage (21% of modules damaged or missing, extensive racking system damage). These 72 cell panels were 2.112 m long by 1.052 m wide, totaling 2.2 m². These panels were larger than those seen on the 60-MW ground-mounted site. On this site, there were several other features aside from module size that contributed to this damage.

An analysis of module surface area compared to percentage damage was inconclusive, however (Figure 16).

Figure 16. Module surface area showed no conclusive correlation to failure rates

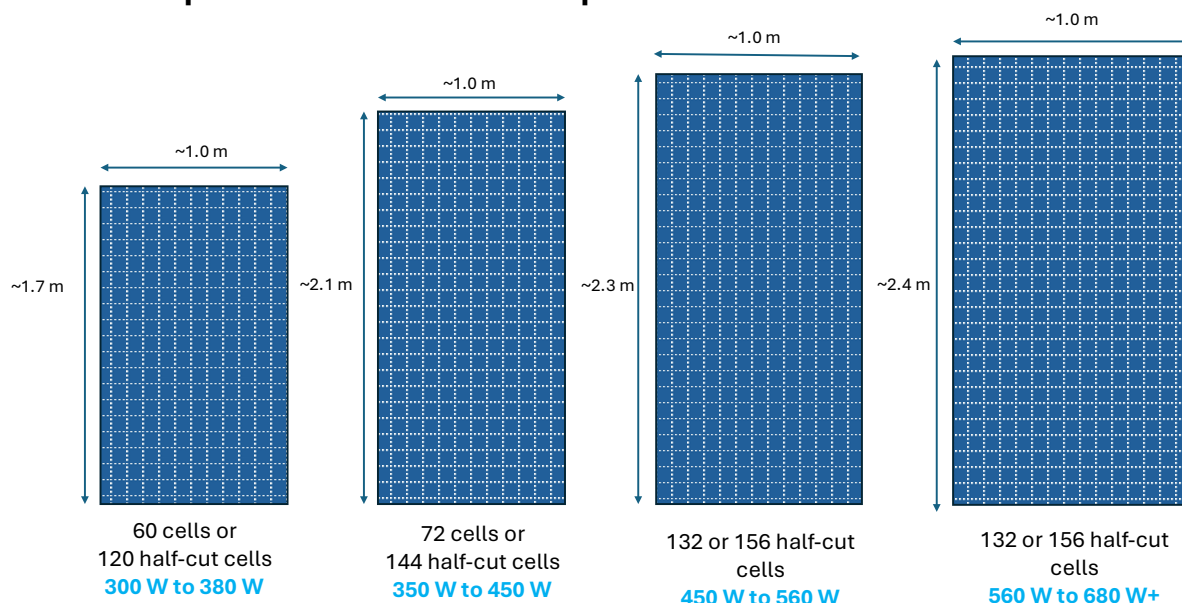
Module manufacturers have recently been making larger and larger modules. These “large-format” modules also have thinner glass and thinner frames to compensate for the extra weight that comes with this larger form factor. There is no precise definition of a large-format module, but they are generally longer than 2.0 m (6 ft. 6 in.) and greater than 500-W rated DC output. We did not see any of these large-format modules in our site assessments, and strongly recommend they are not used on Guam. Figure 17 shows the typical size of various types of modules.

Figure 17. Various typical PV module sizes. Traditionally, rooftop PV modules were 60-cell modules and ground-mounted systems used 72-cell modules. Recently, many manufacturers have replaced 60-cell modules with 120-half-cut-cell modules and have replaced 72-cell modules with 144-half-cut-cell modules within the same module dimensions. Recently, “large-format” modules have hit the market that are longer and wider than the traditional 60- and 72-cell modules. Large-scale solar PV systems have widely adopted these large-format modules. They offer higher power density but lower robustness, especially as manufacturers have reduced glass and frame thickness to compensate for the weight increases that come with larger form factors. Large-format modules (longer than 2.0 m or higher than 500 W) should not be installed on Guam. We recommend installing 60-cell modules (or 120-half-cut-cell modules) or equivalent on rooftop systems.

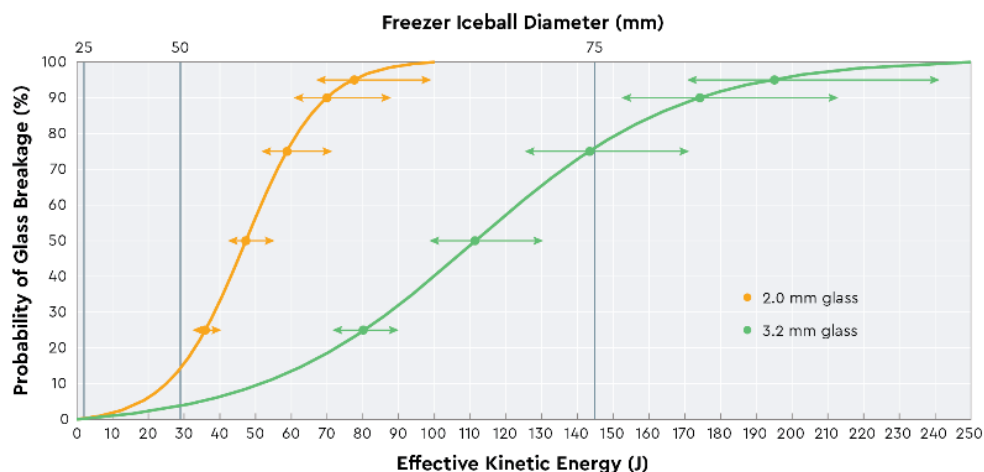
Traditional PV module glass is 3.2 mm or thicker. This glass is normally tempered. As manufacturers have shifted to larger modules and bifacial modules that produce power from the front and back sides and have both front and rear glass, thinner glass has become more common. These new modules typically feature 2.0-mm glass. This glass is weaker both because it is thinner and because it is too thin to be tempered. It is “heat treated” instead, which does not result in glass as strong as tempered glass. **In hail impact tests, 3.2-mm glass performs much better than 2.0-mm glass**, and thus should be less likely to break from flying debris as well. We believe that all the modules we saw had about 3.2-mm glass, so we were not able to see a variation in storm impacts by glass thickness. However, we advise against using thinner glass.

Figure 18 demonstrates that it takes more impact energy to break PV modules with 3.2-mm glass than it does to break modules with 2.0-mm glass.

Figure 18. PV module impact testing results show that 2.0-mm glass is much more likely to break than 3.2-mm glass when impacted by objects of lower kinetic energy (lower mass and/or velocity).

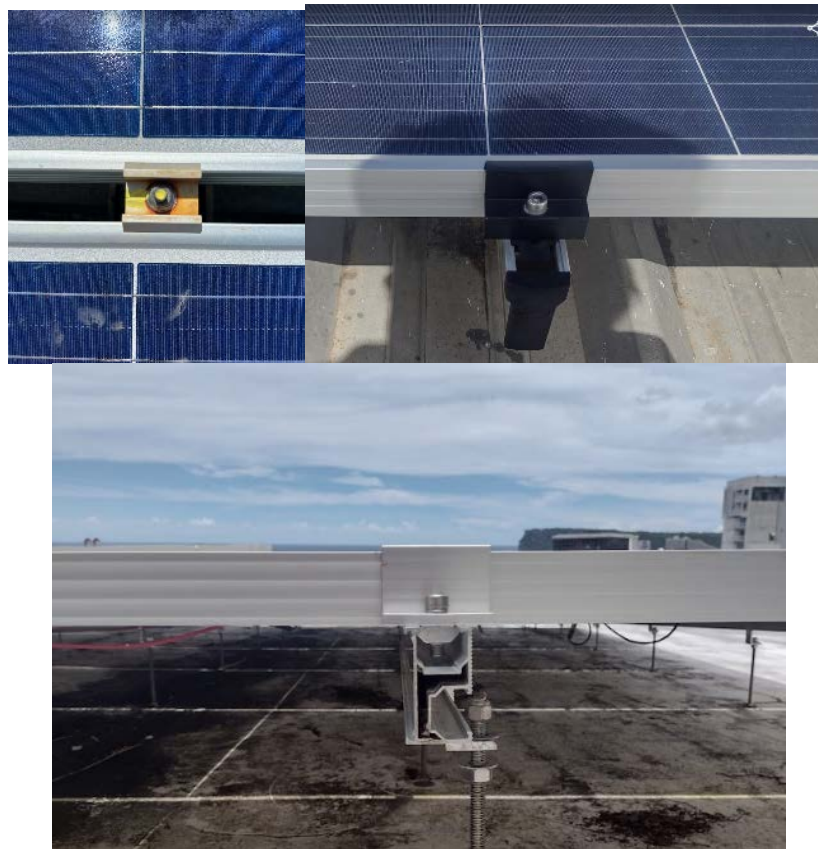
Figure 19. Various top clamps that are commonly used to attach PV modules to racking systems. Top left: A "mid-clamp" that holds adjacent modules simultaneously. Top right: An end clamp that holds the last module in a row. Bottom: The nut or bolt head of top clamps typically fits into a slot in the racking rail.

For most top-clamp module attachments, the same clamp holds adjacent modules on the left and right side and requires clamping force on both sides to maintain clamp force (Figure 19). This is a weakness of the system, because if one module comes loose or is damaged in a way that reduces its force on the clamp, the adjacent module is no longer held securely. This module can then come free under wind loads. The same can then happen for the subsequent module. The result is that an entire row of modules can be lost because of one point of failure. This “progressive” or “cascading” failure was observed on several top-clamped systems. The impact

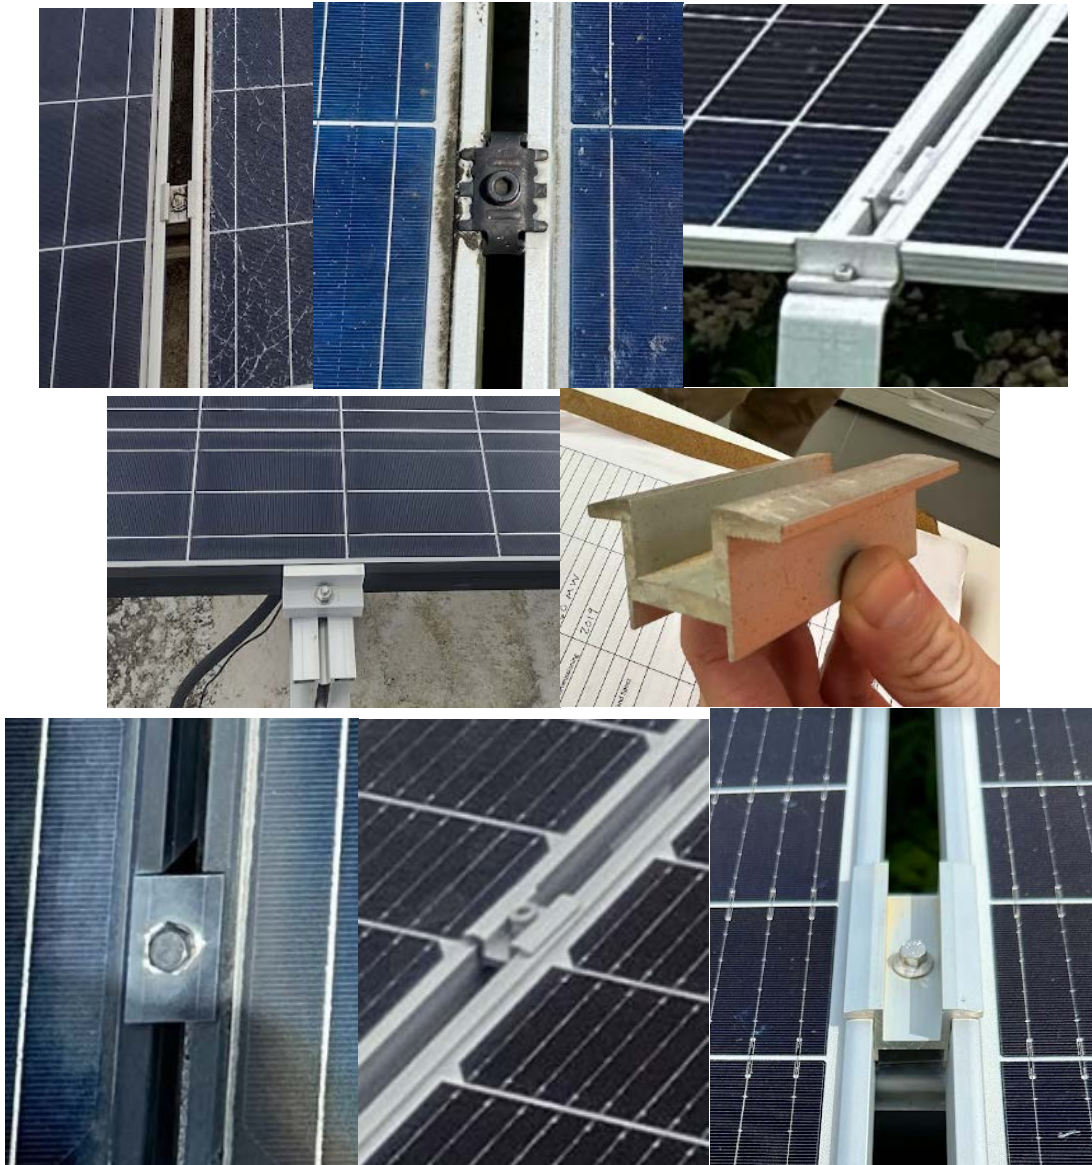
Top clamps differ in the amount of surface contact area between the clamp and the top of the module frame. This is significant because more surface area can provide more friction to resist movement of the panel out of the clamps under wind loads (Figure 21). Individual clamps we

saw varied from 0.28 in² to 1.17 in² of contact area. There are typically four clamps per module. Surface area of all clamps ranged from 1.125 in² to 4.67 in² per module. Clamps losing grip on the module and releasing it was a primary failure mode on several systems.

Figure 21. Top clamps come in many different shapes and sizes. Notice the varied lengths and amounts of overlap between the clamps and the module frames.

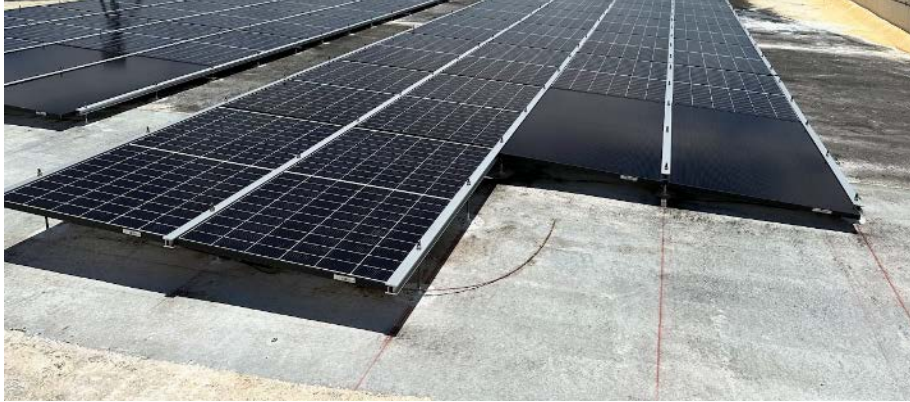
One local installer has developed their own module clamping approach that uses continuous clamping down the entire length of the module frame. This approach offers the advantage of a much greater clamp contact area with the modules (Figure 22).

Figure 22. One local racking system utilizes a continuous clamping approach down the entire length of the modules

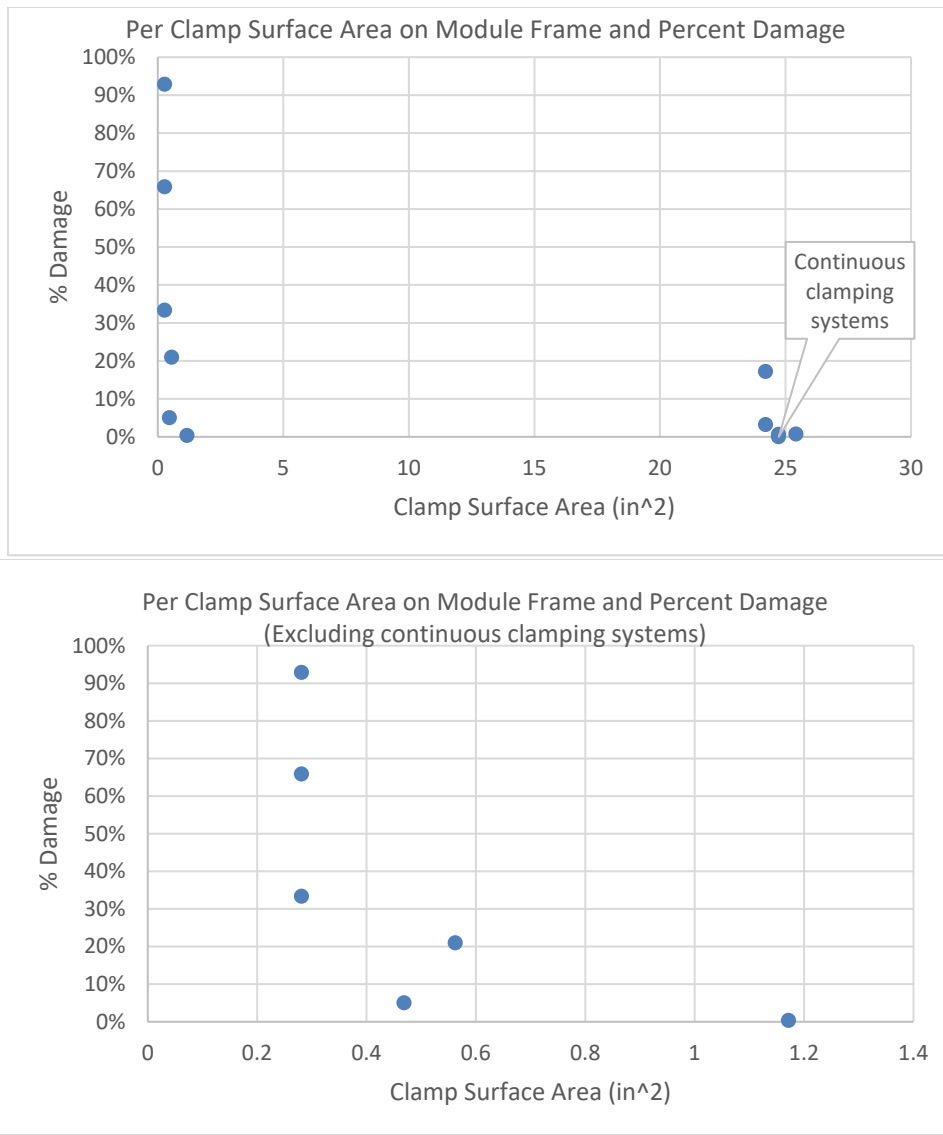
In general, clamps with a greater surface area of contact between the clamp and the top of the module frame should hold PV modules more securely. Analyzing total clamp surface area per module generally supports this, especially for this continuous clamping mounting system.

Figure 23. Clamps with more contact area with the module frames experienced less damage in general. Top: All measured top clamps including continuous clamping systems. Bottom: Excluding continuous clamping systems.

Note: The continuous clamping system with approximately 20% damage had several failure modes such as excessive flying debris which is not attributed to clamp surface area.

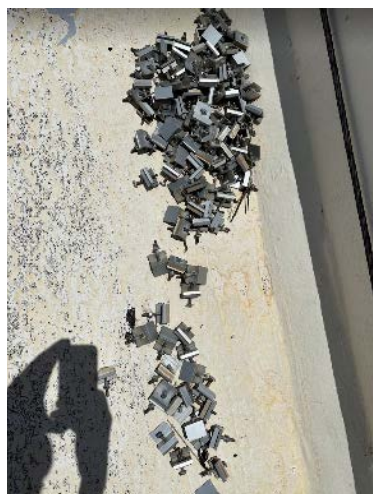
In particular, the Unirac Pro Series mid- and end clamps had high failure rates. We saw three systems with these clamps that all had very high failure rates—33%, 34%, and 93% of modules held with these clamps were lost or damaged. These clamps have very small contact area in the slotted rail. These clamps advertise needing 63° of rotation to install; we suspect less than that would release them. If these clamps are not adequately tightened, or if they vibrate loose during wind loads, it does not take much for them to come out of the racking, leaving modules unattached and free to blow away. The roofs of these three systems were littered with top clamps that had freed themselves from the racking. Most of these clamps looked undamaged, showing no signs of deformation or damage (Figure 25). One system even employed eight of these clamps per module. This was the system with 93% failure rate, showing that using more bad clamps does not increase likelihood of survivability.

Figure 25. Unirac Pro Series T-bolt clamps that rotated free of the racking littering a rooftop. Note that clamps do not show signs of deformation or damage, implying they came free from the racking relatively easily.

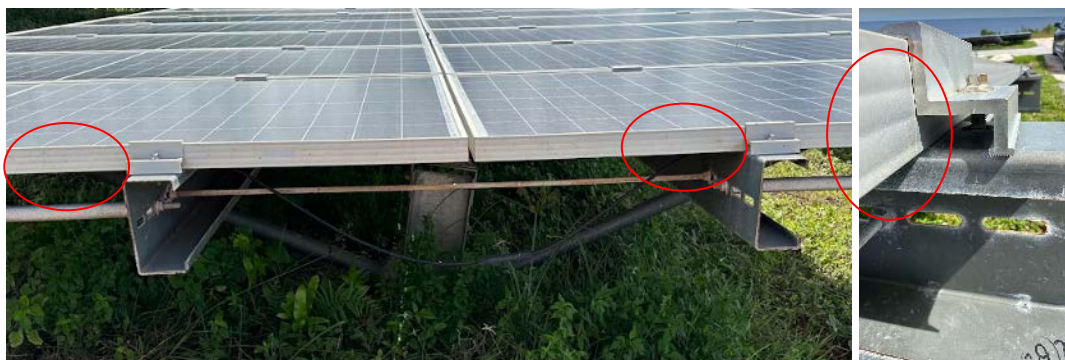
Some of these top clamps can bolt directly into a rail as well. Systems with top clamps that bolted directly into the rails were all ground-mounted systems (likely due to this being physically easier during installation), but they suffered either no damage or very little damage.

Figure 26. Top clamps through-bolted directly to racking rails are more secure because they cannot rotate out of rail slots

Recommendation: Through-bolt modules to racking if feasible. If using clamps, clamps that directly bolt into rails rather than sliding into slots are preferred. If using slotted rail clamps, ensure clamps do not release from racking with less than about 90° of rotation. Do not use Unirac Pro Series top clamps. Priority: High.

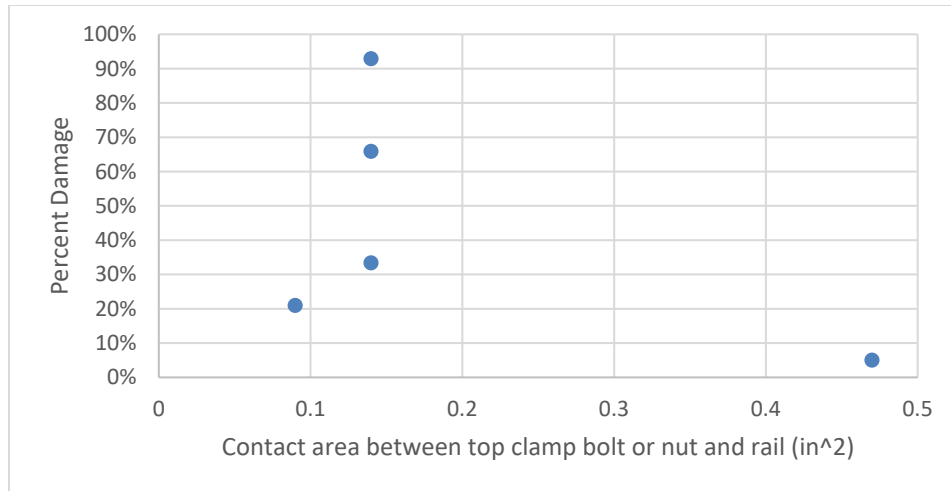
While we were only able to measure this contact area on five systems, those with below 0.2 in² of contact area per clamp suffered substantial damage (Figure 28).

Figure 28. Per-clamp contact area with racking rail and percent damage

Recommendation: If using clamps that attach into slotted rails in the racking, select clamps that have at least 0.2 in² of contact area between the clamp and rail slot per clamp.
Priority: High.

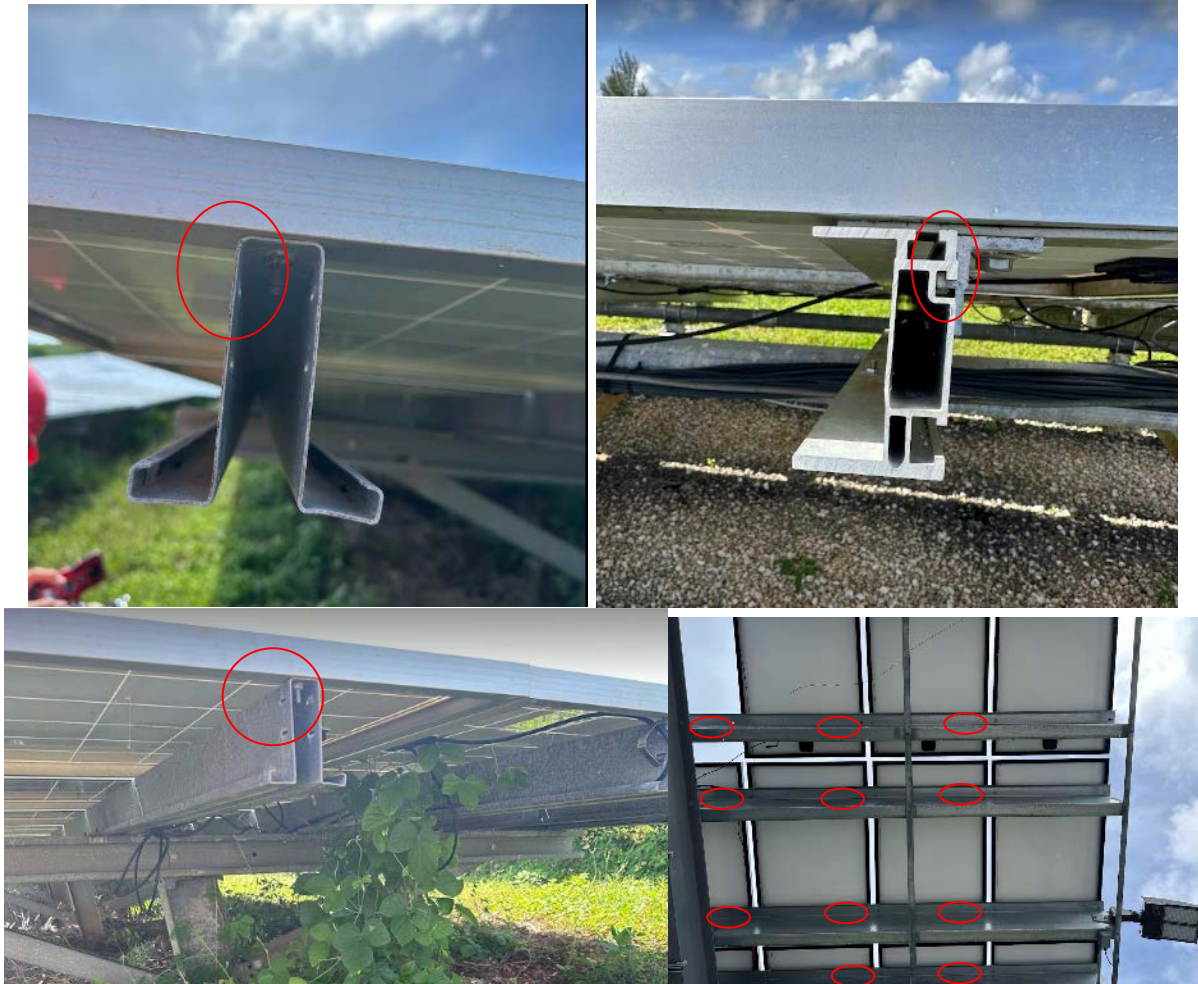
Figure 31. Various through-bolting approaches in which the bottom flange of the module's metal frame is bolted directly to the racking system underneath

Direct bolting to racking has some benefits over clamping. The bolts are not shared between modules, so if one comes loose, only one module is vulnerable; there is no chance of progressive failure. The bolts do not typically slide into slots in the rail, so they cannot simply rotate out. Through-bolting can be difficult, however, for rooftop systems where physically getting under the modules to install bolts may be impractical. There is also more labor time involved in through-bolting because there are approximately twice as many fasteners needed.

Recommendation: Through-bolt modules to the racking if feasible. Ensure washers are thick enough to avoid bolt tear-out of the hole or slot in the racking. Priority: High.

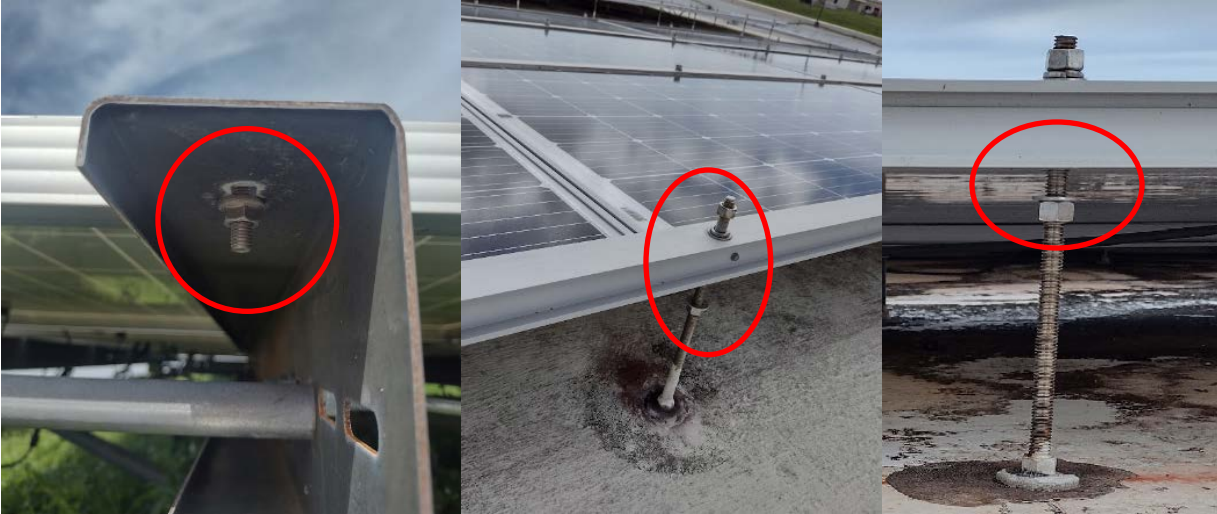
A well-designed and installed bolted joint should resist loosening under design loads. PV bolt design is a relatively immature field, however, with many inexperienced designers and installers. It may not be realistic at this point in time to expect PV bolted joints to perform the way they do in other industries (e.g., transportation, buildings, bridges). There are several factors that can lead bolts and nuts to loosen over time:

- If they are not installed to the specified torque (either too loose or too tight).
- If they are exposed to repetitive loads such as wind loads that may cause vibration in the system.
- If winds cause resonance in the system. This may be hard to determine but has been observed in PV systems. Current design standards do not directly address design for resonance.

Figure 37. Bolts on PV systems can loosen over time. Locking hardware can help resist this loosening.

Recommendation: Use locking mechanisms on bolt hardware such as wedge-locking washers, Belleville washers, nylon patches, ultraviolet (UV)-rated nylon-insert nuts, or thread lock. Do not use split “lock” washers. Priority: High.

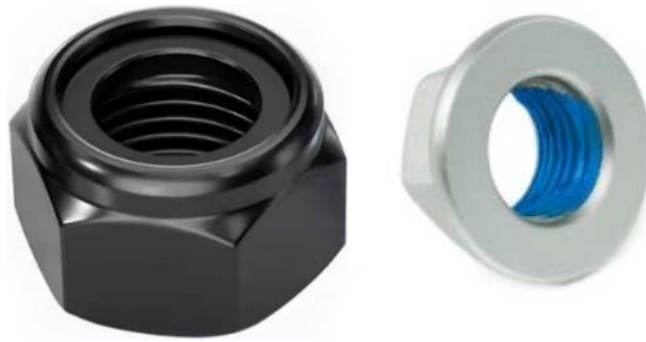
A prevailing torque but with a nylon insert or a nut with a pre-applied nylon patch could provide an effective, inexpensive solution to loosening. Nylon in nylon-insert nuts can degrade when exposed to UV light, so they should only be used when sufficiently shaded, unless using a but that contains a special formulation of nylon that contains a UV blocker. Nuts with pre-applied nylon patches should also be immune to this UV degradation. Aside from potential UV degradation, nylon is moisture sensitive, and its properties might change over time as it is exposed to moisture, as it would be on Guam. Also, installing these nylon nuts on some racking systems could be a laborious process with a hand-held wrench, which may add significant labor time.

Figure 38. Two types of nylon nuts that can be used to resist loosening. Left is a prevailing torque nylon-insert nut. Right is a flange nut with pre-applied nylon patch.

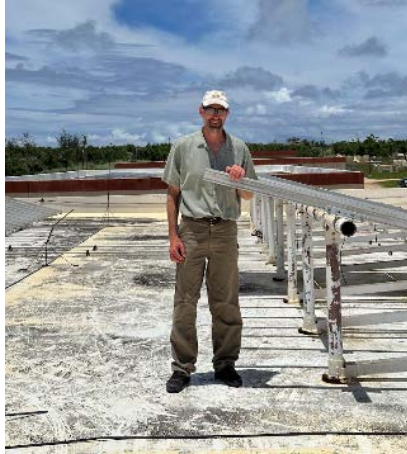
- Systems in which PV modules were low tilt and low to the roof surface or ground fared well. Systems with high tilt angles where the high side of the module was more exposed and allowed more wind uplift on the underside of the panels suffered much more damage (Figure 41). Some systems with high tilt angles suffered total loss. On other systems that were missing sporadic modules, these missing modules were often on the highest row of panels; modules with the most underside area were exposed to potential wind uplift forces. One system had a section with a high tilt angle and a section with a low tilt angle. The high-tilt-angle section suffered extensive damage, while the low-tilt-angle section was undamaged (Figure 42).

Figure 41. PV racking with high tilt angles allows more wind uplift forces on the undersides of the modules

Recommendation: Select racking elements of thicker gauges that provide both lateral and longitudinal support. Try to avoid systems that only support modules along one axis (laterally or longitudinally). These racking systems impact extra loading onto the modules, loads they are not designed to withstand. Cross bracing in racking systems is ideal. Priority: High.

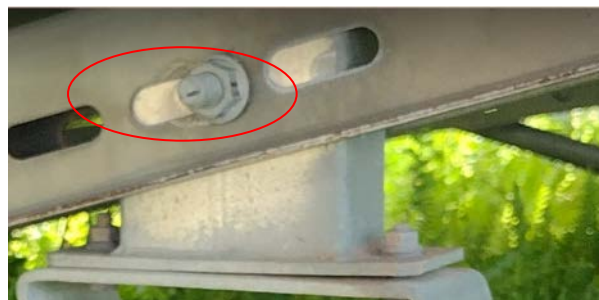
- Clamp separation. Under loads, surfaces that are meant to be held together by a bolt may separate. This could be due to bolt loosening. Once these surfaces separate, there is not sufficient friction holding them together, and they are susceptible to movement and damage. This was seen on the ground-mounted system with damage, but this could be a secondary failure that is the result of another failure mode.

Figure 49. Clamp separation between two racking members. This could be a secondary failure as a result of other racking system failures that allowed movement in the racking system.

Recommendation: Consult a bolted joint engineer in system design; likely a secondary failure mode in this case. Priority: Low.

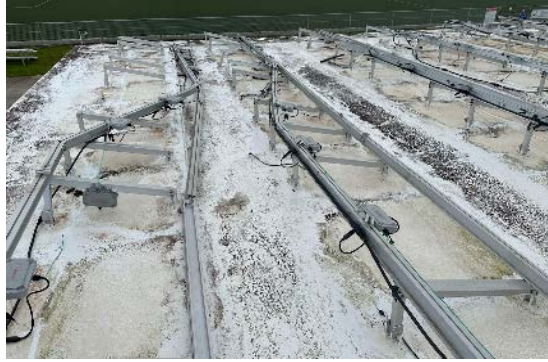
Systems with panels installed in these roof zones saw higher failure rates than in the center areas of the array (Figure 51).

Figure 51. Roof corner zones, especially on roofs without parapets, experience the highest wind loads and often experience the most damage (as shown here)

Recommendation: Do not install modules in SEAOC PV 2-17 roof Zone 3. Priority: Medium.

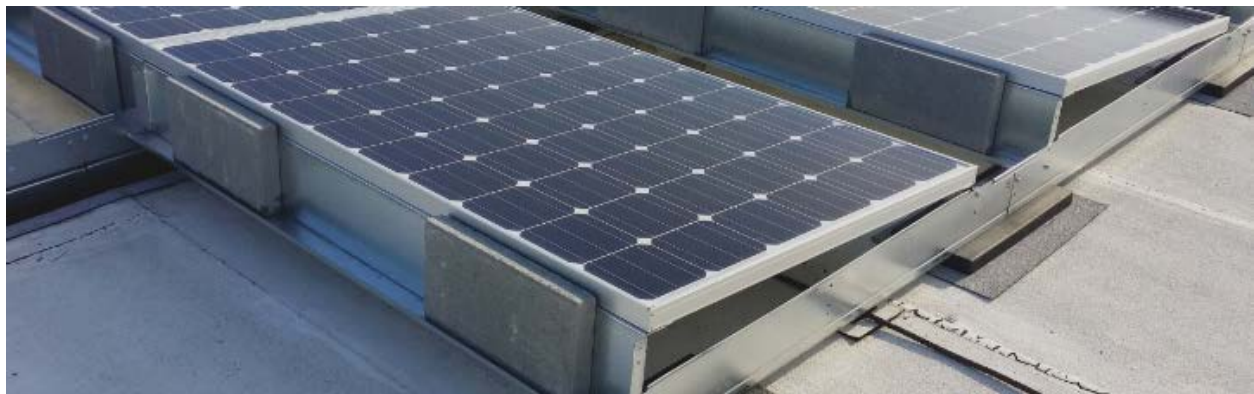
The NREL team did not observe any wind deflectors on Guam PV arrays, though they are commonly used elsewhere. They are typically installed around the perimeter of an array (or on the windward side) to block the gap between the PV modules and the roof to prevent wind from getting underneath the modules and providing uplift forces. We saw notably more damage occurring on the high side of PV arrays where wind can get under the top row. Wind deflectors may help limit these failures.

Figure 52. Rooftop solar system with wind deflectors on rear side to block wind and prevent uplift forces

Recommendation: Install wind deflectors on the high side of PV arrays between the roofs and panels. Priority: Medium.

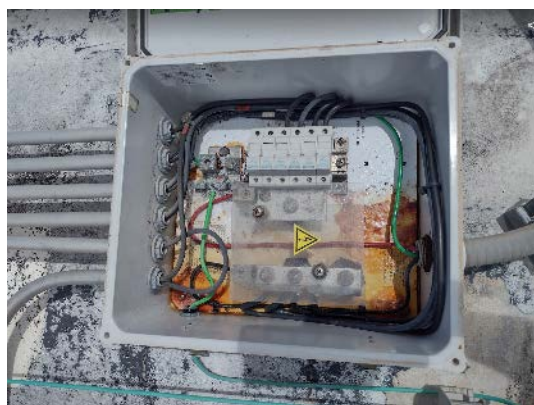
One combiner box had clear evidence of water intrusion. As it was on the high side of a roof, this was likely the result of the cover blowing open during the storm (or perhaps rain driven in through inadequate seals).

Figure 54. Combiner box damaged from water intrusion. This box was NEMA 4X rated, but still not of high enough quality.

Recommendation: Specify NEMA 4X enclosures in Guam. NEMA 4X in Guam alone is not sufficient. All exterior housings must be continuously welded, NEMA 4X (or better), fully gasketed, continuously hinged (piano hinge) with three-point door closure clamps, and designed to prevent water intrusion from hose-directed water, splashing water, and wind-driven rain. Gaskets must be molded and of one continuous shape with no seams. All equipment mounted to the interior of the enclosure shall use back plates to minimize exterior cabinet penetrations. Conduit entry into electrical equipment shall be designed to prevent water intrusion. The minimum mounting height of enclosures shall be based on the 500-year flood plain and surge levels. Priority: Medium.

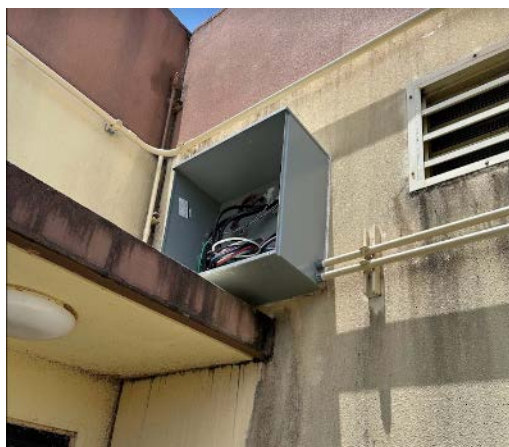
We saw an instance of an electrical pull box with a missing cover that likely blew off in the storm. This enclosure was not adequately rated for the conditions (assumed NEMA 3 rating). The missing cover could have led to water ingress into the box, through the conduit, and into the AC breaker panel and PV panel, though in this case we saw no evidence of water damage to these panels.

Figure 56. Electrical pull box with missing cover, likely blown off during the storm. The box does not appear to be rated for the conditions; it is likely a NEMA 3-rated enclosure. This leaves the system vulnerable to water ingress that could flow through the conduit into other electrical components such as inverters and AC breaker panels.

Recommendation: Clear roof drains to avoid flooding that can damage DC surge protectors. Follow electrical enclosure recommendations in this report—NEMA 4X plus additional requirements. Consult a PV service provider or local installer for repair. Priority: Medium.

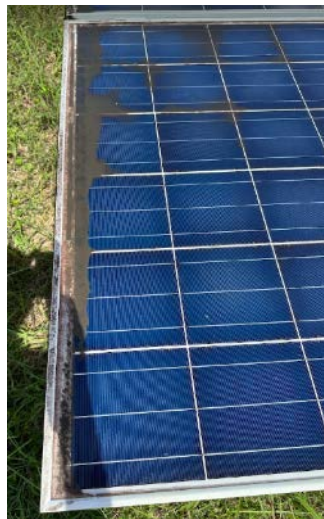
Algae buildup was seen on buildings throughout Guam, especially on roofs. It can build up on solar panels, especially along the lip of the frame on the lower side of modules. Regular cleaning (one local installer recommends quarterly) or treatment with algaecide can be effective in preventing this and maintaining expected solar panel production, given the algaecide is environmentally friendly. One reason for the algae buildup is the low tilt angles of the panels. With higher tilt angles, rainwater would clean the panels more effectively and less water would pool by the lower frame lip after rains. Lower tilt angles, however, are more resilient against wind events. We recommend low tilt angles of around 4° – 5° as a compromise, though this might necessitate more frequent cleaning. One local installer believes 10° is necessary to eliminate this buildup.

Figure 60. Algae buildup along the frame on the lower side of PV modules. This site is experimenting with algaecide to mitigate buildup.

Recommendation: Ensure slope is high enough for water to shed and wash off algae and other “muck.” Priority: Low.

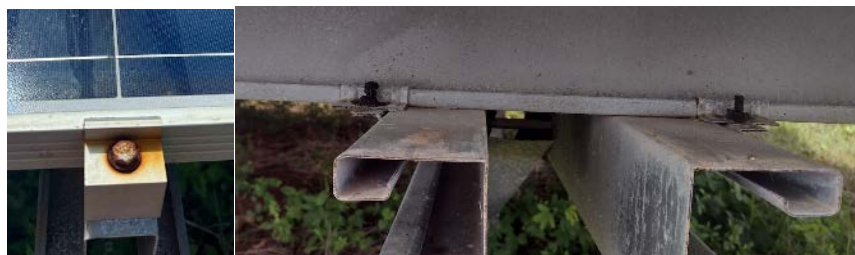
systems. The oldest system visited had severely rusted bolts, but no failures were observed due to corrosion. Aluminum oxide was present in places, but not at a significant enough level to be of concern.

Figure 62. Salt mist and humidity make Guam a very corrosive environment (rated C5 on the International Organization for Standardization’s (ISO) corrosivity scale). This can cause signs of corrosion where dissimilar metals contact. We saw corrosion on infrastructure attachments on Guam. It was typically worse on non-PV infrastructure. We saw no failures related to corrosion.

Recommendation: Use marine-grade stainless steel hardware in Guam. Priority: Medium.

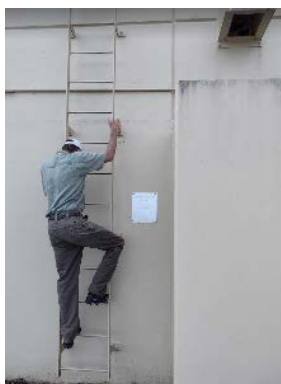
Several rooftop systems had difficult or no access to the array. Some would need a lift to access, others would need a key to a roof hatch. On occasion, inverters were located on these roofs or mounted high in rooms that needed ladders to access and view.

Figure 63. An example of good rooftop and PV array access from an outside ladder. Some buildings did not have easy roof access, impeding maintenance and damage assessment.

All rooftop systems need to be easily accessible. We recommend access with a minimum 10-foot ladder. Installing external ladders on building walls is the preferred access method. Systems that cannot be accessed cannot be maintained or even evaluated for damage and safety after a weather event. Many of the systems on Andersen Air Force Base were not easily accessed, so damage could not be easily assessed after the typhoon. These systems typically needed a lift for roof access. After the storm, lifts were in high demand for higher-priority recovery tasks, so were not available for PV assessment. Buildings on which PV is installed should not rely on lifts for access.

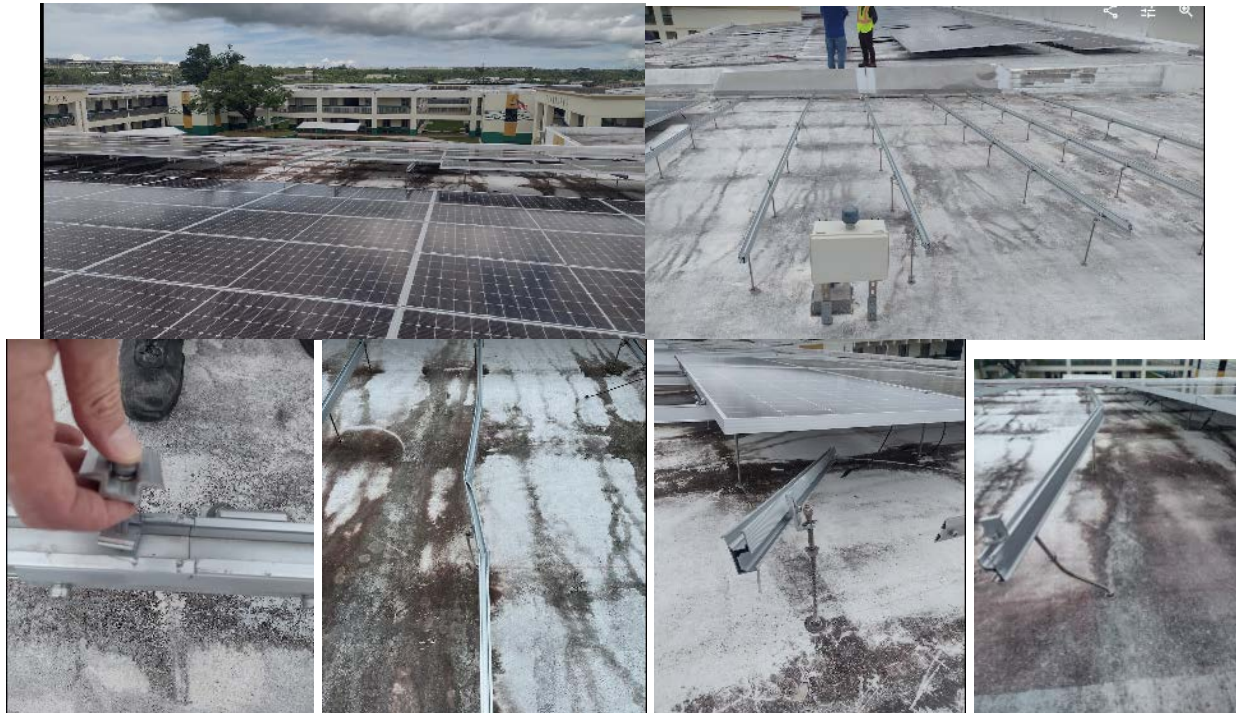
JFK High School PV Damage Assessment After Typhoon Mawar in Guam

- Overall failure rate: 859 of 4,100 modules lost (21%), total damage much higher because many all-thread rods and rails were bent (both too thin), and rails had clamps pull out.

- Much higher losses on west roofs on campus than more eastern roofs—wind out of west (ocean side). High-side edges near roof corners had most damage (Zone 3 SEAOC), high side near roof edge next most (Zone 2). No modules were lost from one section on the lower roof that was likely shielded from wind.

- Lots of bent, twisted, damaged racking. Aluminum rail seemed particularly thin. No cross bracing between racking supports. As racking moves, it puts lots of stress on module or allows modules to release. The rail system was recommended by JA Solar.

- **Roof:** Concrete sloped about 2°
- **NWS estimated windspeed:** L4; 130 mph with gusts to 165 mph
- **Failure modes (in approximate order):**
 1. End clamps came loose, cascading failure to remainder of row, many clamps still in rack.

2. Mid-clamps came loose, cascading failure to remainder of row, many clamps still in rack.
 3. Clamps pulled out of rails (too thin rails).
 4. Rails bent (to thin rails).

- Install array flush with roof height above roof racking. Use more robust racking, torque clamps, larger and more robust clamps, and smaller modules. If elevated (sloped) above roof, use fewer modules in height so the back side is not as high above roof, cross bracing between rails/rows, more rails (three per module, i.e., six attachment points), thicker all-thread.
- Recommend using smaller-format modules for roof mount. These 465-W modules were larger than those typically used on roofs, allowing more area for wind loads to cause uplift.

- Hire contractors with proven success installing PV in storm-prone regions.
- Remove all existing racking and get professional local installers to install a new, more robust racking system.
- Salvage panels that are usable, and consolidate into the areas that saw less damage from this storm. Install smaller modules on areas that saw the most damage from this storm.

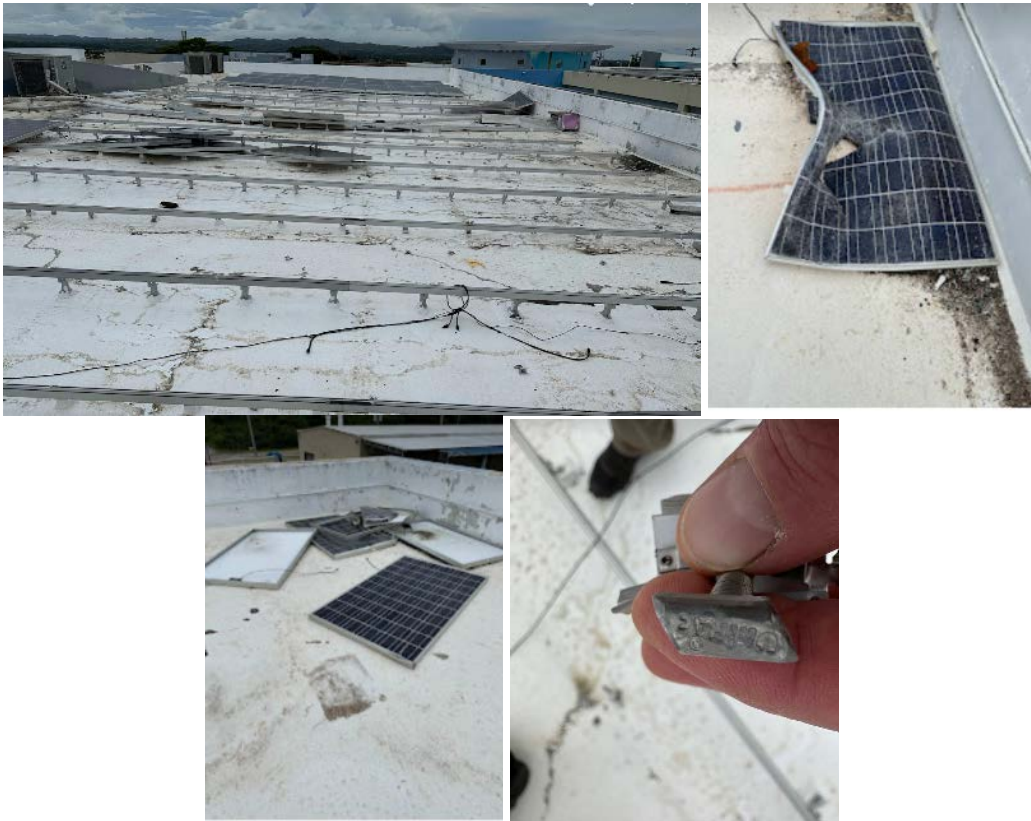
Guam Community College PV Damage Assessment After Typhoon Mawar in Guam—Unirac Array

- **Estimated damage:** 66%
- Unirac array on lower roof (4°), most modules lost, many racks bent, near total loss (79 modules out of 120). Originally 12 rows of 10 modules; 41 remaining on rack. Many modules broken and scattered around roof. Failure rate of 66%. Rows of modules were either all present or all missing, aside from one row with one module remaining. Indicates progressive/cascading failure. Surviving rows were the three closest to one parapet on the north side of the main array section and the one row closest to the southern parapet on a smaller section.

- Solar clamps mostly came free from racking, either loosened or rotated out, and were scattered across the roof undamaged. Some clamps showed damage. Clamps slightly offset toward lower side of module—about 15% of the way up from the bottom and 20% down from the top.

- Racking rails attached to the roofs were largely still intact. First row lower rail was loose. Rails anchored to roof with L-feet about 2 feet apart. Lower and upper cross rail for modules in portrait only.

- Lots of corrosion on system hardware.
- Schott Solar 235-W panels (not manufactured since 2012) on Unirac system gives indication of age of system. Discoloration on cells of panels.

- Pacific Solar rack had zero loss on neighboring roof.
- Roof rail unsupported. Should be double bolt on roof L-feet. Allowed modules to move a lot. Joint opening on L-foot.
- Progressive failure.

- Install a system with proven success as replacement to Unirac system and on vacant flat roofs.
- Do not use systems with Unirac ProSeries clamps.
- Racking rails must be supported and braced for lateral movement to limit movement.

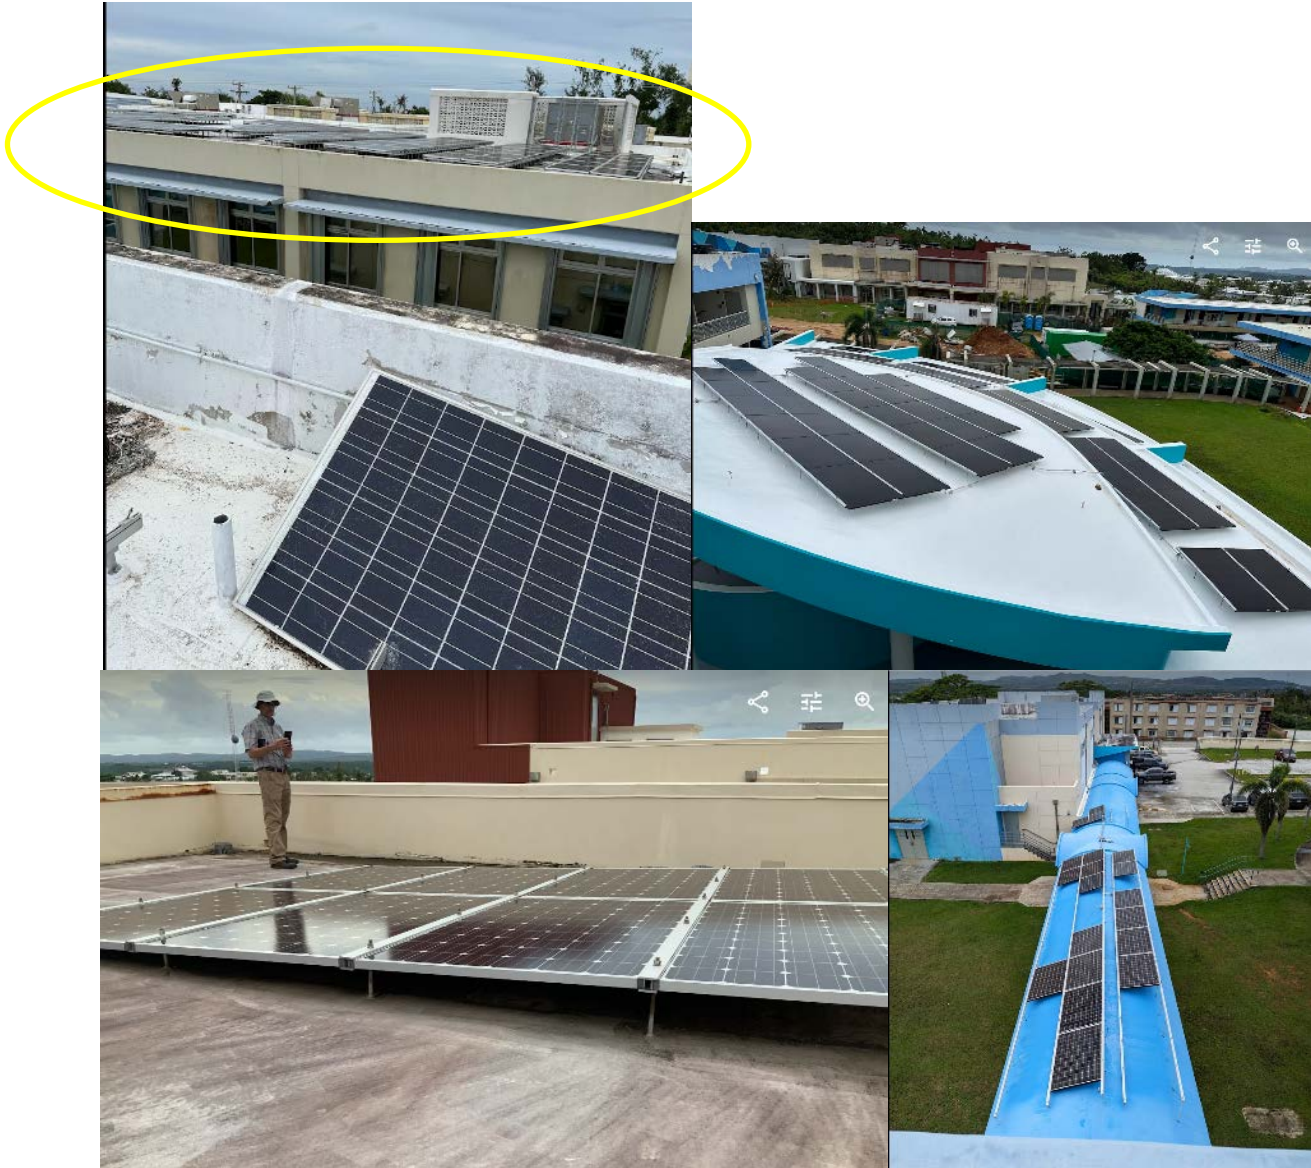
Guam Community College Solar PV Damage Assessment After Typhoon Mawar in Guam: Other systems

- **Estimated failure rate:** 7%
- Pacific Solar rack had zero loss on all other roofs except 13 of 32 on curved roof; 194 total modules across four PV systems.
