Solar Photovoltaic (PV) Damage Assessment After Typhoon Mawar: Findings and Recommendations for Resilient PV on Guam

Technical Report
NREL/TP-5R00-89629
November 2024

A team from the National Renewable Energy Laboratory (NREL) visited Guam in August 2023 to assess failure modes of solar photovoltaic (PV) systems as a result of Category 4 Typhoon Mawar and to provide recommendations to increase the resilience of PV systems on Guam. The team visited 30 systems, all commercial and utility scale, comprised of rooftop, ground-mounted, and canopy/carport systems. The team observed systems with no apparent damage, as well as systems that were completely lost. Systems fared very well overall. The average damage to rooftop systems was 18%, with a median of 2%, meaning that few systems suffered total loss. Only 8 of the 25 rooftop systems suffered more than 5% damage. All ground-mounted systems suffered less than 0.5% damage. One carport had 16% damage. PV systems at Andersen Air Force Base suffered 5% damage on average, with a median of 0.6%. In almost all cases, damage was the result of:

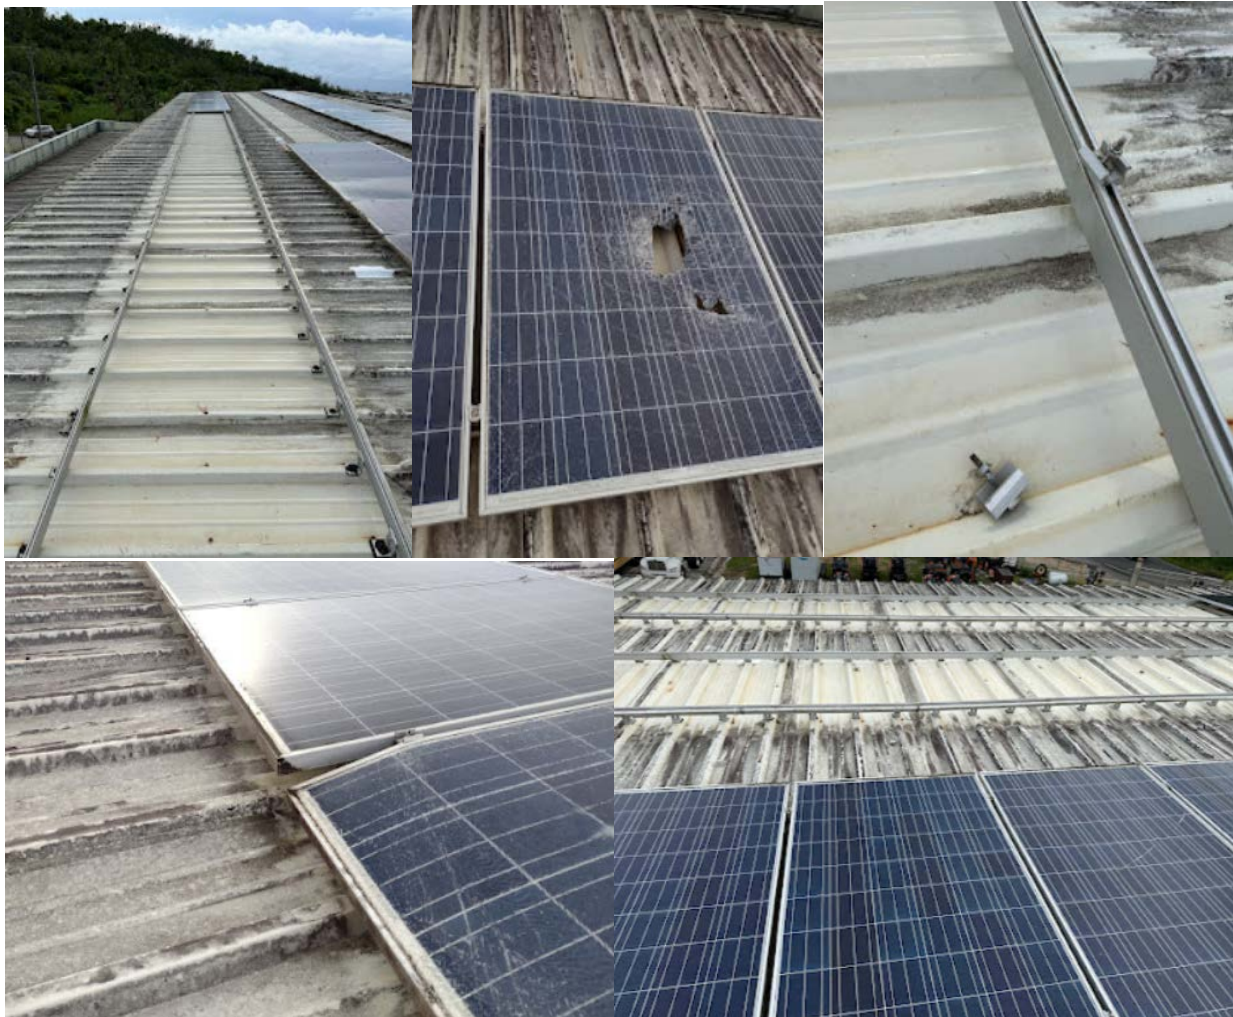
Metal Roof Commercial Building Rooftop PV Damage Assessment After Typhoon Mawar in Guam

- Overall failure rate about 33%
- Unirac array flush to roof (4°), many modules lost, estimated 60 of 180 total.
- Solar clamps mostly came free from racking, either loosened or rotated out, and were scattered across the roof undamaged. Some clamps showed damage.
- Racking rails attached to the roofs were all still intact and reusable. Rails anchored to roof with L-feet 1 foot apart. Lower and upper cross rail for modules in portrait only.
- Lots of corrosion on system hardware.
- Large sections of rows missing, indicating progressive/cascading failure.
- Plastic wire ties used for wire management were broken.
- Damage from flying debris, likely dislodged PV panels. Adjacent building damage from PV panels.

2. Middle row roof edge (Zone 2), wind vibrated panel and loosened Unirac T-bolts in rails end clamp, edge module then removed, then mid-clamp Unirac T-bolts in rails, then modules removed in cascading failure of remaining row.

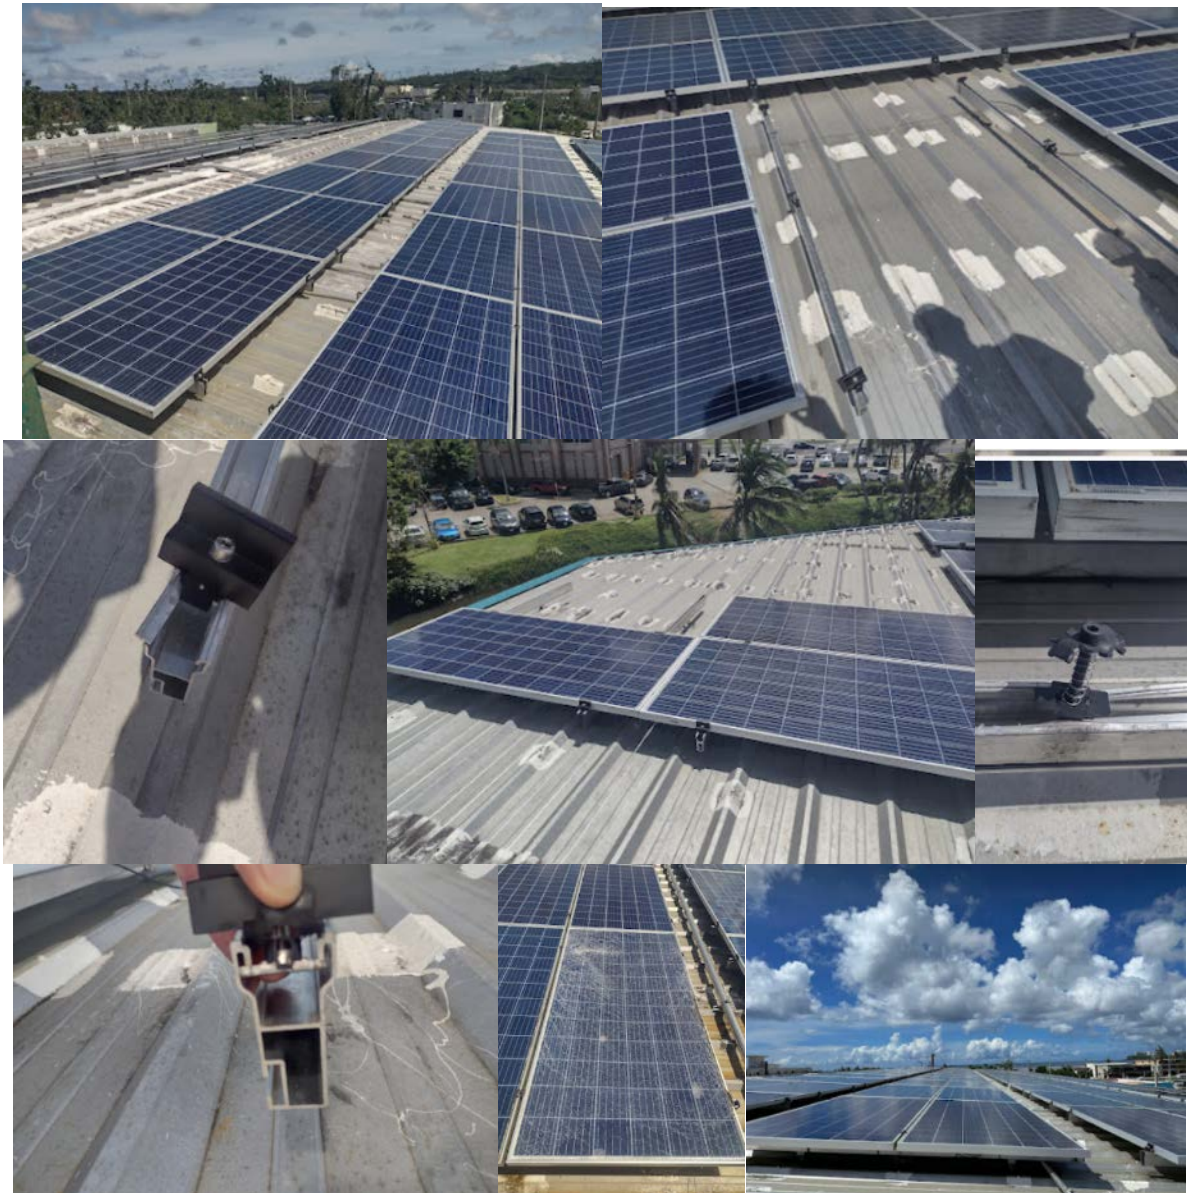
Paradise Fitness Metal Building Roof PV Damage Assessment After Typhoon Mawar in Guam

- Overall failure rate about 5%, seven modules lost on lower roof, none apparently lost on upper roof. Array installed very close to roof edge in some cases, edge (SEAOC Zone 3) modules missing in several cases.
- 4° tilt installed flush with roof.
- Used an Everest racking and module attachment system. Four mounting points but fared very well. More surface area in contact between clamp and module and significantly more surface area in contact between flat nut and racking rail. Nuts require 90° rotation and angling to remove from rack channel.

2. Middle row (Zone 1), wind vibrated panel and loosened bolts in rails end clamp, edge module then removed, then mid-clamp bolts in rails, then other modules removed, three total. Group of two modules, middle and end clamps still in rail, no rail damage.

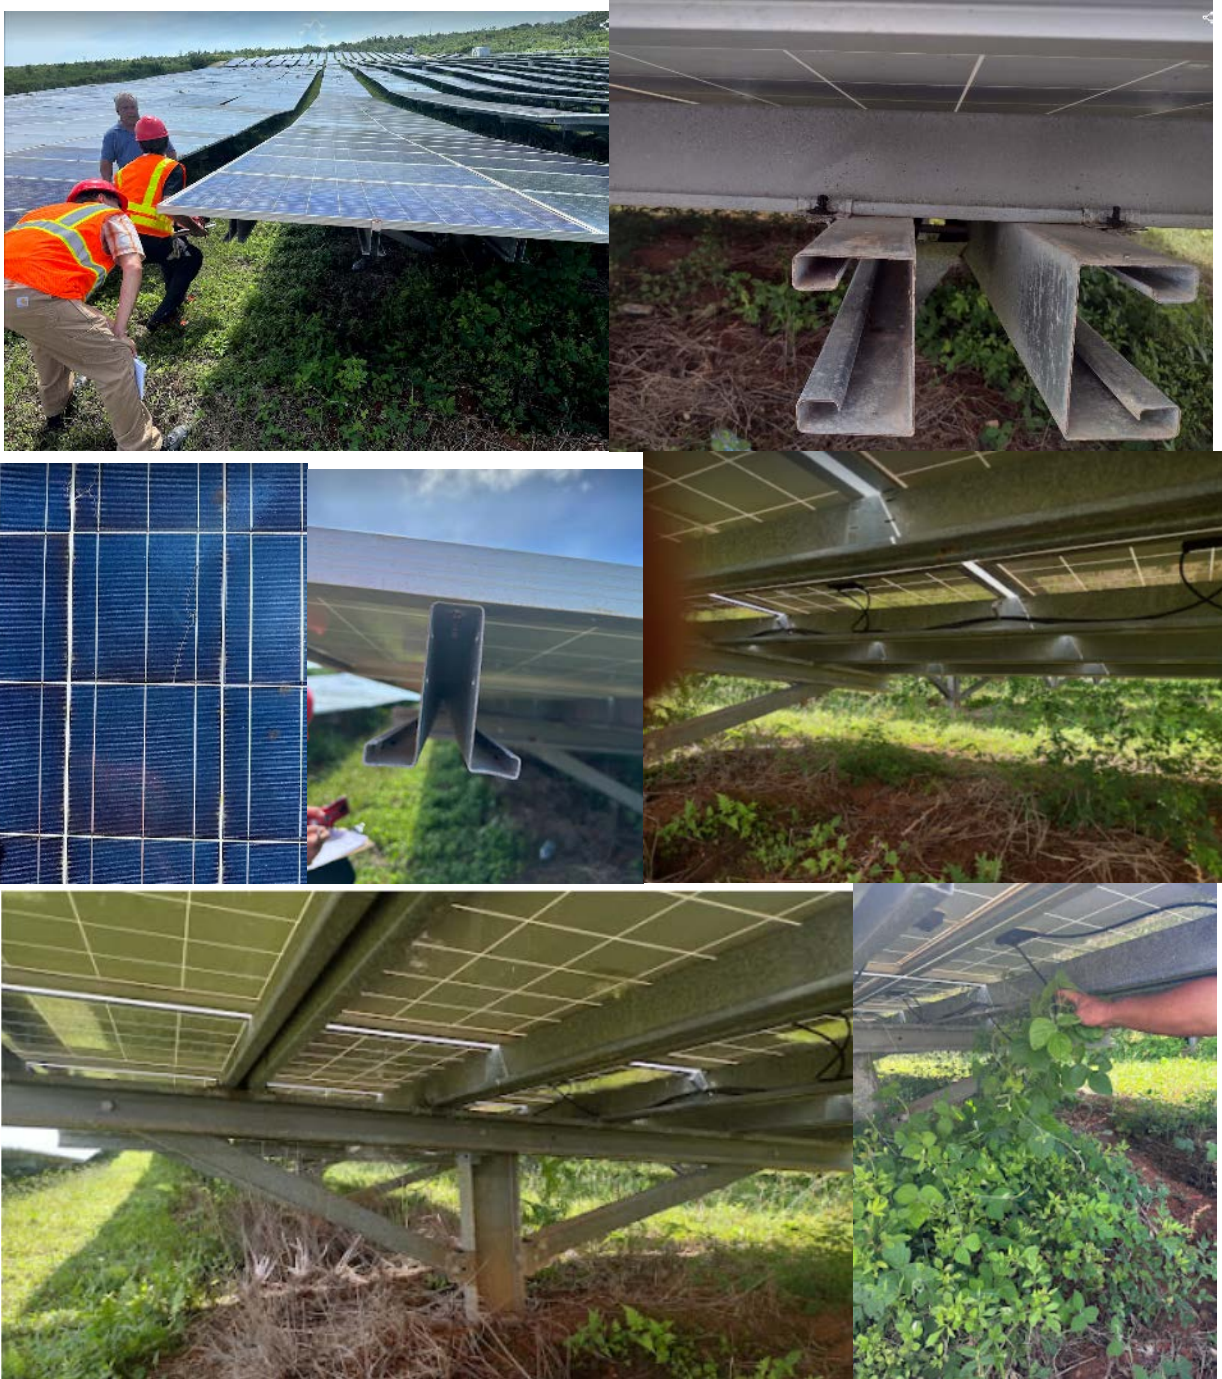
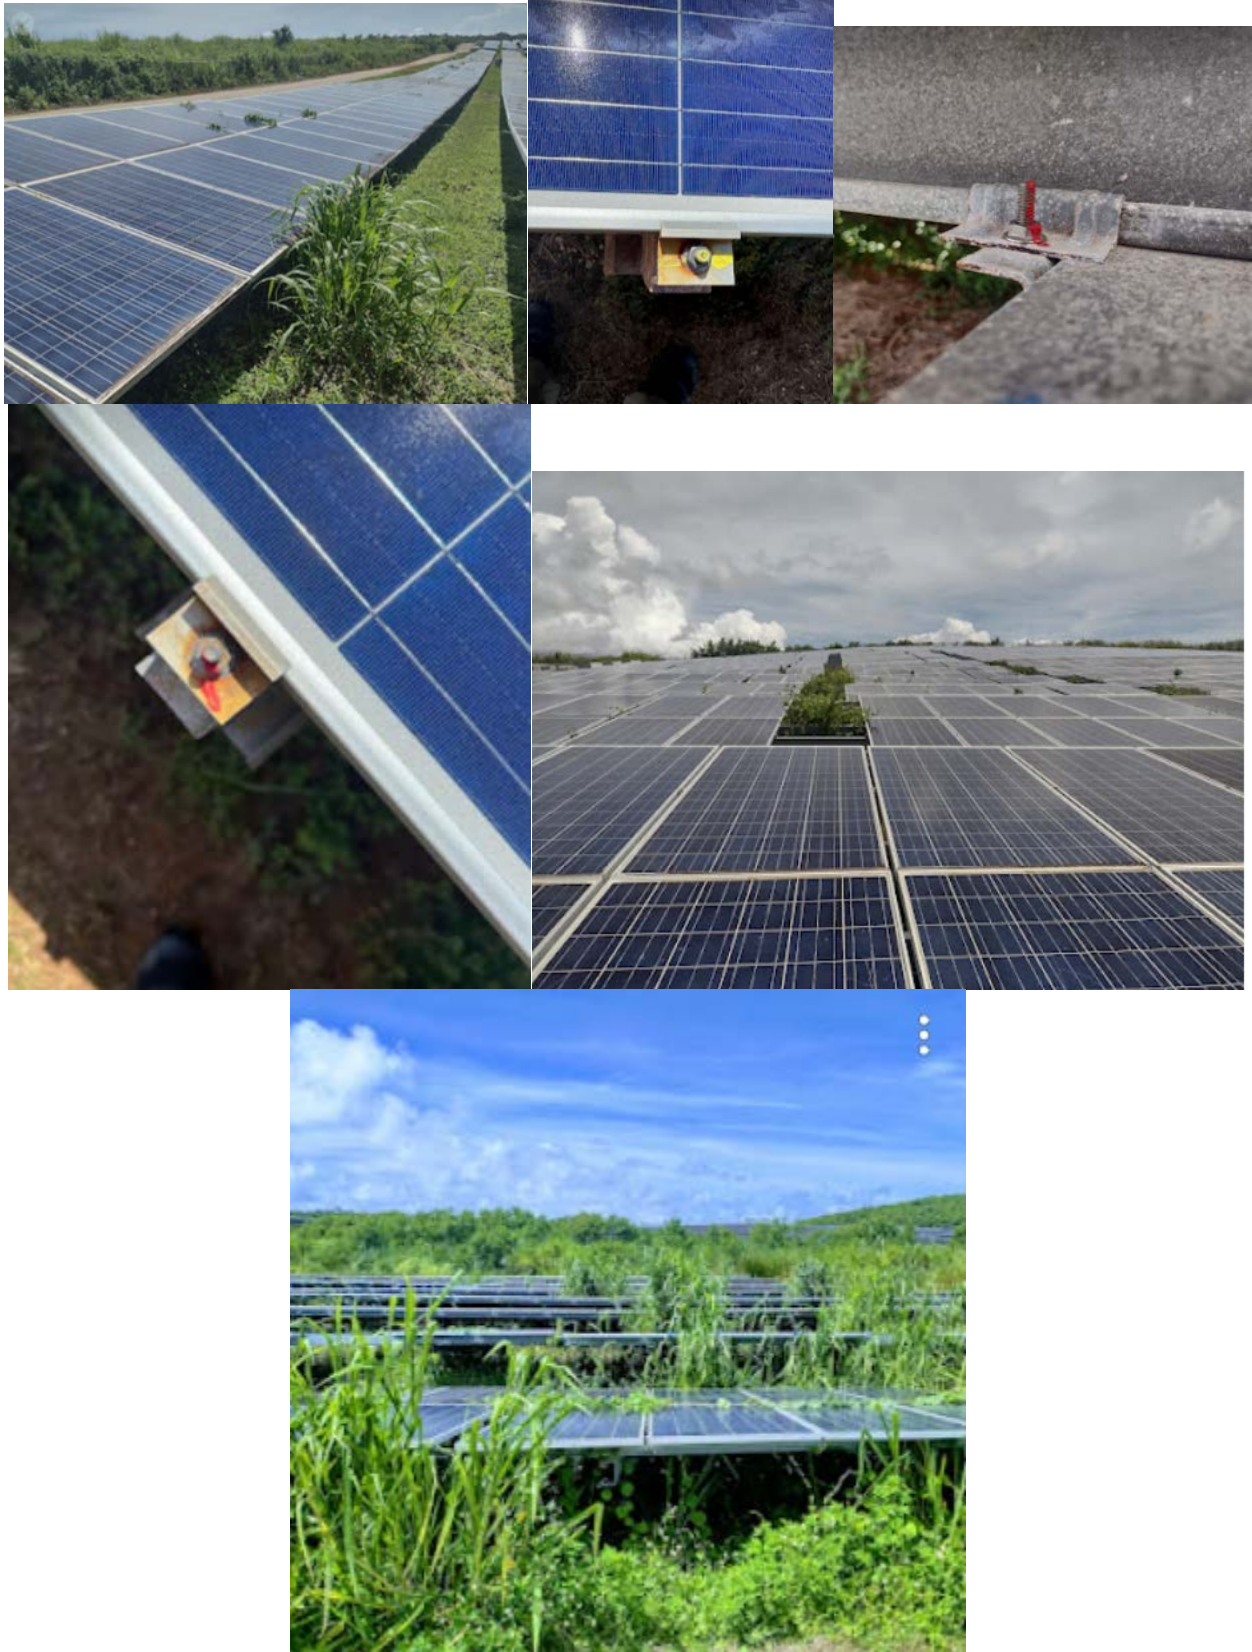
Dandan Ground-Mount PV Damage Assessment After Typhoon Mawar in Guam

- Zero panel failures, moisture in inverters but no failures reported.
- System low to ground, low tilt angle. Six-point attachment: four through-bolts and two top clamps in middle of modules. Stiff structure. Thick racking elements. Two in portrait layout (2P), meaning each row was two panels high in portrait orientation. High side about 42 in. off ground. Low side about 25 in.
- Wind gaps in some sections of the array.

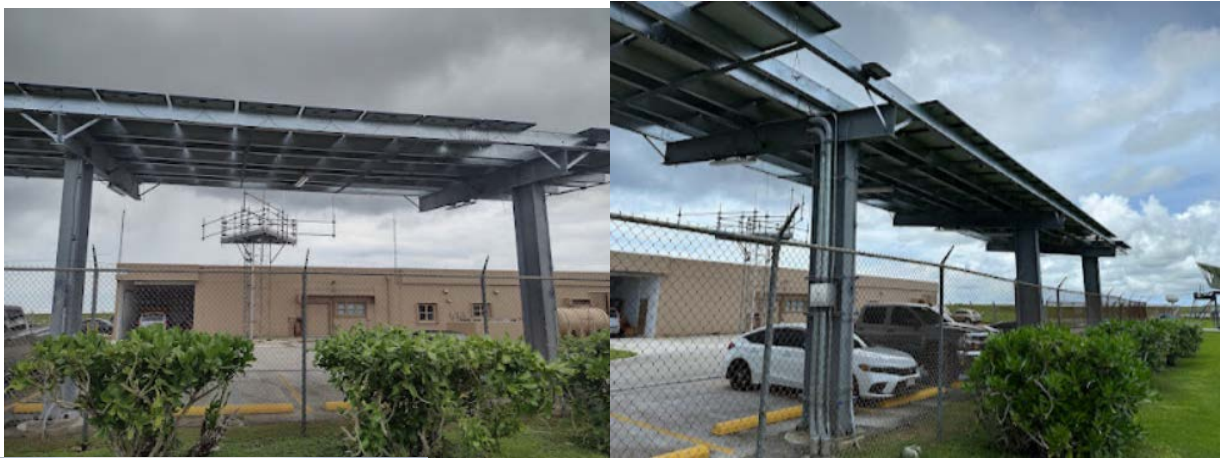
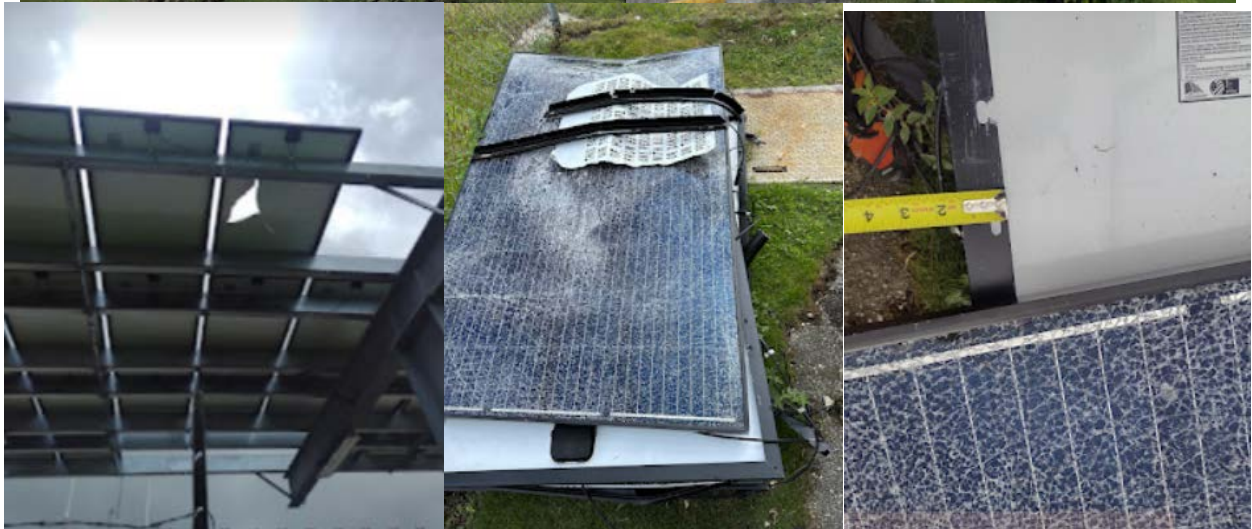
FAA Carport PV Damage Assessment After Typhoon Mawar in Guam

Overall failure rate 16%, 15 of 92 modules destroyed, 13 removed with 2 in rack but destroyed by flying debris.

- **Racking System:** Unknown, panels approximately 22 ft off ground low side, 24 ft high side. Unclear why so high; adds significant wind load and structural cost. 27-in. × 10.75-in.-thick I-beam on 42-in. concrete pier 14 ft deep.
- **Modules:** Mission Solar 310W
- **Module attachments:** Modules through-bolted to rails, two rails, i.e., four attachment points/panel
- **Roof:** Metal panel approximately 4° slope
- **NWS estimated wind speed:** H3; 129 mph with gusts to 164 mph
- **Failure mode:** Panel frames ripped out at bolts (47 of 52 bolts still in rails).

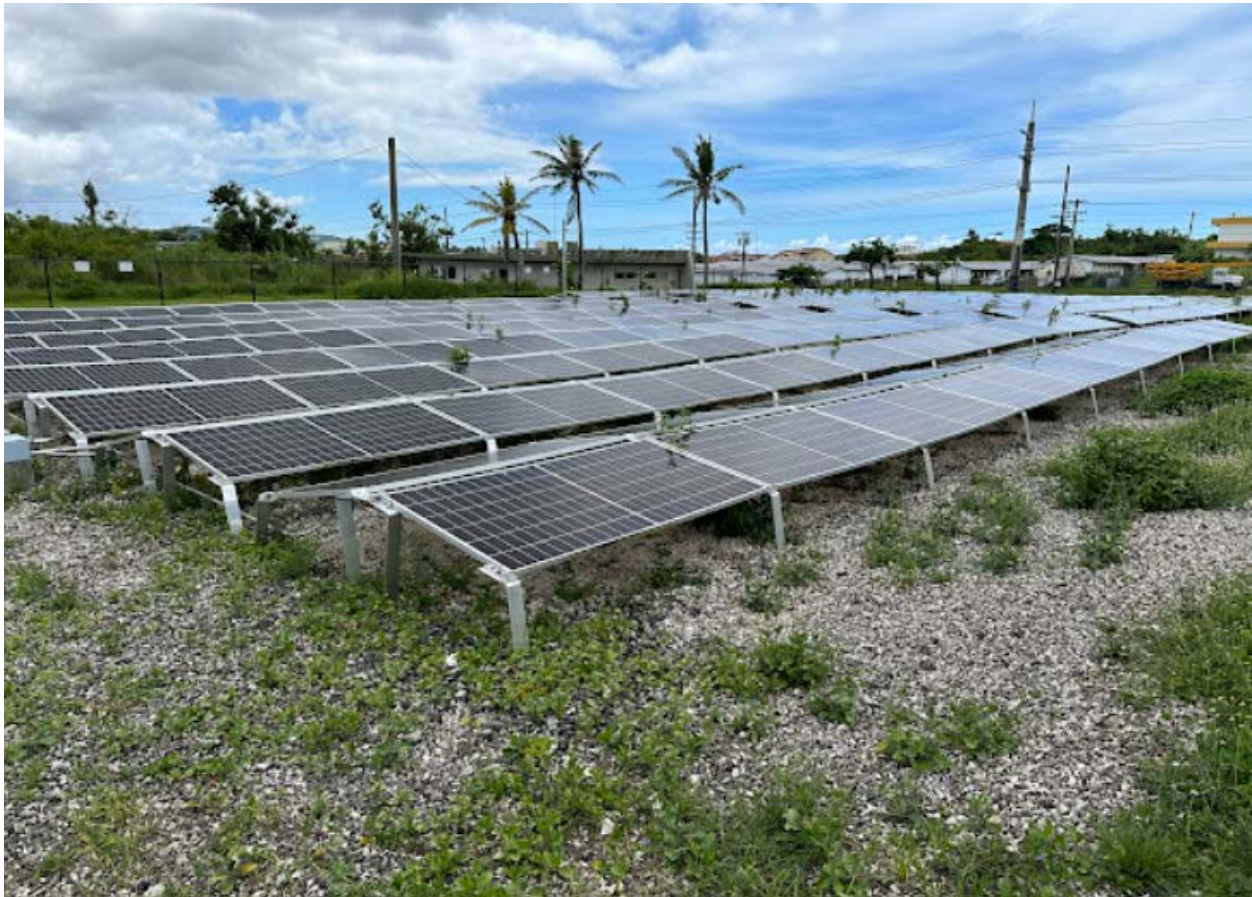
Shell Station PV Damage Assessment After Typhoon Mawar in Guam

- 0% panel failure.
- Racking movement clear. Likely invisible damage to modules.
- Modules loaded in the corners. Modules bent. Using module as structural element. Clamped at worst place. Yielding of module.
- Fasteners on module top clamps.
