Advanced Diagnosis and Accelerated Testing of Balance of System Components for Utility Scale PV Installations

David Miller

National Renewable Energy Laboratory

Technical Report
NREL/TP-5K00-91818
January 2025

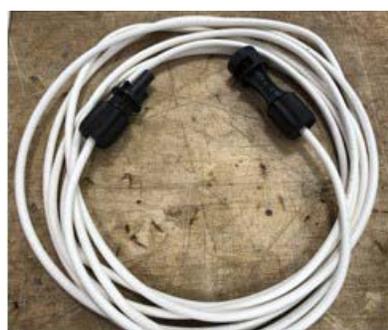
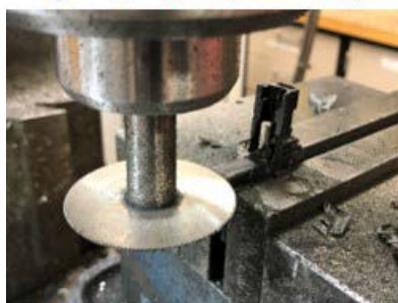
*cable connectors
(on jumper cable)*

*machining to extract
metal pin & socket*

Figure 6: The specimen extraction procedure for cable connectors includes: inspection of as-received samples (top), the machining of the external plastic to reveal the external detail of the metal components (middle), and the extraction of the contact spring from the metal socket (bottom).

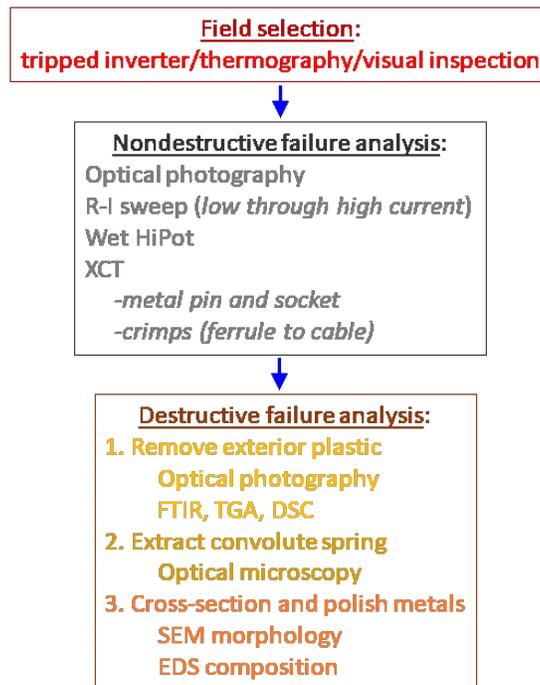
Figure 9: Summary of connector specimen examinations, including field selection (at PV installations), nondestructive methods (before disconnecting the plug and socket), and destructive characterizations (after removing the external plastic).

At least 50 field specimens were examined using the failure analysis protocol in Figure 9. Most field specimens were cable connectors. Field cables were examined using the additional methods of profilometer surface roughness characterization and instrumented indentation. Some cable and connector specimens have already been examined after accelerated testing. Unaged cable and connector specimens were also examined to provide a baseline relative to field and indoor-aged specimens.
