Fatigue of Composite Material Beam Elements Representative of Wind Turbine Blade Substructure

John F. Mandell, Daniel D. Samborsky,
David W. Combs, M. Ethan Scott,
Douglas S. Cairns
*Department of Chemical Engineering
Montana State University
Bozeman, Montana*

NREL Technical Monitors:
Richard Osgood and Walt Musial

November 1998

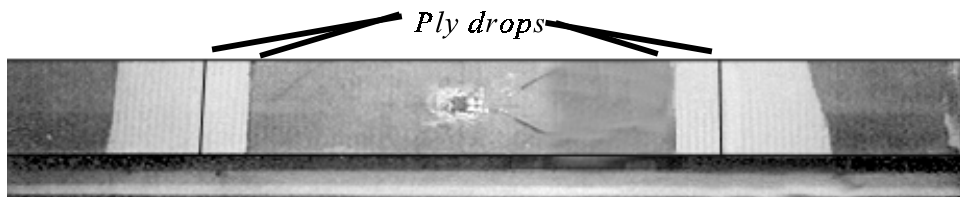
Figure 14. Delamination of ply drops, beam 3.

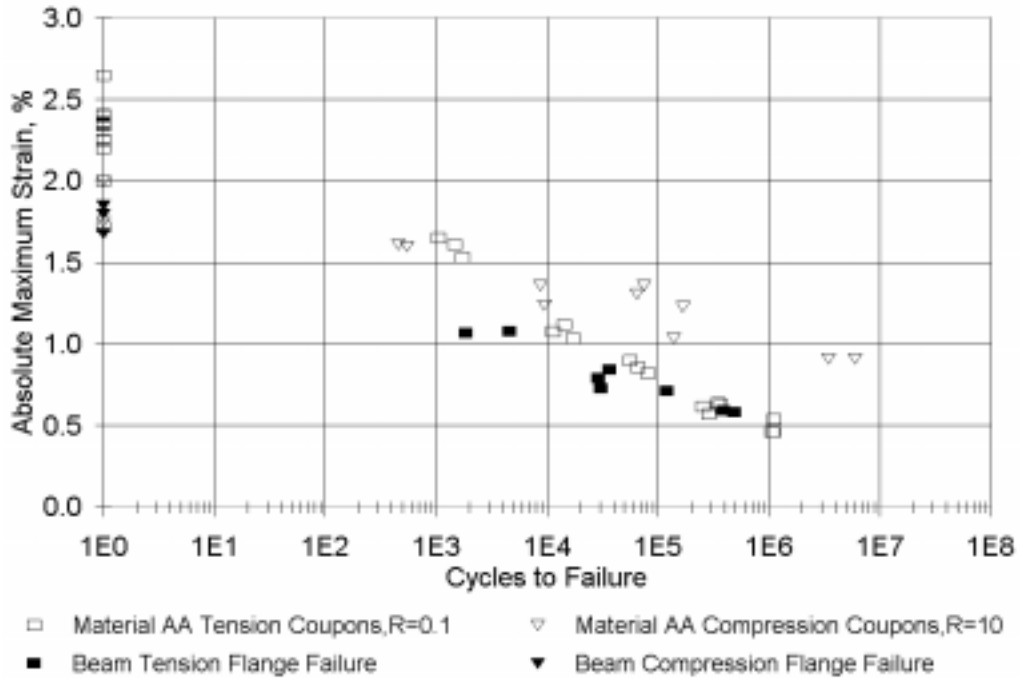
Figure 31(a) compares the failure strain conditions for the AA flange beams with the strain-cycles data for the material AA coupons. (The solid square and triangle symbols are the measured initial strains on the tension and compression flanges, respectively; the symbol shown indicates which flange actually failed.) The static beam tests (6, 9, and 13) resulted in compressive flange failures

with damage in the web as well (Figure 31(a)). The measured static compressive flange strains at failure cover the range observed for the compressive coupon tests (Figure 31(a), one cycle). Figure 31(b) compares the web material CH10 coupon results with the beam data; the CH10 tensile fatigue strains are, again, similar to the beam failure strains. In order to compare coupon data with web flange strains in the beams, the beam strains are adjusted downward to 0.82 of the measured flange outside surface strains to give the strain at the outside of the web flange (assuming a linear strain variation across the beam depth).

We conducted fatigue tests with beams having the AA material flanges (without holes) for beams 7, 8, 9, 10, 11, 12, and 14. These beams all failed on the tension flange, and the results in Figure 31(a) show close agreement with the failure strains and cycles for tensile coupons of the same material, tested at $R = 0.1$ (the same R value as the beam tensile flange). The predicted shift from compressive failure at low cycles to tensile failure at high cycles is observed in the beam results only in the static compression failures compared with tensile fatigue failures; no lifetimes could be produced in fatigue between 1 and 1,000 cycles because of difficulties in controlling tests in the low cycle range. Photographs of failure details are given in the Appendix for most beams, and Figures 32 and 33 gives a combined photograph of all flanges in this series as well as several detailed photographs.

Figure 31(a). Beams 6 - 14, 22 and 23 with material AA flanges and material CH10 web compared with material AA coupon fatigue data.

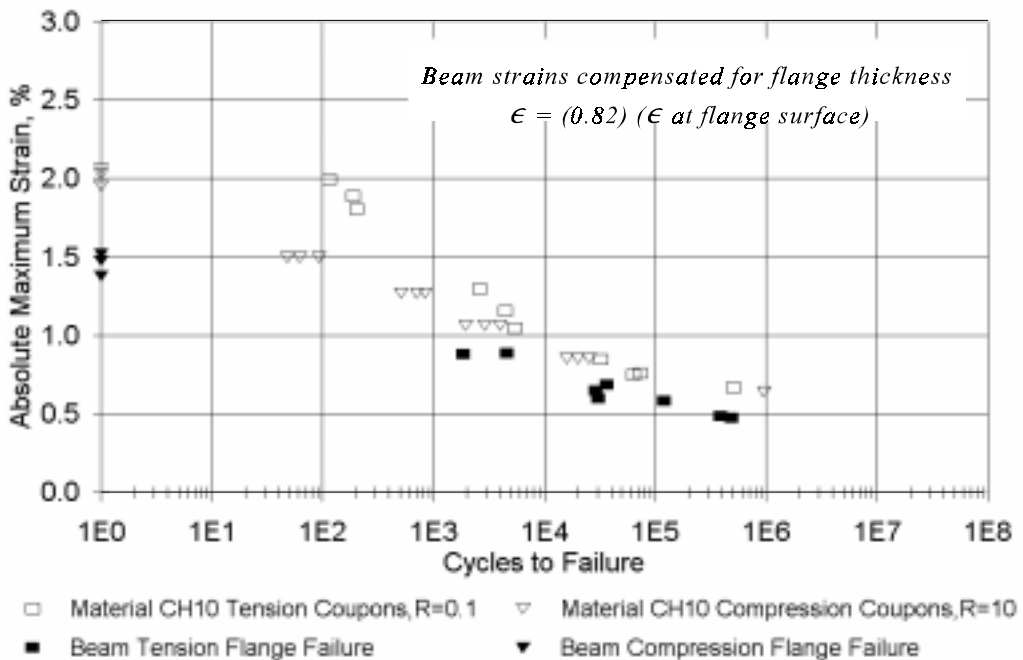
Figure 31(b). Beams 6 - 14, 22 and 23 with material AA flanges and material CH10 web Compensated for flange thickness compared with material CH10 coupon fatigue data.

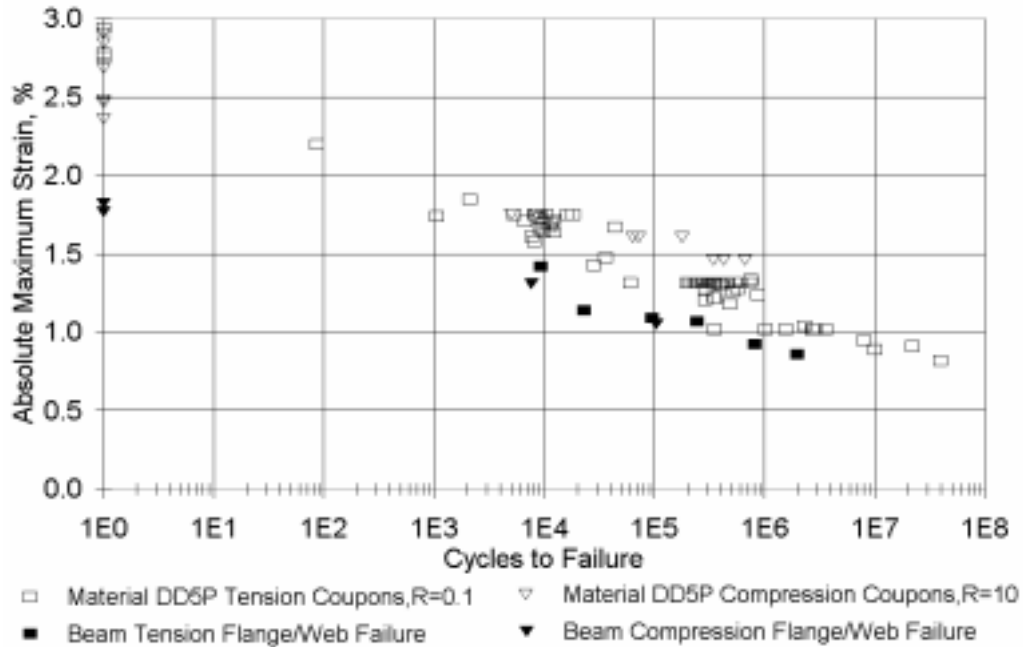
Figures 34 and 35 compare the beam data with flange material and web material coupon data, respectively. All of the failures were predominantly in the web, with some flange interaction. The results in Figure 35 show that the web flanges should have already cracked heavily prior to flange failure, and this appeared to be the case. Thus, most of these failures were induced in the web flange area, and agree generally with the web coupon data in Figure 35. Significant flange-web delamination near the ends of the shear stiffeners was also observed, as shown in Figure 36.

Figure 34. Beams 18 - 21 and 24 - 29 with material DD5P flanges and material CH10 web compared with material DD5P coupon fatigue data.

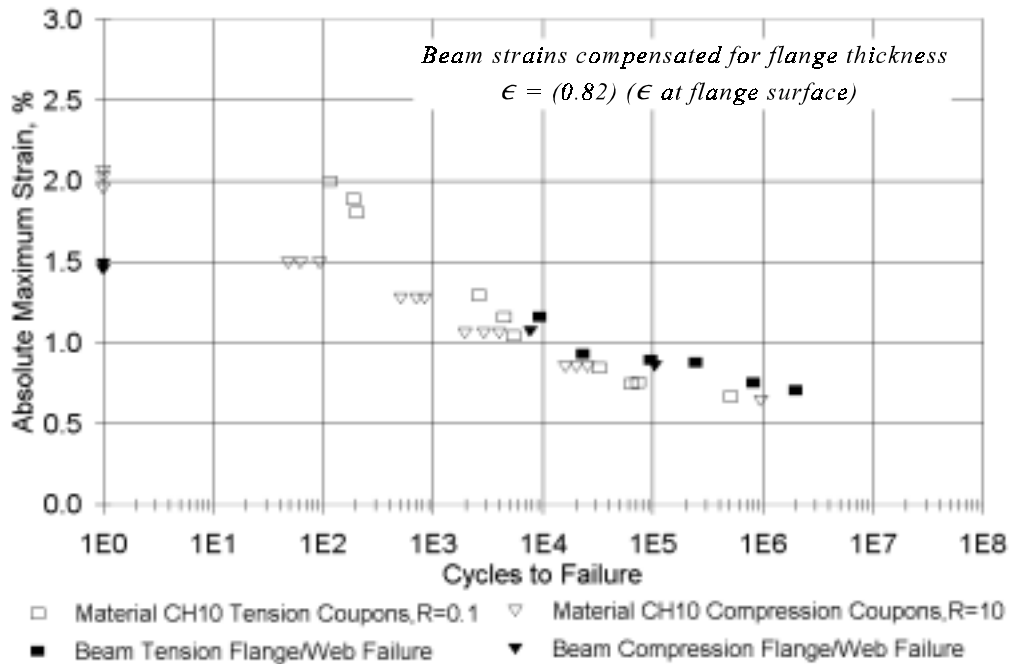
Figure 35. Beams 18 - 21 and 24 - 29 with material DD5P flanges and material CH10 web compensated for flange thickness compared with material CH10 coupon fatigue data.

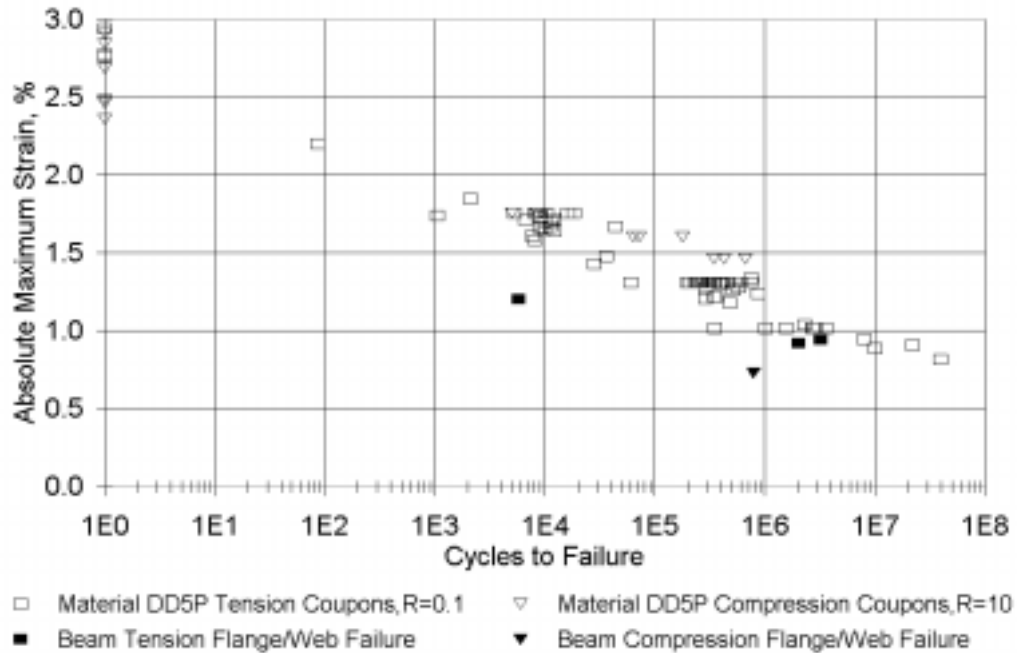
Table 18 gives the results for beams with DD5P flanges and CH3, CH12, and DD5P webs. Figures 37 and 38 give the DD5P flange/CH3 web results for beams 30-33 compared with flange and web coupon data respectively. All of the beams in this group showed a variety of delamination and web damage. The beam data in Figures 37 and 38 agree generally with the flange and web coupon data,

Figure 37. Beams 30 - 33 with material DD5P flanges and material CH3 web compared with DD5P coupon fatigue data.

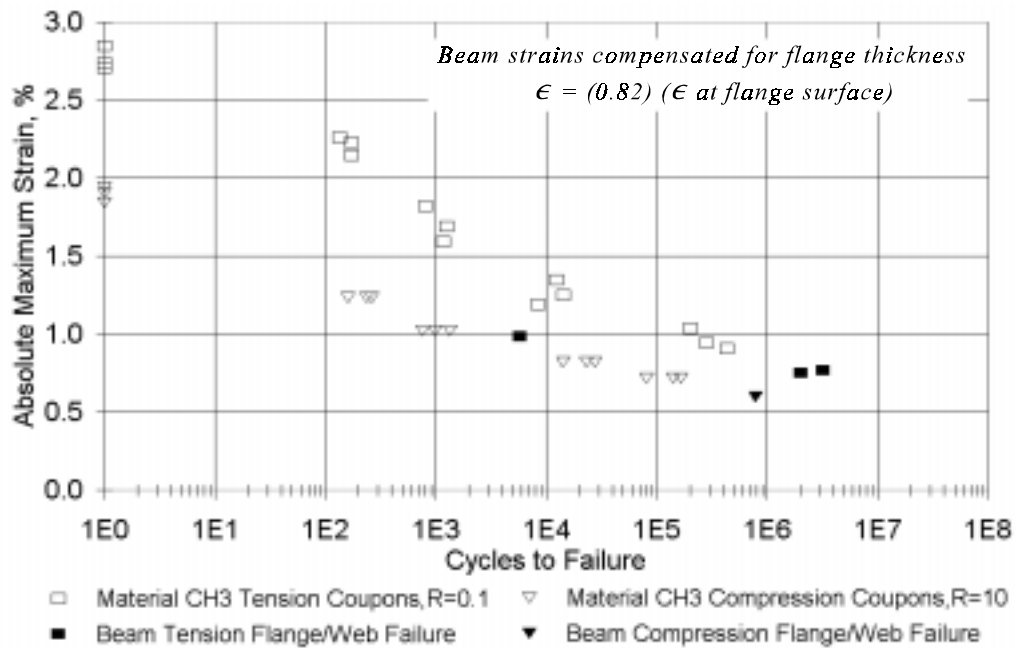
Figure 38. Beams 30 - 33 with material DD5P flanges and material CH3 web compensated for flange thickness compared with CH3 coupon fatigue data.

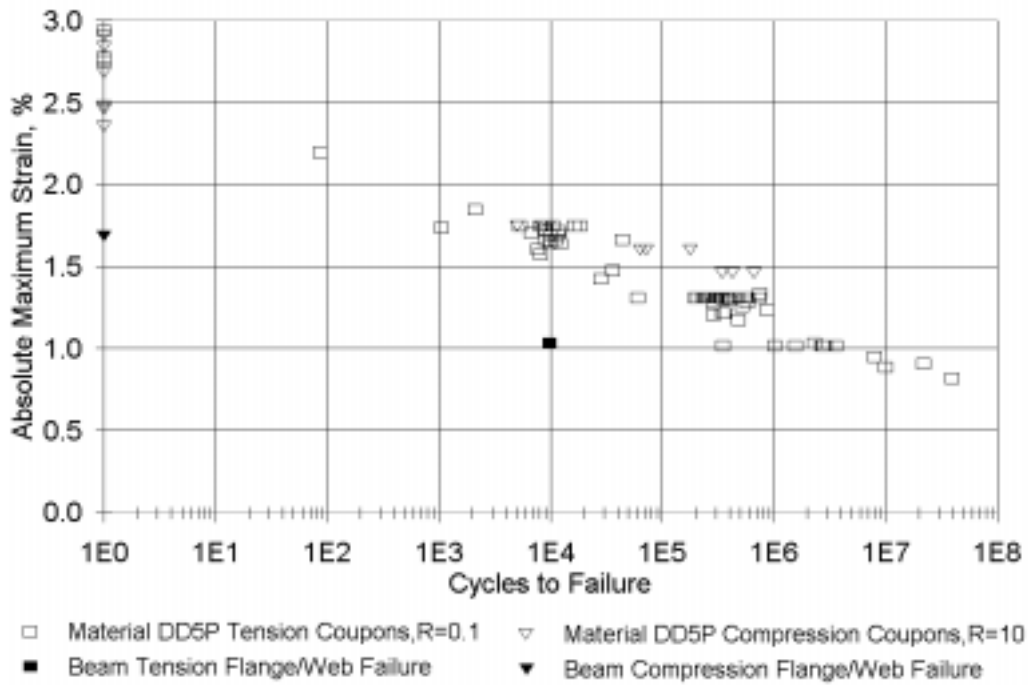
Beams 34 and 35 included DD5P material flanges and CH12 web material (see Table 18 and Figures 39 and 40). As indicated in Table 18, these beams produced delamination failures in the load transfer area of the load pads. The fatigue failure (beam 35) was at a strain well below either set of coupon data, as expected from the load-transfer problems.

Figure 39. Beams 34 and 35 with material DD5P flanges and material CH12 web compared with material DD5P coupon fatigue data.

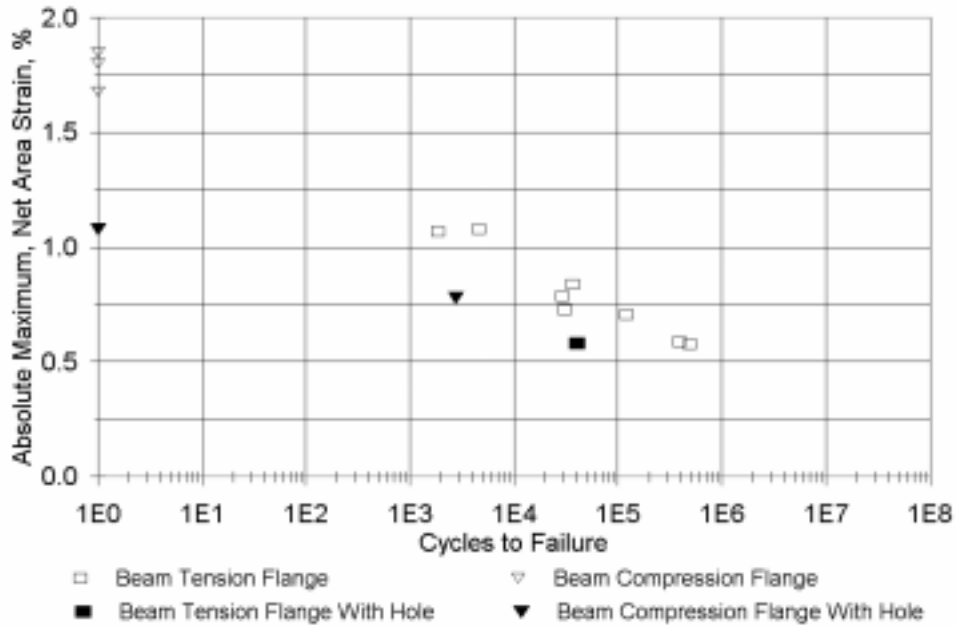
We fabricated three beams with several 13-mm-diameter holes drilled through both tension and compressive flanges (see Table 19). As expected, Figure 47(a) shows that the holes did reduce the static strength and fatigue life, relative to beams without holes. Figure 47(b) confirms that the beams behave similarly to the coupons containing holes. The static-tested beam (17) and the low-cycle fatigue beam (15) failed in compression, as expected from the coupon data, although at lower stress and higher cycles, the failure shifted to the tensile flange (beam 16). Again this is consistent with the coupon predictions. The mode shift is expected by comparing Figure 43(b) with 43(d). Figure 48 shows the details of failed beams with holes and other details as given in the Appendix.

Figure 47(a). Comparison of AA material flange beams without holes to AA beams with 13 mm diameter holes in the flanges.

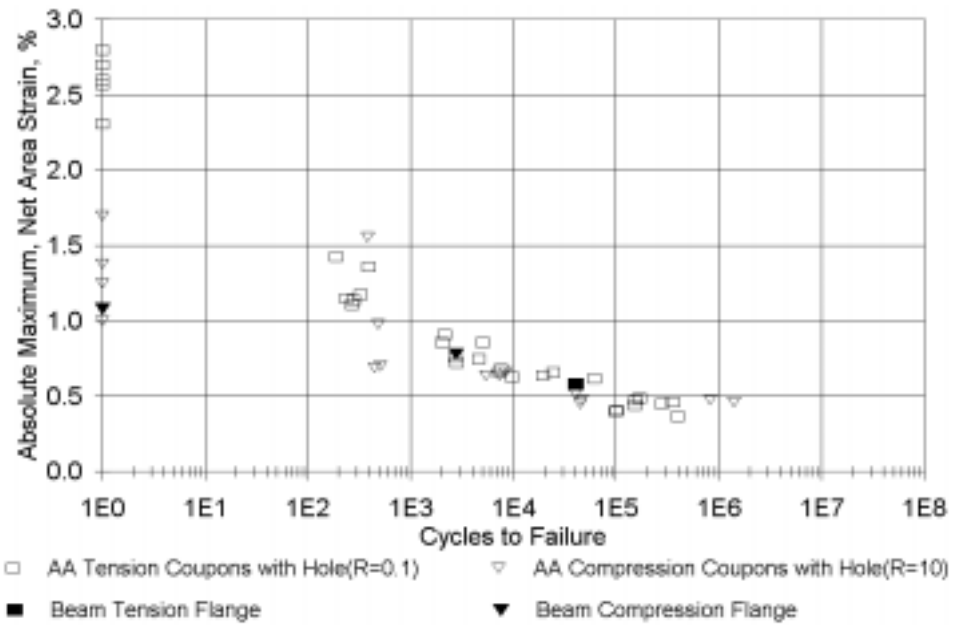
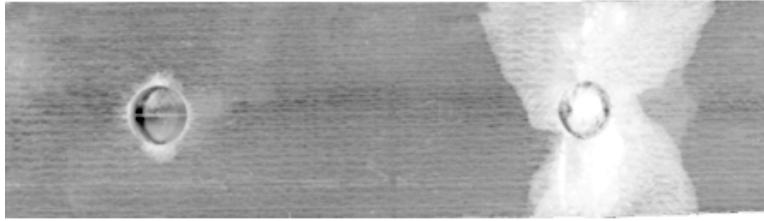
Beam 15 Compression flange

Beam 15 side view

Figure 48. Beam 15 with holes, static compression flange failure.

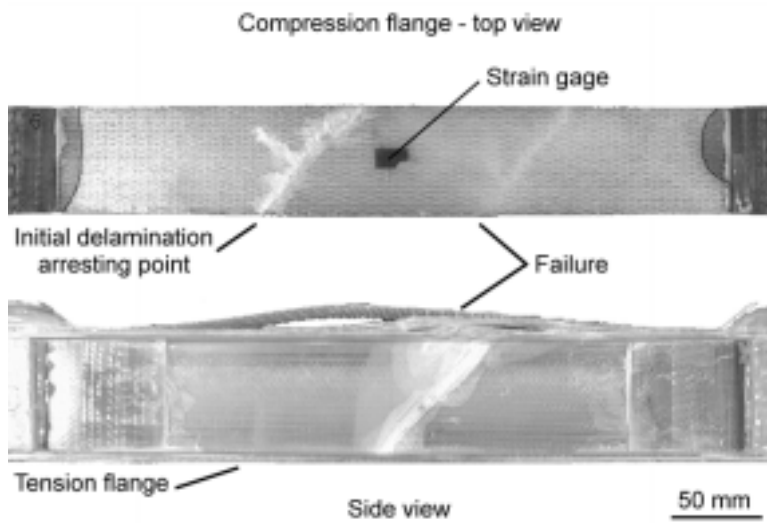
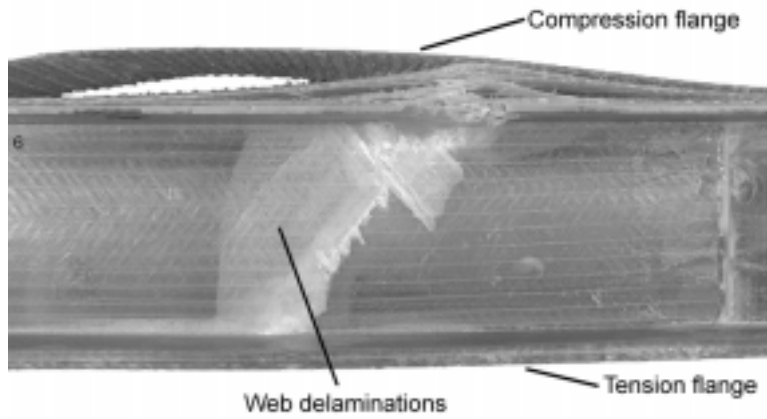
Beam 6 was tested statically to failure. The beam was loaded under actuator displacement control at a rate of 0.25 mm/s until failure, which involved a total ramp time of 74 seconds. An initial beam stiffness of 3,711 kN/m was measured. As the beam was loaded, the compression flange started to twist along the X - axis, prior to final compressive failure of the compression flange. The total amplitude of this twist was approximated at 6 to 8 mm prior to failure and the onset of this twisting occurred at approximately 90 to 95% of the ultimate load. This twisting was also evident in the failed beam as one side of the beam flange had fragmented $\pm 45^\circ$ strands pointing up, while the other side of the flange had the fragmented strands pointing down. Figures 58 and 59 show the failed beam. Further examination of the buckled compression flange indicated that the outside 0° ply (ply 3, Table 22) delaminated first from the adjacent $+45^\circ$ layer (ply 4, Table 22). This delamination arrested at $x = 267$ mm, which was evident by the white damage band in the outside plies at this point. It was not evident where the delamination started. From this initial arrest at $x = 267$ mm, the delamination continued to grow towards both inside compressive load pads at $x = 152$ mm and $x = 464$ mm.

The web had multiple delaminations under the initial flange failure site generated after the flange failure. Some delamination spots are visible at $x = 191, 267, 343$ and 394 mm, at the compression flange - web intersection that could be buckling nodal points. No shear stiffener, torsional stiffener or tension flange damage or delaminations were visible. The load - flange absolute maximum strain graph is shown in Figure 60 and indicates a maximum tension flange strain of 1.80% and a minimum compression flange strain of -1.6% which occurred at an ultimate applied load of 67.08 kN at a maximum mid-span deflection of 22 mm.

Figure 58. Beam 6.

Figure 59. Beam 6.

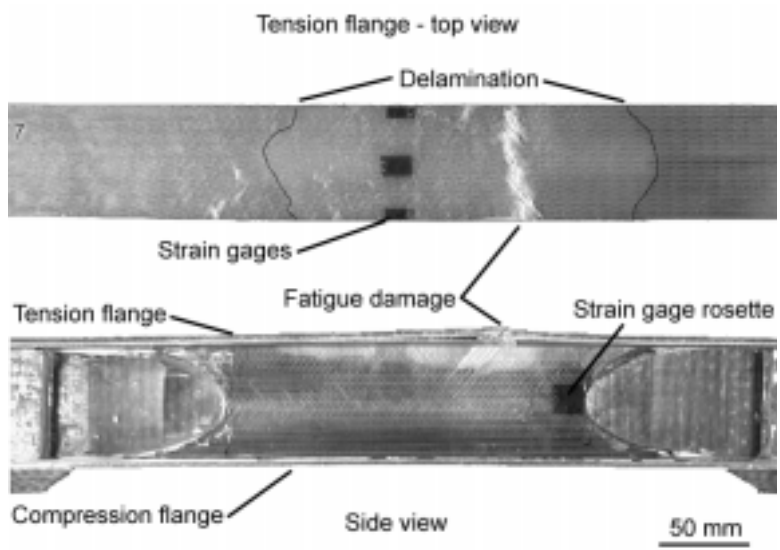
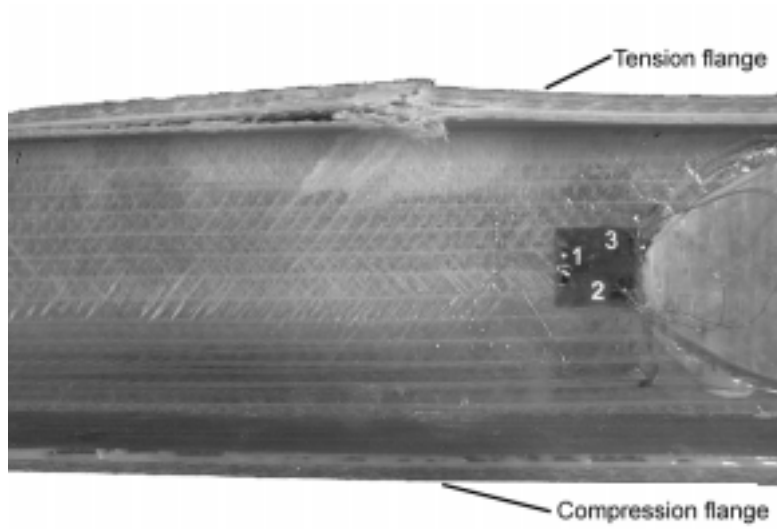
As the fatigue test continued, the damage sites increased in size and some damage spots coalesced to form failure lines. These sites continued to grow until the worst damage site extended across the tensile flange that caused final failure of the tension flange at 492,147 cycles. The failure site occurred at $x = 356 \pm 5$ mm and is shown in Figures 66 and 67.

The flange damage was very localized, while the delamination of the entire flange from the I-beam preform extended from $x = 260$ to $x = 406$ mm and was due to the flange failure. The delamination in the beam occurred between the $+45^\circ$ (ply 12, Table 22) and the adhesive, and between the $\pm 45^\circ$ plies (plies 15,16, Table 22). The failure also caused delaminations to extend 16 mm down into the shear web. No shear stiffener, torsional stiffener or compression flange damage or delaminations were visible. The Instron 8501 displacement interlocks were set so that any actuator travel ± 3 mm above the nominal fatigue running displacement would stop the fatigue test and limit any post failure damage from being generated. This procedure was observed for all the beams.

Figure 66. Beam 7.

Figure 67. Beam 7.

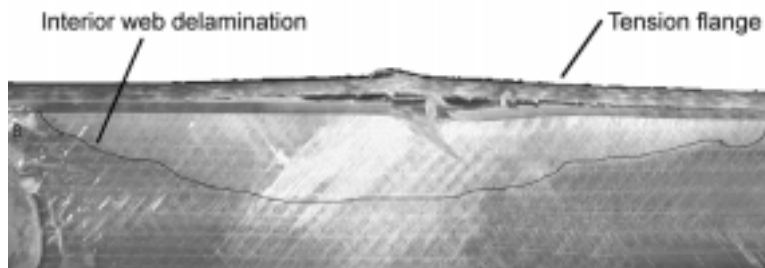
At 29,051 cycles, the tensile flange failed and separated at $x = 324 \pm 9$ mm, which caused the flange to delaminate from the preform between $x = 255$ to $x = 368$ mm and is shown in Figures 68 and 69. The delamination involved extensive fiber bridging between the inside flange $+45^\circ$ (ply 12, Table 22) and the adhesive on the preform. This beam was fatigued at a higher strain than Beam 7 and thus had more internal strain energy stored in it prior to failure, which is apparent by the amount of damage generated in the web as compared to Beam 7. The web delamination extended 45 mm from the tension flange and was located at $x = 324 \pm 44$ mm. No shear stiffener, torsional stiffener or compression flange damage or delaminations were visible.

Figure 69. Beam 8.

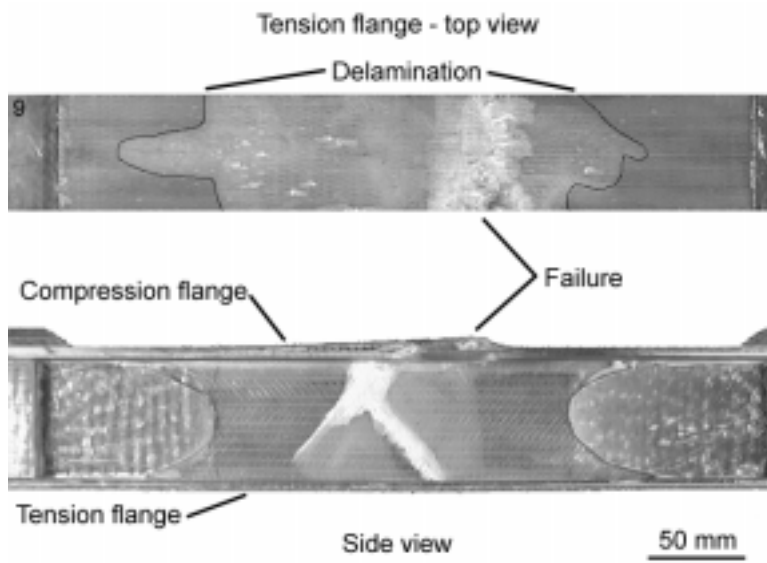
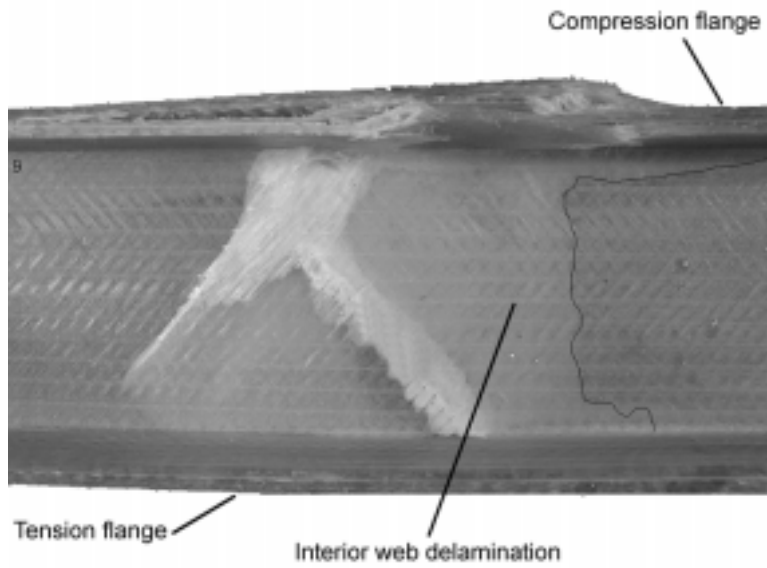
Beam 9 involved a static test. The beam was loaded under actuator displacement control at a rate of 0.25 mm/s until failure, which involved a total ramp time of 43 seconds. An initial beam stiffness of 3,556 kN/m was measured. Beams 9 and 10 were constructed with the 0° plies on the outside (Material AA2) of the flange rather than the +45° (Material AA). This layup reversal did not significantly affect the stiffness of the beam when compared to the other beams. It was apparent, after the static test, that there was substantial fiber waviness in the fabric that caused the beam to fail prematurely. Curved fiber tows, with a radius of 4 to 5 mm, turned white as they delaminated from the material around them on both the tension and compression flanges. Figures 70 and 71 show the failed beam. The ultimate load that the beam held was 59.2 kN and corresponded to a maximum tension flange strain of 1.78% and a minimum compression flange strain of -1.80%. The load versus maximum strain graph is shown in Figure 72. The buckling failure of the compression flange occurred at two sites: $x = 260 \pm 6$ mm on the flange and $x = 298 \pm 10$ mm on the preform. Delamination of the flange from the web flange occurred from $x = 203$ to $x = 419$ mm and was between the adhesive layer and 0° (ply 12, Table 23) ply and also between the 0° (ply 12, Table 23) and -45° (ply 11, 23) plies. The delamination also heavily affected the web, $x = 260$ mm to $x = 356$ mm, as the web delaminated fully between the interior -45° plies and also placed a spot delamination in the adhesive region on the tension flange. No shear stiffener, torsional stiffener or other tension flange damage or delaminations were visible.

Figure 70. Beam 9.

Figure 71. Beam 9.

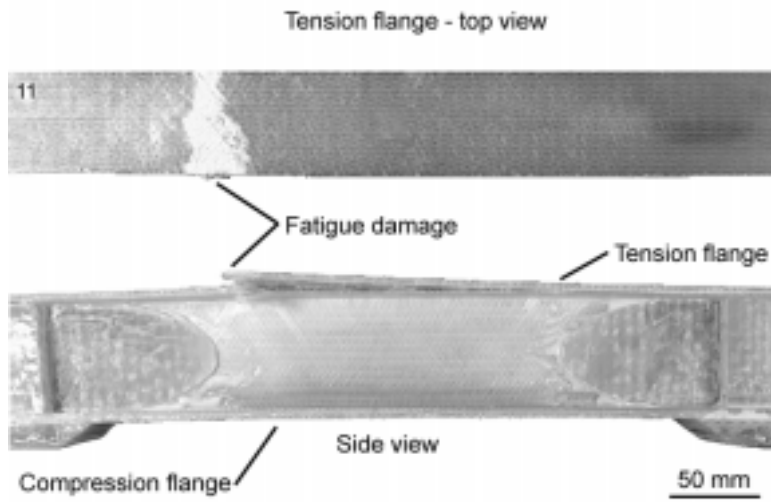
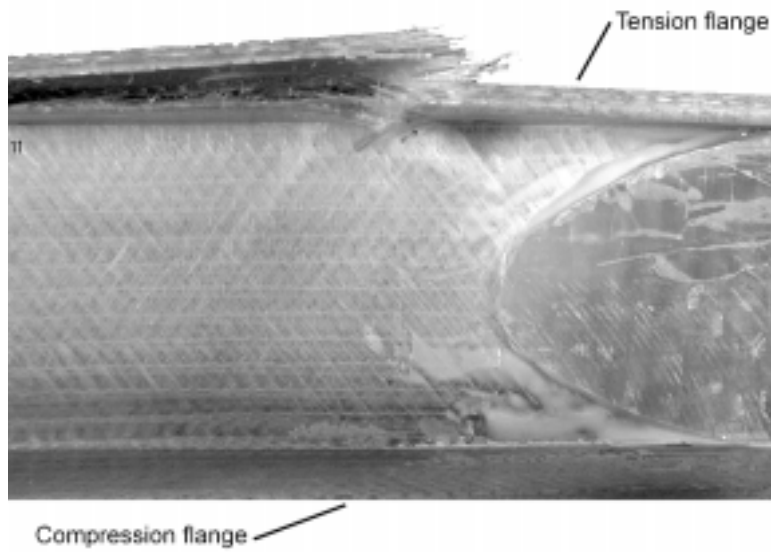
Final failure of the flange occurred at $x = 381 \pm 17$ mm and was very localized with some tearing of the top $\pm 45^\circ$ plies (ply 1 and 2, Table 22), which was noticed just prior to final failure. Delamination of the tensile flange occurred between the polyester matrix and the $+45^\circ$ ply (ply 13, Table 22) on the web flange with multiple amounts of fiber bridging and was located at $x = 229$ to $x = 400$ mm. Some delamination in the web was present and was caused by the flange failure. Figures 77 and 78 show the failed beam. No shear stiffener, torsional stiffener or compression flange damage or delaminations were visible. The load pads were manufactured as three separate plates that were then adhesively bonded together to get the required 12 mm load pad height. The upper most plate of this load pad assembly had partially delaminated in the adhesive interface from the rest of the pad. It is hypothesized that the adhesive layer was not thick enough to resist the applied compression loading on these pads. All four pads show the same partial delamination problem, but this did not influence the beam performance during the test.

Figure 77. Beam 11.

Figure 78. Beam 11.

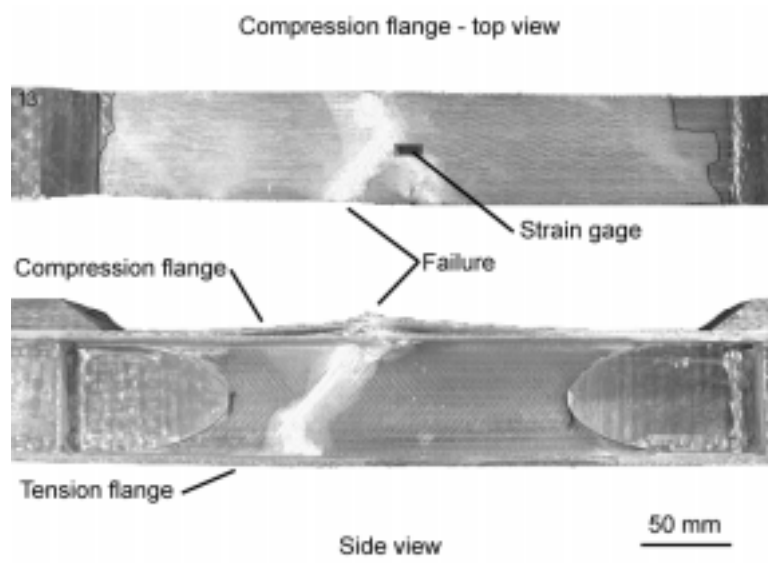
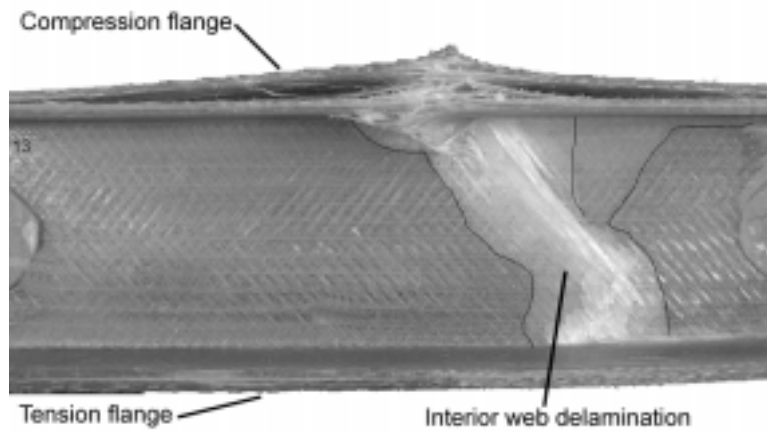
Figure 81. Beam 13.

Beam 13 involved a static test. The beam was loaded under actuator displacement control at a rate of 0.51 mm/s until failure, which involved a total ramp time of 21 seconds. An initial beam stiffness of 3,516 kN/m was measured. The ultimate load was 60.72 kN and corresponded to a maximum tension flange strain of 2.10%, a minimum compression strain of -1.85% and a maximum mid-span deflection of 17 mm. The load versus maximum strain graph is shown in Figure 80. The beam failed in the compression flange at $x = 330 \pm 25$ mm with delaminations between the 0° (ply 10, Table 22) and +45 plies (ply 11, 22) over the distance of $x = 165$ mm to $x = 457$ mm. The failed beam is shown in Figures 81 and 82. The failure at $x = 330$ mm caused the web to delaminate towards the tension flange under this failure point, causing an additional delamination spot under the tension flange. No shear stiffener, torsional stiffener or other tension flange damage or delaminations were visible.

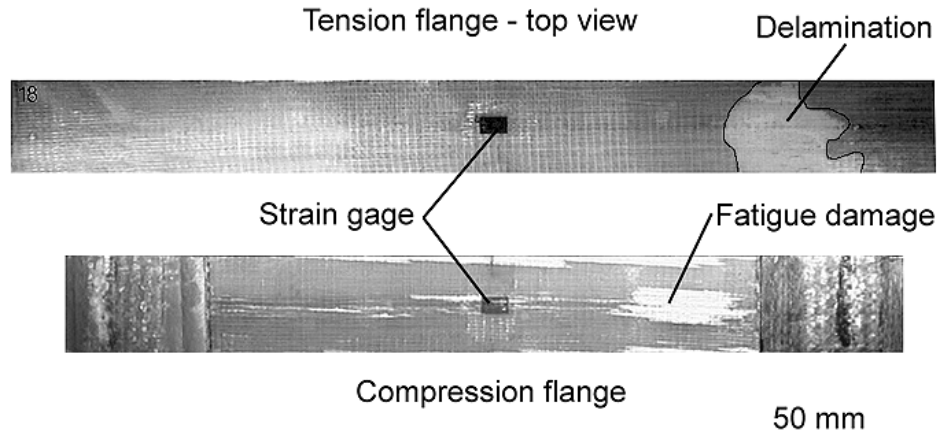
Figure 86. Beam 18.

Beam number 18 was fatigued at a rate of 1 Hz under sinusoidal load control with a maximum load of 62.3 kN and a minimum load of 6.3 kN. The maximum load produced an initial maximum tension flange strain of 1.42% and a minimum compression flange strain of -1.34%. The initial beam stiffness was measured as 4,134 kN/m. During the fatigue test, it was evident from the 0° fiber bundles delaminating from the flange surface that the DD5P flange material had been manufactured with a 2° to 3° angle. This angle caused the 0° edge terminated fibers to delaminate, starting from the flange edge and growing inward along the fiber bundle axis. This damage was confined to 4 to 6 mm from the flange edges and involved both the tension and compression flanges. The beam stiffness was checked throughout the test and is summarized in Table 25. As the fatigue test progressed, the tension flange started to delaminate from the C - channel between the 0° ply (ply 8, Table 24) and the +45° ply (ply 7, Table 24). This initial delamination started in the center of the beam and was located directly above the tapered shear stiffeners, $x = 165$ mm and $x = 457$ mm. This delamination grew until the test was stopped after 9,367 cycles. At this point, the delamination extended from $x = 127$ mm to $x = 571$ mm, but had not completely traveled across the width of the flange. The compression flange had some transverse tensile cracks under the edges of the web and extended from $x = 152$ to 457 mm. There was also major flange damage at $x = 381$ to 432 mm, directly below the tapered shear stiffener, that was 18 mm wide. This damage involved broken 0° on the surface and delaminations throughout the thickness of the flange. The web had delaminations extending into the shear stiffeners, but otherwise the center web, $x = 215$ to $x = 394$ mm, had no other noticeable damage. One shear stiffener showed cracking at $x = 444 \pm 12$ mm on the tension flange side and was involved with the web delamination underneath. The failed beam is shown in Figure 86.

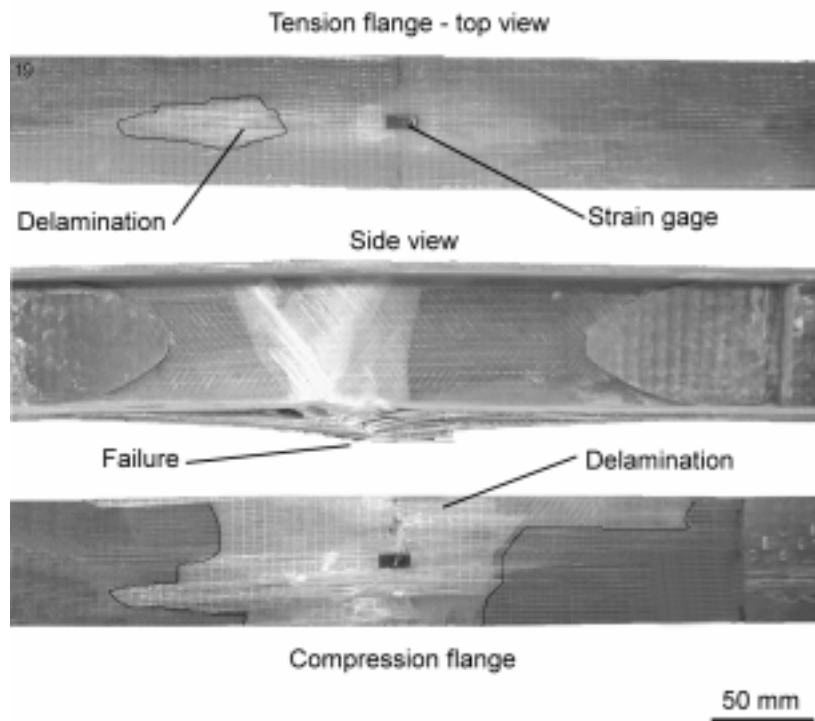
Figure 88. Beam 19.

Beam 19 involved a static test. The beam was loaded under actuator displacement control at a rate of 0.05 mm/s until failure, which involved a total ramp time of 208 seconds and a total mid-span deflection of 13 mm. An initial beam stiffness of 4,245 kN/m was measured. As with the other static tests, the compression flange twisted prior to final failure. This twisting was also evident in the failed beam as one side of the beam flange had fragmented glass 0° and $\pm 45^\circ$ tows pointing up, while the other side of the flange had the fragmented glass tows pointing down. The compression flange failed at $x = 305 \pm 15$ mm with multiple delaminations throughout the flange thickness. The compression flange delaminated between the 0° ply (ply 5, 24) and -45° ply (ply 6, Table 24) from $x = 305$ to 457 mm. The flange also delaminated between the 0° ply (ply 8, Table 24) and the adhesive from $x = 158$ to 305 mm. The failure caused a delamination to travel into the web and created two spot delaminations on the tension flange in the adhesive layer. One shear stiffener showed some delamination at its tapered tip. No other shear stiffener, torsional stiffener or other tension flange damage or delaminations were visible. A maximum tension flange strain of 1.96% and a minimum compression flange strain of -1.82 %, which occurred at a ultimate applied load of 89.18 kN, is shown in Figure 87. The failed beam is shown in Figure 88.

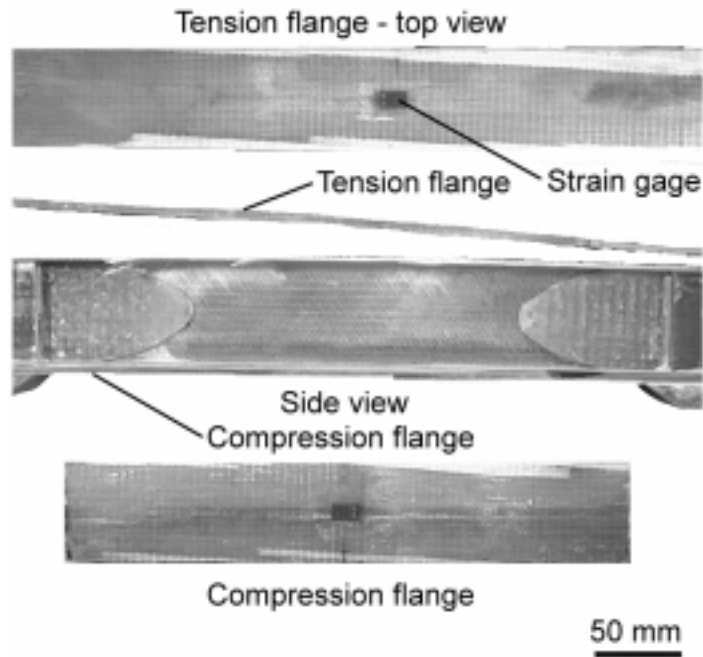
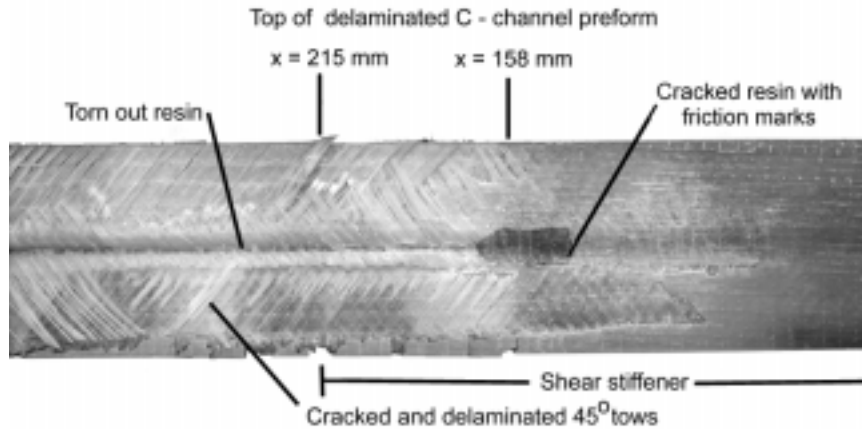
Figure 89. Beam 20.

Beam number 20 was fatigued at a rate of 4 Hz under sinusoidal load control with a maximum load of 53.4 kN and a minimum load of 5.3 kN. The maximum load produced an initial maximum tension flange strain of 1.09% and a minimum compression flange strain of -1.09%. The initial beam stiffness was measured as 4,218 kN/m. The beam stiffness was checked throughout the test and is summarized in Table 26. The flanges of the beam showed the same 0° fiber misalignment, 2° to 3° , as in Beam number 18 and affected the edges of the flanges. The beam failed after 94,391 cycles due to the tension flange delaminating from the C - channel involving the 0° ply (ply 8, Table 24), the adhesive layer and the $\pm 45^\circ$ ply (ply 9, Table 24). This delamination was located between $x =$

-75 to 521 mm. Along with the edge 0° fiber delamination, the compression flange also had transverse tension cracks from $x = 178$ to 445 mm on the flange located beneath the outside edge of the web. The web had delaminations extending 25 mm into the web towards the compression flange. The failed beam is shown in Figures 89 and 90.

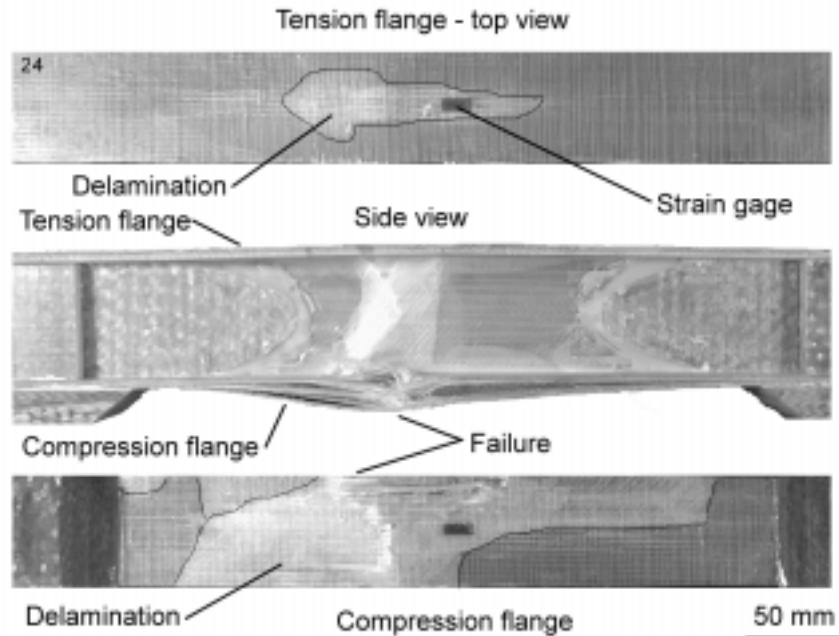
Figure 92. Beam 24.

Beam 24 involved a static test. The beam was loaded under actuator displacement control at a rate of 0.075 mm/s until failure, which involved a total ramp time of 190 seconds and a total mid-span deflection of 20 mm. An initial beam stiffness of 4,221 kN/m was measured. The beam had four acoustic emission sensors on the flanges: two on the tension flange centered at $x = 76$ and 549 mm, and two on the compression flange centered at $x = 165$ and 432 mm. A maximum tension flange strain of 1.93% and a minimum compression flange strain of -1.77% that occurred at a ultimate applied load of 88.29 kN. As with the other static tests, the compression flange twisted prior to final failure. This twisting was also evident in the failed beam as both sides of the beam flange had fragmented glass 0° and $\pm 45^\circ$ tows pointing up. This was a different mode of buckling than the other beams had shown. The compression flange failed at $x = 320 \pm 10$ mm with multiple delaminations throughout the flange thickness. The compression flange delaminated between the 0° ply (ply 5, Table 24) and -45° ply (ply 6, Table 24) from $x = 146$ to 437 mm. The failure caused

delaminations to travel through the web and into the tension flange adhesive layer. Transverse tension cracks were present on the tension flange from $x = 250$ to 458 mm. The failed beam is shown in Figure 92. No shear stiffener, torsional stiffener or other tension flange damage or delaminations were visible.

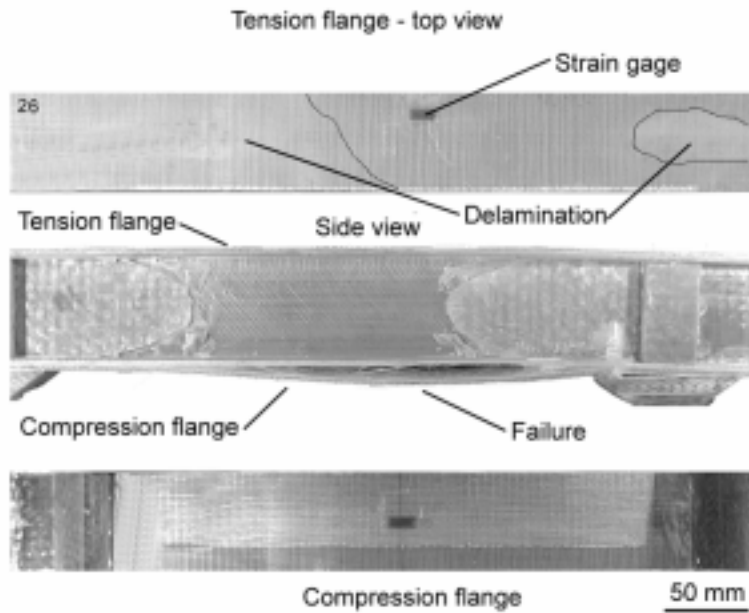
Figure 94. Beam 26.

Beam number 26 was fatigued at a rate of 2 Hz under sinusoidal load control with a maximum load of 57.8 kN and a minimum load of 5.8 kN. The maximum load produced an initial maximum tension flange strain of 1.22% and a minimum compression flange strain of -1.05%. The initial beam stiffness was measured as 4,355 kN/m. The beam stiffness was checked throughout the test and is summarized in 28. After 104,407 cycles, the beam failed by compression flange delamination and shear stiffener failure. Shear failure of the compression flange occurred at $x = 133$ mm. This was under the compression flange load pad. The compression flange delaminated between the 0° ply (ply 8, 24) and the adhesive layer. Delamination of the tension flange above the shear stiffeners, $x = 178$ and 428 mm, was noticed at 10,000 cycles and continued to grow until failure. The beam is shown in Figure 94. All shear stiffeners showed some signs of delamination from the web.

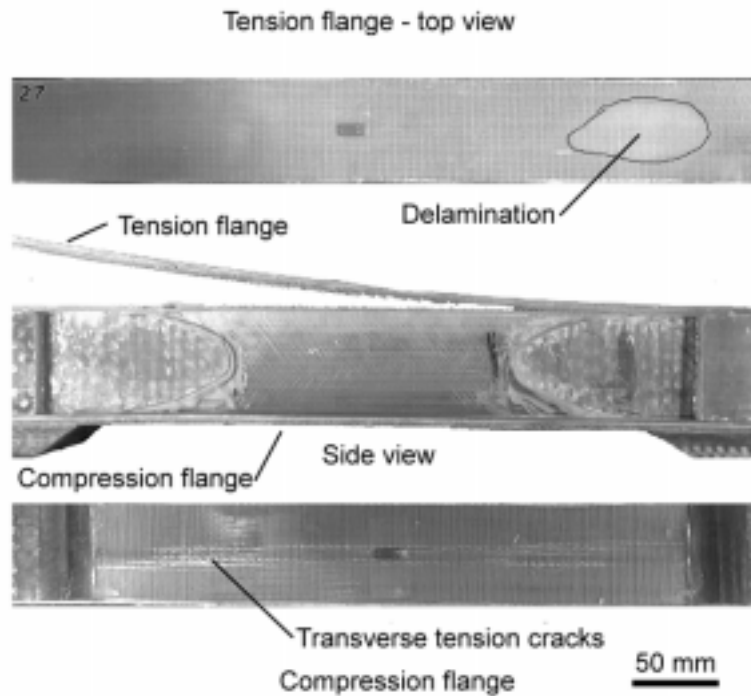
Figure 95. Beam 27.

Beam number 27 was fatigued at a rate of 3 Hz under sinusoidal load control with a maximum load of 53.4 kN and a minimum load of 5.3 kN. The maximum load produced an initial maximum tension flange strain of 1.07% and a minimum compression flange strain of -1.00%. The initial beam stiffness was measured as 4,069 kN/m. As with the other DD5P beams, two tension flange delamination spots started over the tapered shear stiffener area, $x = 178$ and 445 mm. These spots grew during the fatigue test until the delamination was under a tension flange load pad. After 243,876 cycles, the tension flange delaminated. The delamination involved the adhesive layer and the adjacent 0° and 45° plies and was from $x = -75$ to 483 mm. Some transverse cracks were present on both the tensile and compression flanges prior to failure. The shear stiffeners under the delamination show some damage, but it is not known if this was present prior to failure. The web also has delaminations extending 15 mm down towards the compression flange. The failed beam is shown in Figure 95.

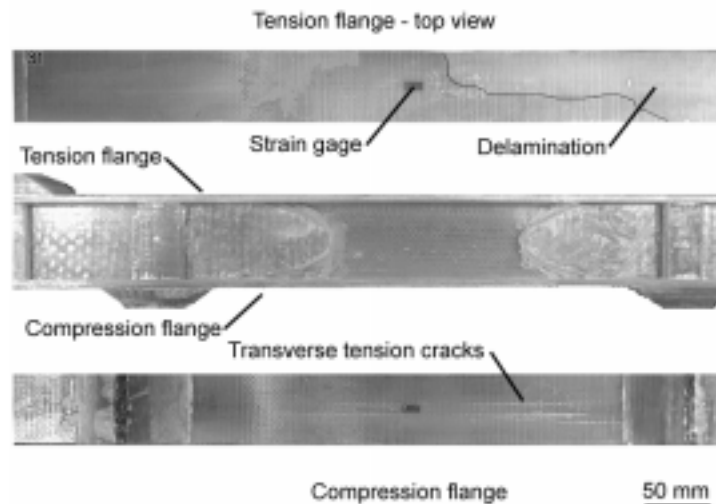
Figure 100. Beam 31.

Beam number 31 was fatigued at a rate of 4 Hz under sinusoidal load control with a maximum load of 53.4 kN and a minimum load of 5.3 kN. The maximum load produced an initial maximum tension flange strain of 1.92% and a minimum compression flange strain of -0.89%. The initial beam stiffness was measured as 4,764 kN/m. The stiffness was also checked after a power outage at 796,633 cycles, 4,170 kN/m and after 2,030,240 cycles 3,248 kN/m. The test was stopped after 2,030,240 cycles. After these cycles 3 of the shear stiffeners had started to delaminate from the web and the tension flange had delaminated from the C - channel between $x = 25$ and 280 mm. There was also web delamination damage at $x = 195$ mm that extended down from the tension flange into the tapered shear stiffener area. The compression flange also had multiple transverse tension cracks under this shear stiffener area. The beam is shown in Figure 100.

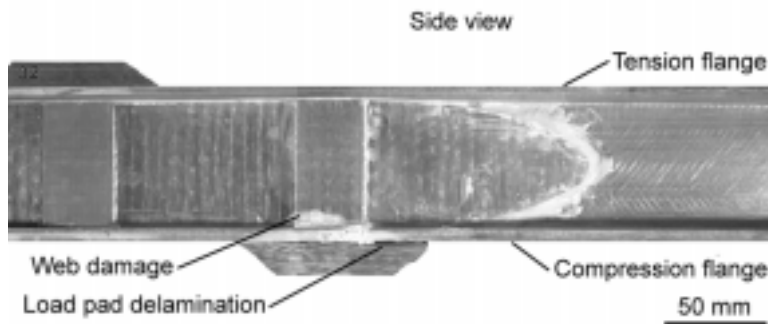
Figure 101. Beam 32.

Beam number 32 was fatigued at a rate of 5 Hz under sinusoidal load control with a maximum load of 53.4 kN and a minimum load of 5.3 kN. The maximum load produced an initial maximum tension flange strain of 0.86% and a minimum compression flange strain of -0.73%. The initial beam stiffness was measured as 4,639 kN/m. The beam stiffness was checked throughout the test and is summarized in Table 30. The fatigue test was stopped after 783,153 cycles. Like Beams 26 and 30, this beam started to have the same failure mode. The compression flange has sheared through the thickness at $x = 127$ mm under a compression flange load pad at the edge of the torsional stiffener. The compression flange did not have any visible transverse tension cracks. The only other damage on the beam was the spot delaminations on the tension flange over the shear stiffeners. The beam is shown in Figure 101.

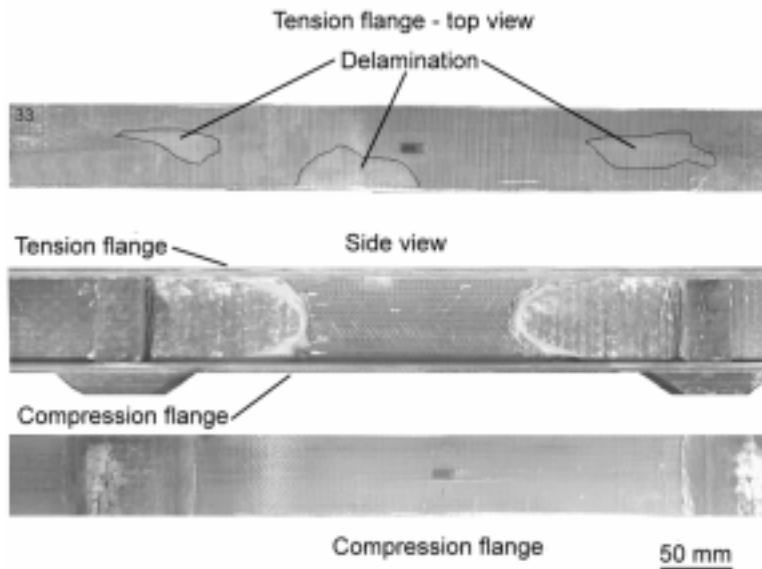
Figure 102. Beam 33.

Beam number 33 was fatigued at a rate of 4 Hz under sinusoidal load control with a maximum load of 53.4 kN and a minimum load of 5.3 kN. The maximum load produced an initial maximum tension flange strain of 0.94% and a minimum compression flange strain of -0.93%. The initial beam stiffness was measured as 4,606 kN/m. The beam stiffness was checked throughout the test and is summarized in Table 31. The beam was stopped after 3,200,000 cycles. Although the beam had not failed, there was some tension flange delamination, three spots, which were growing and extended down into the C - channel at $x = 318$ mm. The compression flange had some minor transverse tension cracks. The beam is shown in Figure 102.
