Fatigue of Composite Material Beam Elements Representative of Wind Turbine Blade Substructure

John F. Mandell, Daniel D. Samborsky,
David W. Combs, M. Ethan Scott,
Douglas S. Cairns
*Department of Chemical Engineering
Montana State University
Bozeman, Montana*

NREL Technical Monitors:
Richard Osgood and Walt Musial

November 1998

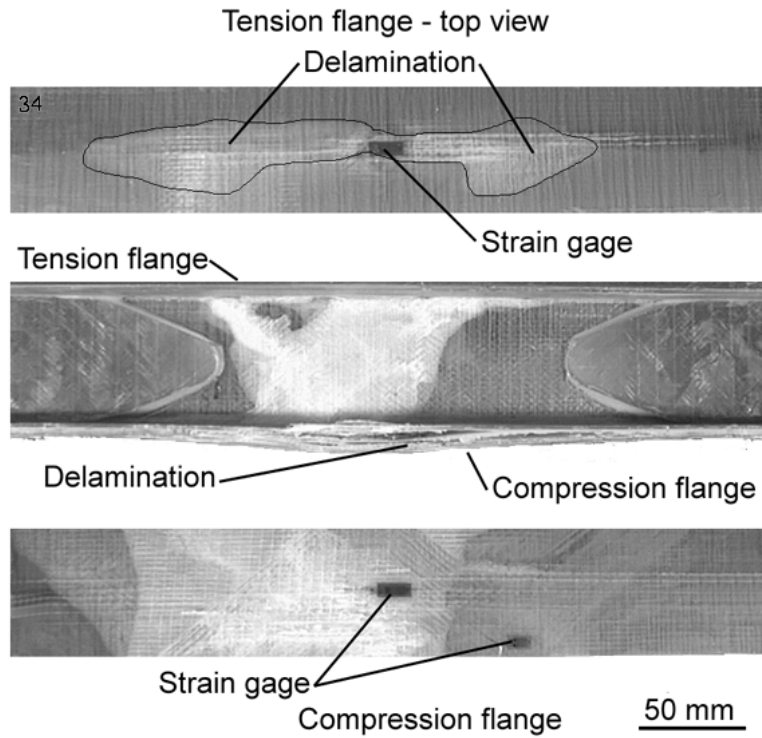
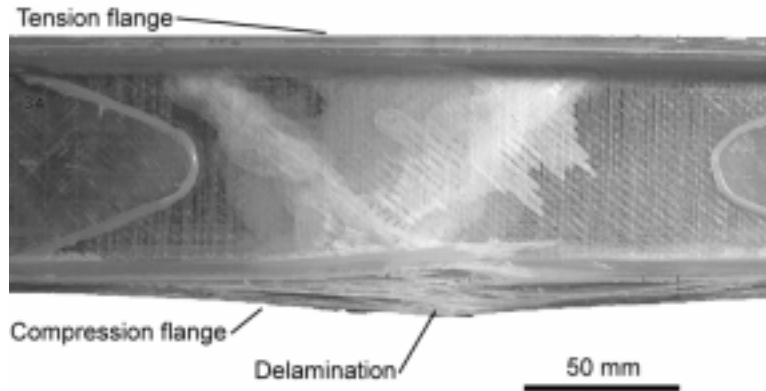
Figure 105. Beam 34.

Beam 34 involved a static test. The beam was loaded under actuator displacement control at a rate of 0.075 mm/s until failure, which involved a total ramp time of 65 seconds and a total mid-span deflection of approximately 8 mm. An initial beam stiffness of 4,990 kN/m was measured. The beam had two additional strain gages on the compression flange edges, both top and bottom of the flange. This was done to determine when the flange starts to buckle. The beam was loaded statically to 60 kN three times before the actual static test. The initial load - flange absolute maximum strain graph is shown in Figure 103 and shows the two standard strain gages on the center of the tension and compression flanges. Figure 104 shows the two compression flange edge gages, back-to-back, which indicates that the onset of buckling in this beam occurs at approximately 75 kN or 1.4% strain. The third load-up involved the static test and indicated a maximum tension flange strain of 1.92% and a minimum compression flange strain of -1.69% that occurred at a ultimate applied load of 83.22 kN. The failure occurred on the compression flange at $x = 292 \pm 20$ mm. The compression flange had transverse tension cracks and multiple delaminations between $x = 150$ and 457 mm. The delaminations extended through the web and into the adhesive layer on the tension flange, producing a delamination from $x = 178$ to 381 mm. The failed beam is shown in Figures 105 and 106.

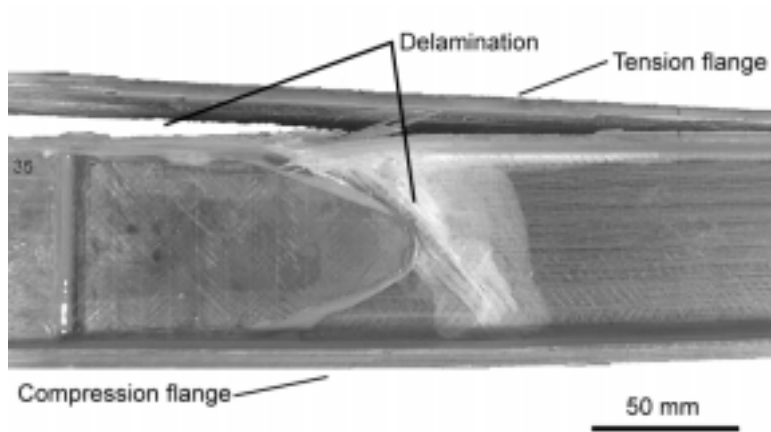
Figure 108. Beam 35.

Beam number 35 was fatigued at a rate of 2 Hz under sinusoidal load control with a maximum load of 62.3 kN and a minimum load of 6.3 kN. The maximum load produced an initial maximum tension flange strain of 1.04% and a minimum compression flange strain of -1.02%. The initial beam stiffness was measured as 4,347 kN/m. The compression flange delaminated from $x = -75$ to 458 mm, after 9,771 cycles. The delamination of the flange caused the web to fail at $x = 190$ mm with delamination in the web from $x = 178$ to 267 mm. There were two spot delaminations on the tension flange, caused by the failure, at $x = 190$ to 356 mm. The failed beam is shown in Figures 107 and 108.

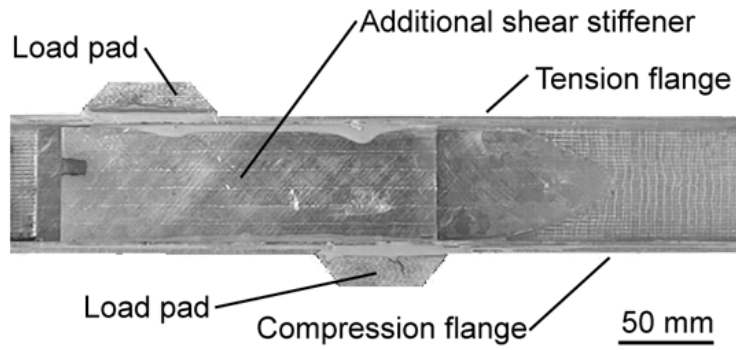
Figure 110. Additional shear stiffener material.

Beam number 51 was fatigued at a rate of 6 Hz under sinusoidal load control with a maximum load of 53.4 kN and a minimum load of 5.3 kN. The maximum load produced an initial maximum tension flange strain of 0.76% and a minimum compression flange strain of -0.75%. The initial beam stiffness was measured as 4,867 kN/m. The beam was stopped after 3,000,000 cycles with no significant change in stiffness and no major damage. Figure 109 shows the only noticeable damage on the beam, transverse tension cracks on the compression flange. Figure 110 shows the additional shear stiffener material that was added to the beam.

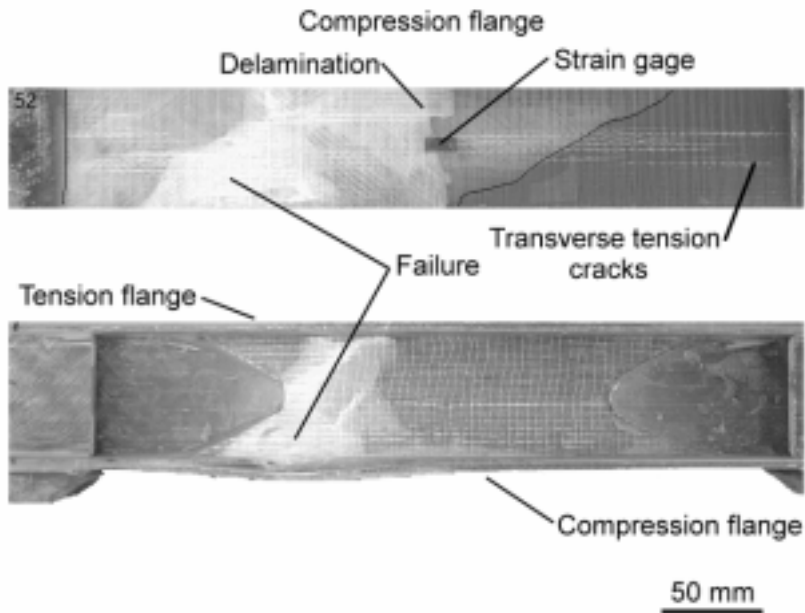
Figure 111. Beam 52.

Beam number 52 was fatigued at a rate of 3 Hz under sinusoidal load control with a maximum load of 62.3 kN and a minimum load of 6.2 kN. The maximum load produced an initial maximum tension flange strain of 0.93% and a minimum compression flange strain of -0.89%. The initial beam stiffness was measured as 5,145 kN/m. Initially the compression flange showed no evidence of buckling, but after 16,000 cycles, it was noticed that the compression flange had a small localized buckling node at $x = 395$ mm that was present on only one flange edge. This node, or area of increased localized displacement, did not change until the failure of the beam after 62,843 cycles. The compression flange failed at $x = 395$ mm, the node, with multiple delaminations in the preform and flange. The compression flange delaminations extended from $x = 200$ to 460 mm and were between the 0° ply and adjacent 45° plies throughout the flange and preform thickness. This delamination also traveled into the web. The failed beam is shown in Figure 111.

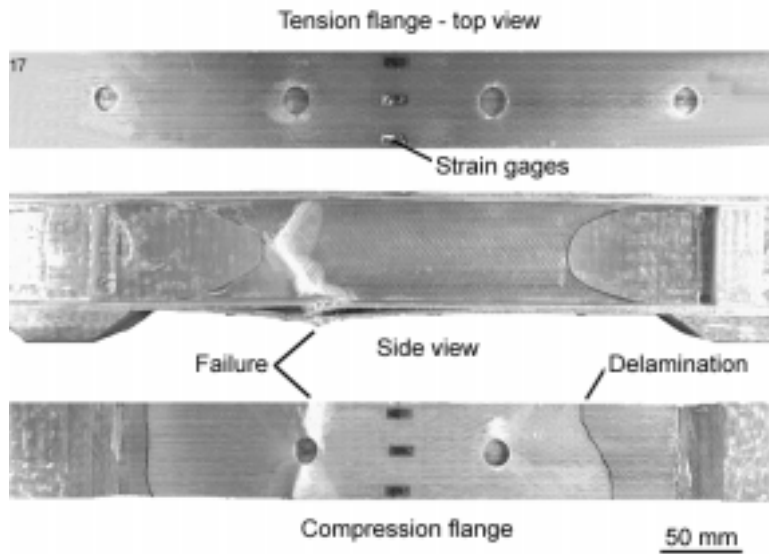
Figure 119. Beam 17.

Beam 17 was tested statically to failure. The beam was loaded under actuator displacement control at a rate of 0.05 mm/s until failure, which had a total ramp time of 196 seconds. An initial beam stiffness of 3,350 kN/m was measured. The beam had a total of six strain gages, with three on the tension flange and three on the compression flange. At 18 kN, the tension flange indicated a center strain of 0.334% while the two edge gages indicated 0.423% and 0.416%. The compression flange center gage indicated -0.365% and the two edge gages indicated -0.388% and -0.374%. The difference in strain from the center, where the flange is discontinuous, and the edge is more pronounced than the strains recorded from Beam 15. As the beam was loaded, the compression flange did not appear to twist as in the other beam static tests. The load-flange absolute maximum strain graph is shown in Figure 118, indicating a maximum tension flange center strain of 1.30% and a minimum compression flange center strain of -1.08%. These strains occurred at a ultimate applied load of 46.97 kN at a maximum mid-span deflection of 15 mm. The failed beam is shown in Figure 119. The compression flange failed at $x = 260 \pm 15$ mm and created a flange delamination from $x = 178$ to $x = 419$ mm. The delamination was between the 0° ply (ply 10, Table 22) and $+45^\circ$ ply (ply 11, Table 22). This delamination traveled up towards the tension flange and produced a spot delamination at the tension flange hole. The second hole on the compression flange had a 12 mm delamination going towards the edge, but the damage at the other hole produced the flange failure first.

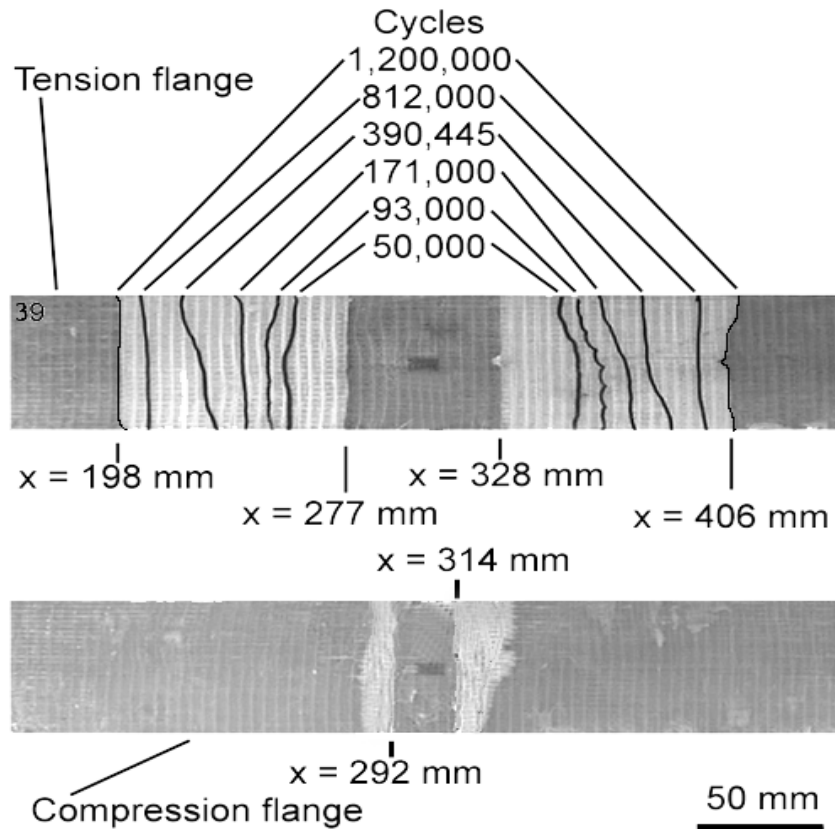
Figure 120. Beam 39.

Beam number 39 was fatigued at a rate of 4 Hz with a maximum load of 35.6 kN and a minimum load of 3.6 kN. The maximum load produced an initial maximum tension flange strain of 0.62% and a minimum compressive flange strain of -0.64%. The initial beam stiffness was measured as 4,804 kN/m. The flange material was the ESA laminate, which had a single, exterior ply drop (ply 1, Table 34). The ply drops on the tension flange were at $x = 277$ and 328 mm. The ply drops on the compression flange were at $x = 292$ and 314 mm. On the tension flange, the delamination started immediately between the surface 0° ply and second internal 0° ply (plies 1 and 2, Table 34). This delamination was uniform across the width of the tension flange. The delamination on the tension flange continued to grow at an average rate of 6.95×10^{-5} mm/cycle until the beam was taken out of the apparatus at 1,225,650 cycles. The tension flange itself did not delaminate from the web flange. The compression flange did not start to show delamination until approximately 11,000 cycles. The compression flange delamination also occurred between the two top 0° plies (plies 1 and 2, Table 34) and grew approximately 30 mm in length and then arrested for the duration of the test. Table 35 lists the average delamination length versus cycles. The beam is shown in Figure 120. No shear stiffener, torsional stiffener or other flange damage or delaminations were visible.

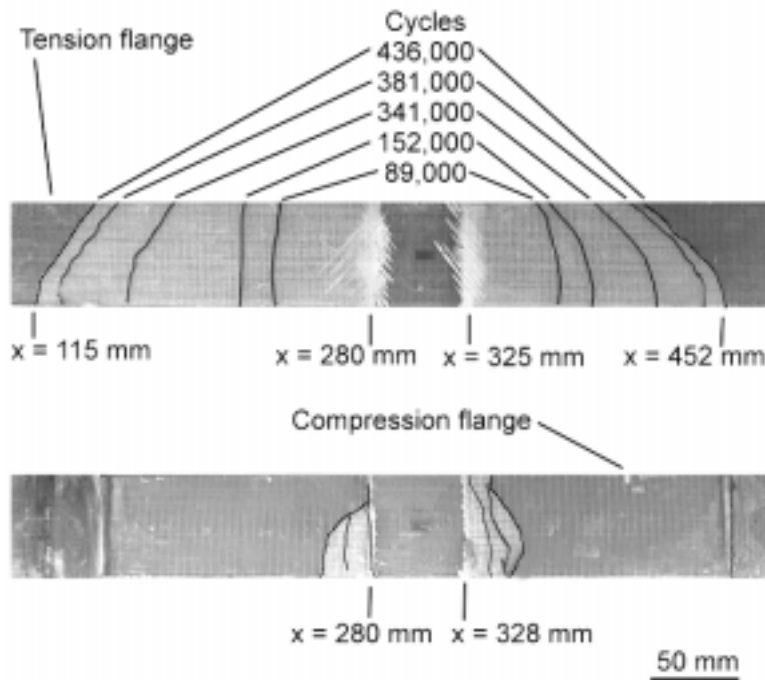
Figure 125. Beam 42.

Beam number 42 was fatigued at a rate of 4 Hz with a maximum load of 35.6 kN and a minimum load of 3.6 kN. The maximum load produced an initial maximum tension flange strain of 0.55% and a minimum compressive flange strain of -0.54%. The initial beam stiffness was measured as 5,524 kN/m. The only difference between Beam 42, as compared with Beam 41, is the strain level at which the beams were run. The tension flange ply drops were located at $x = 280$ and 325 mm and the compression flange ply drops were at $x = 280$ and 328 mm. The delamination appearing on the flanges were similar to Beam 41. On the tension side of the beam the delamination originally started between the 0° ply, (ply 2, Table 39) and the $+45^\circ$ (ply 3, Table 39), but continued between the 0° ply (ply 5, Table 39) and the -45° ply (ply 4, Table 39). The average delamination length versus cycles is listed in Table 41. The average calculated delamination rate on the tension flange was 1.23×10^{-4} mm/cycle. The compression flange did not start to delaminate until almost 100,000 cycles and the average calculated delamination rate was 3.84×10^{-5} mm/cycle. The delaminated beam is shown in Figure 125 below.

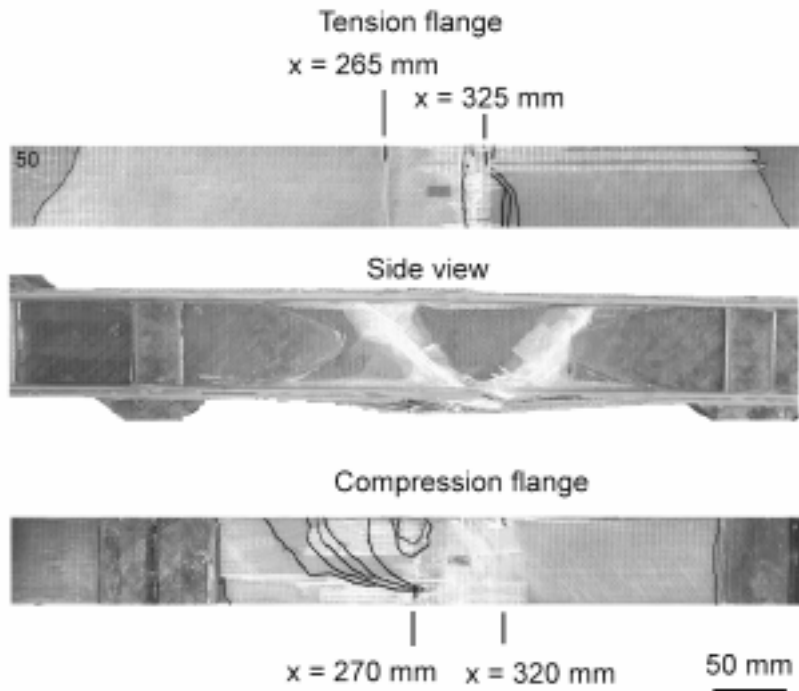
Figure 127. Beam 50.

Beam number 50 was fatigued at a rate of 3 Hz with a maximum load of 48.9 kN and a minimum load of 4.9 kN. The maximum load produced an initial maximum tension flange strain of 0.63% and a minimum compressive flange strain of -0.63%. The initial beam stiffness was measured as 6,054 kN/m. The tension flange ply drops were located at $x = 265$ and 325 mm and the compression flange ply drops were at $x = 270$ and 320 mm. Delamination started into the thin section of the tension flange and then arrested, just as with previous beams. The average delamination length versus cycles is shown in Table 44. The delamination on the tensile flange started into the thick cross-section and propagated uniformly at an average calculated rate of 5.08×10^{-4} mm/cycle. The compression side of the beam showed delamination being initiated at one corner of the ply drop and slowly working its way along the flange edge and then across the flange. Once the crack had propagated across the flange width, the delamination grew unstably to the load pads. The beam was then tested for residual strength after 204,100 cycles. The residual strength was 88.2 kN. The failed beam is shown in Figure 127, indicating a compression flange failure. This failure load compares favorably with that for Beam 34, 83.22 kN, with no ply drops, but thinner flange material.
