Managing the Drivers of Air Flow and Water Vapor Transport in Existing Single-Family Homes

J. Cummings, C. Withers, E. Martin, and
N. Moyer

*Building America Partnership for
Improved Residential Construction*

Revised October 2012

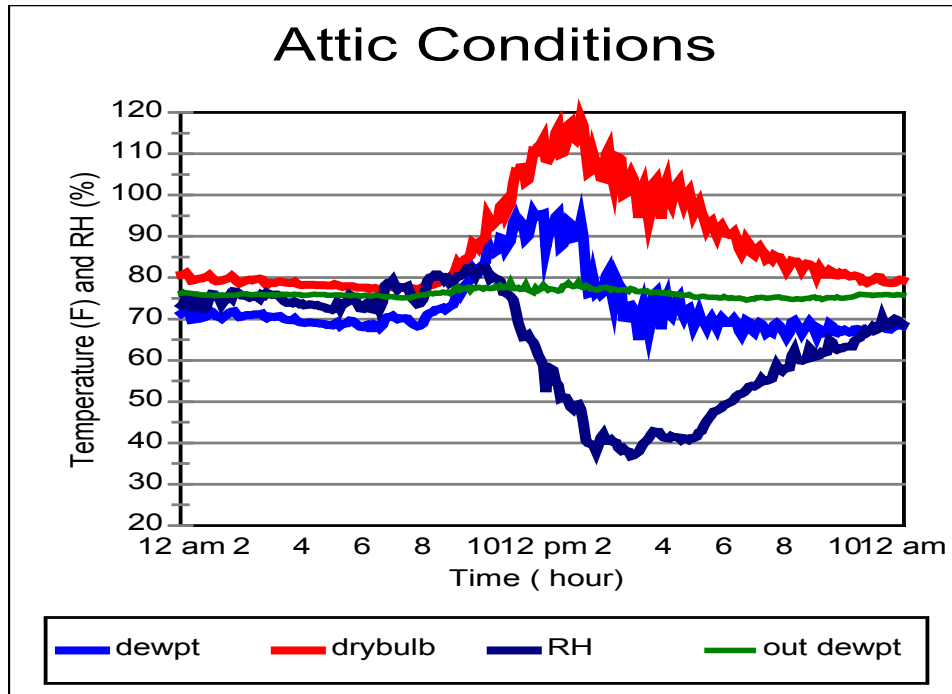
Figure 1. Attic dry bulb and dew point temperatures, attic RH, and outdoor dew point temperature in a Florida home.

Hotter air can hold more water vapor, so RH goes down as air temperature goes up. For each 10°F increase in air temperature, RH goes down by about 26%, assuming that the absolute water vapor content of the air remains constant. The water vapor capacity of the air increases by about 38% for each 10°F rise in air temperature (Table 1). When RH is held constant at 50%, total energy (enthalpy; H) contained in the air also increases substantially as temperature and humidity ratio increase, by almost exactly 23% per 10°F rise. This sharp rise in enthalpy, as the attic becomes hotter, has important implications for cooling loads created by attic air transported into the house.

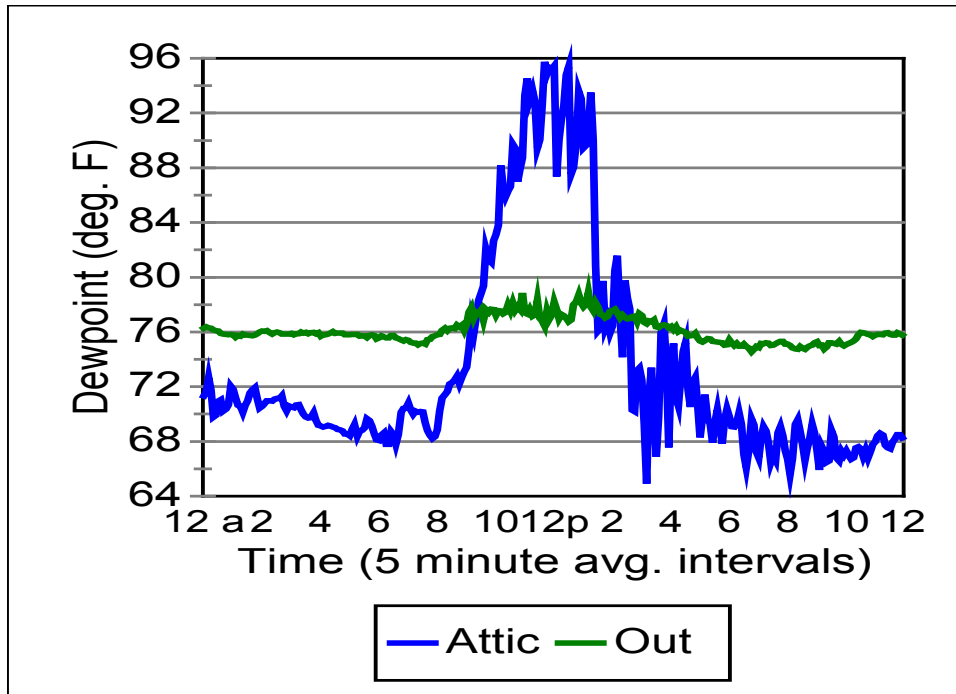
Figure 2. Attic dew point temperature swings widely as the attic temperature rises and falls (Florida home October 4, 1998)

As attic temperature rises and RH declines, the rate of desorption increases, which has the effect of drawing adsorbed moisture away from attic building materials. Water vapor removed from wood and other materials in the attic enters the attic air, pushing up the attic dew point temperature (Figure 2). In this particular Florida home, dew point temperature rises to about 95°F when outdoor dew point temperature is about 77°F. This spike occurs during a time of day when the A/C system runtime is increasing, thus creating the potential for substantial increases in cooling energy use and indoor RH, as attic air finds its way into the house from duct leakage and other forms of uncontrolled airflow.

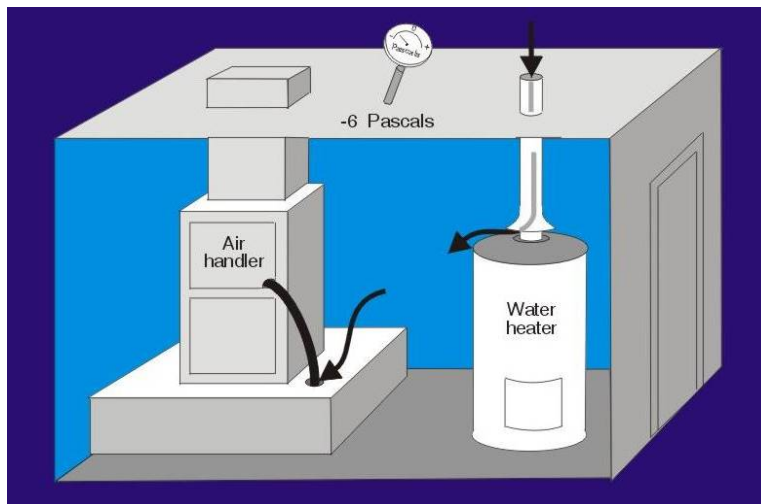
Figure 3. Return leaks in a mechanical room create depressurization which causes air to be drawn into the room from outdoors and potential combustion safety problems.

vent (Figure 3). In addition to creating a combustion safety hazard, this introduces heat from outdoors and retains combustion heat in the house. Return leaks can create small or large energy impacts depending upon the temperature and water vapor content of the air drawn into the leak. At one extreme, air drawn from a hot attic can overwhelm the cooling capacity of an A/C system. A 15% return leak from an attic with peak conditions of, say, 125°F and 75°F dew point temperature can diminish the cooling capacity and efficiency of an A/C system by more than 50% (Figure 4).

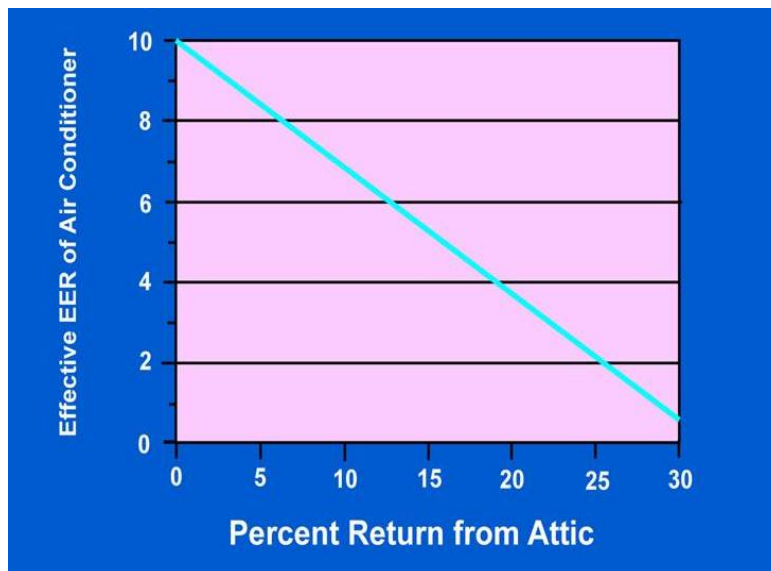
Figure 4. Cooling energy efficiency ratio versus the return leak percent (from attic), assuming attic conditions of 120°F dry bulb and 75°F dew point temperature.

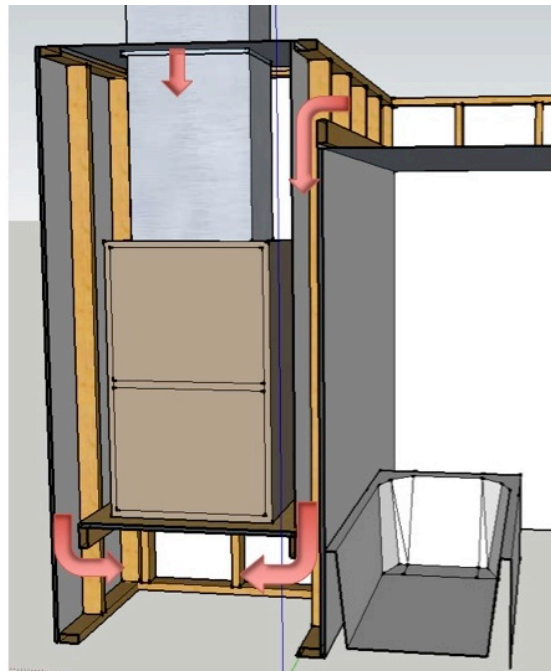
Figure 5. Duct leakage from attic is pulled through pathways in walls. In one extreme case, 55% of the return leakage originated from the attic.

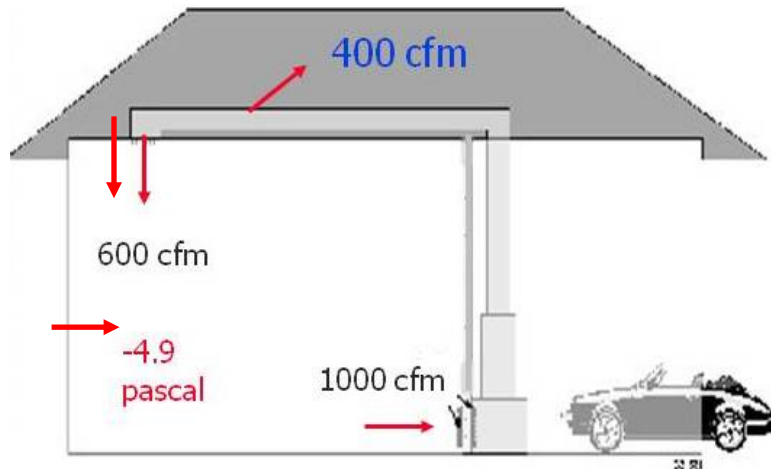
Figure 6. A supply leak of 400 CFM produces space depressurization, which causes 400 CFM of air to be drawn into the house from outdoors and attic.

By contrast, dominant supply leaks can cause a substantial increase in indoor RH, because the supply leakage creates space depressurization, which in turn draws air into the house through all pathways in the envelope. Figure 6 shows that a supply leak of 400 CFM causes space depressurization of -4.9 Pa, which in turn draws 400 CFM of air into the house from outdoors and the attic. During hot and humid weather, high dew point air can be drawn into the house from various sources; outdoors, from the crawlspace or basement, from an attached garage, or from the attic. Depending on the quantity of the net supply leakage (net supply leakage = total supply leakage – return leakage), indoor RH can rise as much as 10 percentage points.

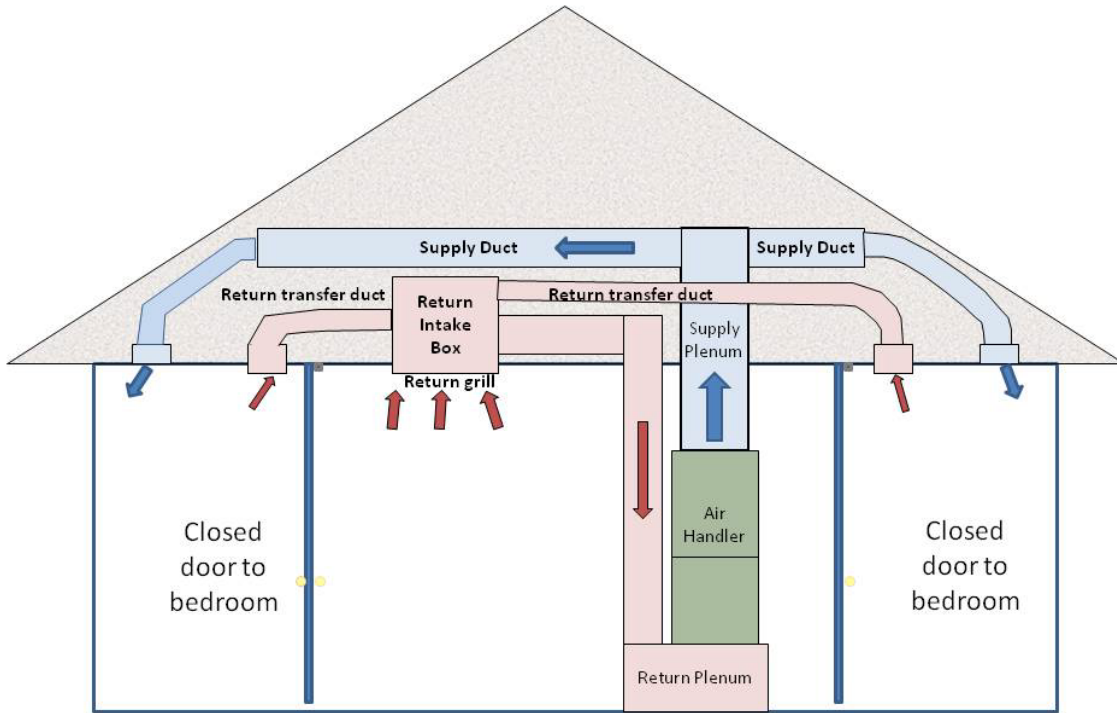
Figure 7. Hybrid ducted return transfer shown from two rooms to a return intake box (Withers).

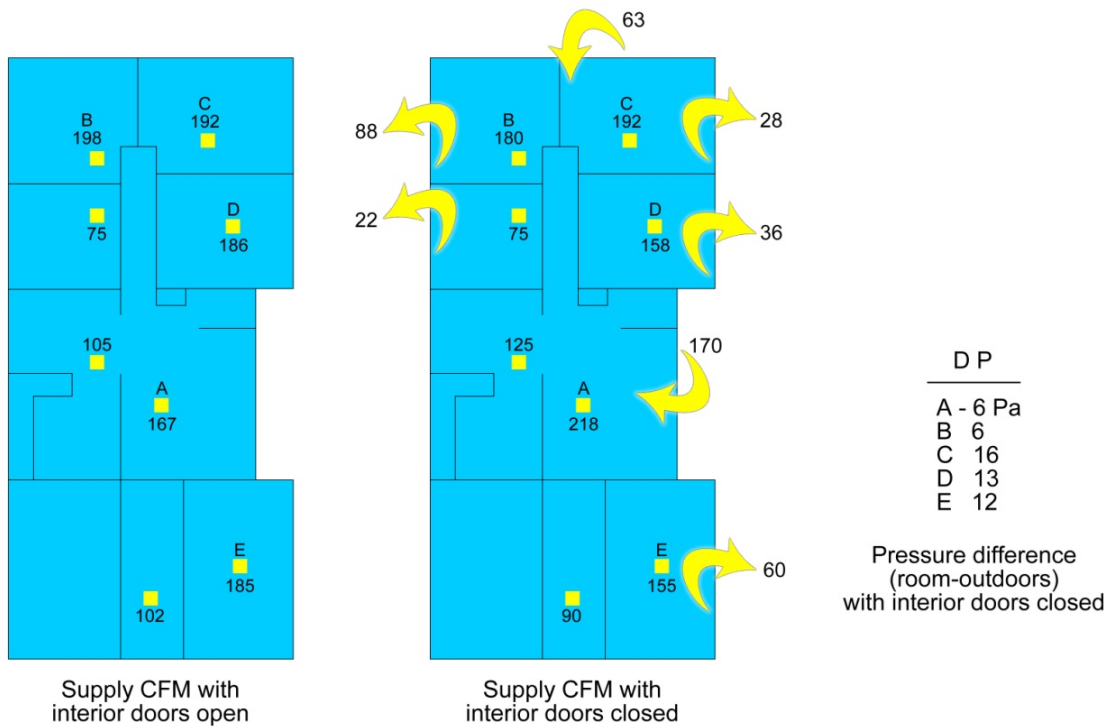
Figure 8. Pressure mapping results in a house with a central return and closed interior doors.

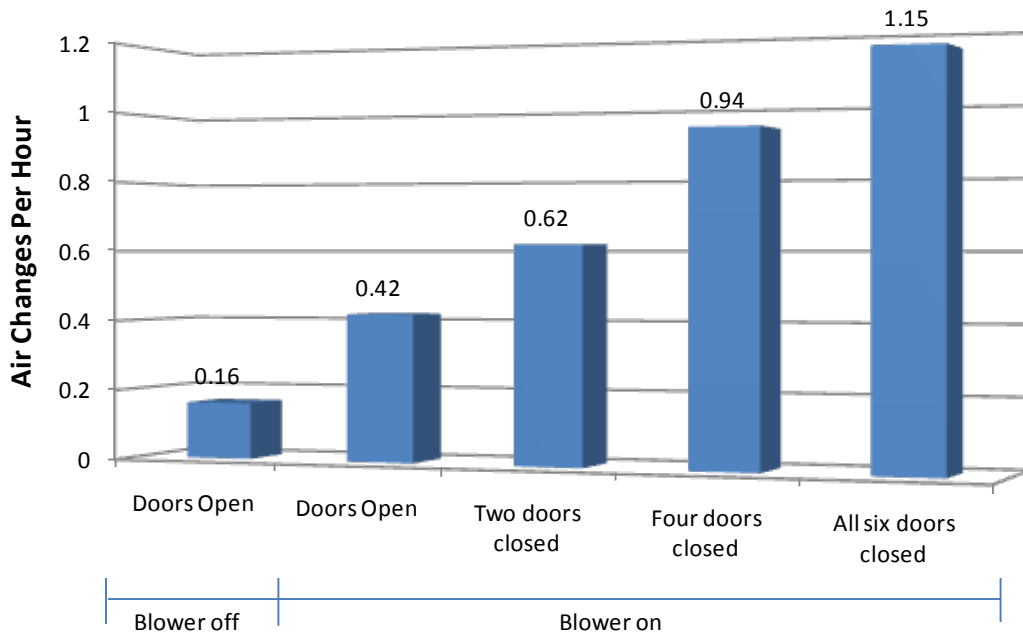
Impact upon infiltration of closing interior doors when air conditioner blower is running

Figure 9. Air infiltration impacts of duct leakage, unbalanced return air, and incremental closing of interior doors.

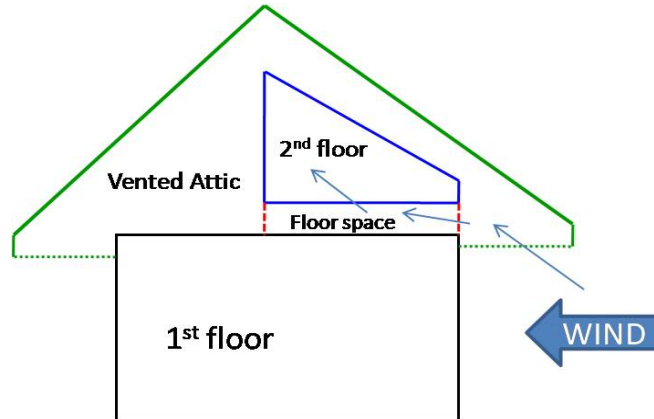
Figure 10. Wind-driven attic air is pushed into the space between floors.

Wind washing—air from outdoors penetrating into the interstitial cavities of the house—is a variation on natural drivers. In this case, the primary driver is wind and the pathway is typically openings from attic spaces or outdoors into interstitial cavities. Figure 10 illustrates a particular form of wind washing that is rather common in homes in the southeastern United States. In this case, wind can drive air from an attic space above a first-floor portion of the house into floor cavities that are located between the first and second stories of the house (Figure 11). In many cases, wind washing airflow does not directly enter into the conditioned space of the house. Rather, the air remains largely contained within these interstitial cavities and at least partially separated from the conditioned air. Once the hot or cold air penetrates into the interstitial cavities, it bypasses the thermal envelope of the house and can readily conduct heat or cold into the conditioned space (Figures 12 and 13). To some extent, however, air can also flow from the interstitial cavities into the conditioned space through openings in the floor of the second story or the ceiling of the first story. Alternatively, duct leakage may interact with wind washing and draw air from these cavities and deliver it into the space.

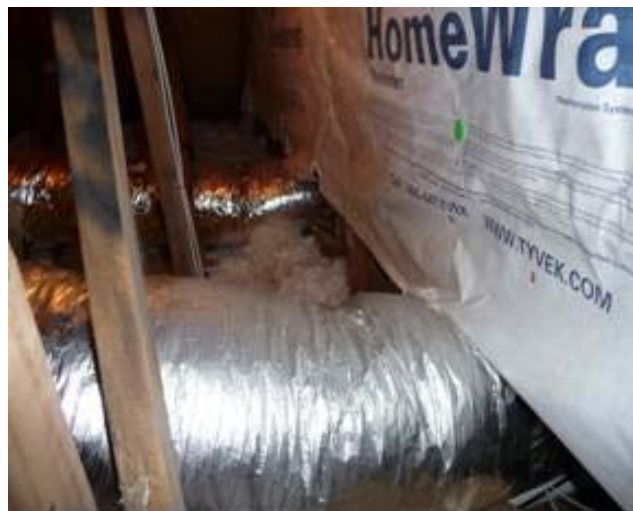
Figure 11. Flex ducts going from an attic space into the interstitial floor cavity under a portion of the second story conditioned space.

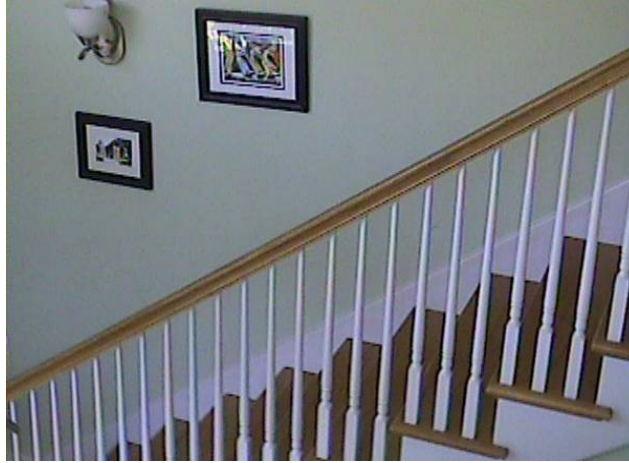
Figure 12. Photograph of stairwell. Floor cavity begins under the hung picture at top.

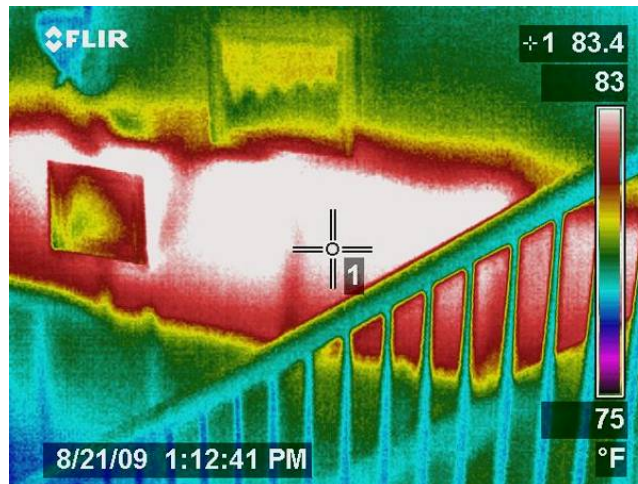
Figure 13. Infrared image of stairwell showing elevated wall temperature from hot air in an interstitial floor cavity. Note location of pictures and light fixture.

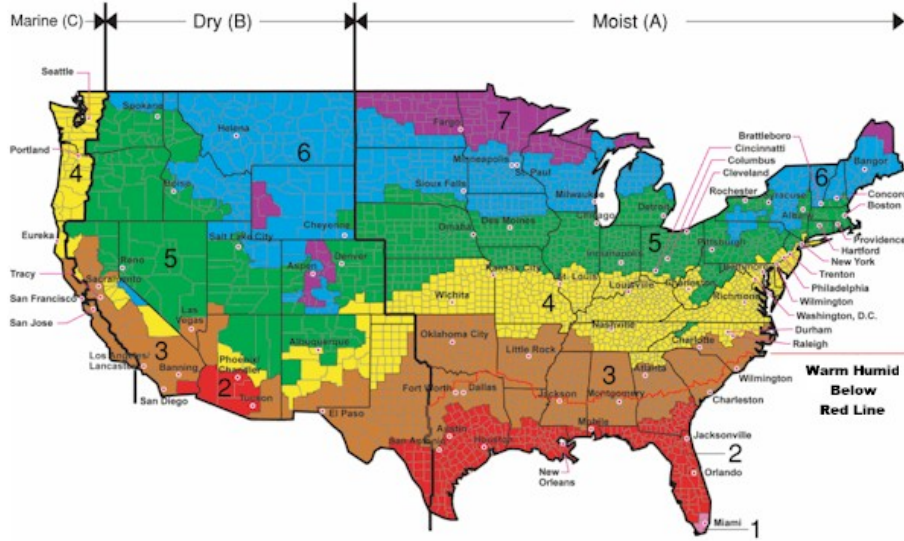
Figure 14. Climate zone map of the United States (DOE)

- Measured airtightness and climate zone. If house airtightness is 6 ACH50 or less in a mild climate (climate zones 1, 2, and 3), 4.5 ACH50 or less in a moderate climate (climate zones 4 and 5), or 3 ACH50 or less in a harsh climate (climate zones 6 and 7), additional house envelope airtightening may not be cost effective unless the leaks are easily accessed and repaired (Figure 14). If houses are 6–8 ACH50, 4.5–6 ACH50, and 3–4.5 ACH50 in mild, moderate, and harsh climate areas, respectively, then reasonably inexpensive airtightening may be justified. If houses are leakier than this, considerable airtightening is recommended.

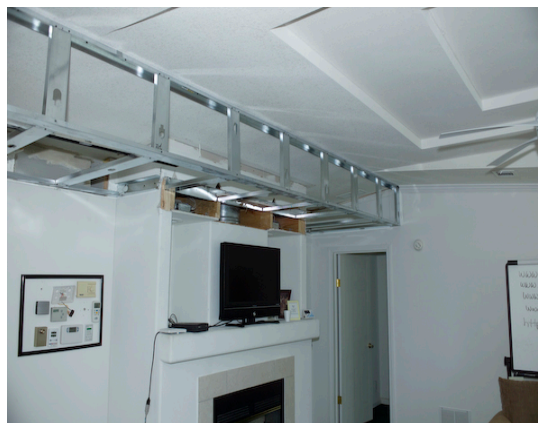
Figure 15. Interior duct system under construction. Metal framing is used to construct a chase that will hide the ducts from view once covered with drywall. The chase should be tight to the attic and leakier to the room.

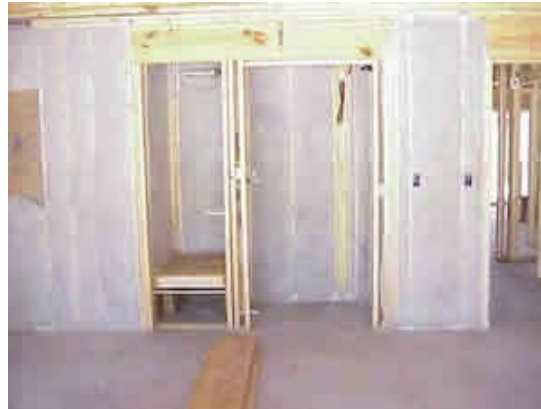
Figure 16. An insulated garage closet located will house an AHU. A weather stripped door will isolate the closet from the garage. A vent from the closet to indoors would also further enhance the system operating efficiency.

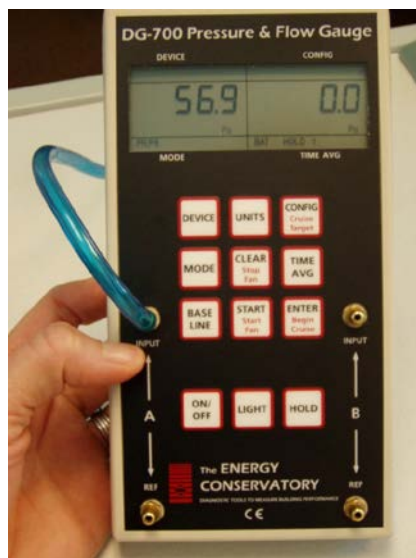
Figure 17. Pressure mapping can be performed using a manometer.

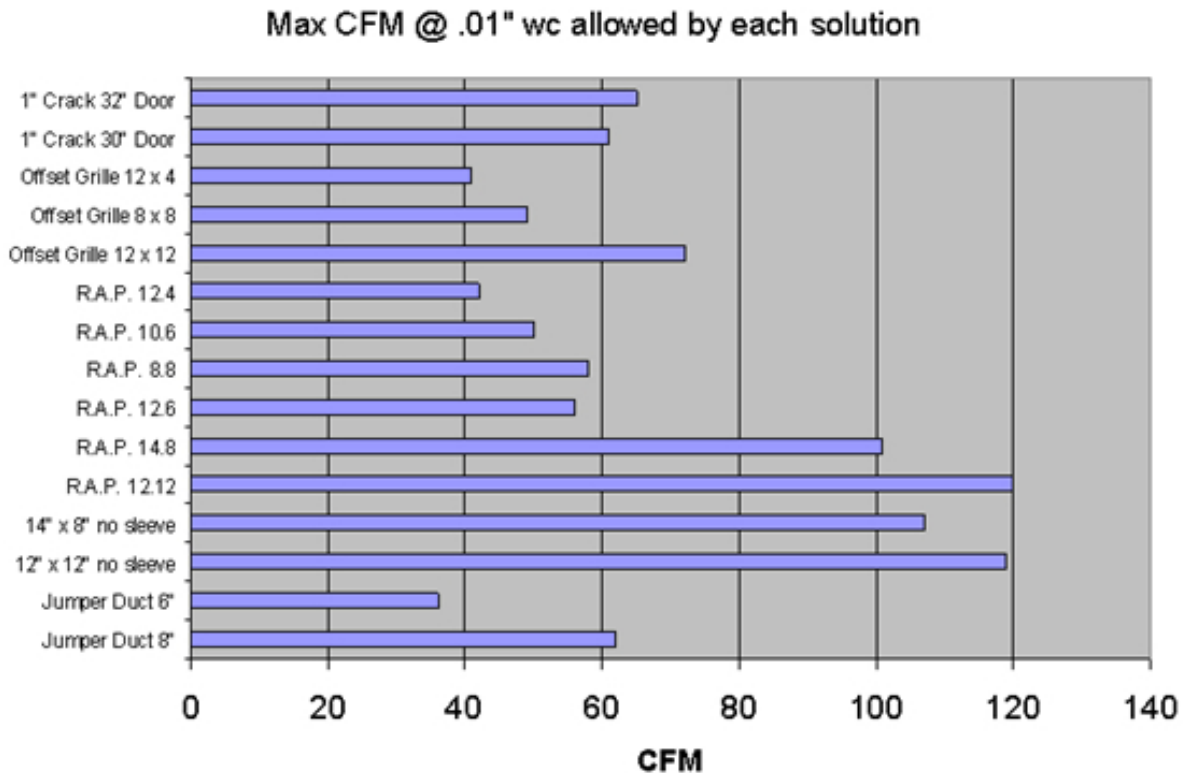
Figure 18. Achievable airflow rates using various return air paths from closed rooms for a given supply at a room pressure of 0.01 in. w.c. (2.5 Pa) with respect to the return zone. For example, an 8-in. jumper duct could be used to maintain 2.5 Pa in rooms with supply air up to 60 CFM. Excerpt from www.ba-pirc.org/casestud/return_air/index.htm.

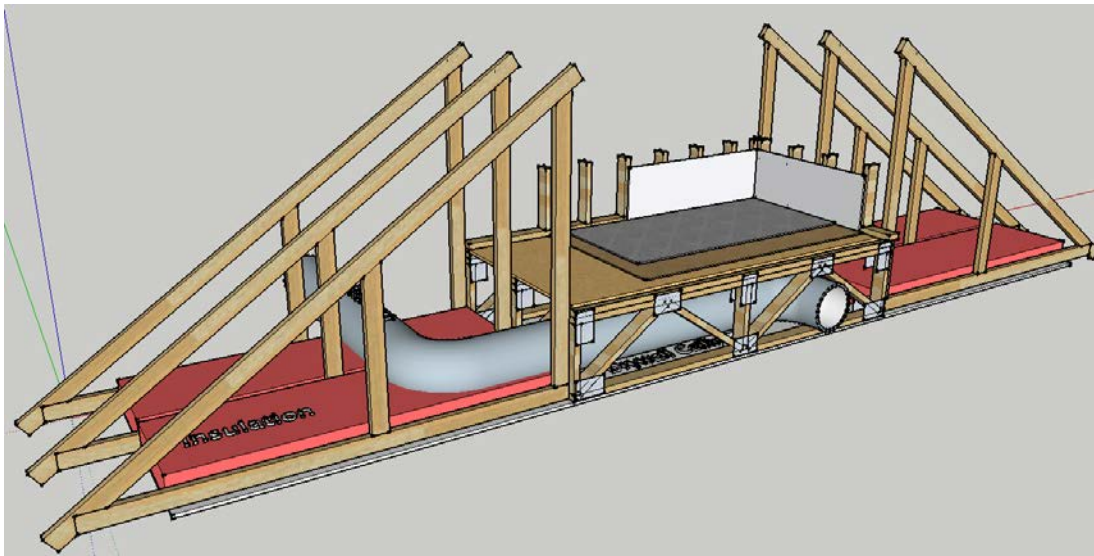
Figure 19. A supply duct is located within the interstitial floor cavity of an upstairs bonus room. The floor cavity is open to an adjacent attic space allowing high dew point air to contact the cool outer jacket of the duct.

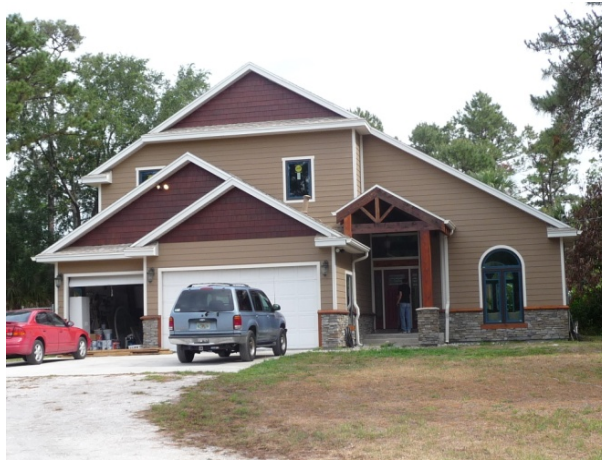
Figure 20. Home with one attic space over garage that abuts second floor wall and floor cavity.

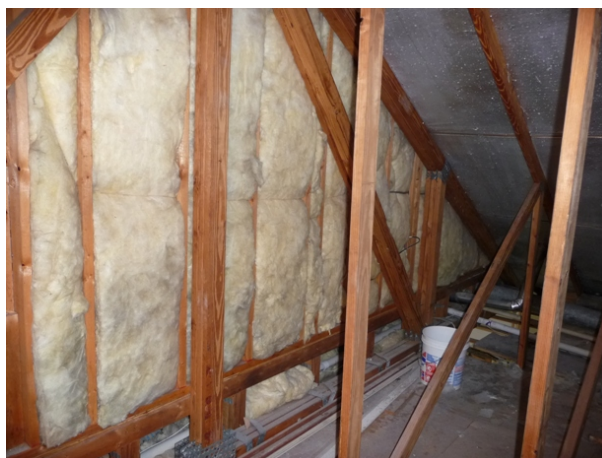
Figure 21. View of kneewall and portions of open floor cavity as seen from inside the attic.

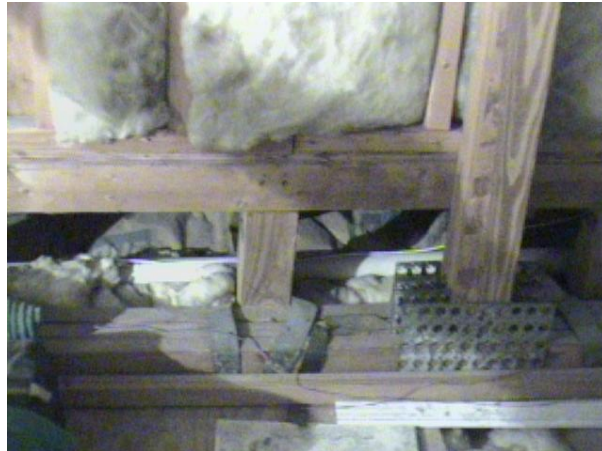
Figure 22. Close-up view of entry to open floor cavity.

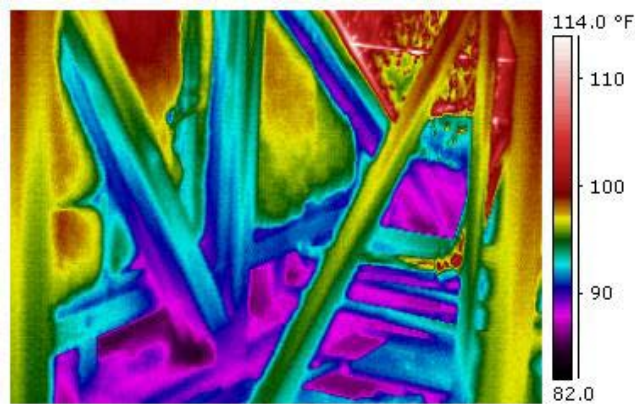
Figure 23. IR image from inside attic before repair shows much cooler area at the bottom where air from floor cavity is displaced into attic.

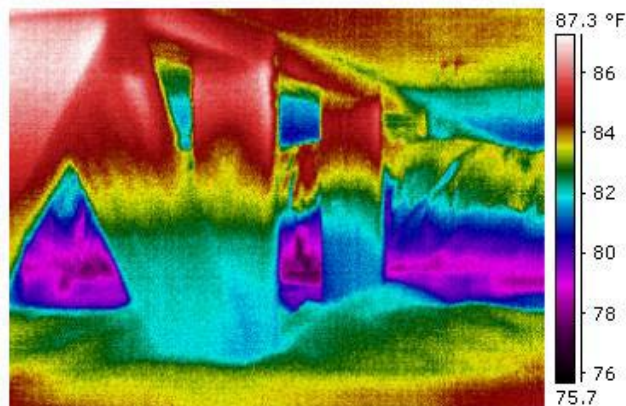
Figure 24. IR image inside floor cavity shows thermal stratification of air, with hotter air at top against second-story floor and cooler air at bottom.

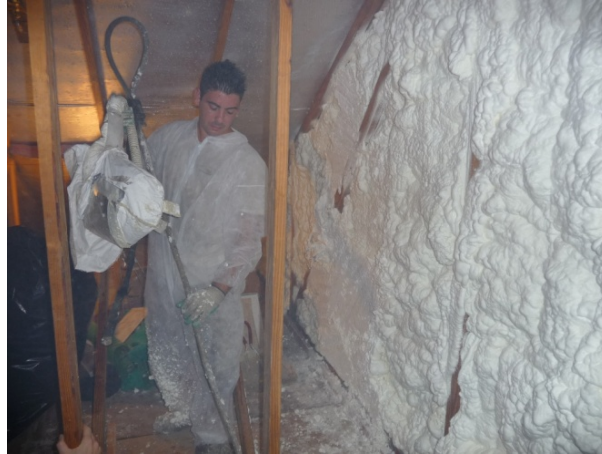
Figure 25. View of kneewall and floor cavity after being sealed with low density expansive foam.

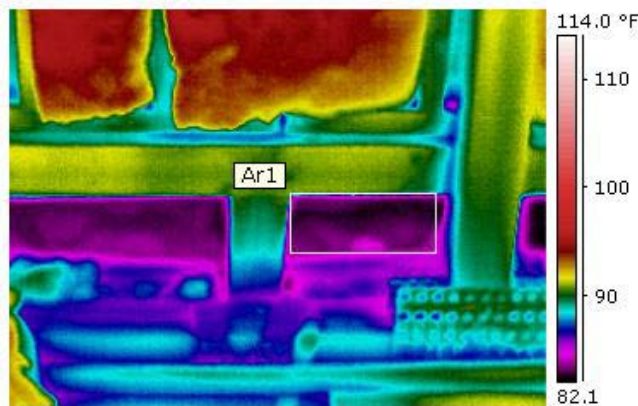
Figure 26. Before sealing the floor cavity, surface temperatures just inside the floor cavity averaged about 85.4°F (inside the Ar1 box).

Wind washing is a form of uncontrolled airflow that often occurs when attic air is driven into interstitial cavities between the first and second stories of a house. Figures 20 and 21 illustrate a typical wind washing case. Figures 22 and 23 show visible and infrared (IR) images of the wind washing openings to the floor cavity. The cooler temperatures indicated in the IR image show that the floor cavity is at a considerably cooler temperature than the attic. Even when wind-driven airflow is small, thermal buoyancy can circulate hot air from the attic space into the interstitial floor cavity, as is illustrated in Figure 24. Cool air flows from the floor cavity into the attic and is replaced by hot attic air. Foam insulation is an effective means to seal the floor cavity opening and to provide improved insulation R-value to the knee wall (Figure 25). The penetration of attic heat into the floor cavity is eliminated when the foam insulation application seals openings to the floor cavities (Figures 26 and 27).

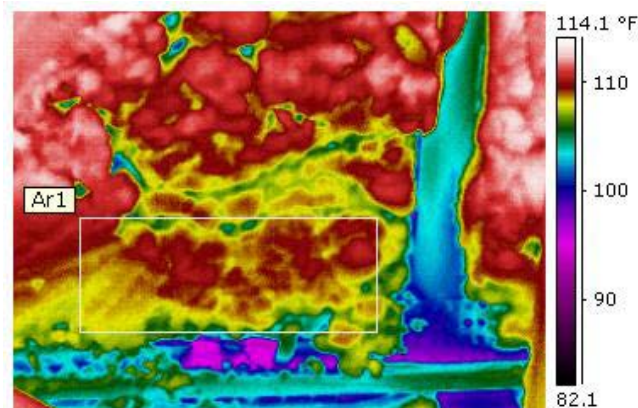
Figure 27. After sealing, the average temperature of the insulation sealing the floor space is about 110.6°F as seen from the attic.

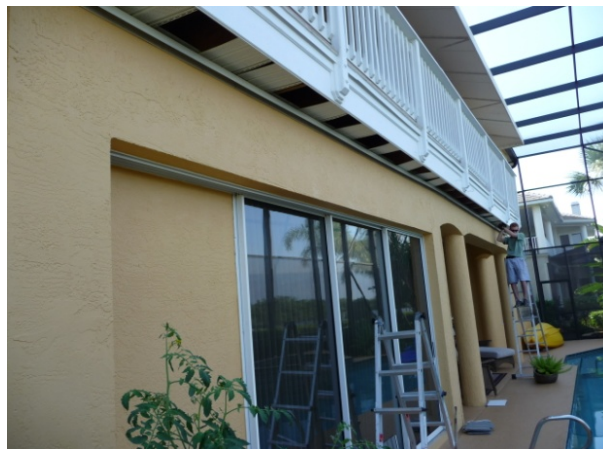
Figure 28. Soffit vent panels removed for inspection and access to seal air pathways from eave into floor cavity.

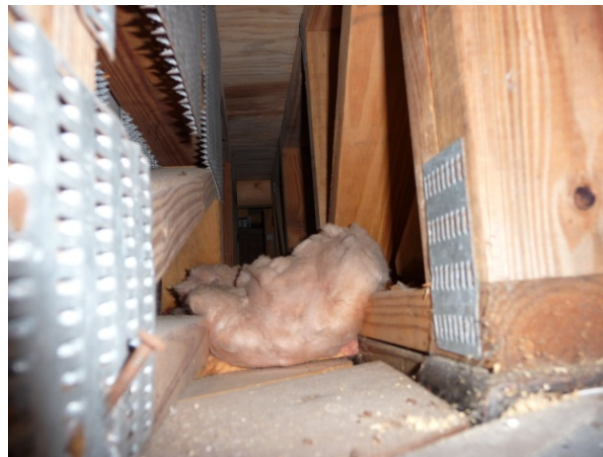
Figure 29. View from the vented eave cavity that is well-connected to second-story floor cavity.

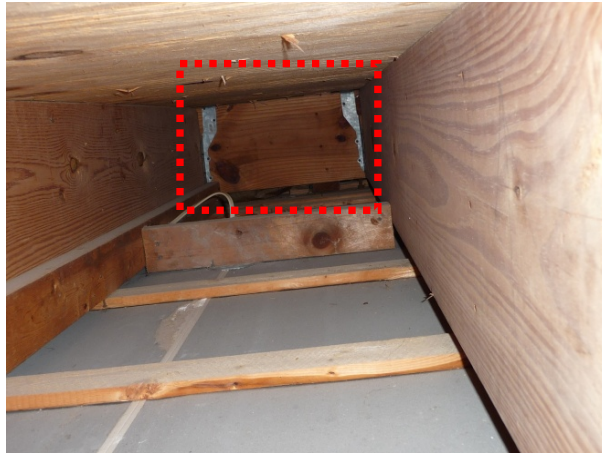
Figure 30. View from eave toward floor cavity shows pathway to floor under joist braced at back, which would be the ideal place for the air and thermal barrier in this construction.

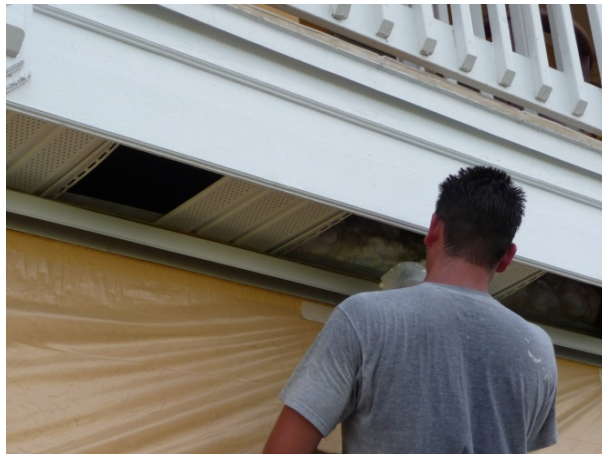
Figure 31. Opening to floor cavity is sealed by application of foam to create an insulating air barrier between each floor joist.

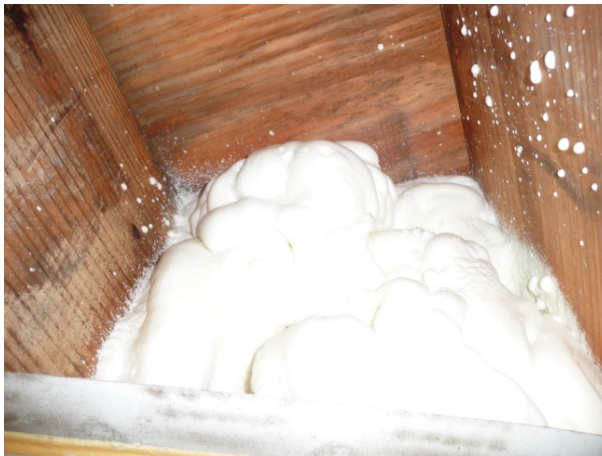
Figure 32. Floor joist cavity is sealed from vented eave.

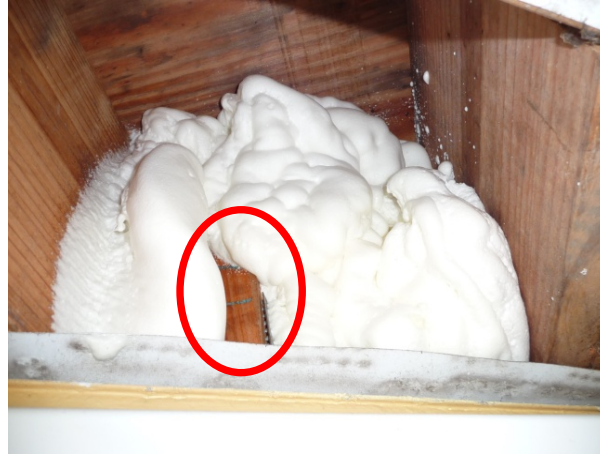
Figure 33. Spray foam expands considerably and conforms effectively around the end of a floor truss section within a floor joist.

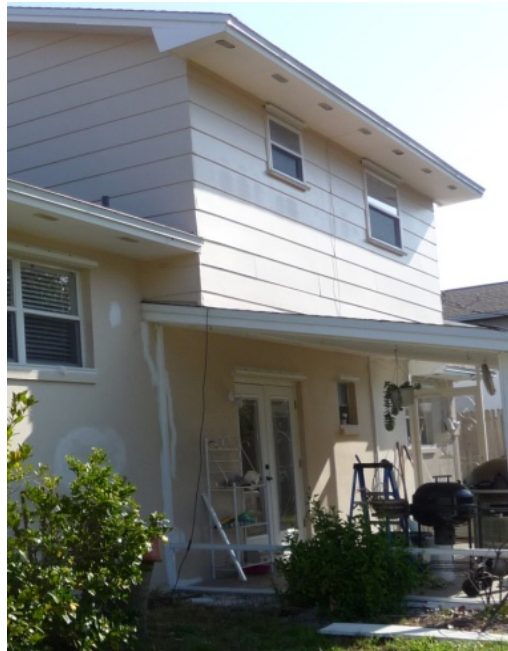
Figure 34. Second-story floor cavity has cantilevered section that was vented on the back side of home.

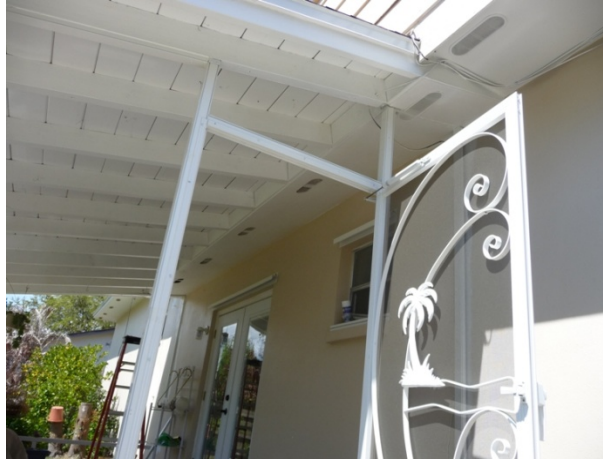
Figure 35. Oval shaped soffit vents can be seen on the underside of cantilevered floor section.

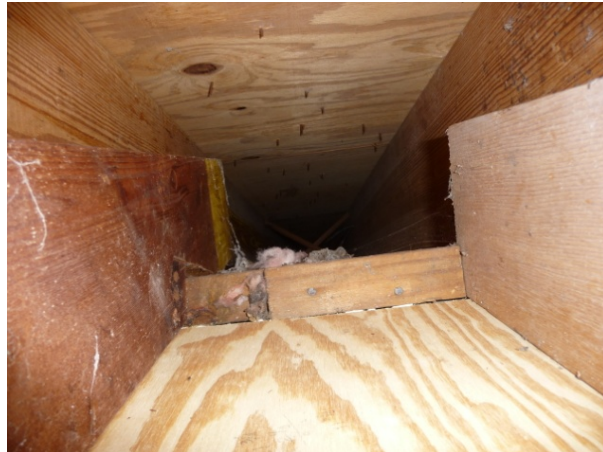
Figure 36. Connection from vented eave to floor cavity where no insulation was found.

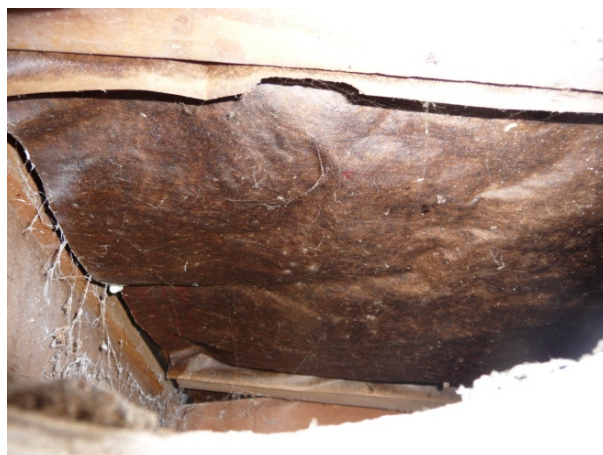
Figure 37. Insulation batts were present in most of the eave areas providing some thermal protection for the floor above. However, because the batts did not fit tightly between the joists, they allow airflow to move into the floor cavity.

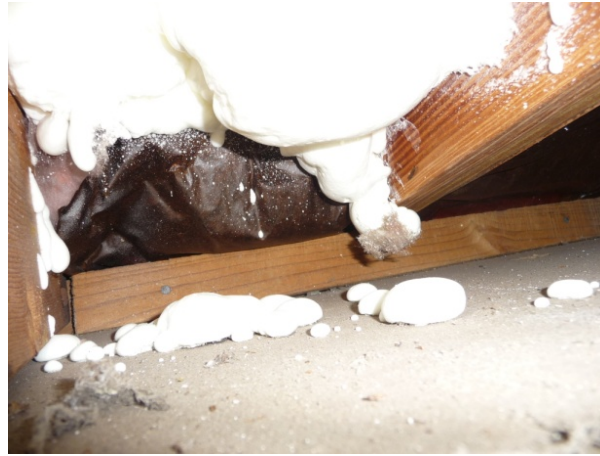
Figure 38. First, the foam spray gun is inserted into the soffit vent hole to apply foam insulation to the floor deck above, beyond the top of the exterior wall.

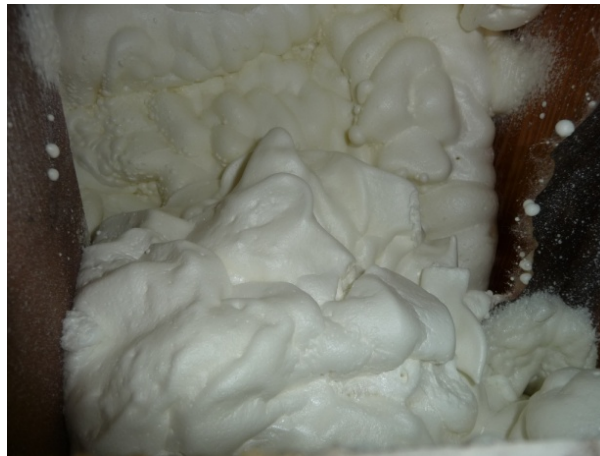
Figure 39. The next step is to complete the seal from floor deck vertically down to the bottom of the soffit surface. This is done between each joist section.

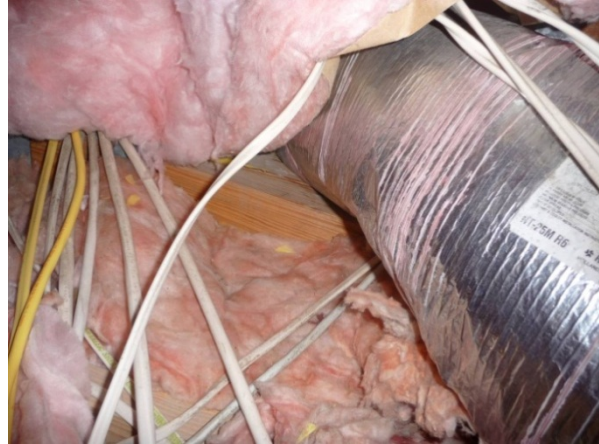
Figure 40. Batt placed against supply duct by homeowner.

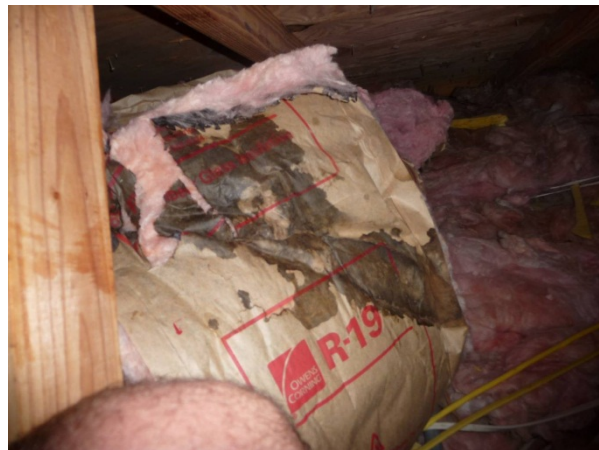
Figure 41. Batt pulled away from duct shows it is soaked where dark areas are seen on paper facing.

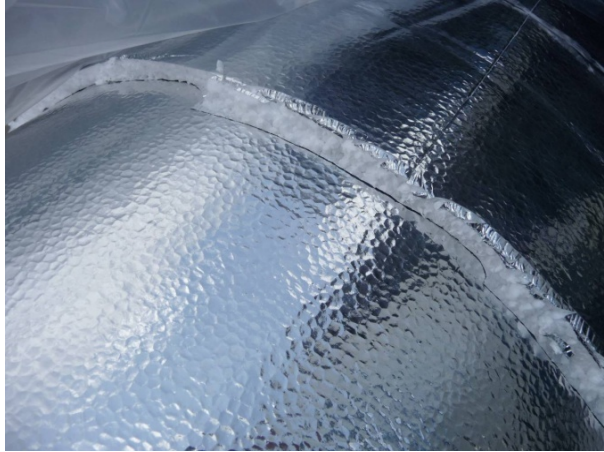
Figure 42. 3/8-in. beadboard insulation with foil face on one side and plastic film on the other.

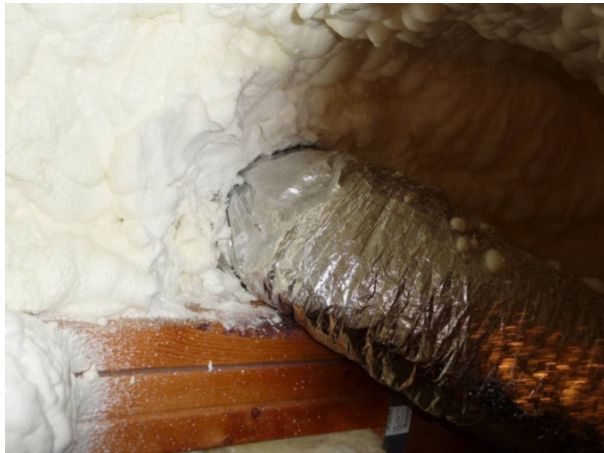
Figure 43. Supply duct from attic into floor cavity has insulation wrapped around duct before blown foam is applied.

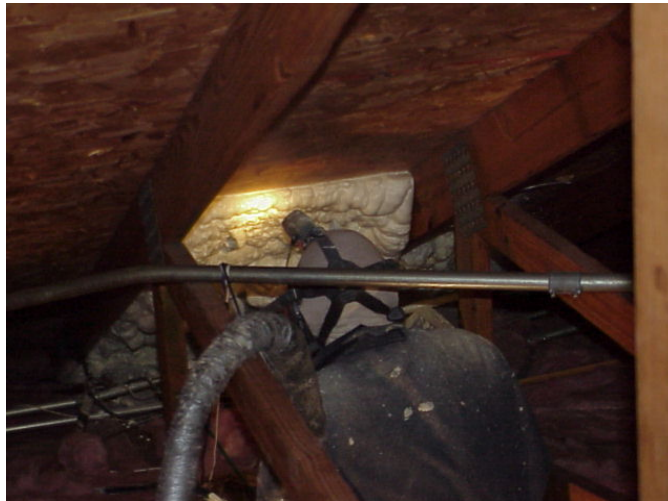
Figure 44. To encapsulate the attic space, spray foam is applied to vents and roof deck. Foam application starts low, at the top of exterior wall, sealing off the vented eave from the attic then continues to completely cover the entire roof deck.

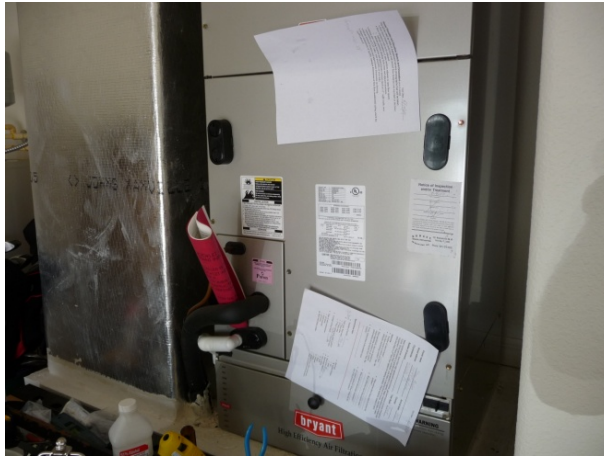
Figure 45. AHU panel leaks are strong enough to hold sheets of paper.

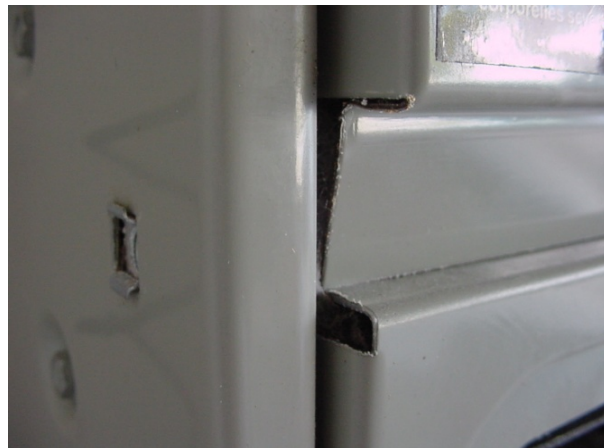
Figure 46. Close-up view of lower corner AHU panel leakage.

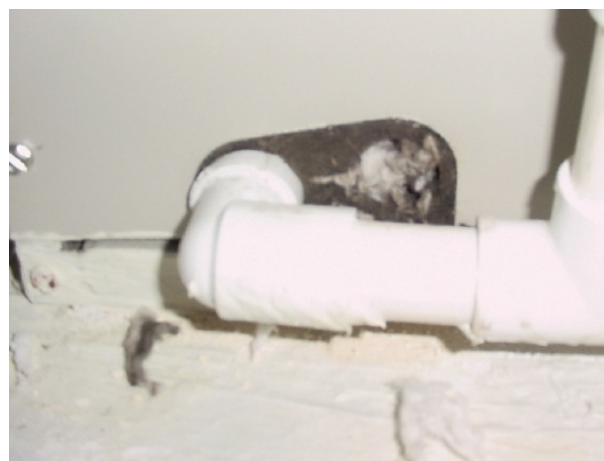
Figure 47. Loose-fill insulation has been sucked into condensate drain penetration leak.

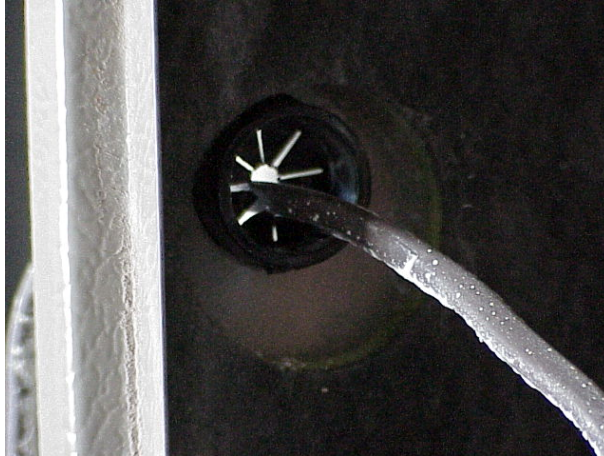
Figure 48. Leaky thermostat wire penetration.

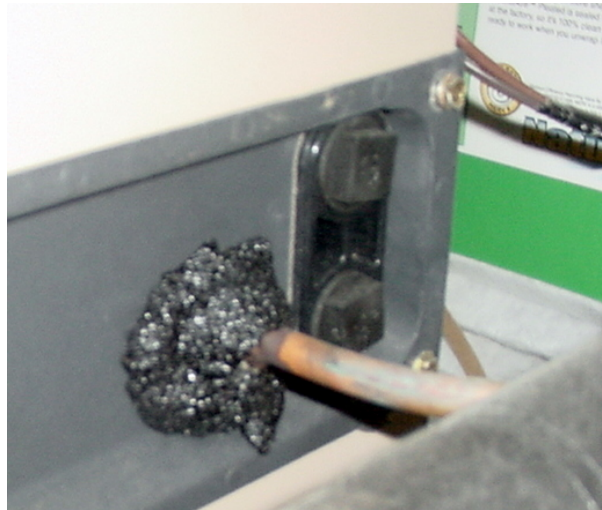
Figure 49. Black cork tape applied around refrigerant line penetration.

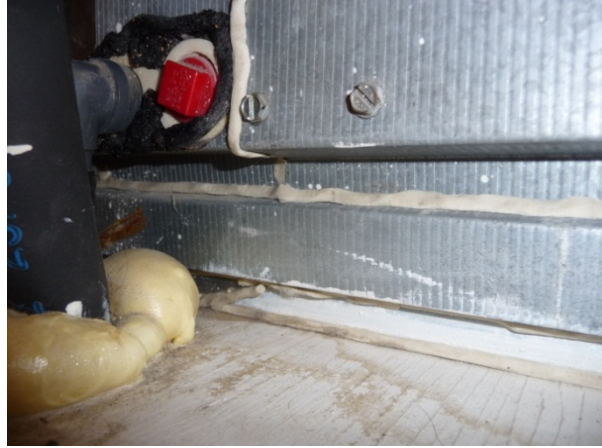
Figure 50. Black cork tape applied around condensate line penetrations and rope putty applied over seams. Expanding foam seals refrigerant line penetration into return support plenum.

Sealants applied at AHU service panels must be removable to allow access. Tapes are commonly used on panel seams, but may leave messy residues over time. Furthermore, tapes do not effectively seal penetrations. HVAC cork tape or putty is effectively seals around wiring and refrigerant line penetrations. Rope putty (found at hardware and home improvement stores) can be applied neatly over seams in thin strips and will not leave a residue when removed. Figures 49 to 52 show typical AHU sealing methods and materials.

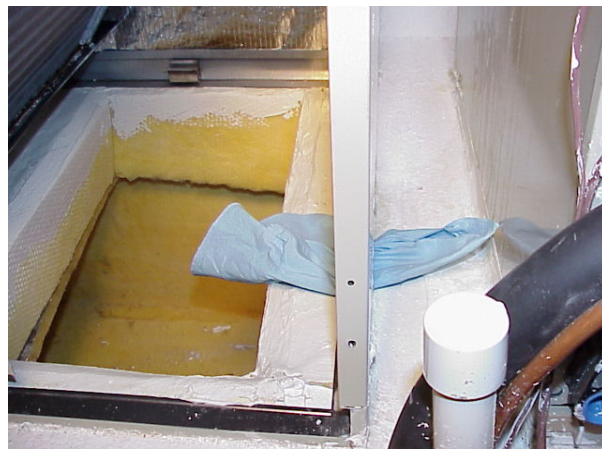
Figure 51. Blue cloth has been pulled under AHU cabinet to illustrate air pathway where the return plenum and the AHU join together.

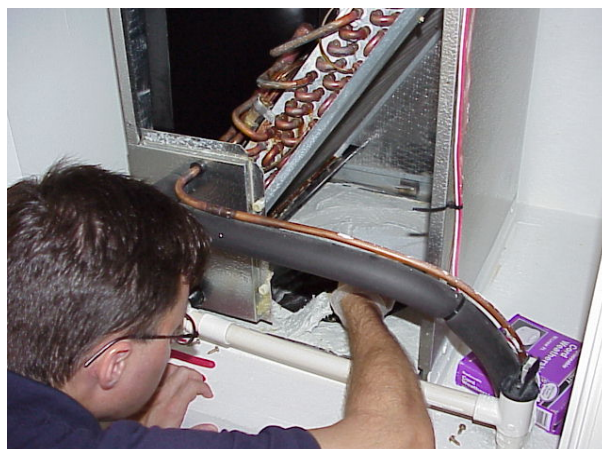
Figure 52. Duct mastic applied in a continuous seal from return duct air barrier to the AHU air barrier. Use care not to get mastic on the coil or any removable panel seam.

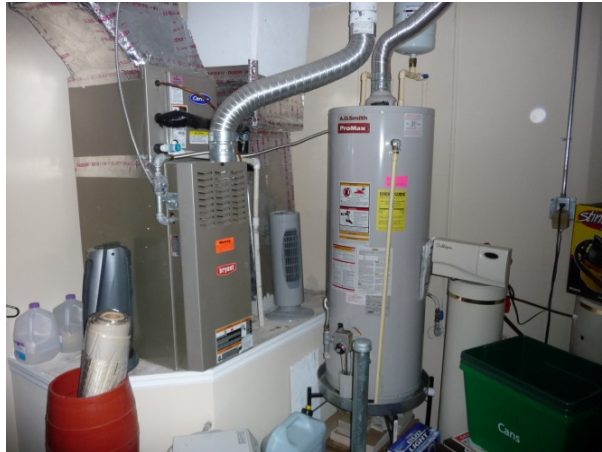
Figure 53. A gas furnace is located on a support platform used as the return plenum located inside a garage next to a gas water heater. Return leakage can depressurize the garage and interfere with proper venting of these atmospherically vented gas appliances.

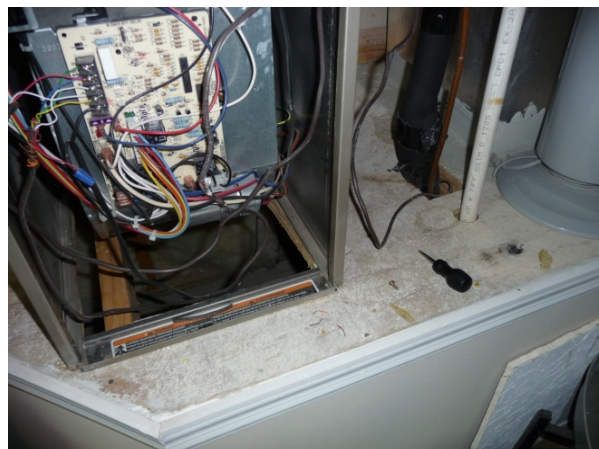
Figure 54. Front panel of furnace is removed for inspection inside the return plenum. Because of limited plenum access, part of the drywall has to be removed to provide access for plenum sealing.

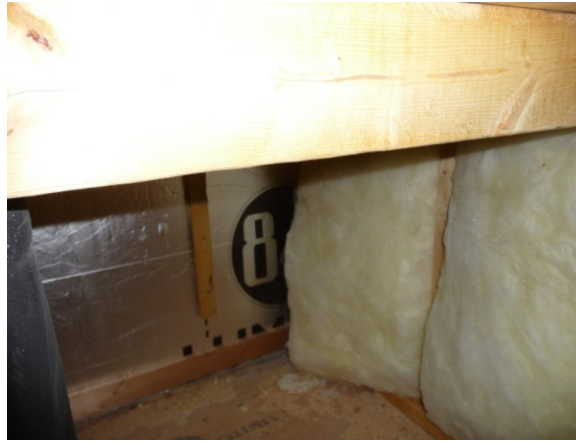
Figure 55. View inside a return plenum located in a second floor closet shows lack of effective duct air or thermal barrier. Attic air could be drawn down leaks in wall cavities and through the floor cavity, which is also well connected to an attic space.
