Managing the Drivers of Air Flow and Water Vapor Transport in Existing Single-Family Homes

J. Cummings, C. Withers, E. Martin, and
N. Moyer

*Building America Partnership for
Improved Residential Construction*

Revised October 2012

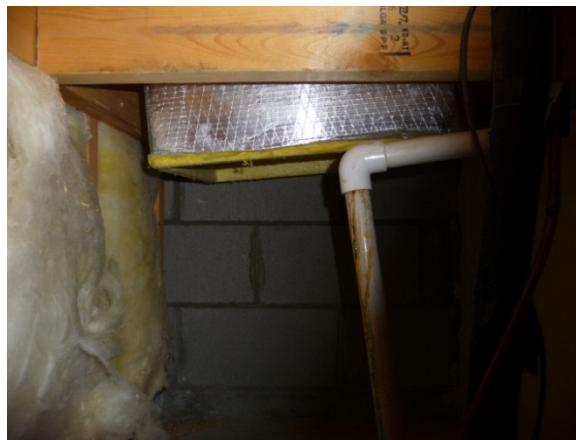
Figure 56. View inside a return plenum located in a garage. Air leaks are drawn primarily from the garage, but a small portion comes from the attic down through the wall cavity where the insulation is located. The block wall in the background is an exterior wall.

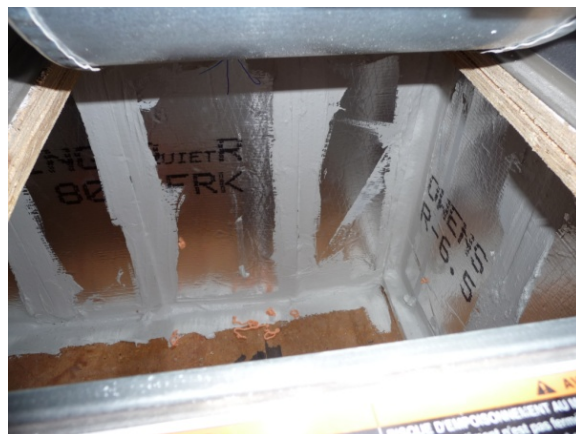
Figure 57. View inside a support platform sealed using ductboard with foil (which is the air barrier) facing inward so seams can be sealed at the foil air barrier with mastic.

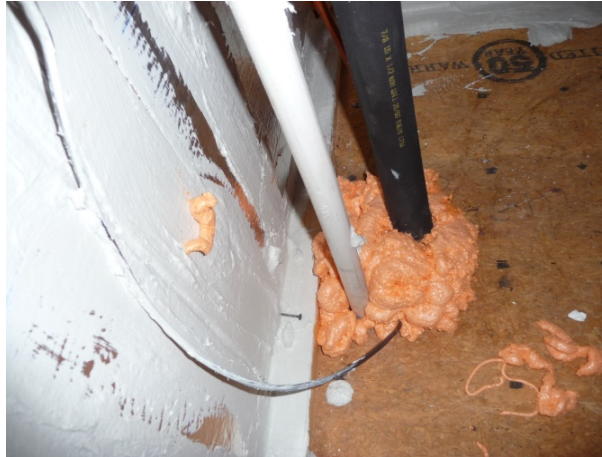
Figure 58. Penetrations in the return plenum are sealed using expansive foam.

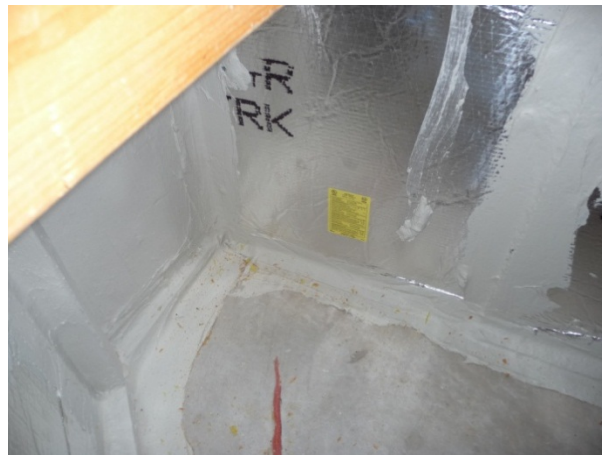
Figure 59. All seams in this support platform return plenum have been sealed using mastic.

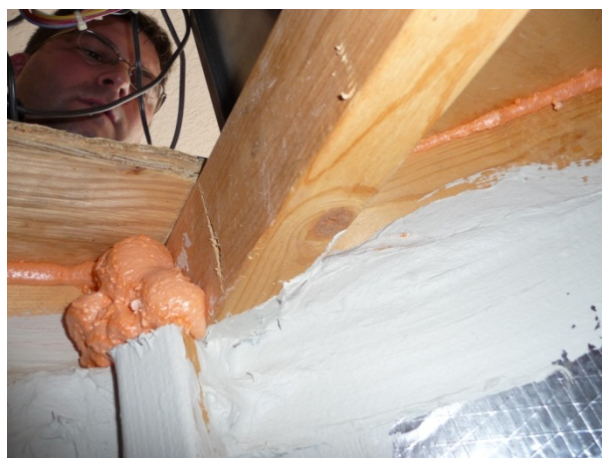
Figure 60. All penetrations and junctions between duct board, structural, and panel components of the return plenum have been sealed.

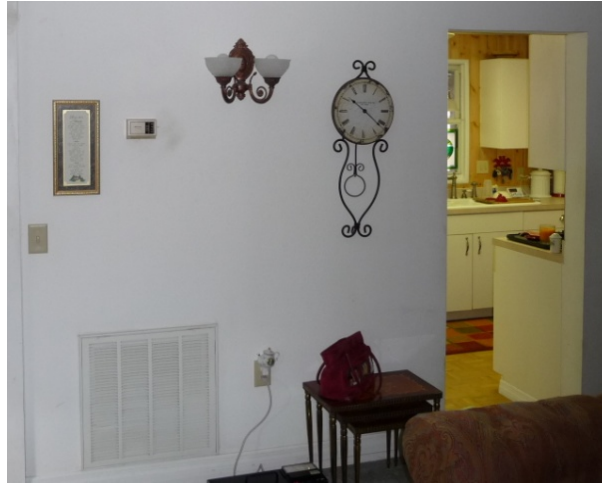
Figure 61. The interior of a return plenum, located under an AHU, can be accessed through the return grille for inspection.

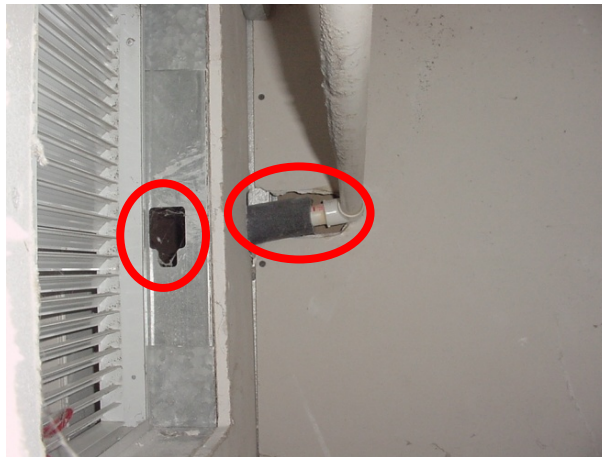
Figure 62. Grille transfer through a wall has leakage into wall cavities that need to be sealed.

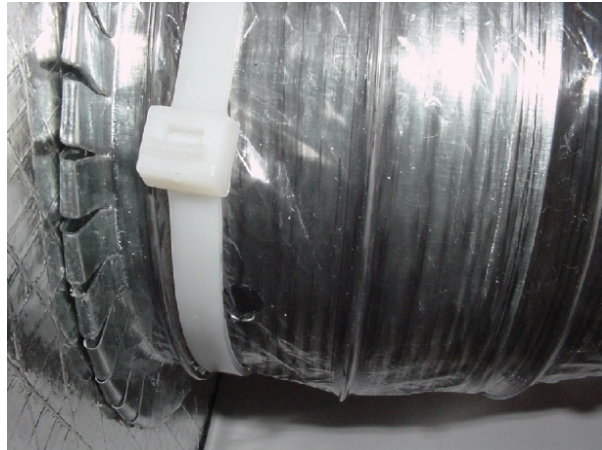
Figure 63. To make this repair, pull back the outer insulation jacket of the flex duct to expose the inner duct connection. Remove the strap and inner duct from metal collar. Remove any loose tape.

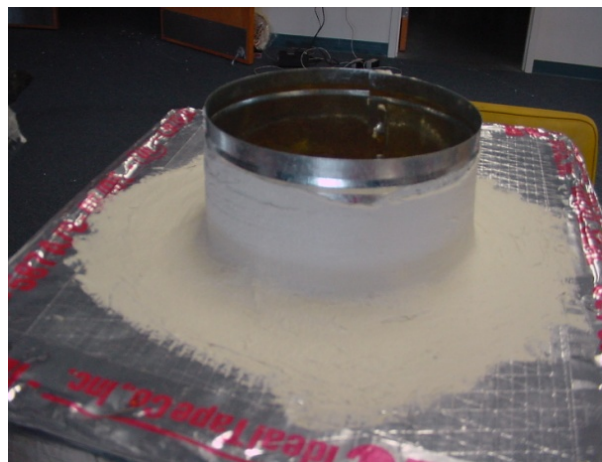
Figure 64. Apply mastic from the foil surface of duct board over and around the metal collar. Mastic can be applied over any securely bound tape.

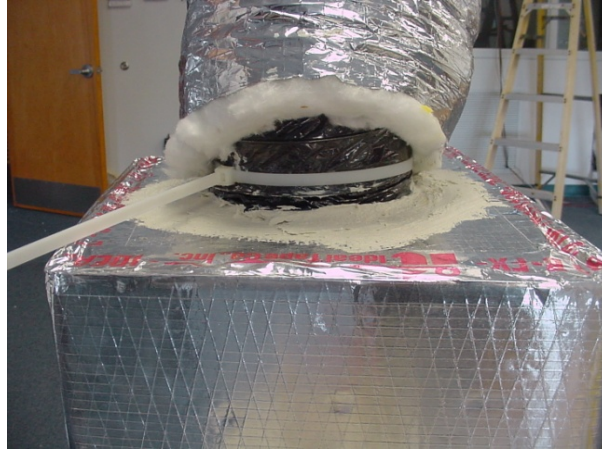
Figure 65. While the mastic is still moist, pull the inner duct liner over the metal collar, then secure tightly with a strap. The strap will pull the inner liner into the mastic and thereby create an airtight seal.

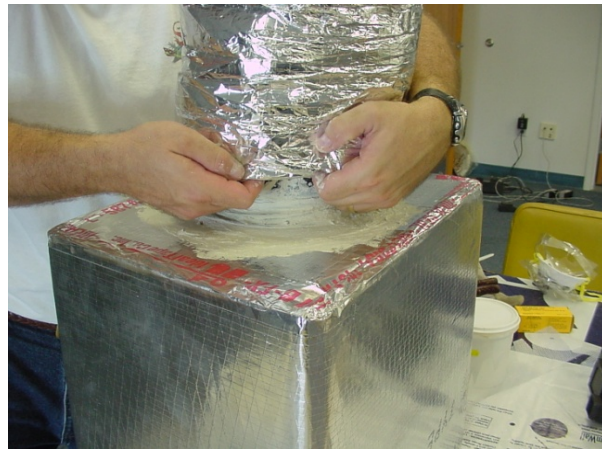
Figure 66. Finally, pull the insulation jacket over the duct inner liner and secure the outer jacket tightly against the foil surface of the duct board. If any sections of the inner duct remain exposed, this may result in unwanted energy losses and potentially moisture condensation when the system is cooling.

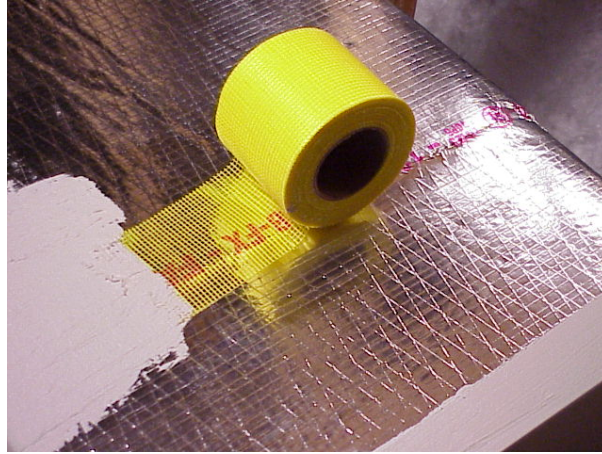
Figure 67. A gap between two sections of duct board was first covered using foil tape. Next, mesh is applied and coated with mastic that overlaps the mesh by 1-½–2 in. on each side.

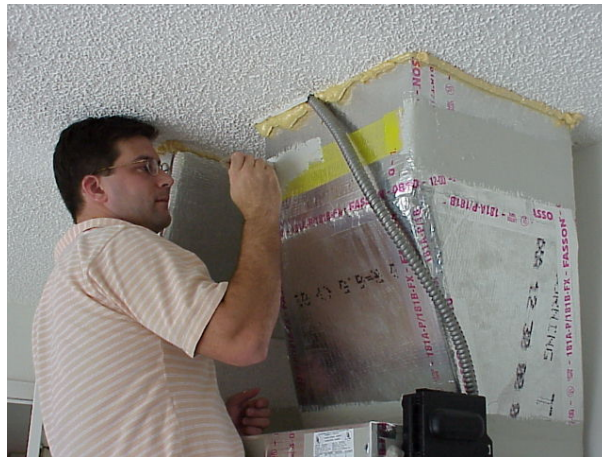
Figure 68. Supply plenum connection being sealed using foil tape, fiberglass mesh tape, and mastic.

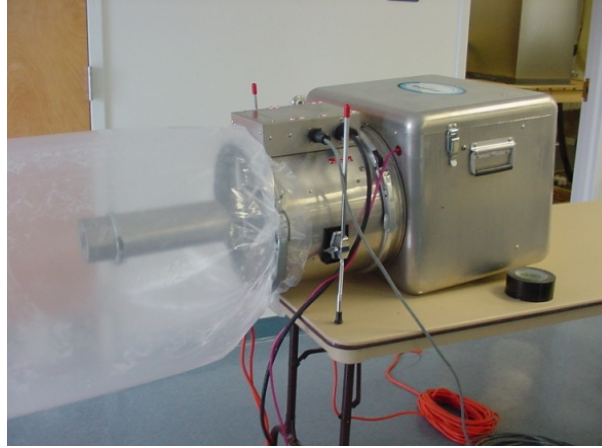
Figure 69. Patented sealing process injects an aerosolized material that builds up on leaks eventually sealing leaks up to about ¼ in. wide.

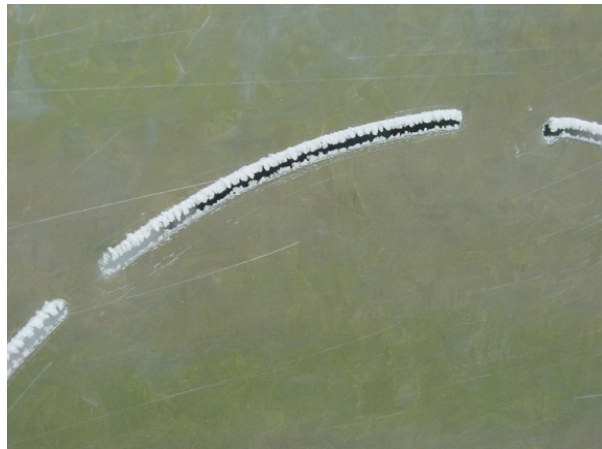
Figure 70. Sealant can be seen building on a demonstration leak.

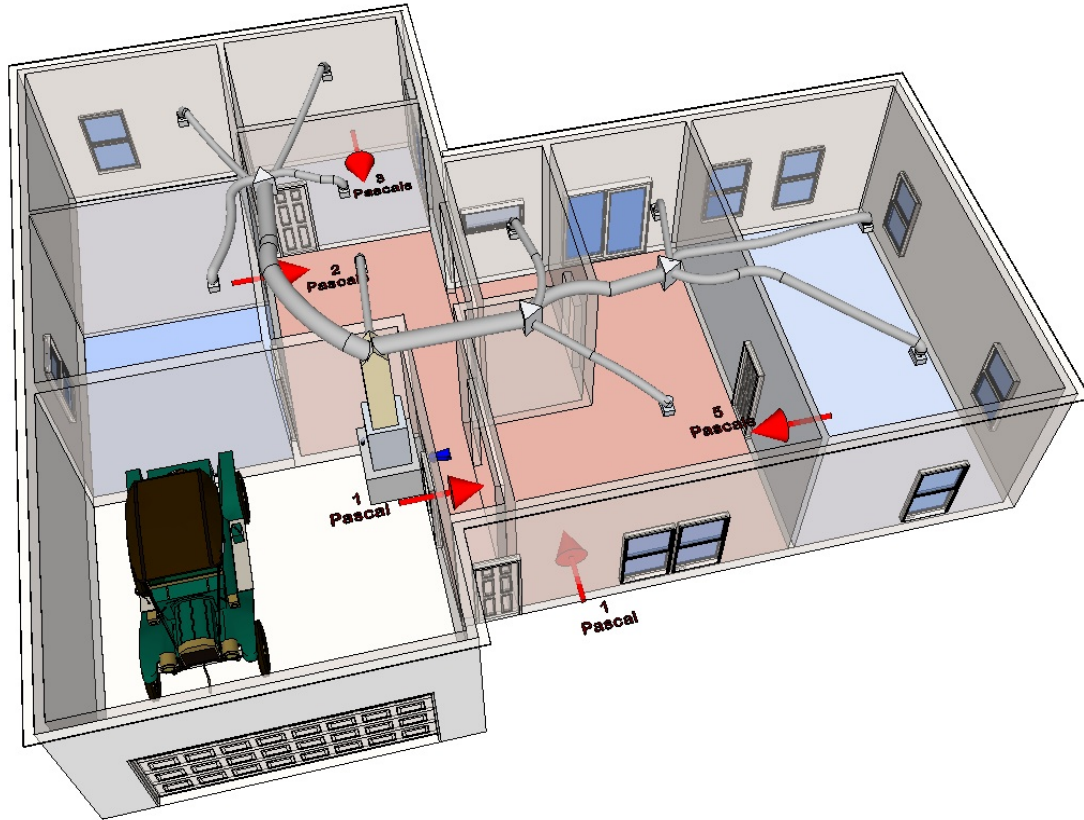
Figure 71. This house has supply ducts to each room, but only a central return grille. Door closure without adequate return air pathway results in negative pressure in the central zone wrt to outside and positive pressure in the closed rooms.

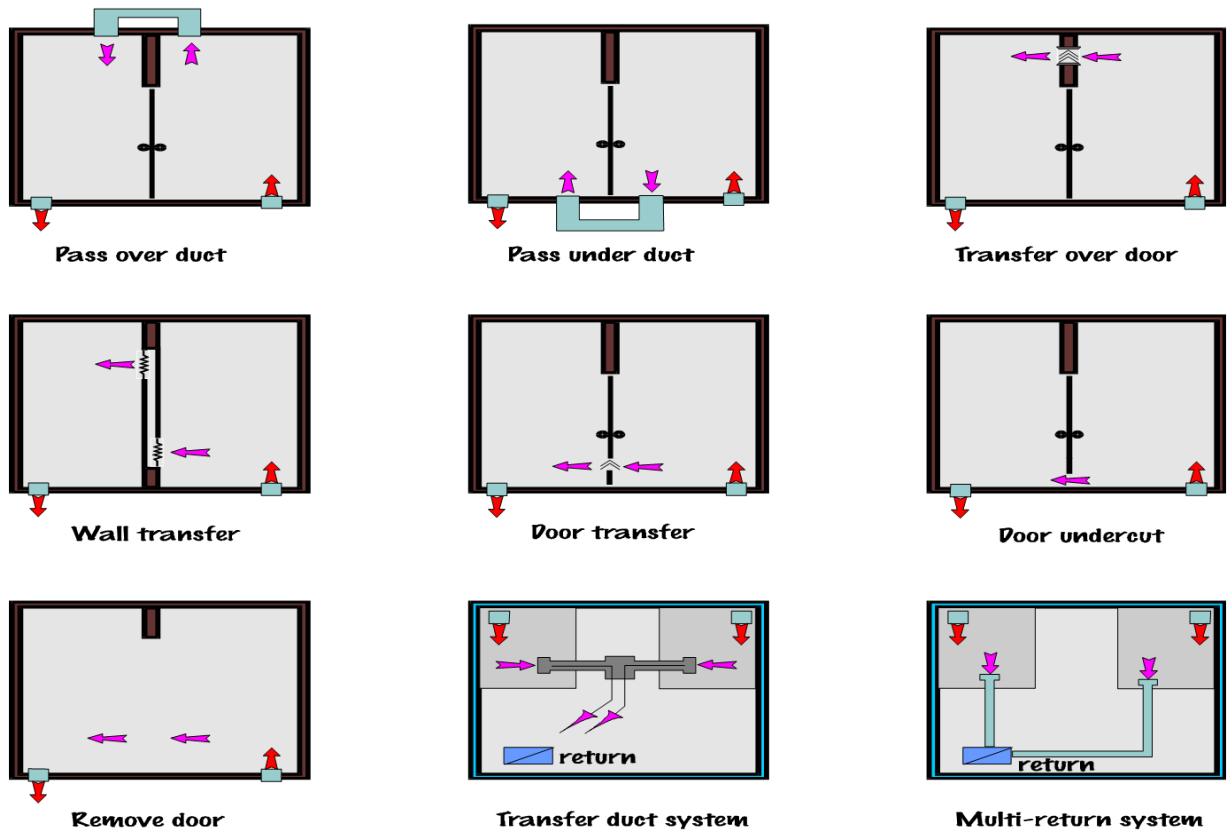
Pressure relief techniques

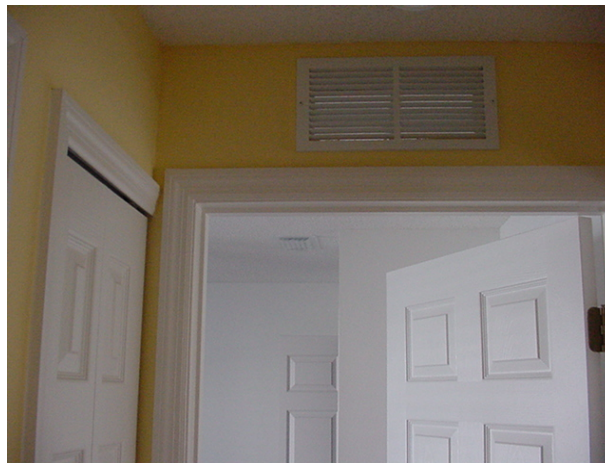
Figure 73. Through-the-wall return transfer from bedroom to hallway.

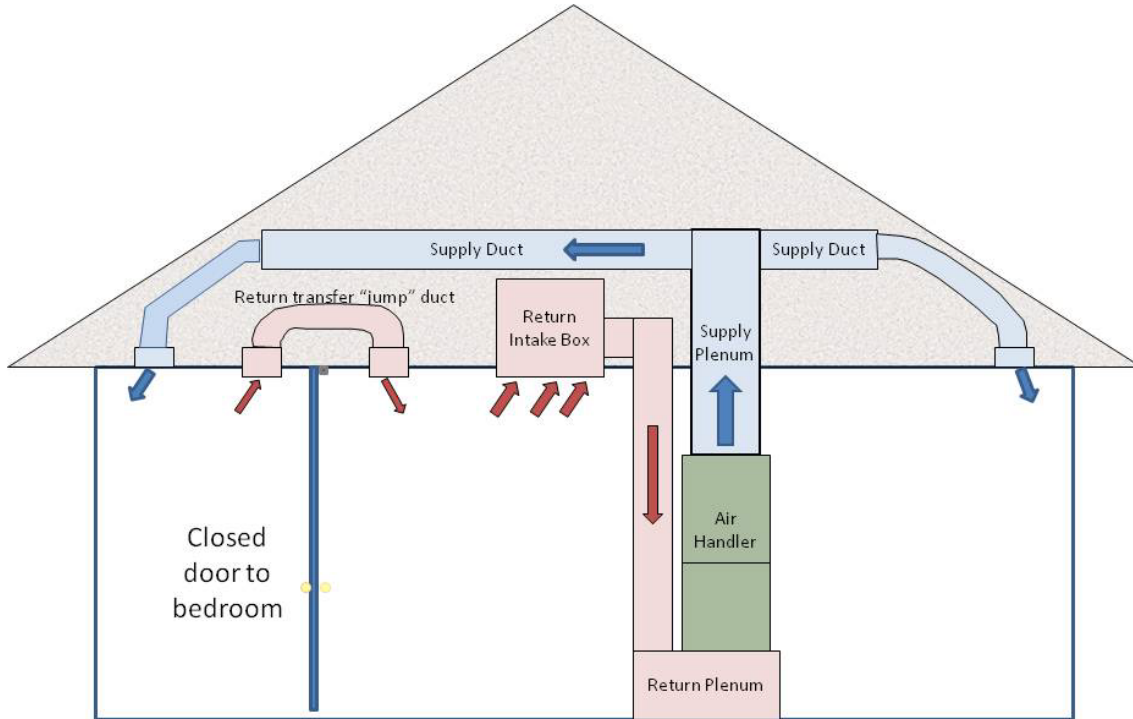
Figure 74. Illustration of return jump duct.
