Effects of Coatings on Water Intrusion and Strain Gauge Durability in Submerged Fatigue Conditions

Ariel Lusty and Paul Murdy

National Renewable Energy Laboratory

Conference Paper
NREL/CP-5700-90144
August 2024

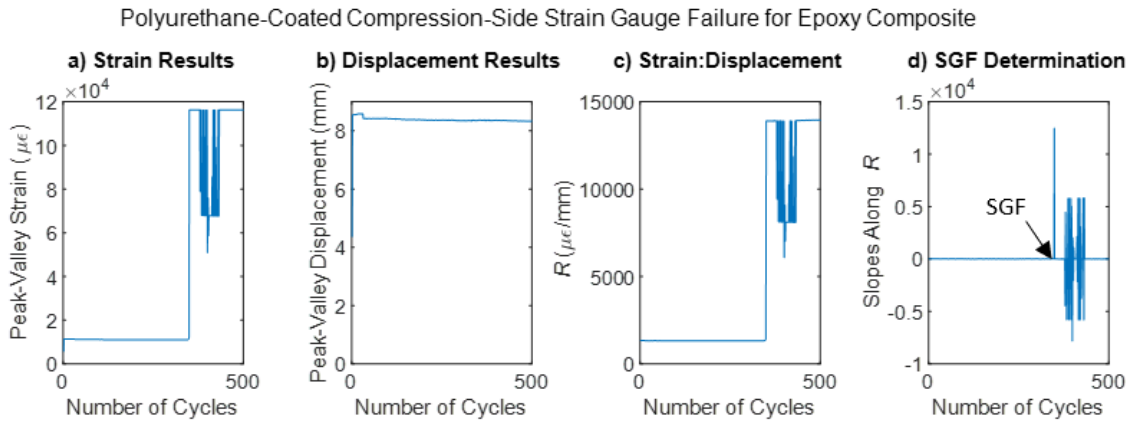
Fig. 3. Plots of a) peak-valley strain, b) peak-valley displacement, c) R , and d) the slopes along R . The number of cycles to SGF was 346 and was determined by the initial spike in plot d). SGF occurred at a peak-valley strain of $1.5 \times 10^4 \mu\epsilon$ and a peak-valley displacement of 8.34 mm.

Cycles to SGF were compared for the two coatings and three composite types. Strain gauges failed prior to composite failure for each test. SGF was calculated in two steps. First, the ratio R of peak-valley strain and peak-valley displacement was calculated. Then, the slopes of R between each cycle were calculated and plotted. Strain gauges were considered failed when the plot of the slopes of R spiked (Fig. 3). Strain values past SGF were considered inaccurate.

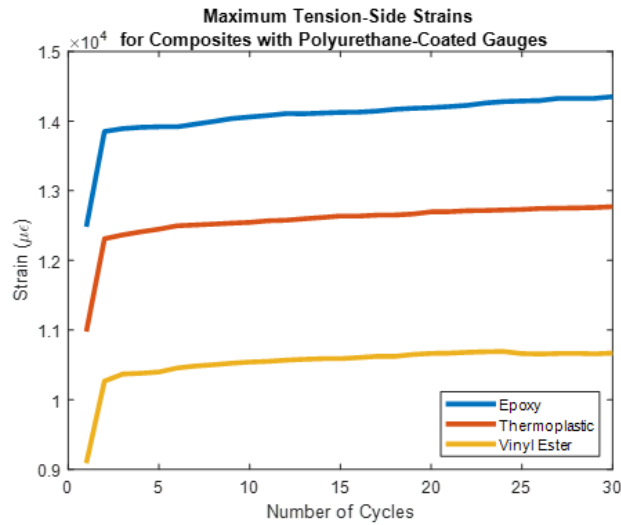
Fig. 4. Maximum strain values for each submerged composite type for the first 30 cycles.

There was a significant difference in the cycles to SGF results between thermoplastic and epoxy composite types, indicating that strain gauge durability was more affected by the composite type than the coating used. The variation in strain gauge durability among composite types could be explained by the differences in resulting strain values among composite types (Fig. 4), as the epoxy had both the lowest strain gauge durability and the highest strains. SGF likely occurred when the metal in the strain gauges cracked (Fig. 5).

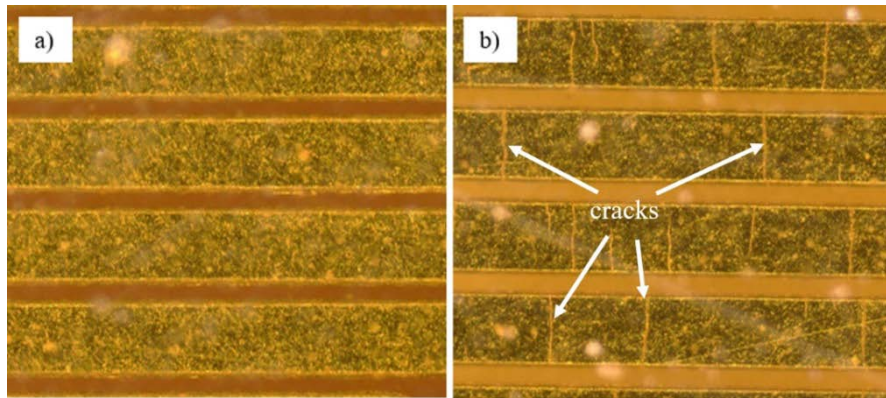
Fig. 5. Optical microscopy images ($300\times$ magnification) of polyurethane-coated strain gauge Constantan foil resistive grid (a) before and (b) after submerged fatigue testing. The white arrows in (b) point to some of the cracked Constantan locations.
