# Silver/Glass Mirrors for Solar Thermal Systems

SERI/SP-271-2293

June 1985

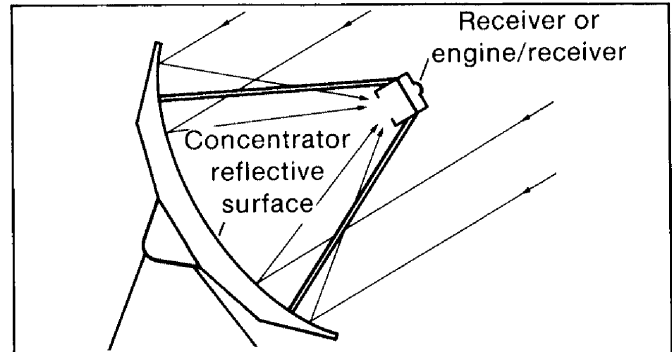
Figure 1-2 Parabolic Dish

Solar thermal mirrors are used in parabolic troughs, parabolic dishes, spherical bowls, and heliostats. The parabolic trough (Figure 1-1) concentrates the sun's rays along a line. The parabolic dish (Figure 1-2) concentrates the sun's rays toward a point. The spherical bowl (Figure 1-3) concentrates light along a rod. The compound parabolic concentrator (Figure 1-4) funnels light from a large aperture into a smaller receiver. The heliostat field employs a vast number of reflectors (flat or minimally parabolic) to focus on a central receiver, as shown in Figure 1-5.

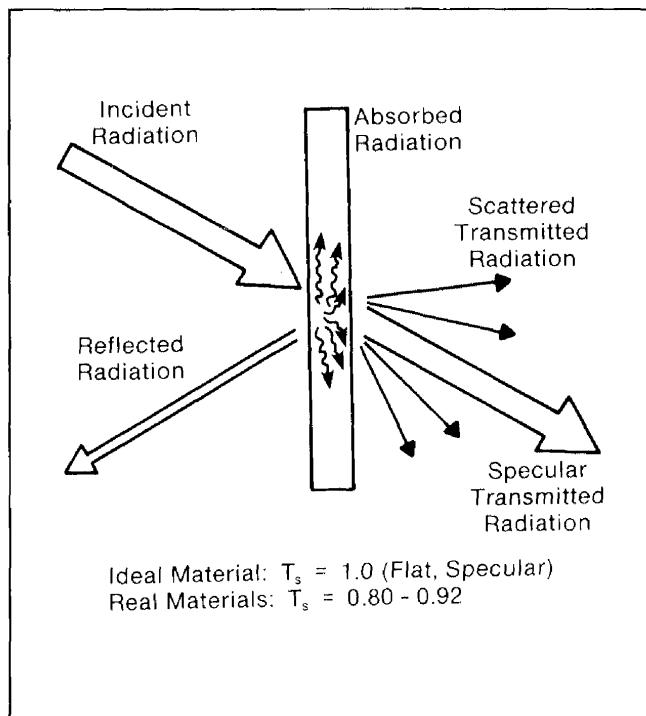
Figure 2-1 Optical Properties of Transmitters (Lind 1981)

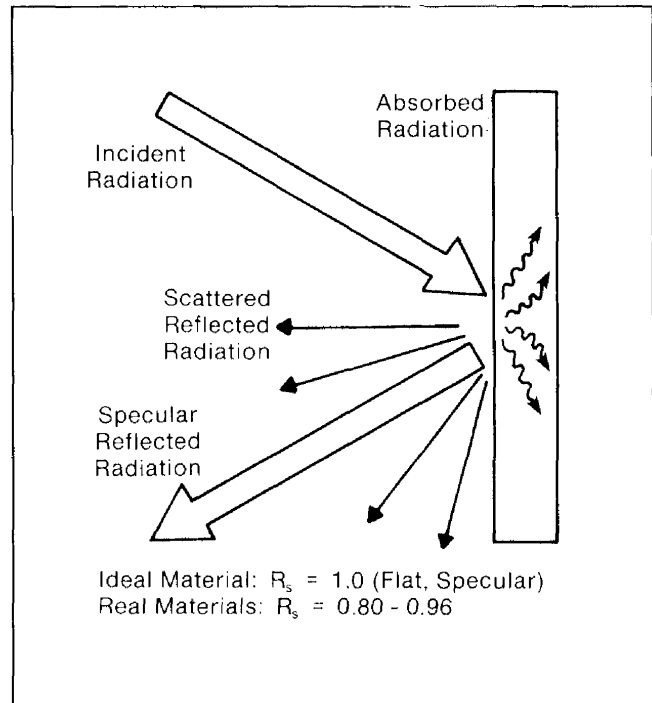
Figure 2-2 Optical Properties of Reflectors (Lind 1981)

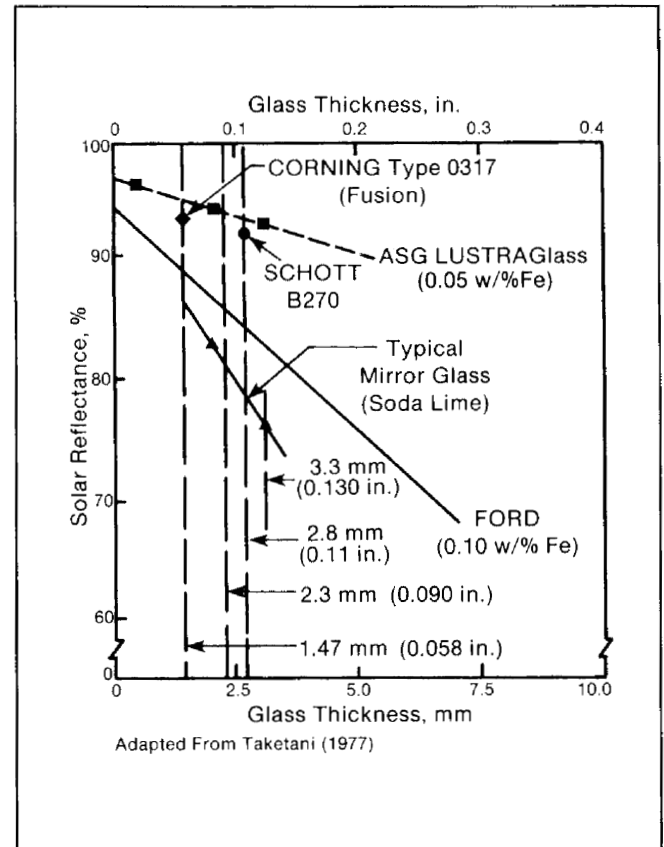
Figure 2-3 Solar Reflectance versus Glass Thickness for Typical Types of Second-Surface Glass Mirrors (Bouquet 1980)

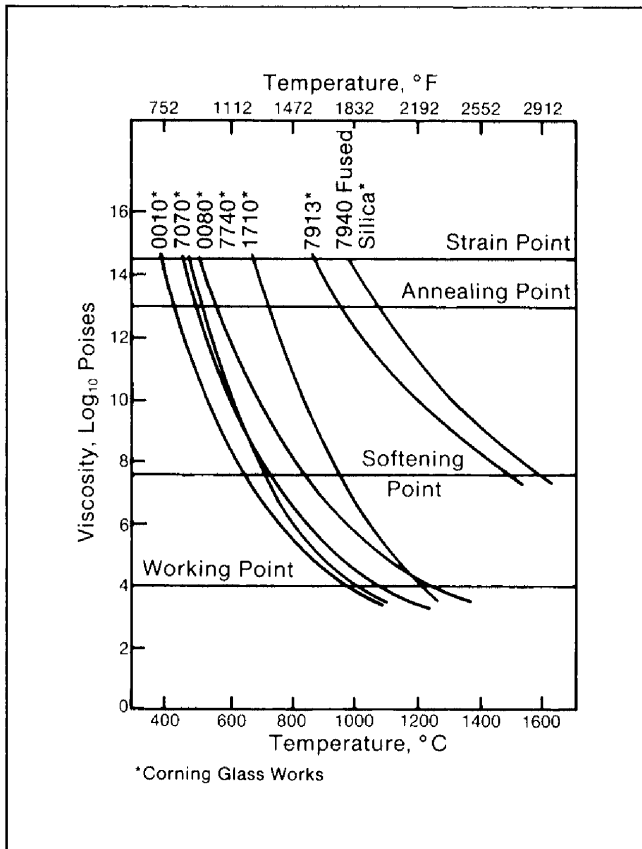
Figure 2-4 Viscosity - Temperature Curves (CIT 1978)

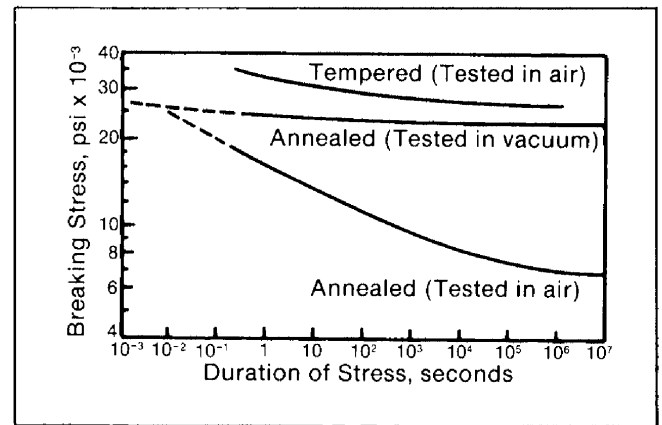
Figure 2-5 Stress Time Characteristics of Glass (Bouquet 1979)

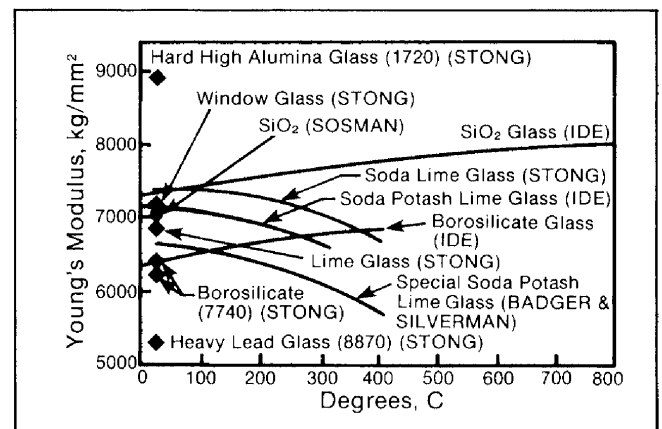
Figure 2-6 Young's Modulus of Various Glasses (Bouquet 1979)

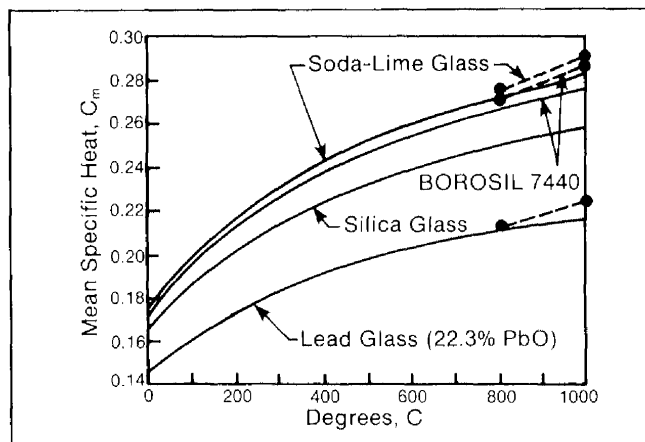
Figure 2-7 Mean Specific Heat of Glasses (Bouquet 1979)

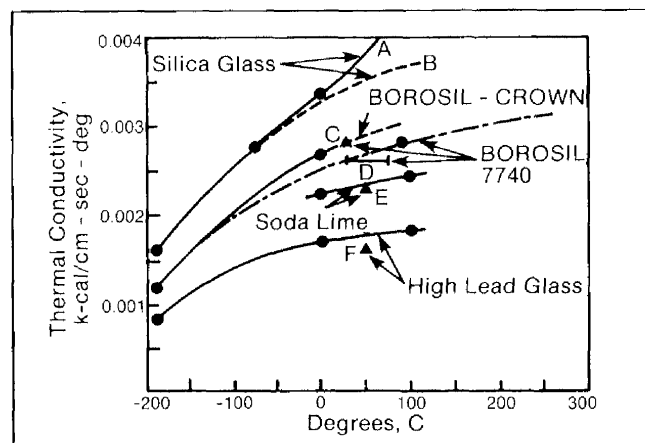
Figure 2-8 Thermal Conductivity of Glasses (Bouquet 1979)

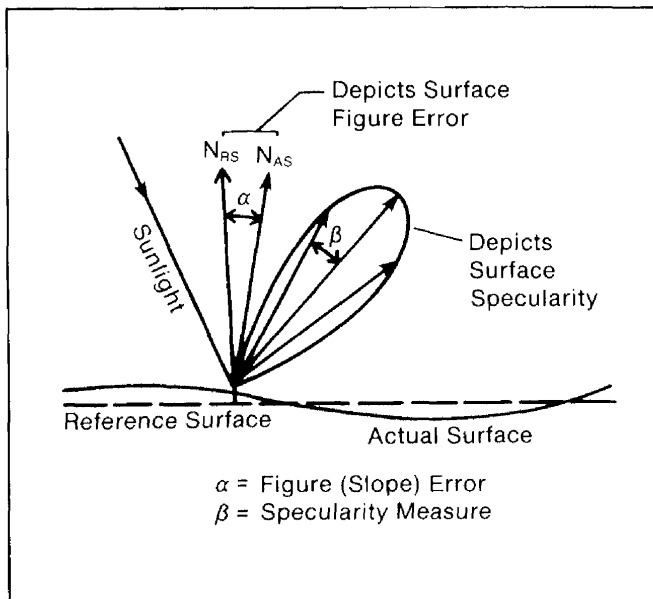
**Figure 2-9 Schematic Representation of a Mirror Surface Showing the Difference Between Figure (Slope) Errors and the Mirror Specularity** (Pettit and Roth 1980)

Two measures of surface irregularities that cause loss of redirected sunlight from a solar mirror are surface specularity and surface figure error. Specularity measures the scattering from surface variations with a characteristic spacing of less than approximately 1 mm, whereas scattering from surface contour (slope) variations on a scale greater than approximately 10 mm is referred to as the surface figure error.

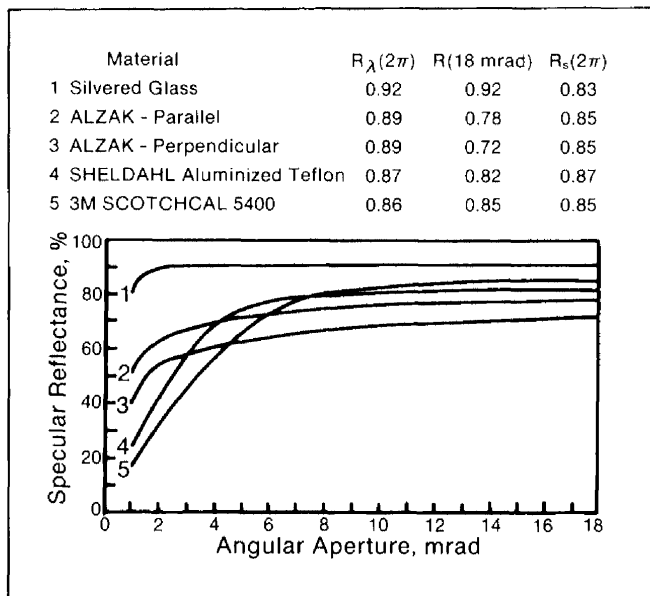
**Figure 2-10 Specular Reflectance Properties for Several Solar Mirror Materials.** The table lists the hemispherical reflectance  $[R_\lambda(2\pi)]$  and the specular reflectance at 18 mrad  $[R(18 \text{ mrad})]$  measured at 500 nm. Also listed is the solar-weighted hemispherical reflectance  $[R_s(2\pi)]$  (Pettit and Roth 1980)

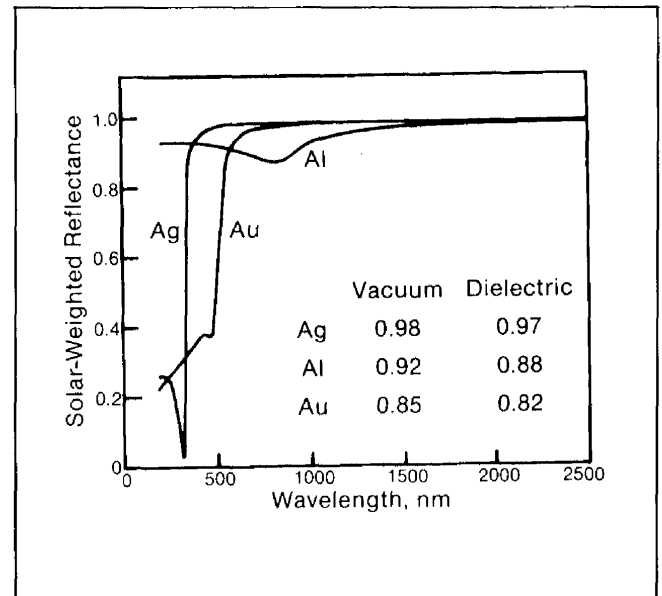
**Figure 2-11 Reflectance Properties of Silver (Ag), Aluminum (Al), and Gold (Au) as a Function of Wavelength for the Metal/Vacuum Interface.** The table lists the solar-weighted reflectance for a metal/vacuum interface and a metal/dielectric interface with an assumed index of refraction of 1.5 (Pettit and Roth 1980)

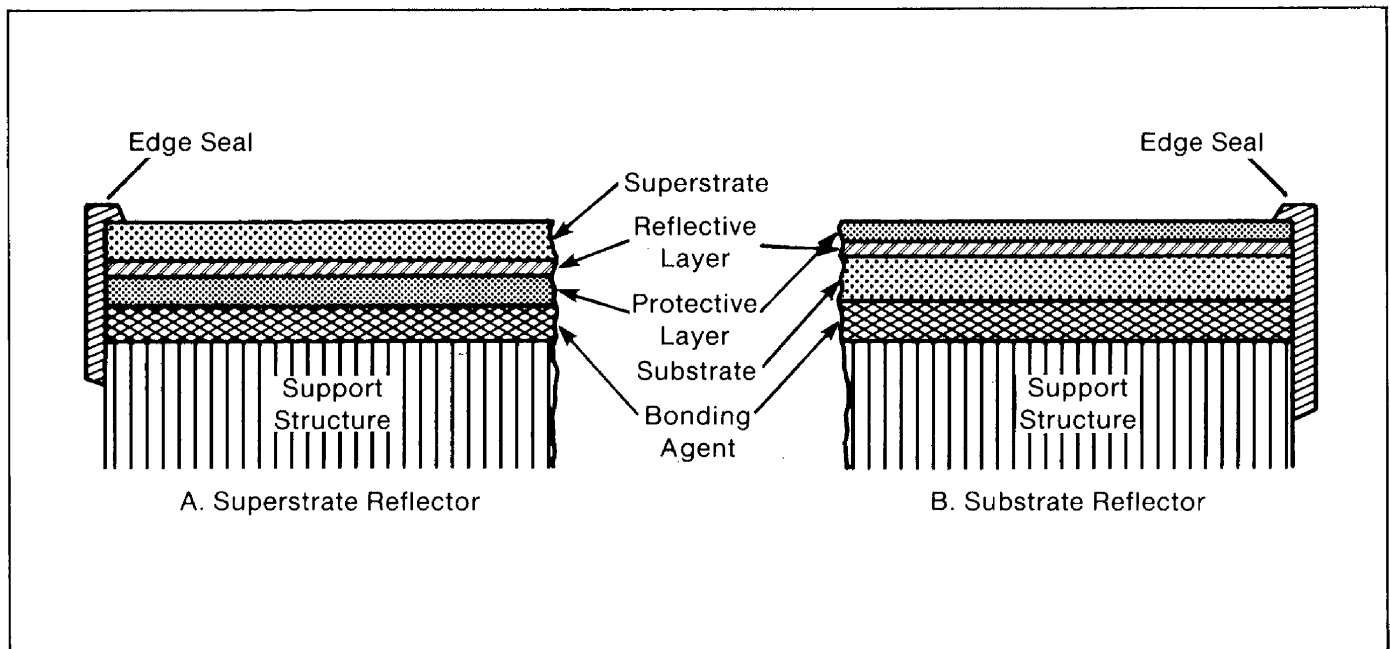
Figure 2-12 Examples of Typical Reflective Surfaces (Bouquet 1980)

The chemical and physical processes involved in the preparation and degradation of silver/glass mirrors are discussed in this chapter. As illustrated in Figure 2-12 (superstrate) in Chapter 2, the silver/glass mirror consists of a multilayer stack of glass, silver, and a protective backing. The protective backing may also consist of two or more multilayers. The most important stability issues for a multilayer configuration are interface reactions, adhesion, and the choice of the protective backing. In the descriptions of possible causes of mirror degradation in this chapter, reference is made to various analytical techniques to discern the causes. A brief description of the purpose of the techniques is contained in Table 3-1.

The life-cycle cost of a particular mirror design depends on the durability of the reflector assembly, such as shown in Figure 2-12 in Chapter 2. The purpose of sandwiching the reflective material into a multilayer stack is to limit reactive constituents from reaching the silver; thus, increasing the performance lifetime of the mirror. Mirror durability, therefore, depends on the materials used to form the multilayers and the environmental exposure parameters. The degradation problems associated with multilayer stacks clearly depend on the ability of the glass and protective backing to exclude reactive materials, the ability of the manufacturer to exclude reactive impurities during manufacture, and the rate of interfacial processes connected with the materials used; e.g., interdiffusion and ion exchange.

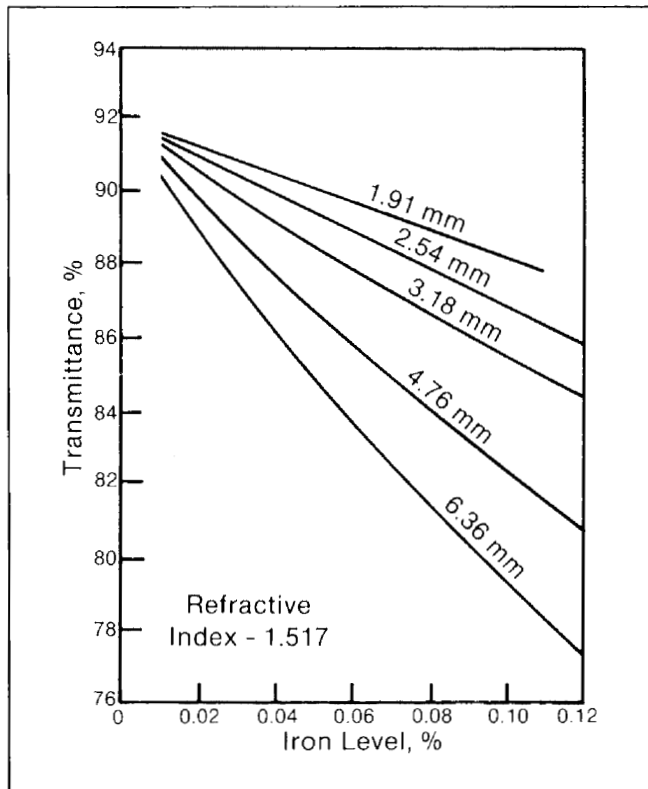
**Figure 2-13 Solar Transmittance as a Function of Iron Content and Glass Thickness** (Bouquet 1979)

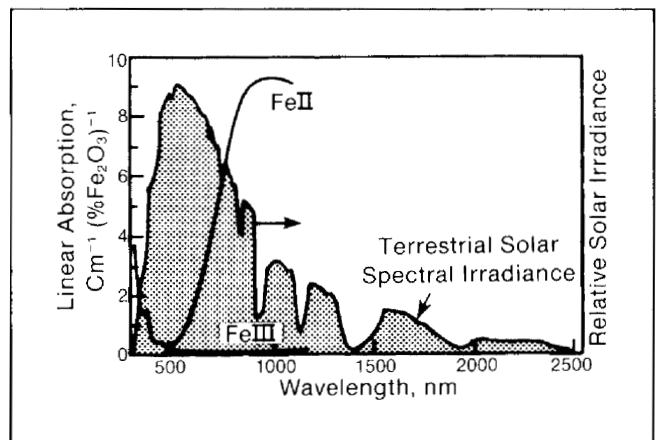
**Figure 2-14 Absorption Coefficients of Fe<sup>-2</sup> and Fe<sup>-3</sup> in Soda-Lime Glass** (The shaded curve is the relative spectral solar irradiance) (Coyle 1981)

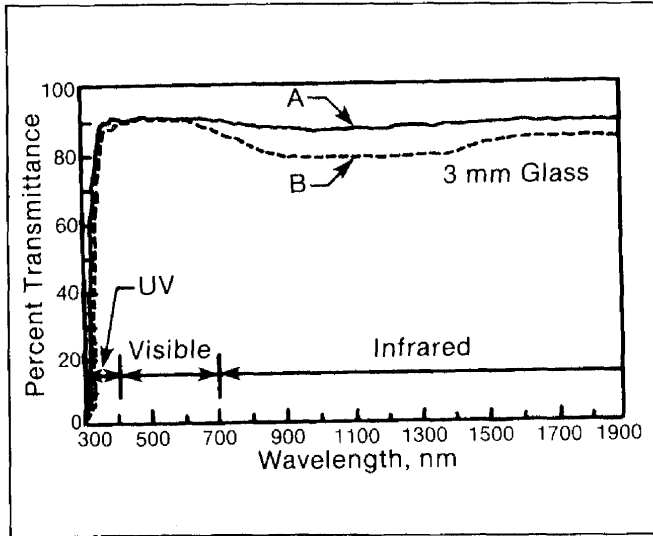
Figure 2-15 Transmittance for Low-Iron, 3-mm Glass (A) and Normal 3-mm Glass (B) (Goodyear 1980)

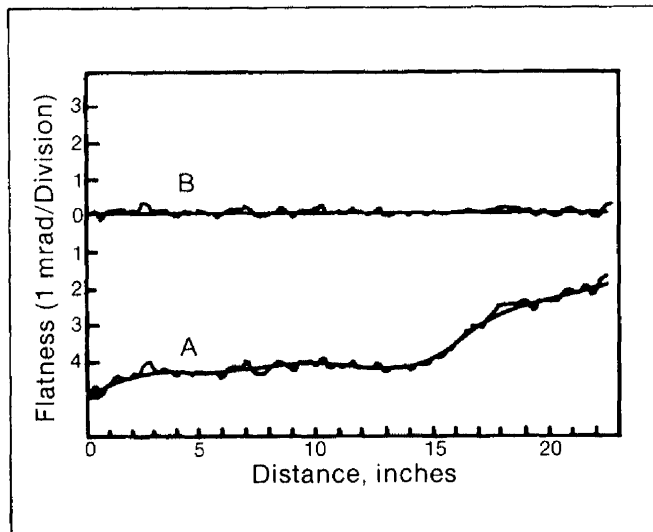
Figure 2-16 Flatness of 3-mm Glass as Measured by Laser Scan at Battelle Pacific Northwest Laboratories. (Glass for Curve A is not corrected for bow; that for Curve B is corrected for bow.) (Goodyear 1980)

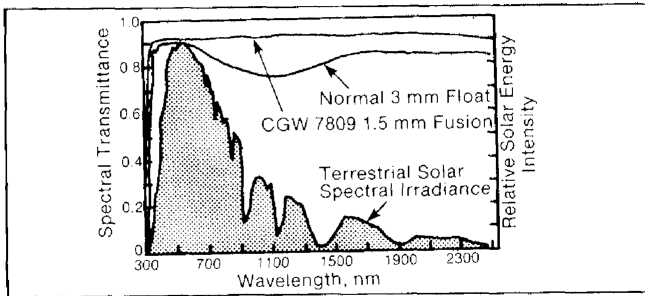
Figure 2-17 Transmittance in Solar Spectrum of CGW-7809 Fusion and Soda-Lime Glass (Coyle and Livingston 1981)

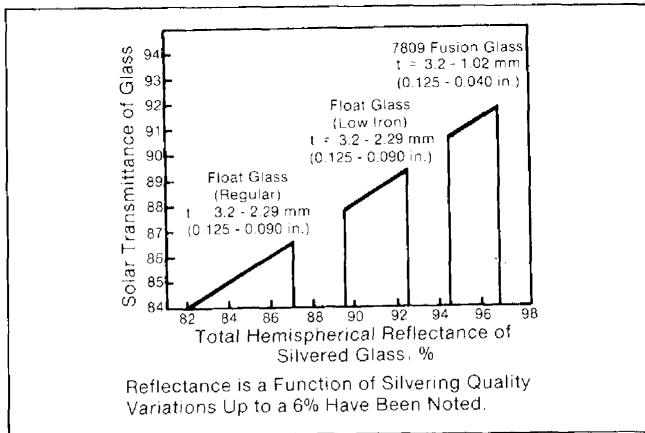
Figure 2-18 Solar Reflectance of Second-Surface Silvered Mirrors on Different Glasses (Coyle and Livingston 1981)

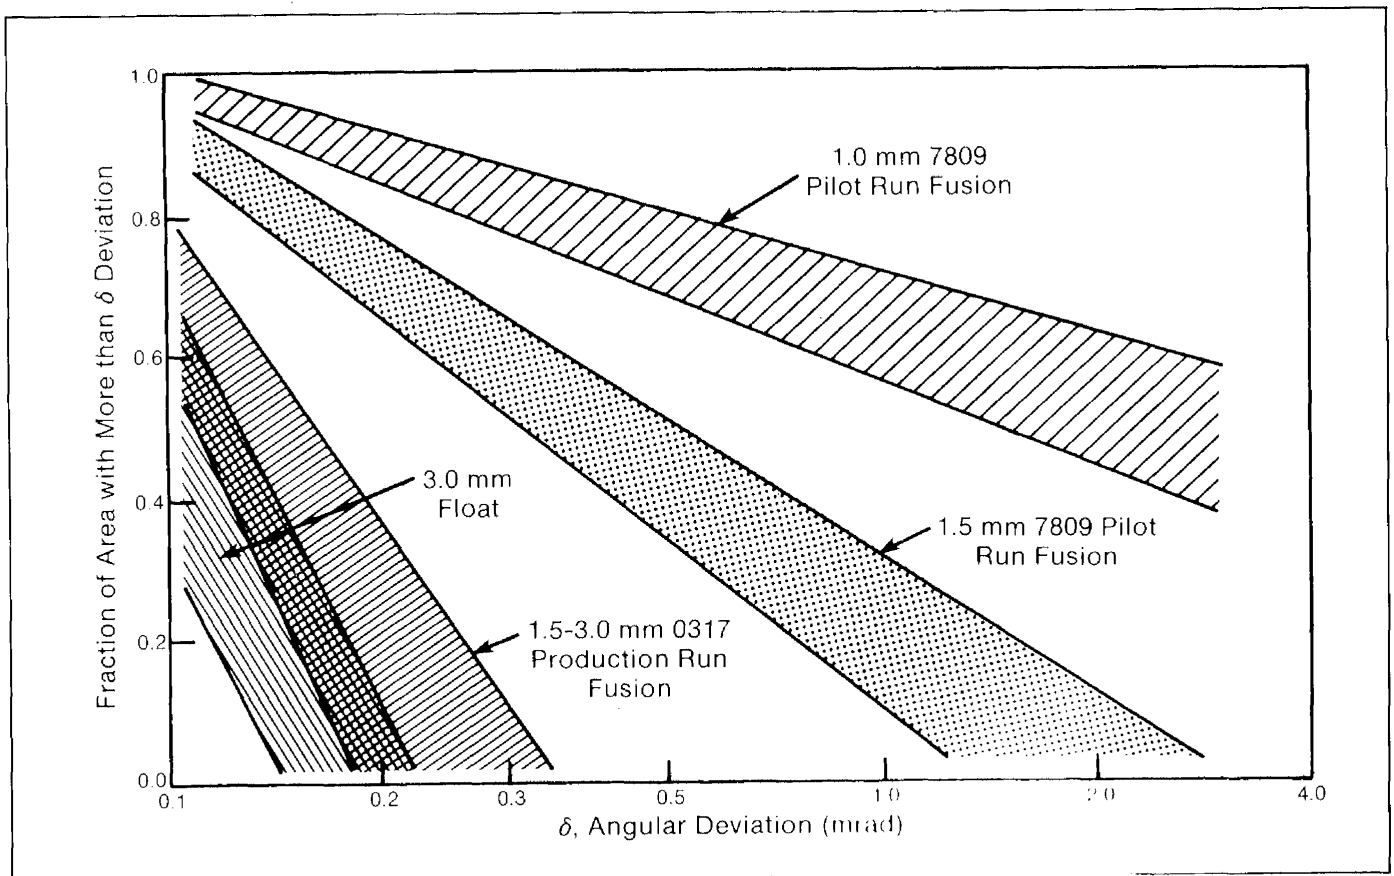
Figure 2-19 Fraction of Glass Surface Area with More than Angular Deviation from Specular Reflection (Coyle and Livingston 1981)

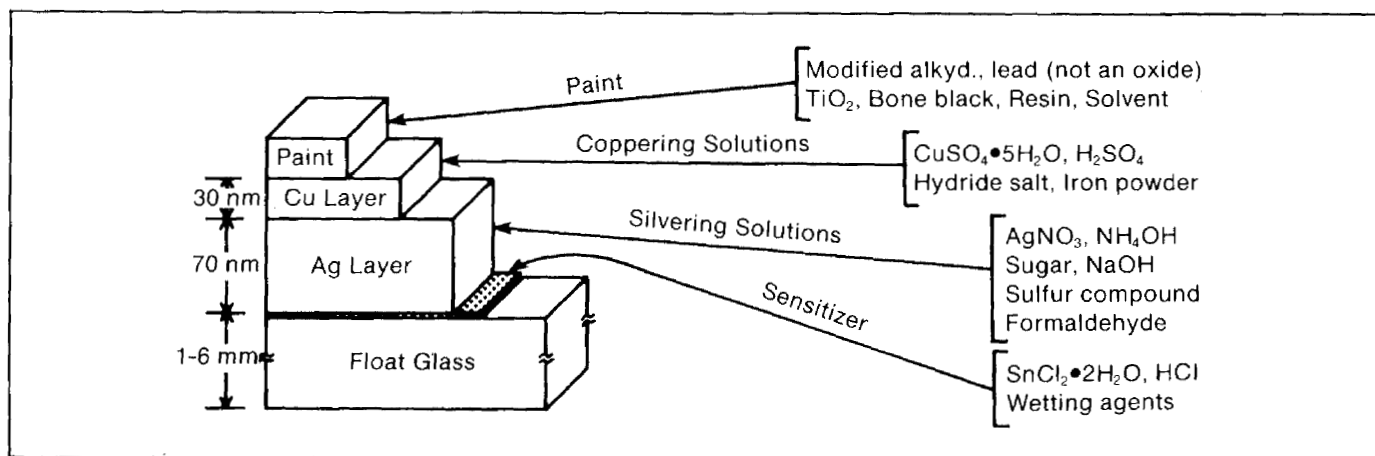
Figure 3-1 Morphology and Chemical Components Used in a Typical Commercial Mirror (Thomas 1983) [Not to scale]

The chemical components that are used to sensitize glass, to deposit silver and copper, and that are in a commercially used paint are shown in Figure 3-1, along with typical thicknesses of the various layers. The covalently bonded superstrate is in contact with the metalically bonded silver and copper layers, and these are bonded to the paint-backing layer. This section first considers the physics and chemistry involved in the step-by-step preparation of a mirror, then discusses the degradation reactions that occur or might occur at the various interfaces, and finally discusses the properties of both freshly prepared and degraded mirrors. Some recent research results will be appropriately included in each subsection.

The components in the paint (Figure 3-1) appear relatively inert, but surface analysis data revealed that Cl and S are also present, as shown in Figure 3-5. The

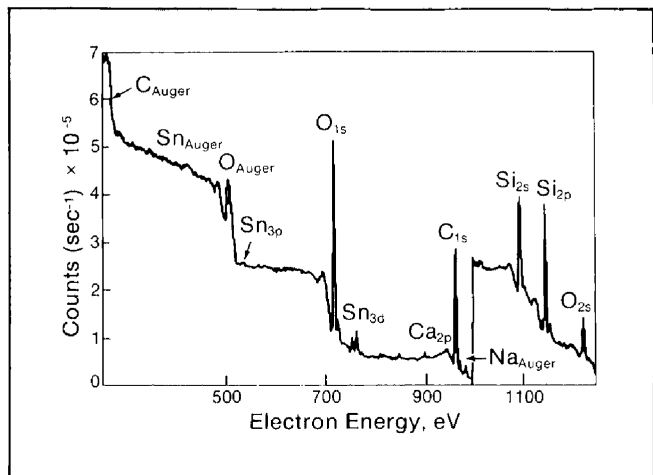
Figure 3-2 ESCA Survey of the Unspattered Air Surface of the Soda-Lime Silicate Float Glass (Pederson and Thomas 1980)

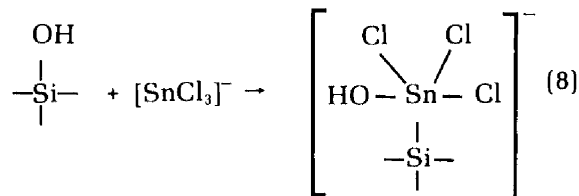
Upon sensitization of glass, it is found that (1) tin has bonded to the surface and cannot be rinsed away (Pederson 1980, 1982; Schweig 1973; deMinjer 1973), (2) the ability of tin to bond to glass is affected by glass cleanliness and wettability (Daniel 1980; Mills 1980; Goggin 1982), and (3) the chloride ions disappear with vigorous rinsing (Pederson 1980, 1982; deMinjer 1973). Thomas' (1983) model for sensitization suggests that  $[\text{SnCl}_3]^-$  initially inserts itself between the surface silicon to hydroxide bonds to form a five-coordinate tin complex on the glass surface

Upon formation of the tin complex, ligand exchange should be favored; in this way the chlorides may exchange readily with water or hydroxyl ligands during rinsing as illustrated in equation (9).

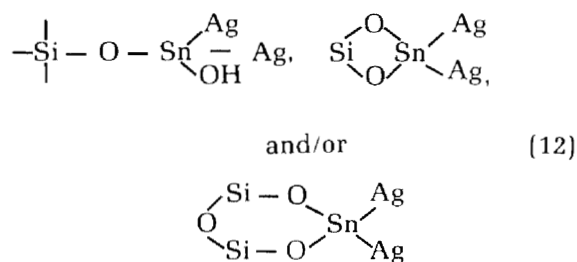
When other researchers applied the basic silver solution to sensitized glass without spraying the reducer so that the plating reaction could not take place (Pederson 1982; deMinjer 1973), they found that tin and silver both remain bound to the surface. A surface species was suggested by Pederson (1982) from XPS data whereby silver is bonded through the tin to the glass, with the Auger parameter data suggesting that silver is bonded covalently; i.e.,

after undergoing an oxidation-reduction reaction,

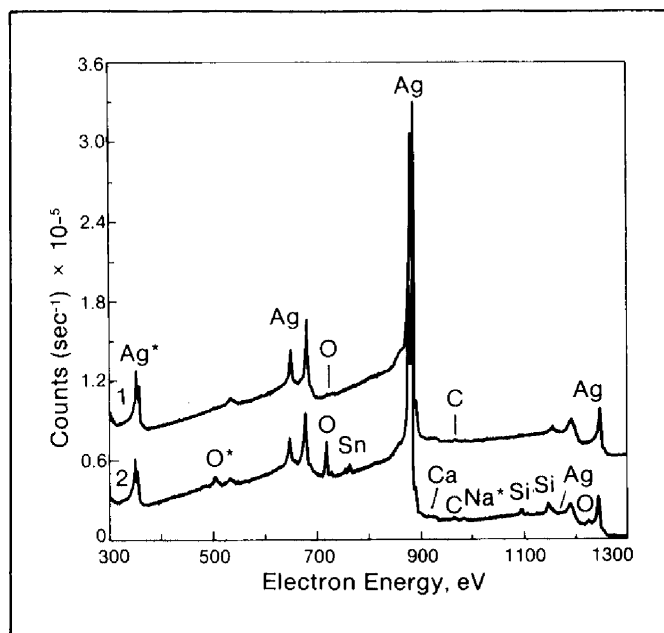
Figure 3-3 XPS Survey Scan of the Elements Present in the Bulk of the Silver Layer (spectrum 1). XPS Survey Scan of the Elements Present in the Silver/Glass Interface Region (spectrum 2). The asterisk indicates Auger signal (Thomas 1983)

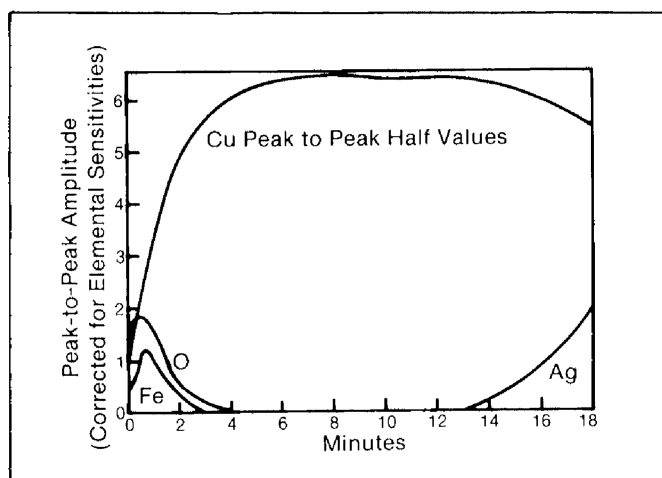
**Figure 3-4a Auger Electron Depth Profile Through the Copper Layer of a One Year Old Mirror after Removal of a Lacquer Backing with Acetone.** The profile has been corrected for elemental sensitivity factors as provided by Physical Electronics (Thomas 1983)

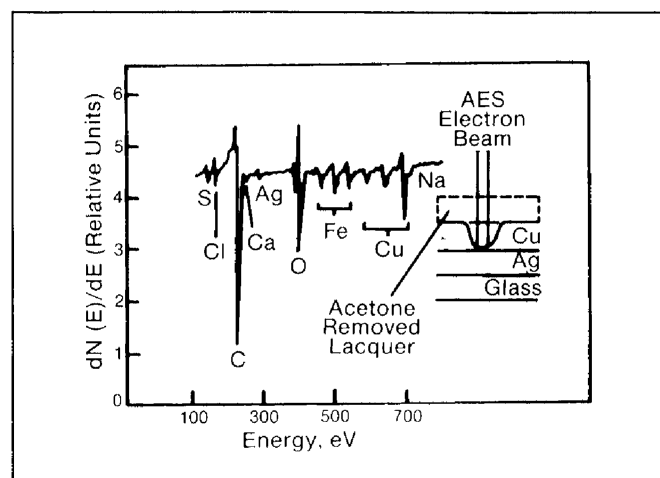
**Figure 3-4b Elements Present on Copper Surface (Zero Time) Shown Using an AES Scan (Thomas 1983)**

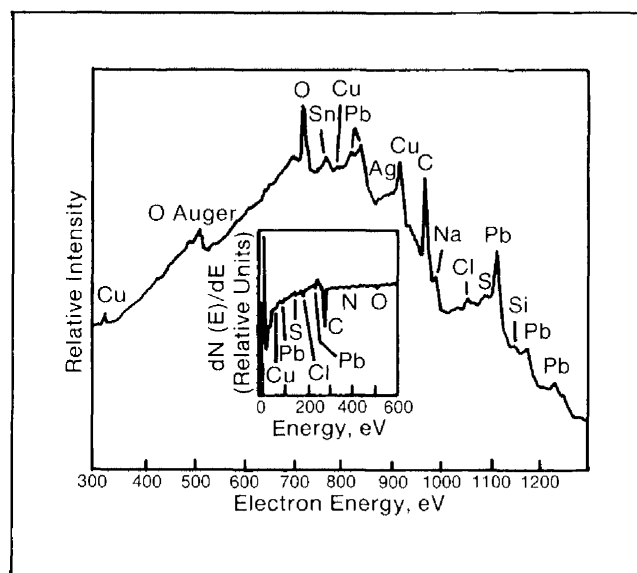
**Figure 3-5 XPS Survey Scan of Interfacial Residue on Mirror Paint After Adhesive Failure.** Inset is an AES of paint/copper surface (Thomas 1983)

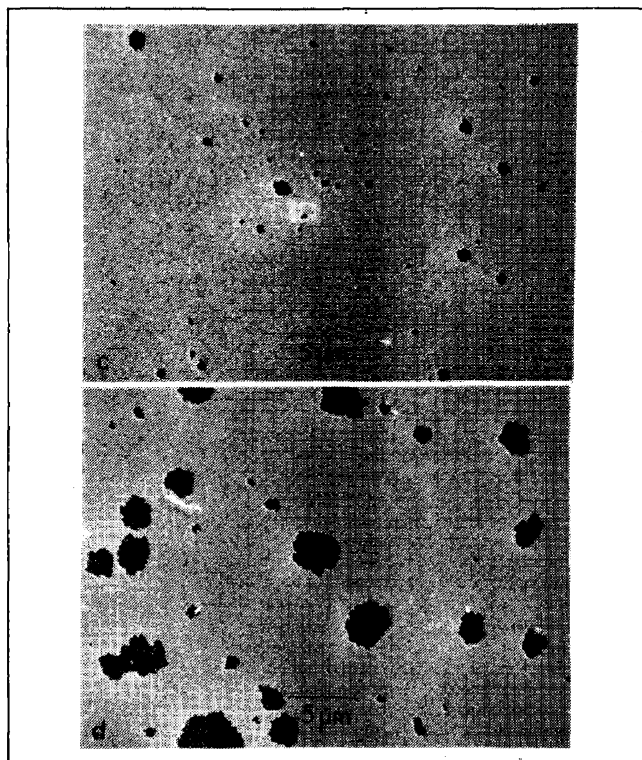
Figure 3-6 Scanning Electron Micrographs of Silver Films on Float Glass Exposed to 1000 ml of Distilled Water at  $90^\circ\text{C}$  (Vitko 1982)

SEM photographs showed that the pinholes enlarge as a function of exposure (Figure 3-6) and that the topographical features are similar to those for corroded heliostat mirrors (Figure 3-7). In accelerated

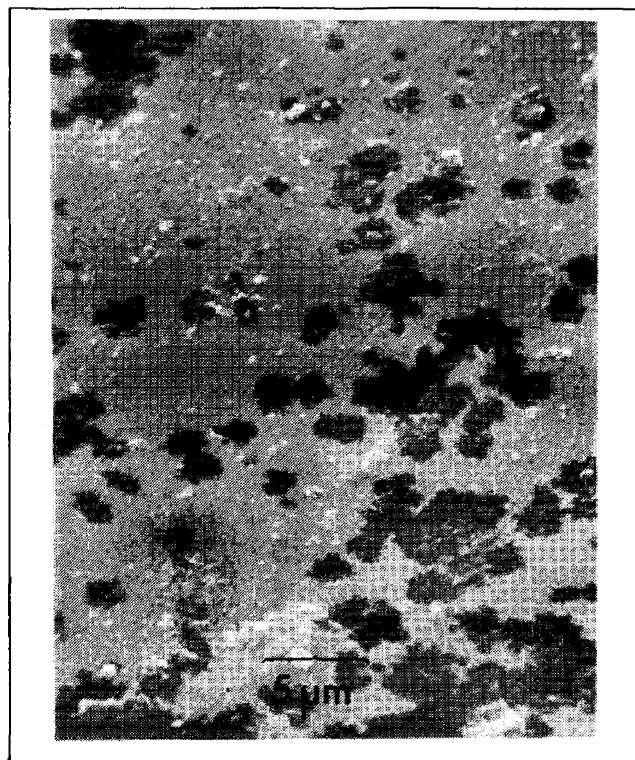
Figure 3-7 Scanning Electron Micrograph of a Field-Corroded Mirror (Vitko 1982)

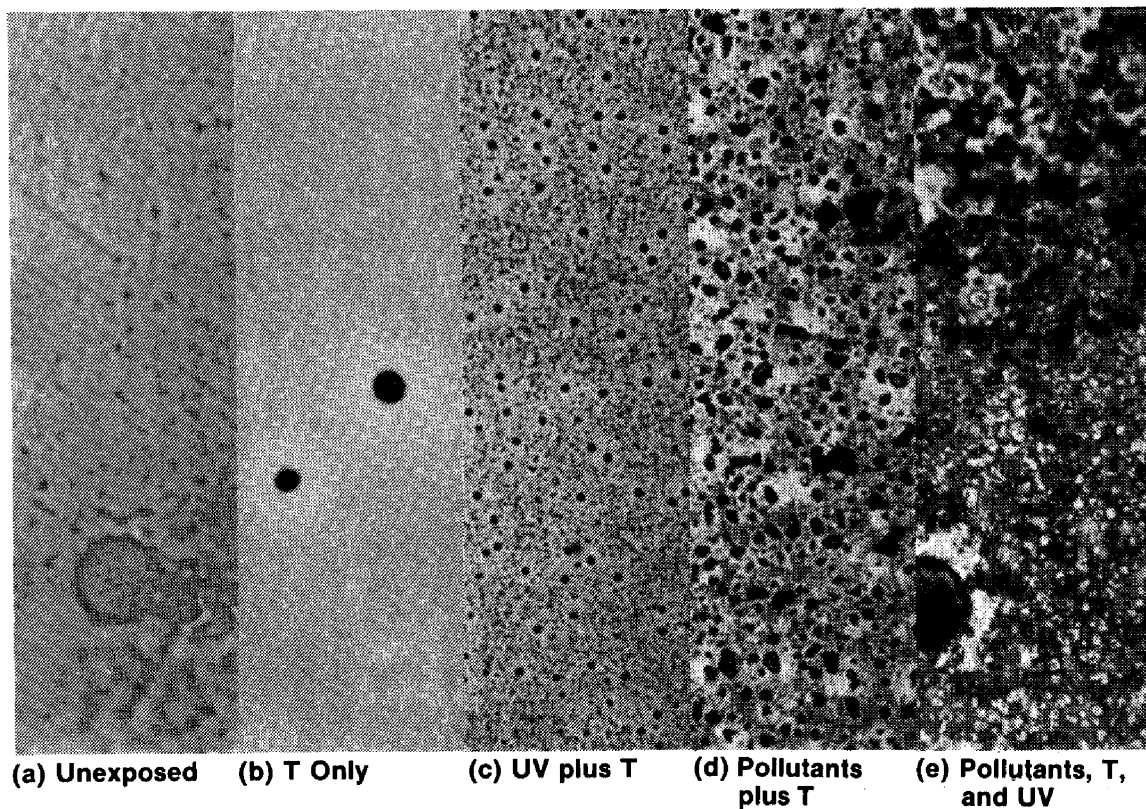
Figure 3-8 Photomicrographs of Undegraded Mirror (a) and After Two Weeks of Exposure to Combinations of T, UV, Pollutants, and Relative Humidity (Gupta 1982)

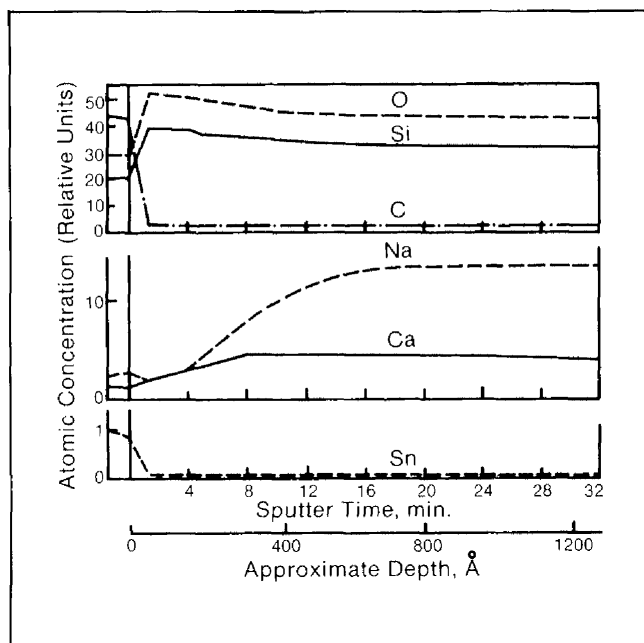
Figure 3-9 ESCA Depth Profile of the Surface in Figure 3-2 (Pederson and Thomas 1980)

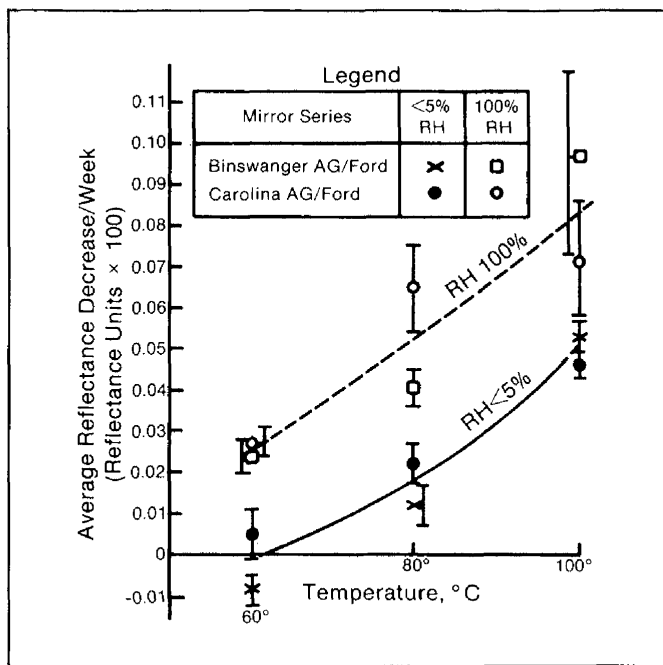
Figure 4-2 Dependence of Degradation in Reflectance on Temperature for High and Low Relative Humidity Using Select, Quality Commercial Mirrors (Masterson 1983b)

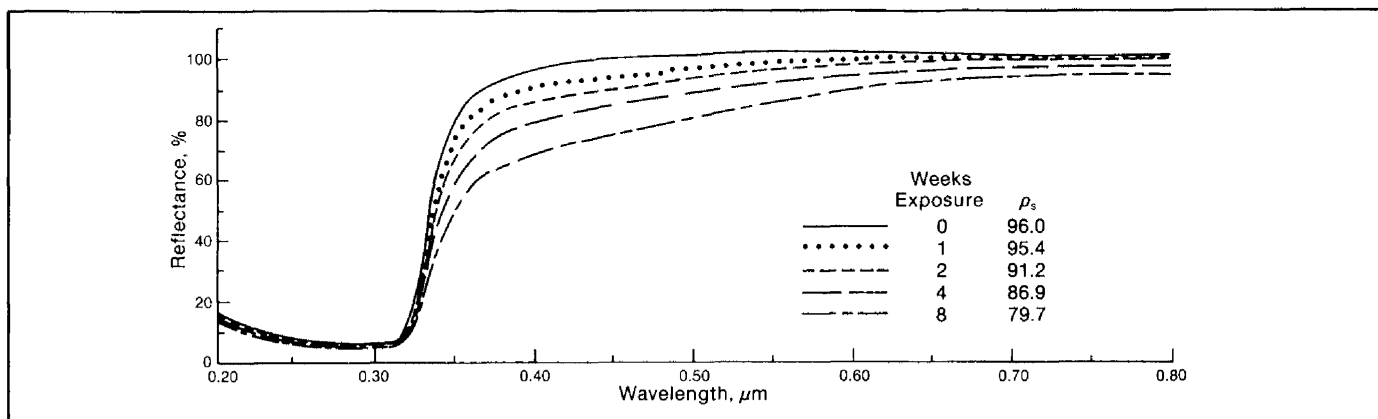
Figure 4-3 Spectral Hemispherical Reflectance for Different Exposures of a Commercial Mirror [Values for the exposure periods and the solar-weighted reflectance ( $\rho_s$ ) are shown in the legend.] (Masterson and Lind 1983a)

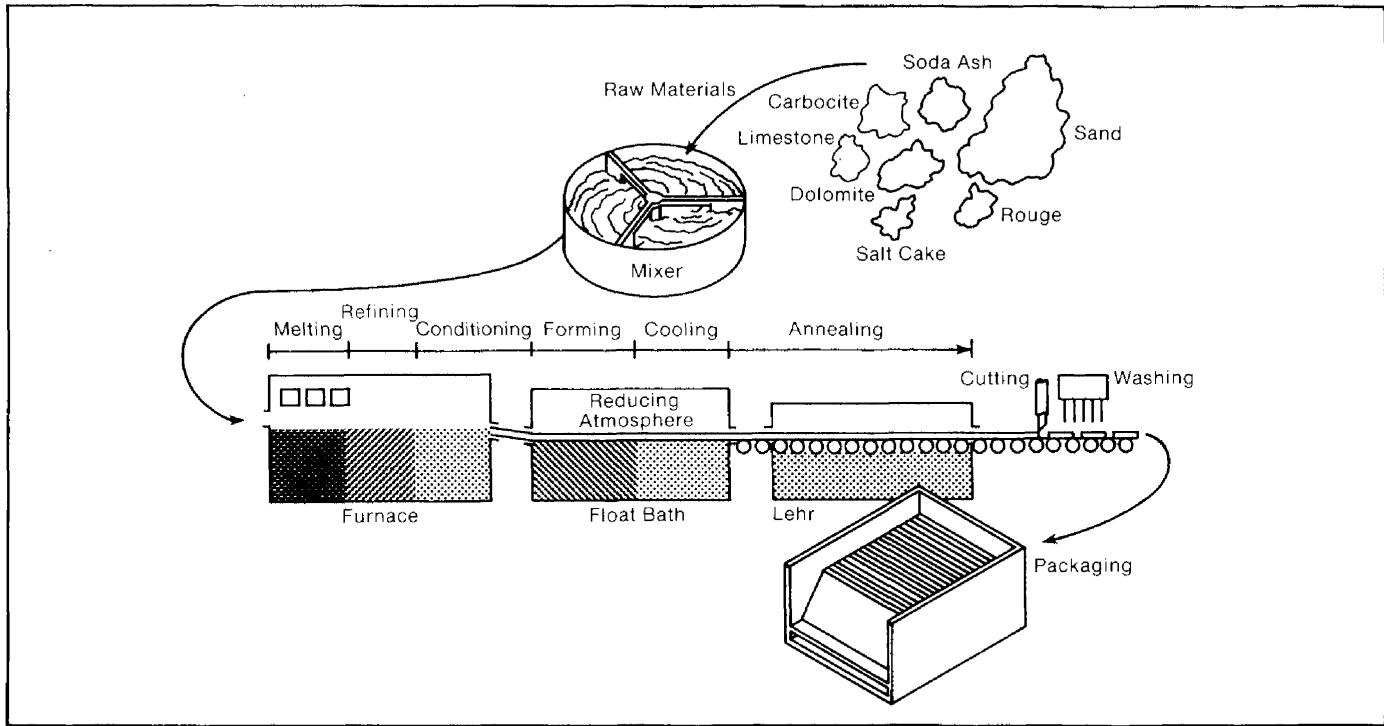
Figure 5-1 Schematic Drawing of the Float Glass Manufacturing Process (Lind et al. 1979)

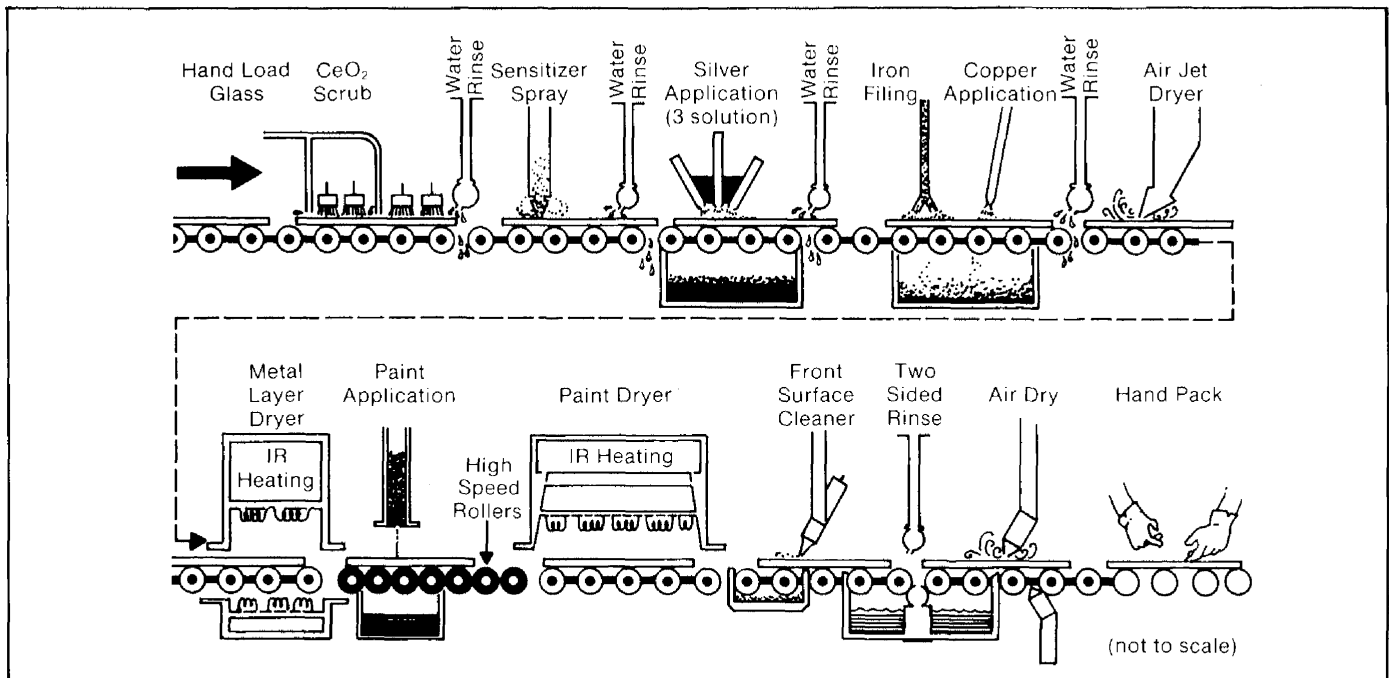
Figure 5-2 Wet-Chemistry Mirror Production Sequence (Lind et al. 1979)

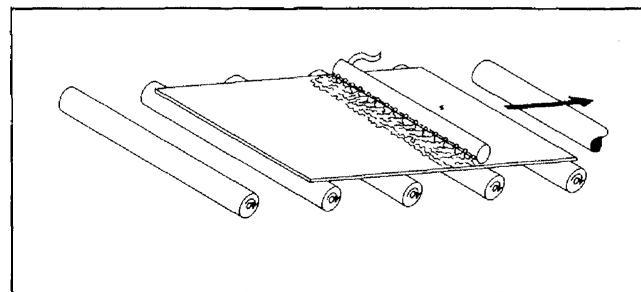
**Figure 5-4 Water-Rinse Mechanism Using Directed Water Spray to Rinse Process Residuals Off Rear Edge of Glass (Lind et al. 1979)**

The slurry residue is then rinsed from the surface using water nozzles directed against the direction of glass motion (Figure 5-4). This moves the residue

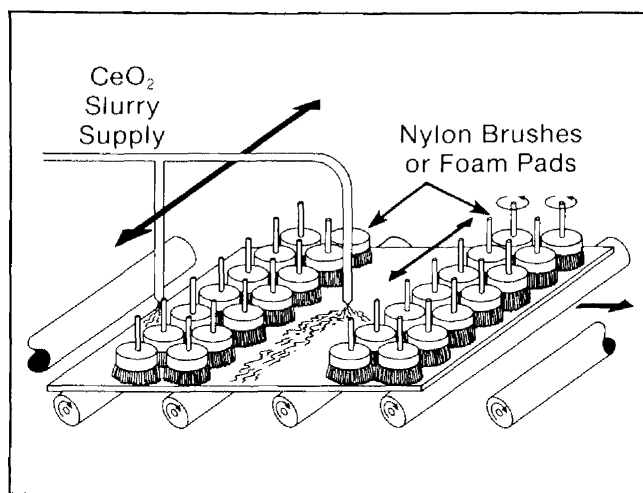
**Figure 5-3 Abrasive Glass-Scrubber Using Continuous Slurry Application and Oscillating Assemblies of Rotating Brushes (Lind et al. 1979)**

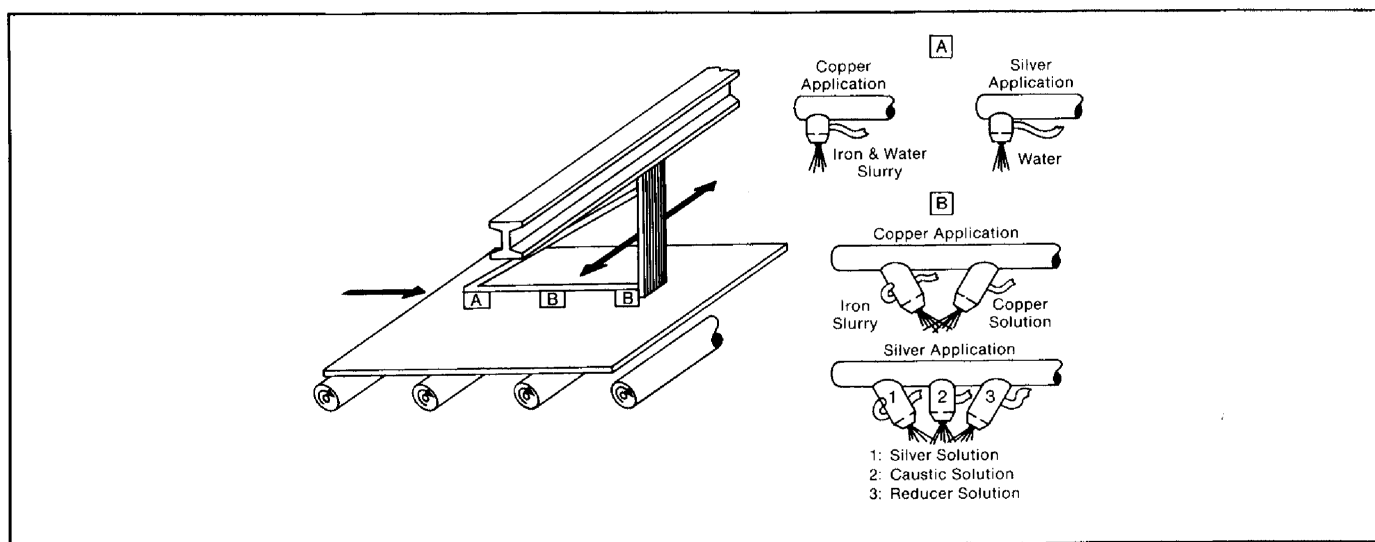
**Figure 5-5 Reciprocating Spray Chemical-Applicator for Wet-Chemistry Mirroring Solutions.** Specific nozzle arrangements are shown for a galvanic copper and a three-part silver process. The details A and B (on right) represent the nozzles placed at A and B on left of illustration. (Lind et al. 1979)

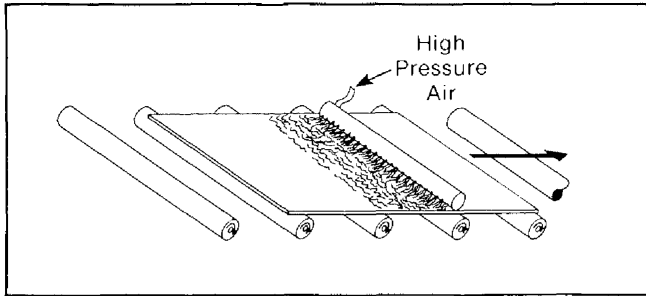
**Figure 5-6 Air-Jet Drying Station Using Directed Air Flow to Force Process Residuals Off Back Edge of Moving Glass Sheet** (Lind et al. 1979)

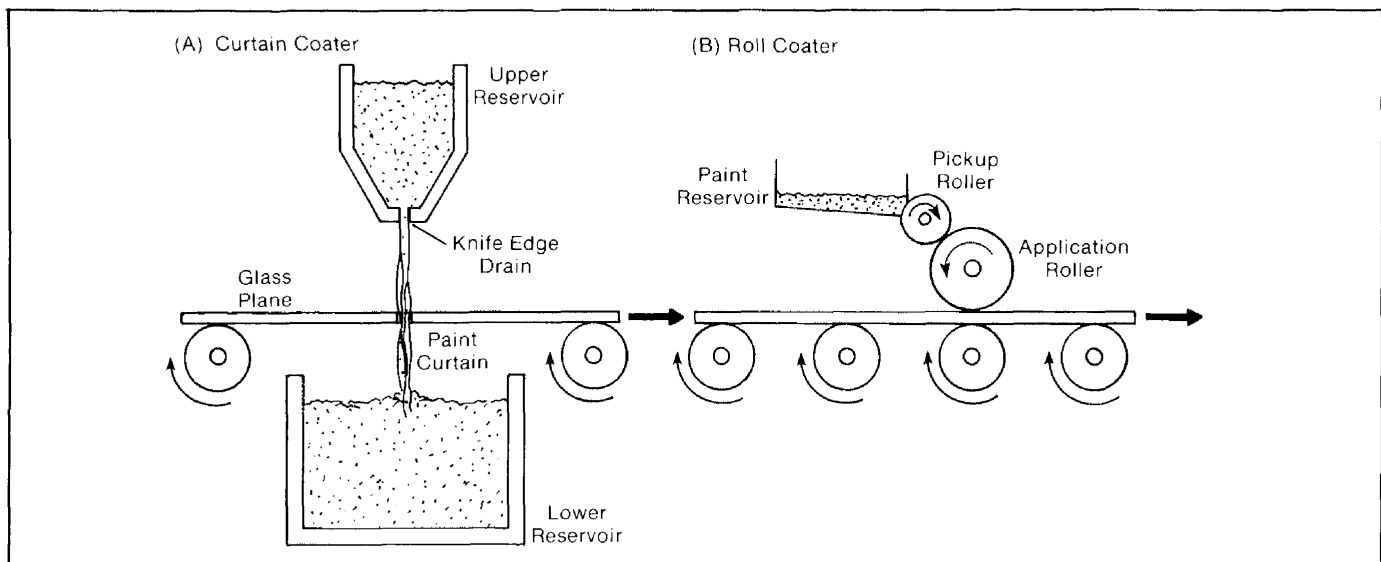
**Figure 5-7 Cross-Section View of Two Types of Paint Applicators** (Lind et al. 1979)

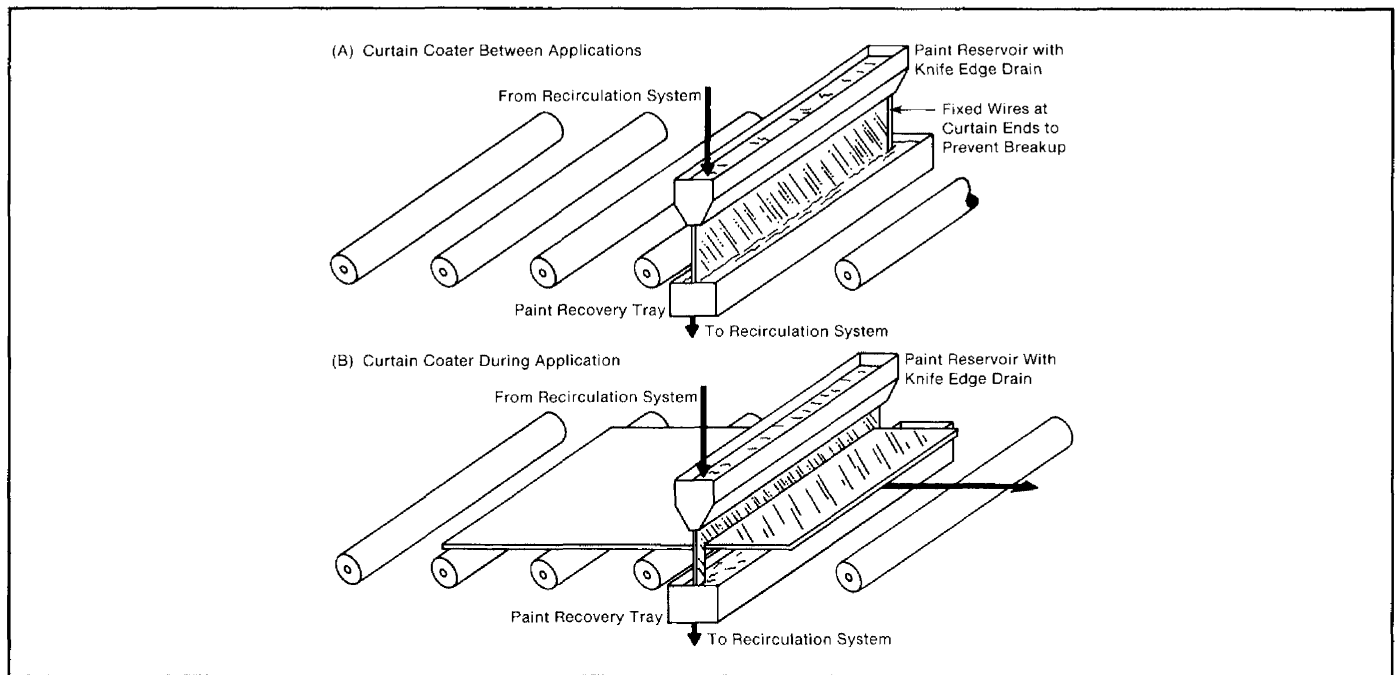
Figure 5-8 Curtain-Coater Operation: (A) Between Applications, and (B) During Application (Lind et al. 1979)
