# Silver/Glass Mirrors for Solar Thermal Systems

SERI/SP-271-2293

June 1985

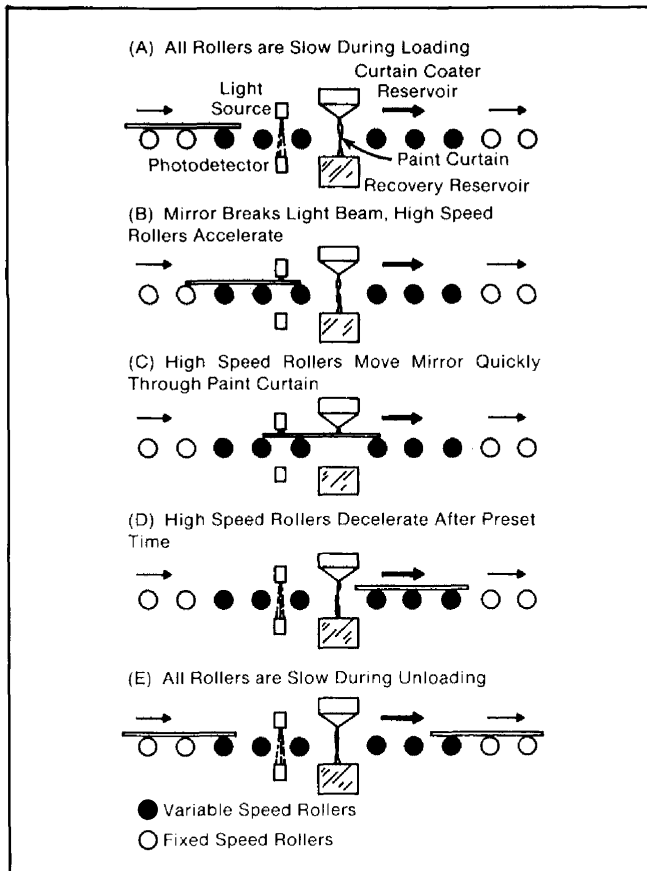
**Figure 5-9 Production Sequence for Variable-Speed Roller Section Associated with Curtain-Coater Operation** (Lind et al. 1979)

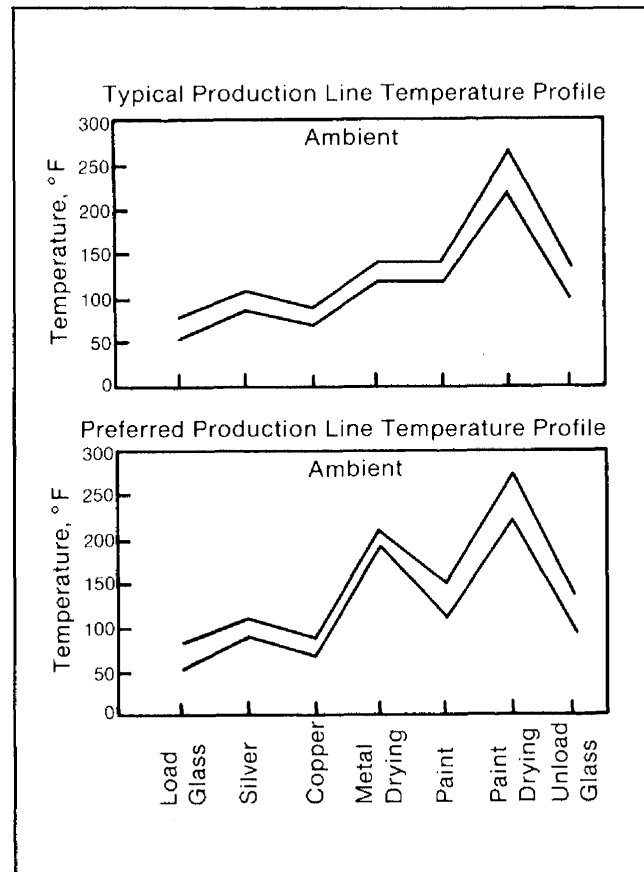
**Figure 5-10 Production-Line Temperature Profiles** (Lind et al. 1979)
